Reading GreenPark Village Clembins geotechnical works monitoring

Archaeological Watching Brief Report

Document Title: Reading GreenPark Village - Clembins geotechnical works monitoring

Document Type: Watching Brief

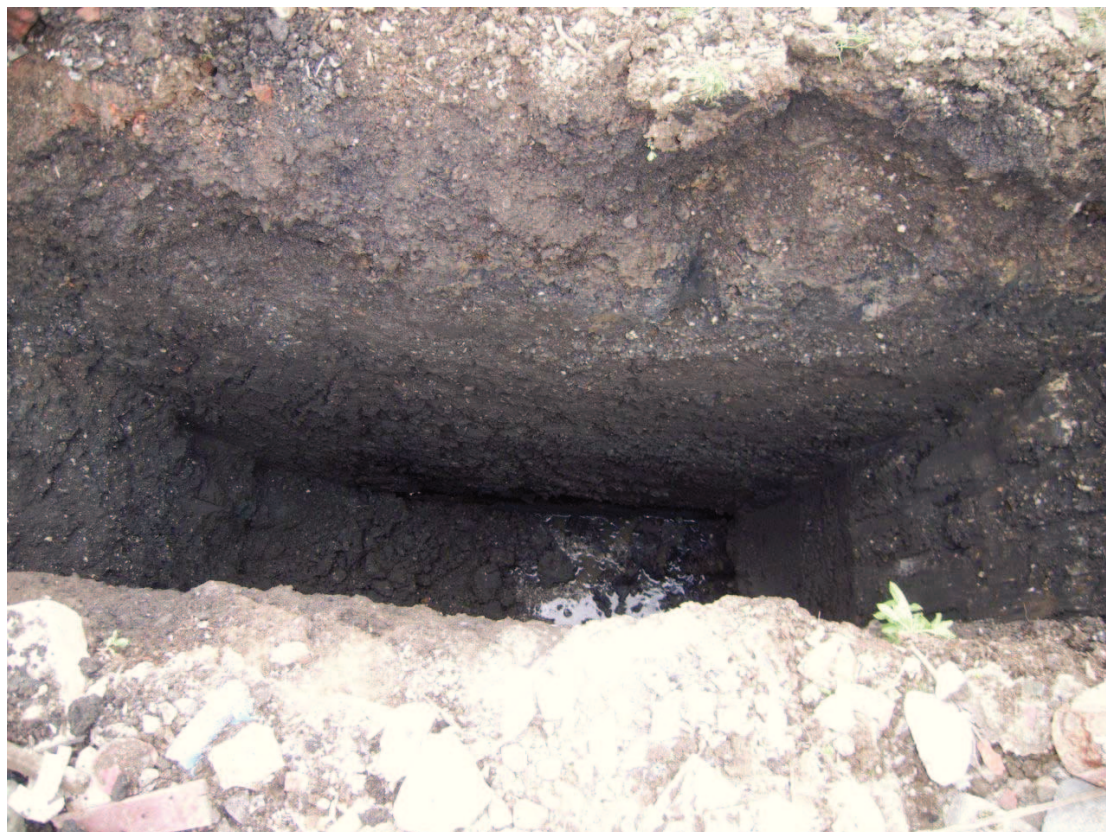
Plate 1
Test pit E showing undated, possibly archaeological fills

- 4.1.3 Test Pits A, B, E, F, H and L: Deposits in these Test Pits represent gravel truncation and infilling. However the deposits contained no identifiable modern artefacts and were not visually clearly recent depositions (i.e very mixed or loose). The deposits are reminiscent of feature (large pit/waterhole) fills recorded in the Bronze Age sites

to the south and south east (*pers comm.* R.Brown and Brossler et al 2004/5) and should be regarded as potentially of archaeological significance.

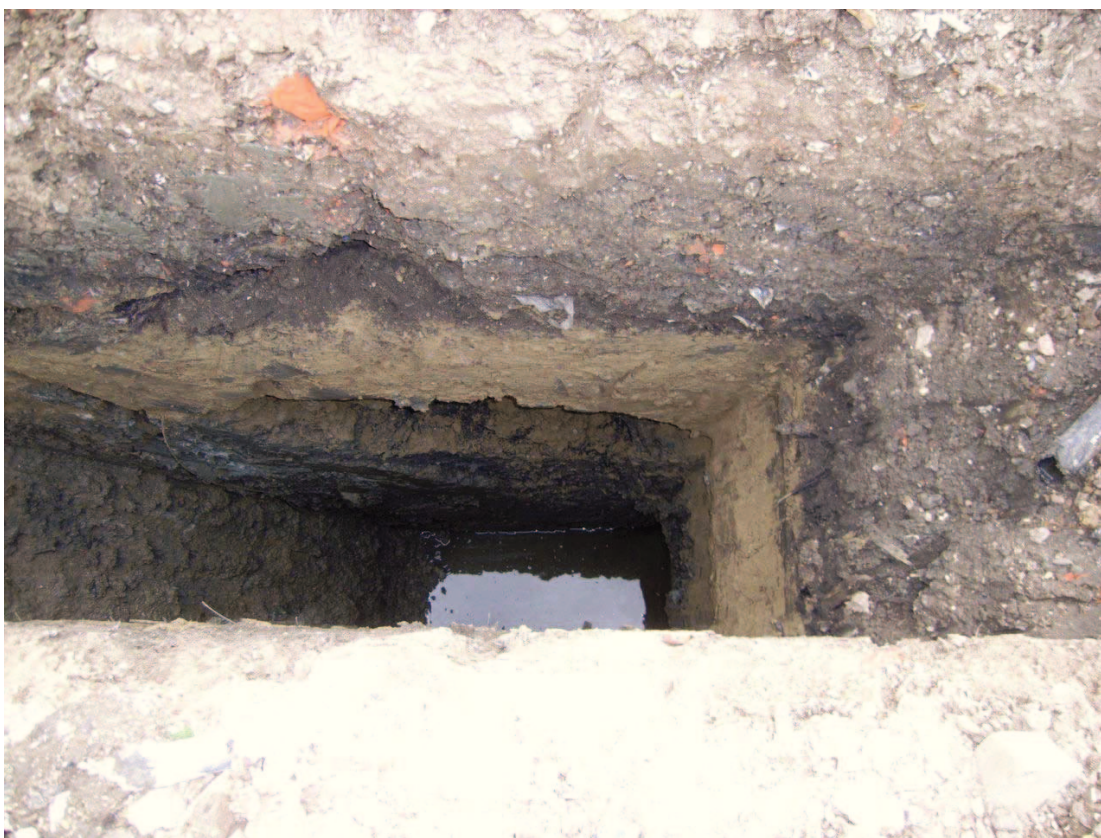
Plate 2
Test Pit I showing deep modern dumped deposits

- 4.1.2 Test Pits I, J and K: These Test Pits evidenced bulk infilling of a modern quarry/lake. Between 1961 and 1976 a large quarry appears in the north-western part of the site (OA 2007). Comparison of the 1991 Ordnance Survey 1:25,000 Scale Map (Fig.1) and recent aerial photos (OA 2007, Fig.8) show that in recent years the north-west corner of this quarry/lake has been filled in. This corresponds to the location of Test Pits I, J and K.
