New Hall School Essex (Time Team Palaces Special)

Archaeological Evaluation Report

Issue No: V1
OA Job No: 4341
NGR: TL 734 102

Three evaluation trenches were excavated in order to establish the extent, condition and date range of archaeological remains of a Tudor Palace of New Hall (otherwise known as Beaulieu Palace). The trench location addressed the specific Project Aims outlined for three major areas of investigation: the Gatehouse, the Chapel and the West Wing (Trenches 1, 2 and 3 respectively).

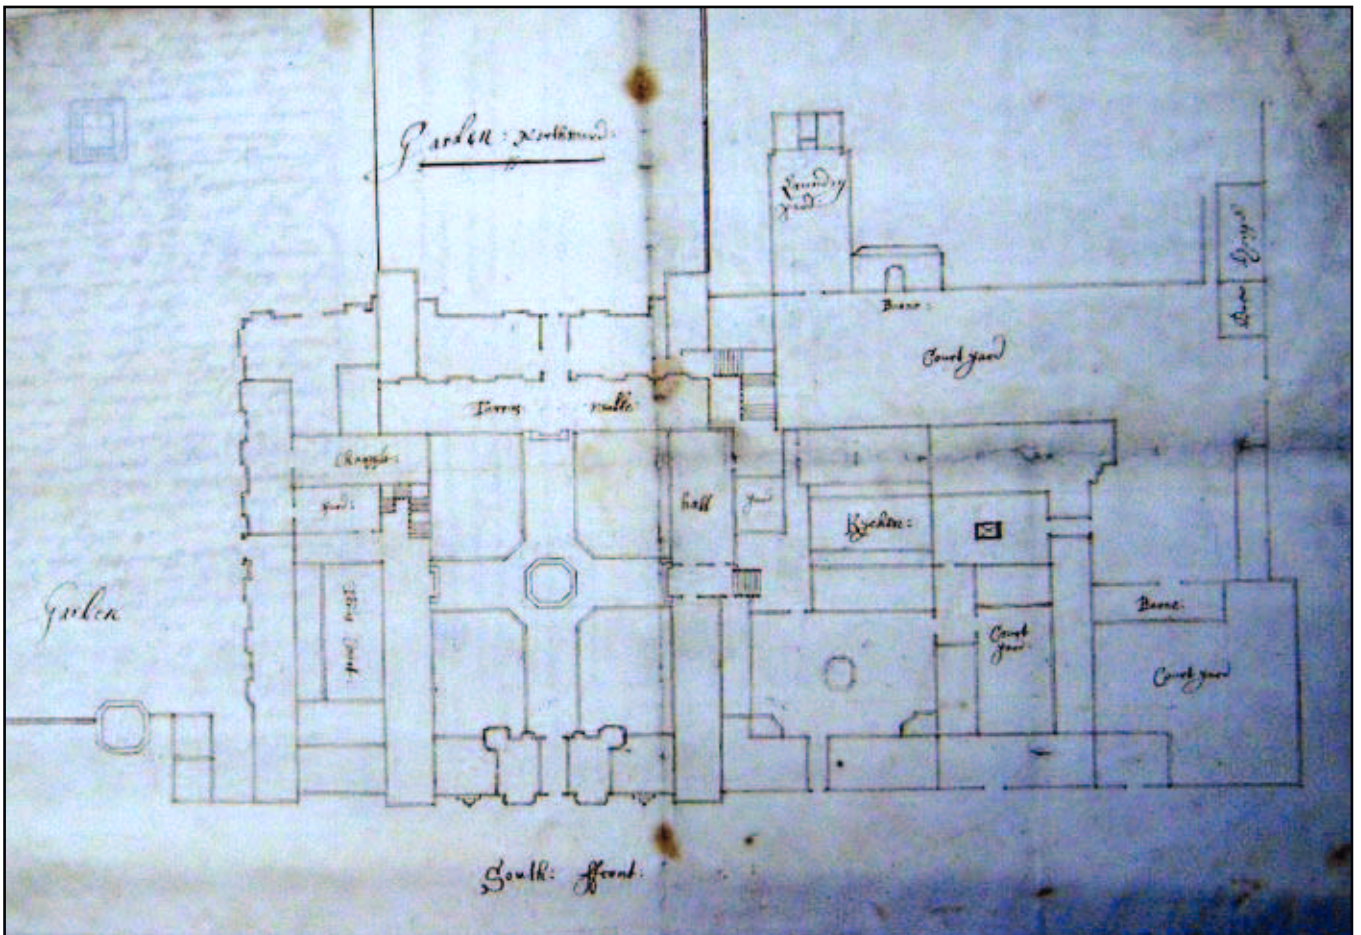
Plate 2: New Hall, 1624 plan

- 3.7.11 The evidence – the small part shown as ‘Garden’ on the 1624 plan (Plate 2), and lack of any change of use through later maps and plans - would indicate that this block to the west of the house continued to be the principal garden area throughout the 17th century and later periods. The 1624 map shows a ‘Garden’ also to the north of the main entrance range. By this stage this may have replaced a former courtyard of buildings (including the King’s apartments), although it is likely that there would have been a ‘Privy’ garden on this north side, either to the east or west of this area. To the south of the ha-ha, a block of open ground c 360m long by c 120m wide, which continues the southern boundary of the ‘Wilderness’ appears also to have always formed part of the setting of the 16th-century palace and later house, probably as open space. The wide approach avenue called ‘The Walk’ which leads from the London Road to the south, and now truncated by the A138, forms a perfectly symmetrical approach to the gatehouse of the 16th-century palace. Although this may have had changes to it during the 17th century its origins are likely to be associated with Henry VIII’s development of the site.

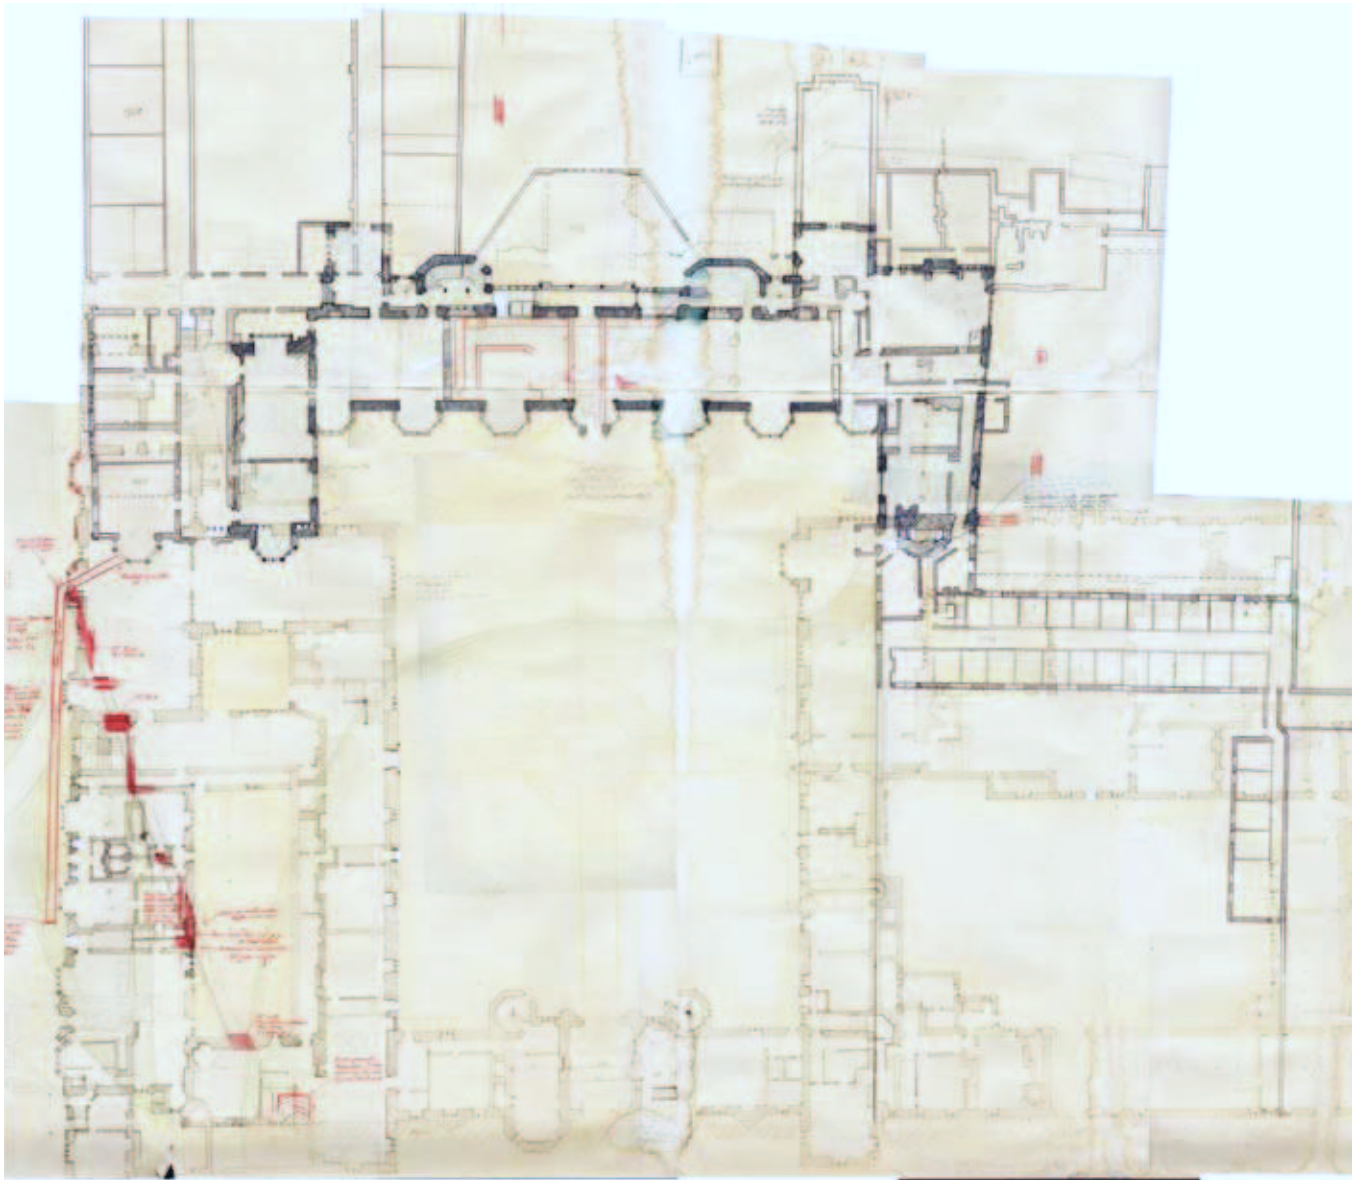
Plate 3: Plan showing archaeological discoveries at New Hall by Sister Mary Stephen

- 1.3.23 According to the Essex Historic Environment Record, no formal archaeological work has been undertaken at New Hall. However, in 1968, during the construction of a new building to the north of the current wing, foundations were unearthed by workmen and recorded on a plan by Sister Mary Stephen (see plan, Plate 3):

“When digging at the back of the house in connection with a new building, we came across what our architect considered to be the earth floor of a medieval manor, revealed by layers of oyster shells. This was six or seven feet below ground. And in front of the house, nearly four feet below ground level, we found a floor of large, irregular cobblestones.”(Stephen 1996)

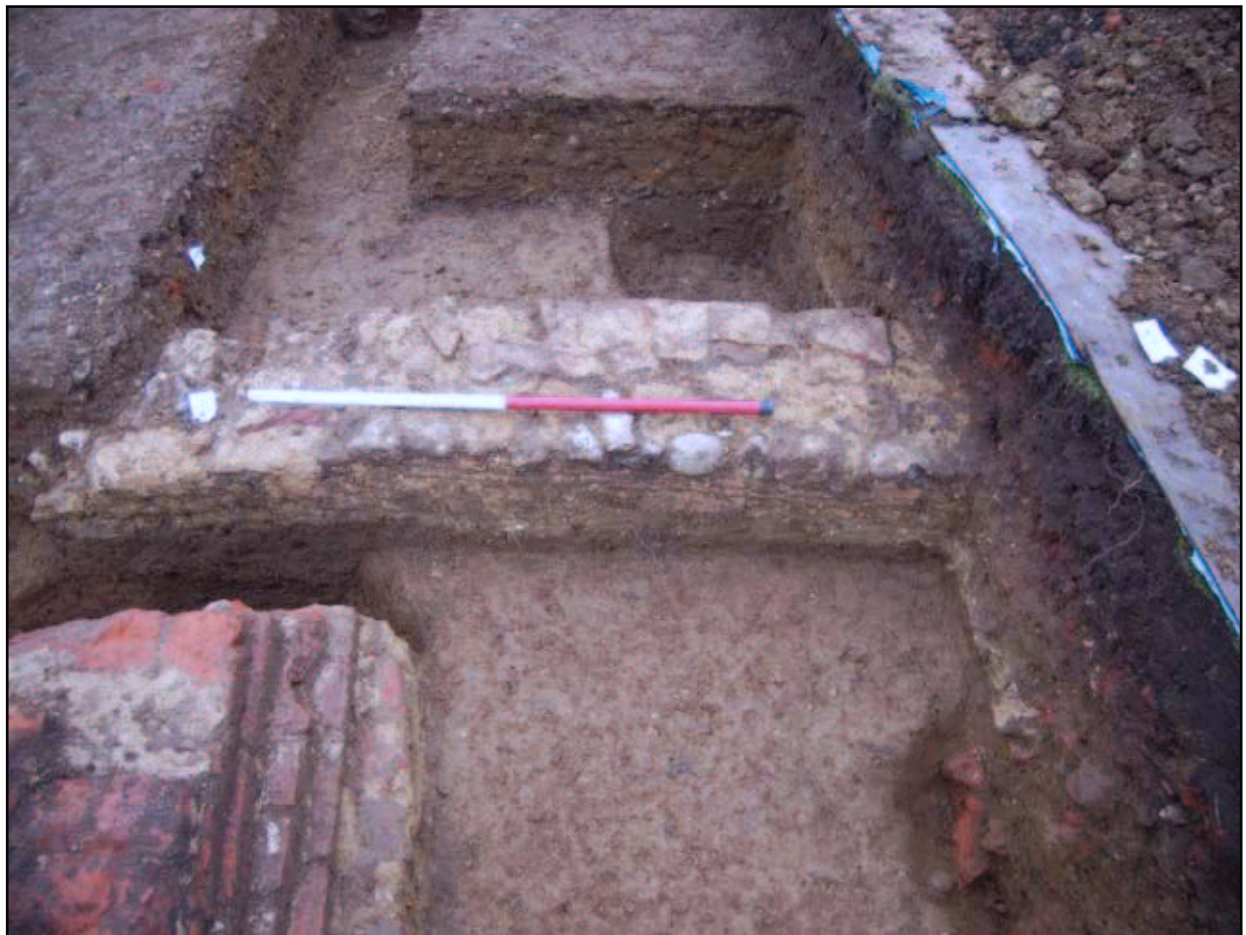
Plate 6: Trench 1, Medieval wall *122*

- 3.2.6 Wall 122 (Plate 6), which was aligned N-S, measured 0.40 m wide and was observed for a length of c. 1.9 m within the trench. A northern terminus was exposed in a sondage, however it appears that it was subjected to a heavy truncation, which might have removed a possible return to the west. The wall was preserved to a maximum height of 0.24 m. The structure was built of layers of flint nodules and horizontal ceramic roof tiles. Up to three such courses were preserved.

- 4.2.8 The excavations revealed that the Tudor structures replaced earlier, medieval buildings, remains of which were represented by wall 122.

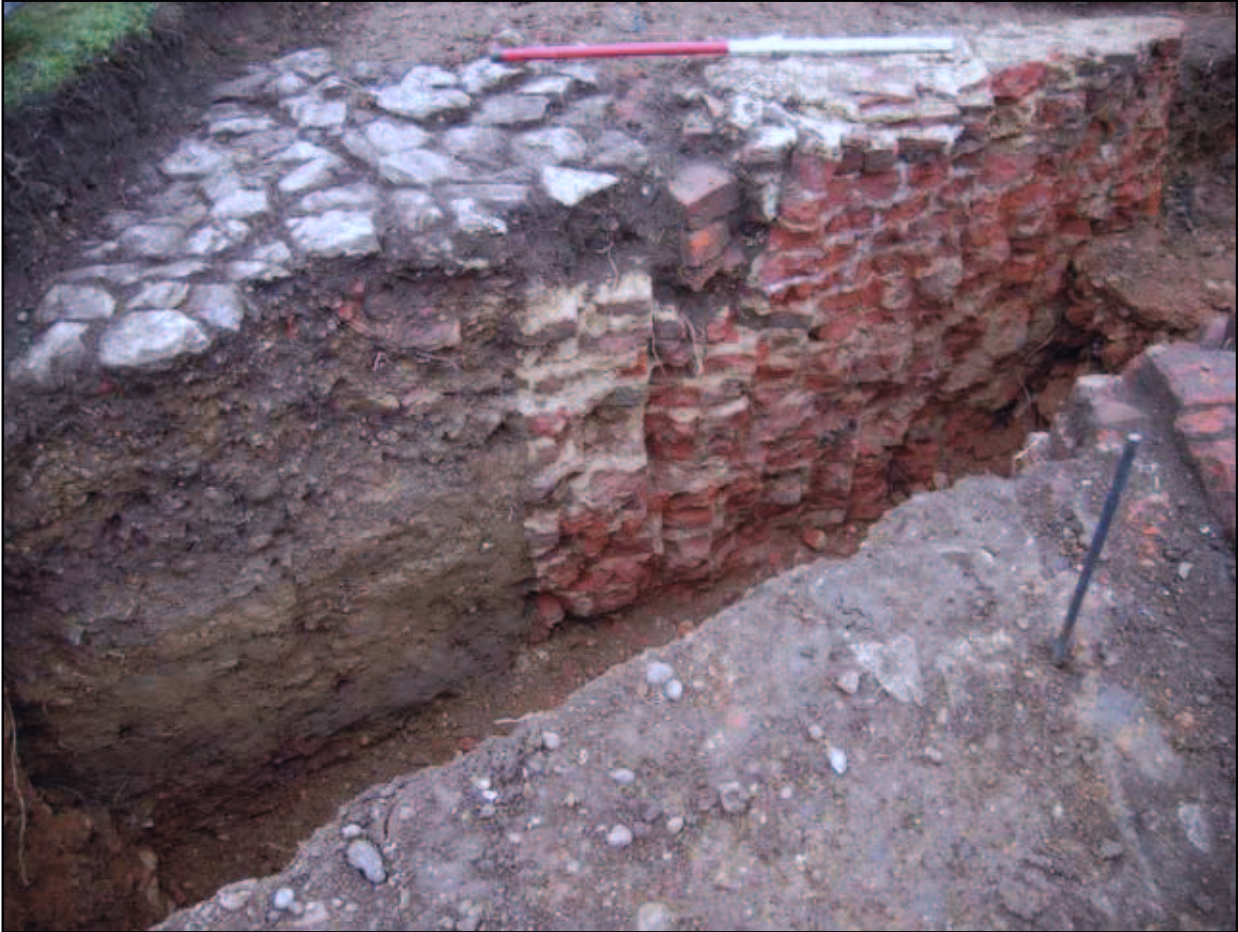
Plate 7: Trench 1, Section through foundations of the Gatehouse, context 115 and later ragstone cobble 120

- 4.3.14 The brick walls [112 and 115] of the Gatehouse measured approximately c. 1 m (3 ft 4 in) in width and were set on substantial stepped brick-built foundations, with a maximum width of c. 1.82 m (nearly 6 ft). The foundations may have been built to this size because there was a soft spot as result of the of feature represented by cut 168 (see 4.3.6 above). This suggests that they were perfectly capable of bearing significant loads, therefore allowing construction of walls of a considerable height.

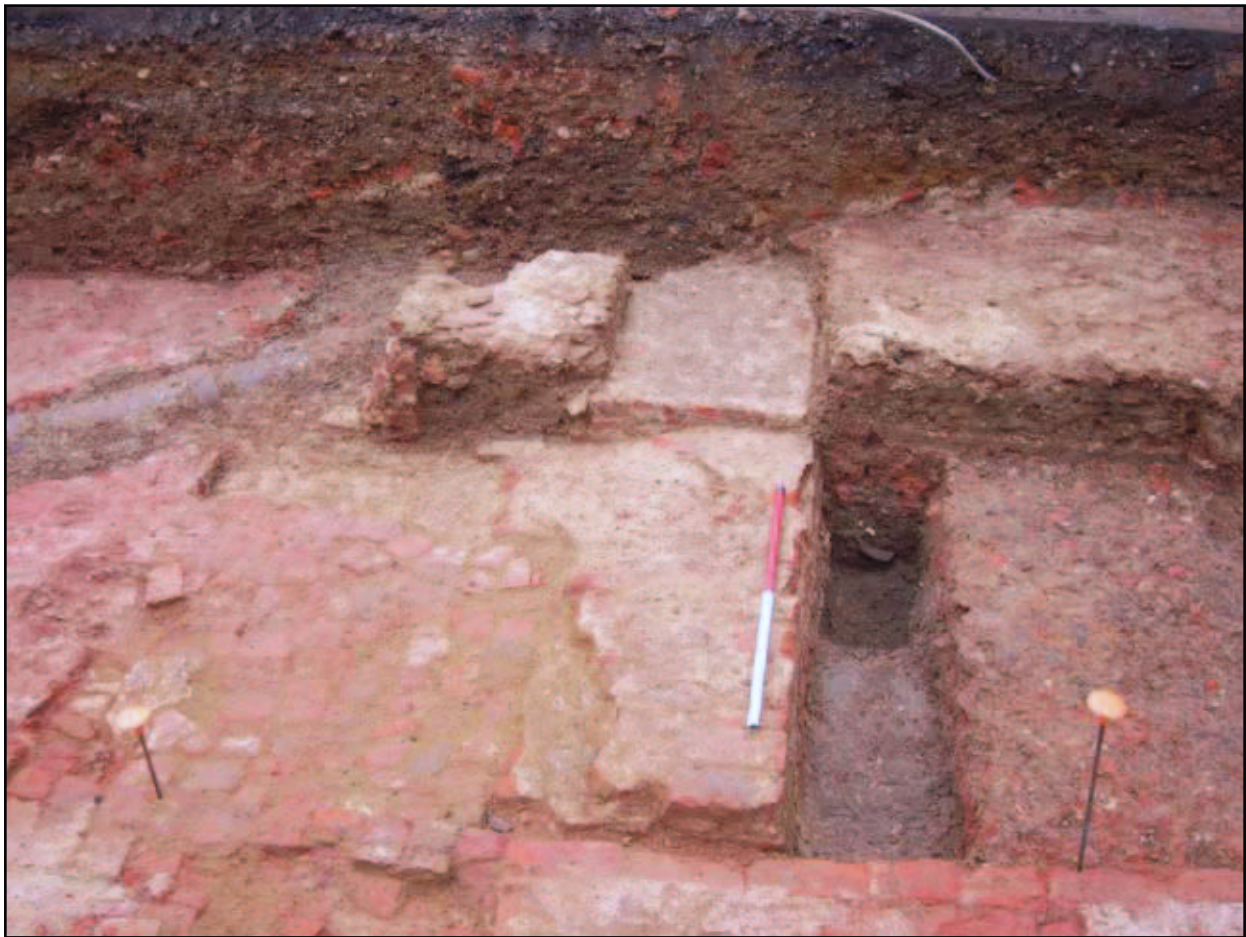
Plate 9: Trench 2, showing walls *212* and *114* with their footings cut through floor makeup layers

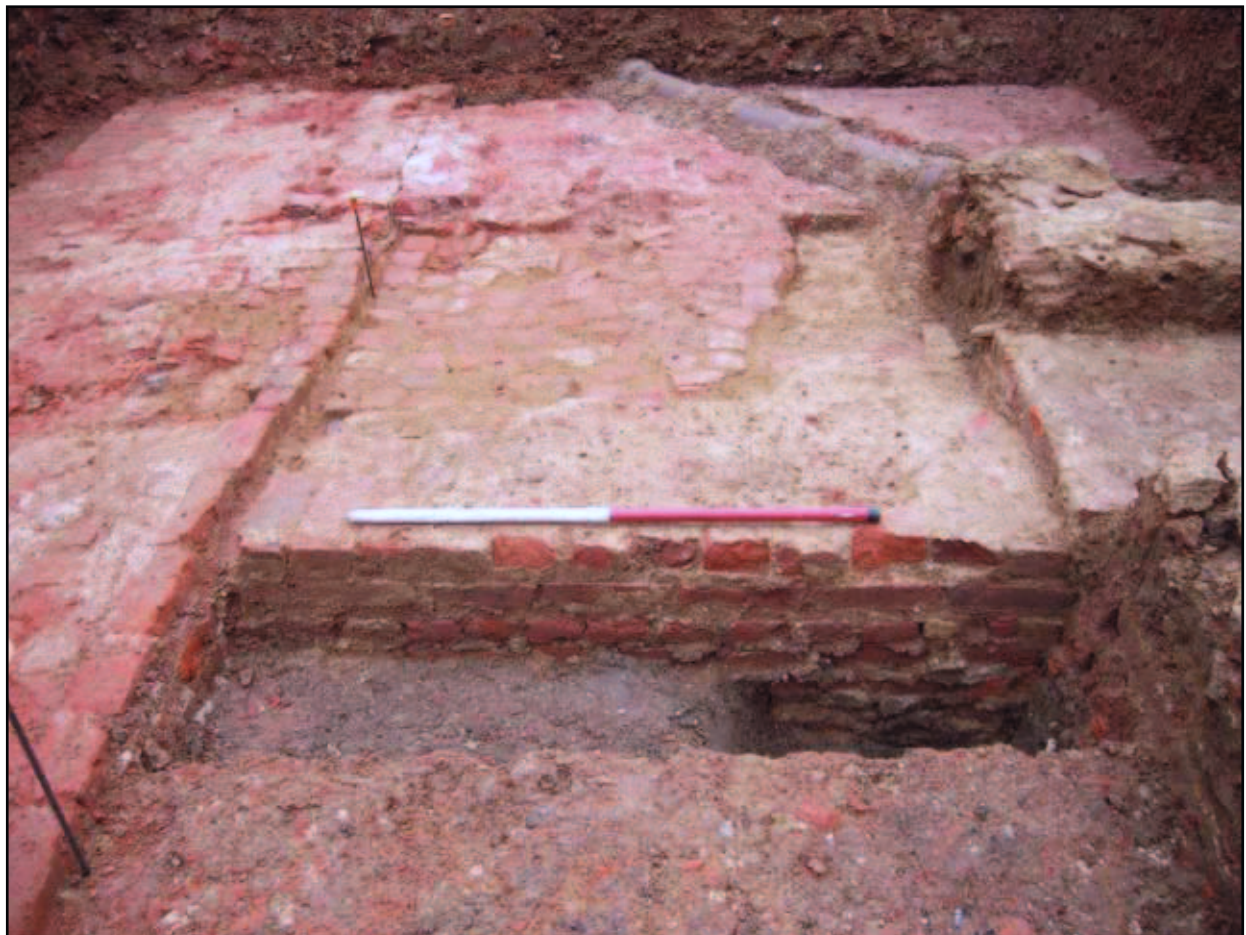
Plate 10: Trench 2, showing wall *214*, with brick levelling *210* beyond in the angle between the main chapel walls *208* and *207*. Also clear is the straight joint between wall *208* and wall *207*.

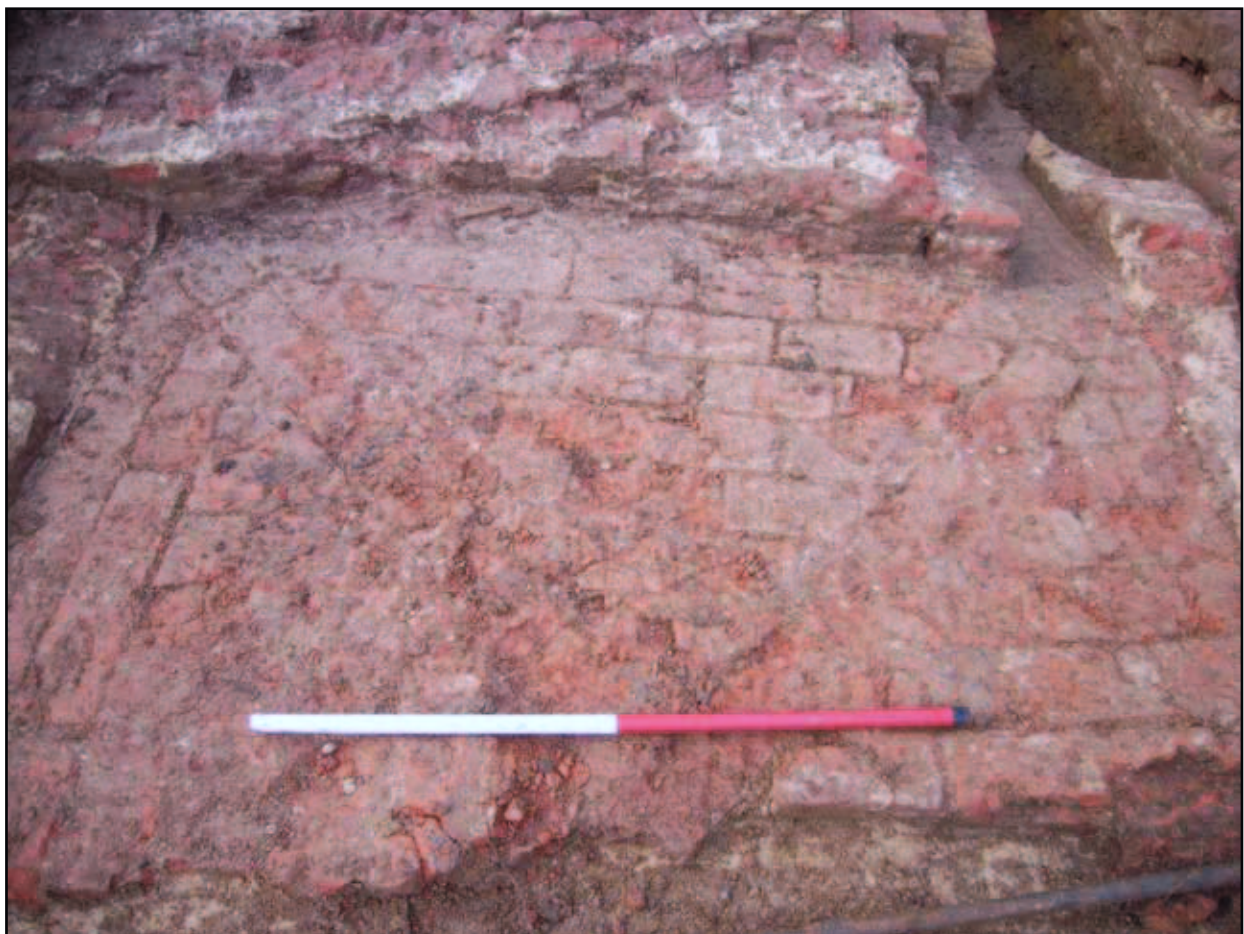
Plate 12: Trench 3, Detail of a brick floor 327. Note that wall 312 is cut back in an arc from floor 327

- 3.4.12 The north western corner of the floor surface [323] in the S room opened into a brick drain 322 which cut through the foundation wall 312 (Plates 12-13). The overall width of the drain was c. 1.2 m (or 4ft) and it is likely that the floor surface [316] in the N room also opened into the drain at its SW corner. However this relationship was removed by later truncation (Plate 14). However, the channel of drain 322 appears to have been Y-shaped in plan, with two outlets leading from the building's interior, and joining into one channel just outside wall 312. The channels would have draining the waste away from the two excavated rooms. The bricks used measured 240 mm x 110 mm x 50 mm (9½ in x 4¼ in x 2 in) and were bonded with a white lime mortar used in other structures of this construction phase.

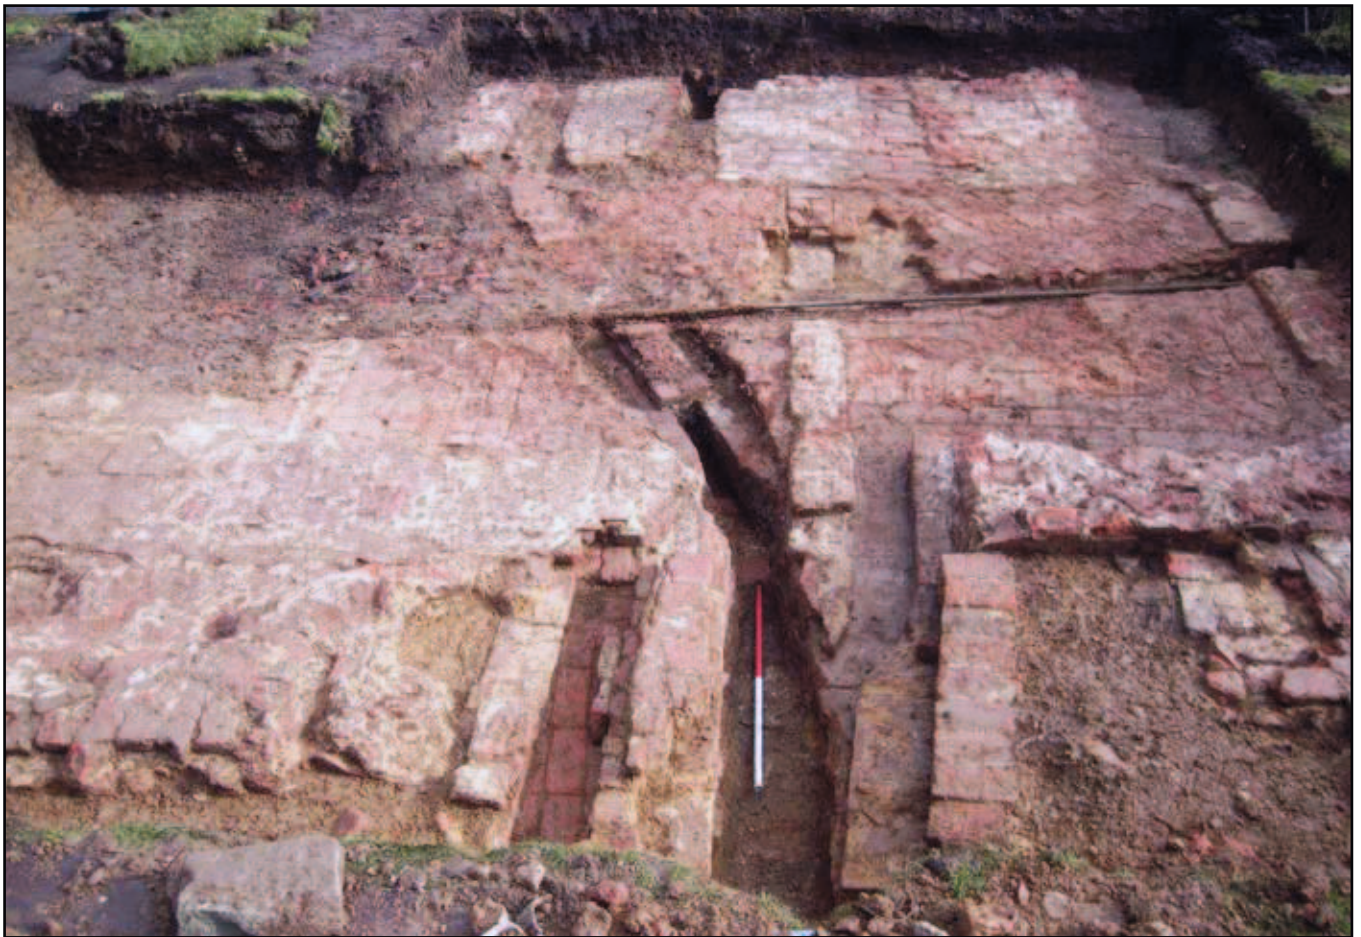
Plate 13: Trench 3, view of small rooms with brick floor sand associated drains

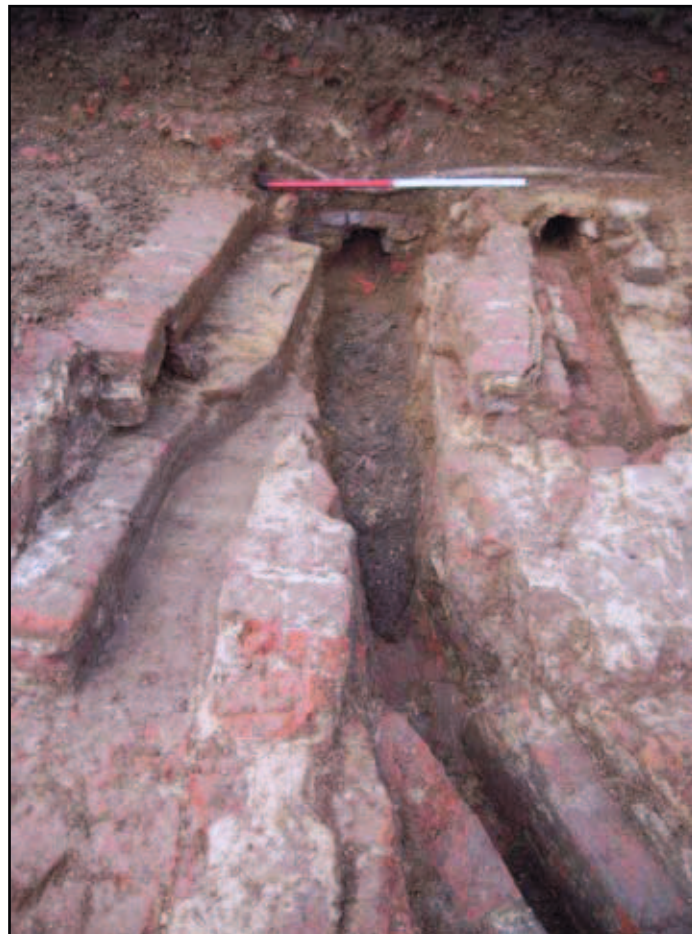
Plate 14: Drain sequence, contexts 318, 321, 322

- 3.4.7 A short length of truncated brick-built drain [321] abutted the S edge of foundation 320. The drain 321 was aligned ENE-WSW and led away from wall 312 at a right angle. It appears to have been slightly recessed (c. 0.1 m) into wall 312. It was built with the same type of bricks and mortar as the bay window foundation 320.

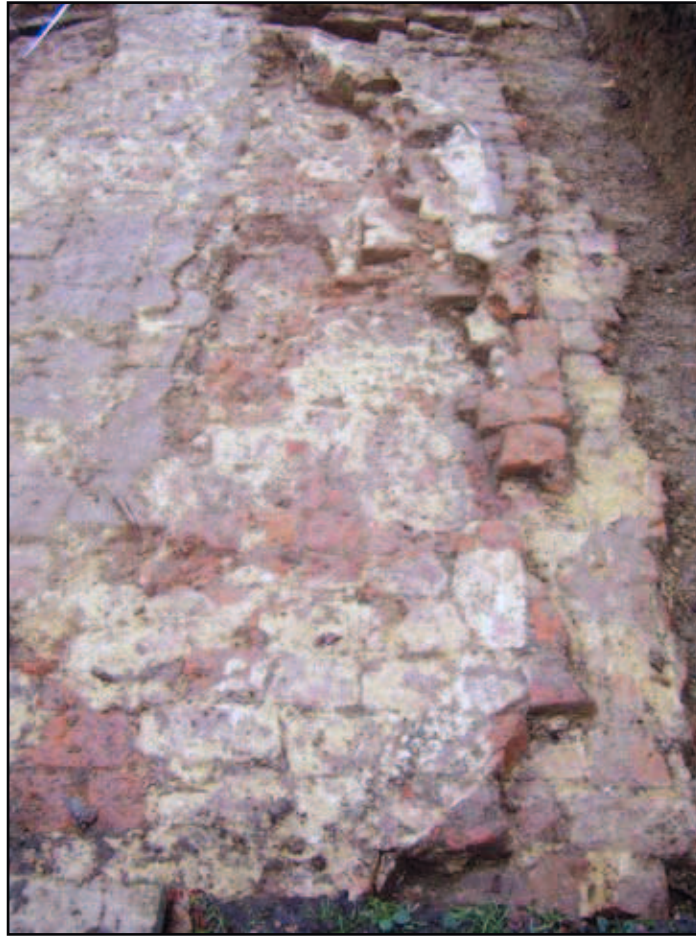
Plate 15: Trench 3, view of footing of north bay window built out from wall 320, showing mortar traces revealing position of window structure

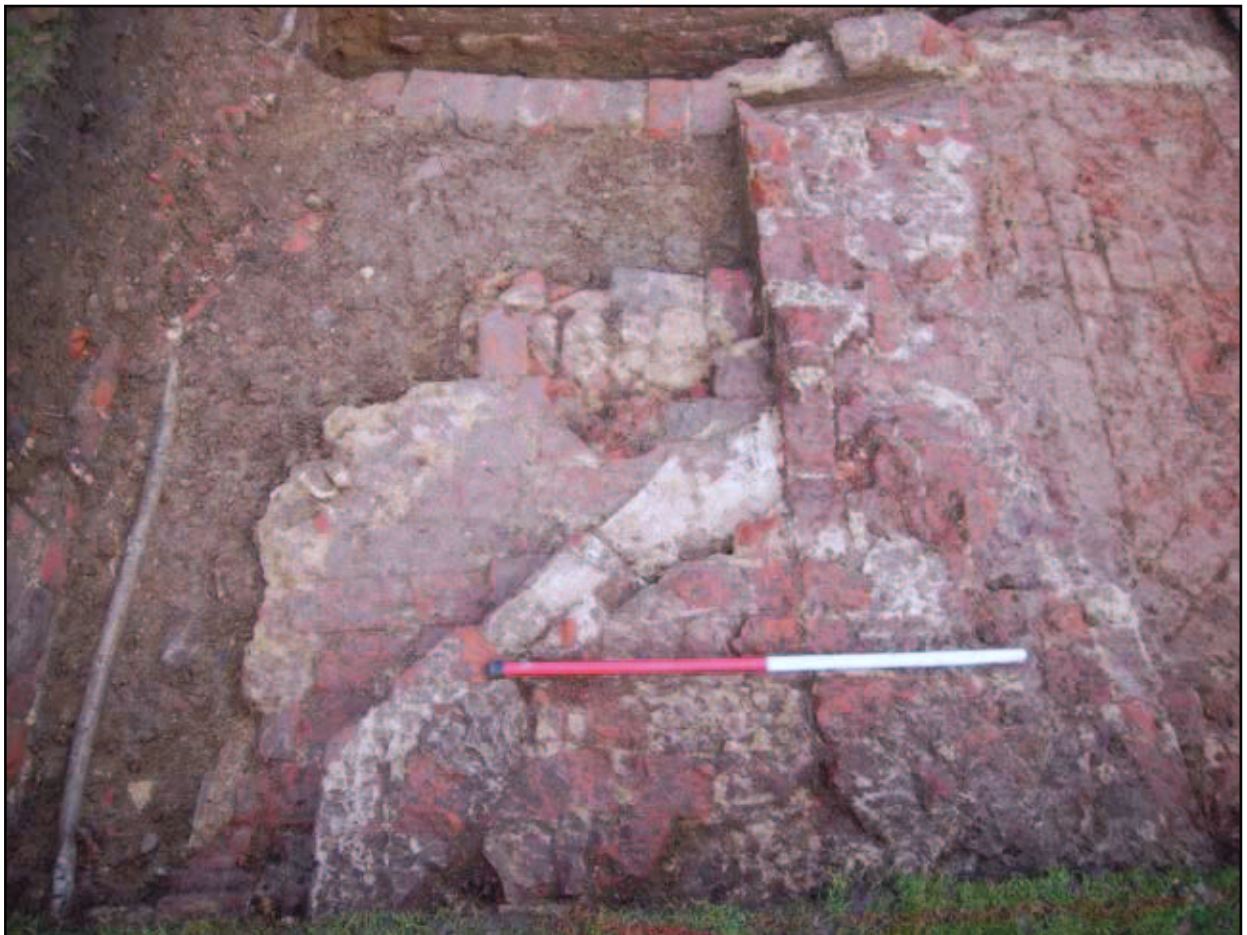
Plate 16: Detail of bay window 333

- 3.4.6 Foundation 333 (Plate 16) for the second of the two exposed bay windows was slightly better preserved, although still disturbed by service trench 313 on its W edge. It was only partly exposed, but up to three courses of brickwork were visible. The extant brickwork of 333 confirmed the trapezoid ground plan of bay windows as described above. Both bay windows, 320 and 333, were built of similar red bricks measuring c. 240 mm x 110 mm x 50 mm (9½ in x 4¼ in x 2 in) bonded with creamy white sandy lime mortar.

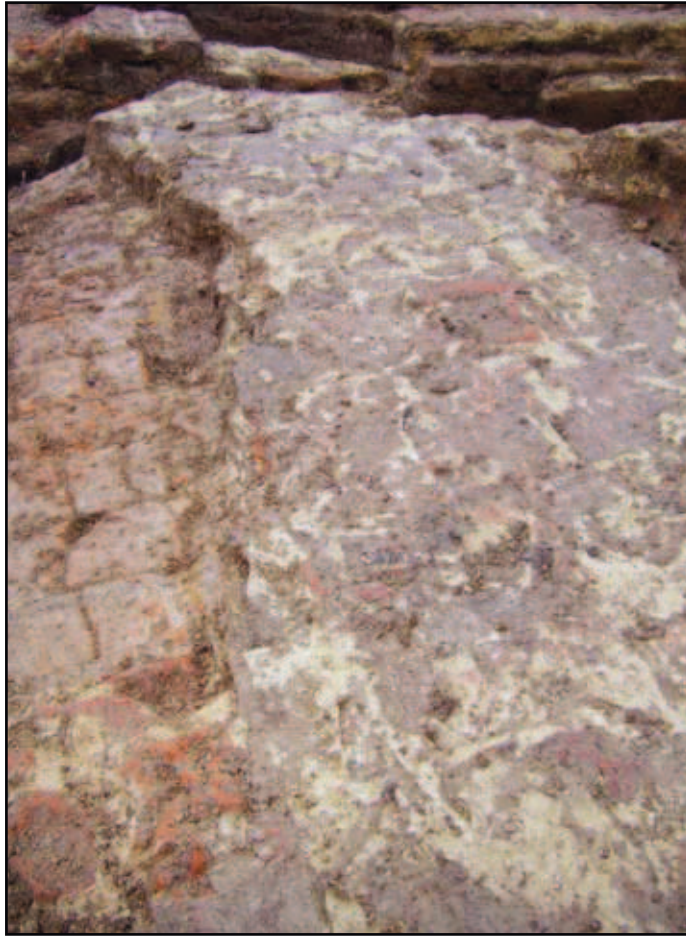
Plate 17: Trench 3, view showing arc cut into wall **312** at the west edge of floor **316**.
