# Trial Trenching at Starveall Farm Claydon Gloucestershire

## Archaeological Evaluation Report

**Client: Bruton Knowles**

NGR: SO 940 317

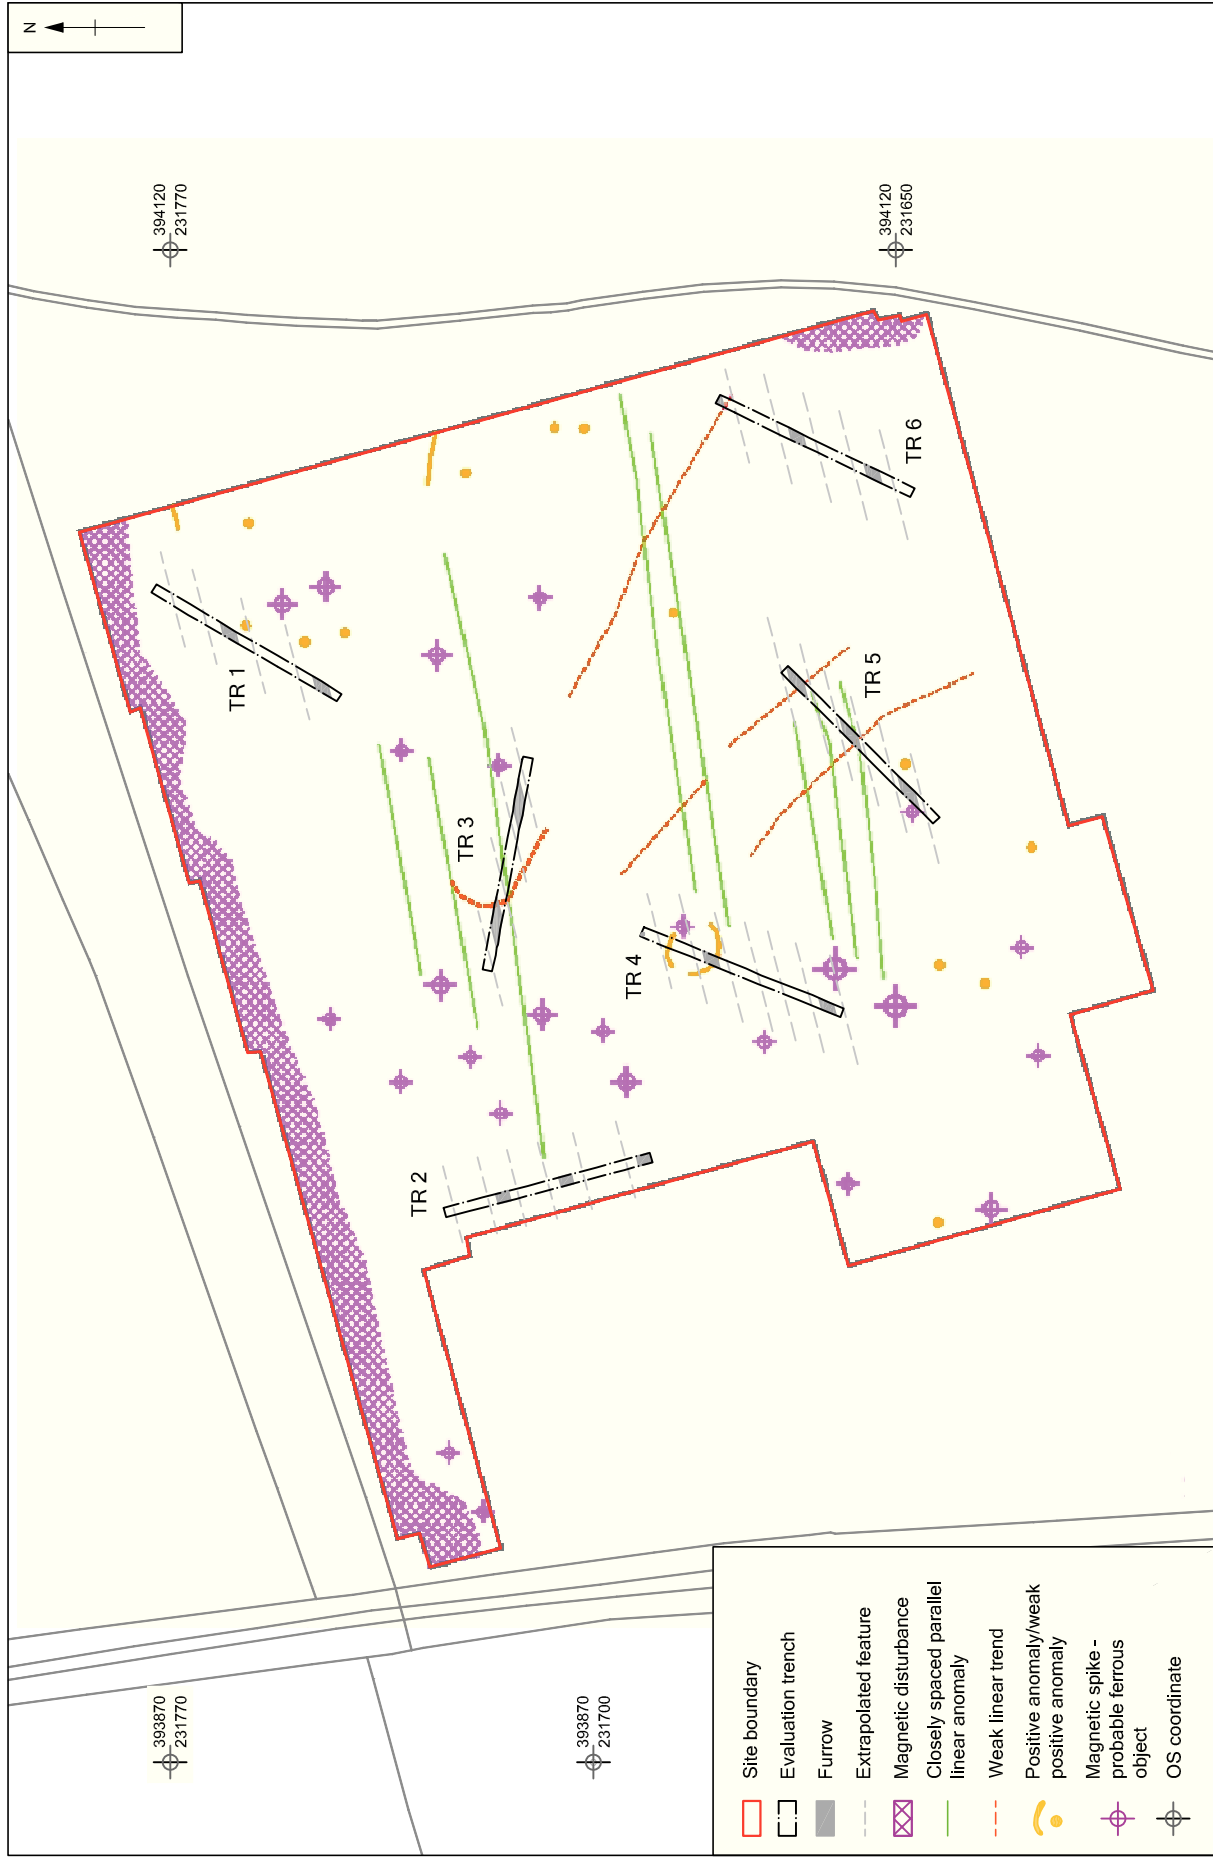
Figure 4: Interpretation of geophysical survey and location of trial trenches

1.3.4 A geophysical magnetometer survey was carried out covering the proposed development area, and was supplemented by an earth resistance survey covering part of the same area to check the results. These surveys have not revealed evidence of any definite archaeological features other than the furrows, although faint traces of a few possible features were noted (see Figures 3 and 4).

- (i) The trenches were positioned to provide overall coverage of the area of proposed development, and to test potential geophysical anomalies tentatively identified by the geophysical survey (see Fig. 4)

- 4.2.1 The trenches were located to test whether the faint geophysical anomalies were of archaeological origin. The evaluation demonstrated that this was not the case.

- 4.4.1 The evaluation trenches did not recover any indication of archaeological features, and no finds preceding the 19<sup>th</sup> century were recovered in the ploughsoils. The faint geophysical anomalies tentatively indicated on the interpretation were not confirmed as archaeological. Some variation in the natural was observed within the trenches, and this may explain the very limited responses in the geophysical survey. On current evidence, there is nothing of archaeological significance within the development area.

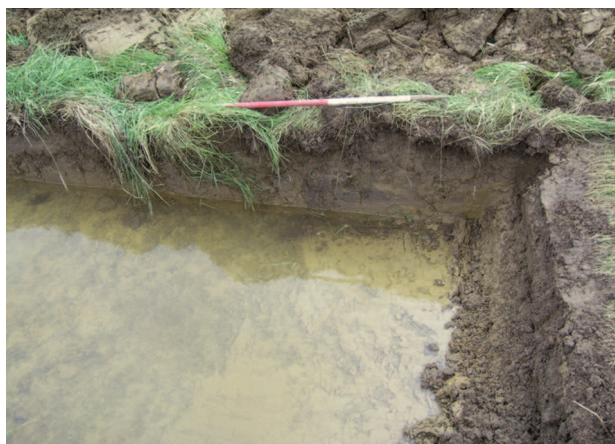
Figure 5: Plan, section and photograph of Trench 1

3.4.1 Trench 1 was orientated North-East – South-West, it was 1.6m wide and 36m in length. It cut through the ridge and furrow, which was present within the ploughsoil. The ploughsoil (0.3m thick) and the subsoil (0.2m thick) overlay the natural clay. There was no archaeology present in the trench.

East-facing photograph of Section 100.

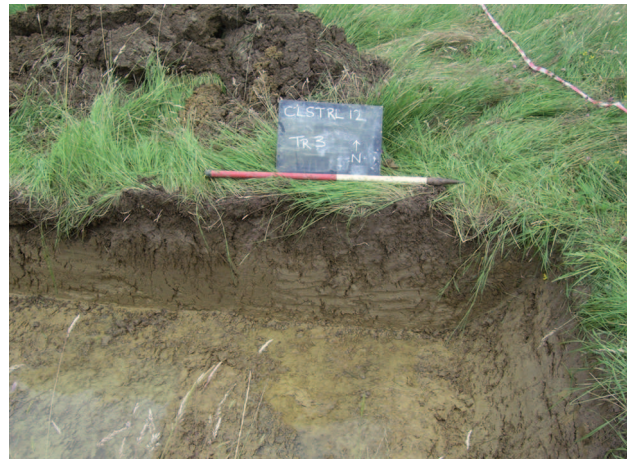
Figure 7: Plan, section and photograph of Trench 3

3.6.1 Trench 3 was orientated East - West, it was 1.6m wide and 36m in length. It cut through the ridge and furrow, which was present within the ploughsoil. The ploughsoil (0.3m thick) and the subsoil (0.2m thick) overlay the natural clay. There was no archaeology present in the trench.

North-facing photograph of Section 300

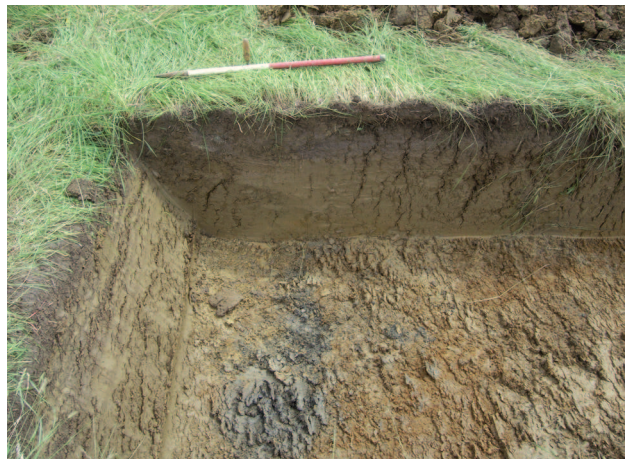
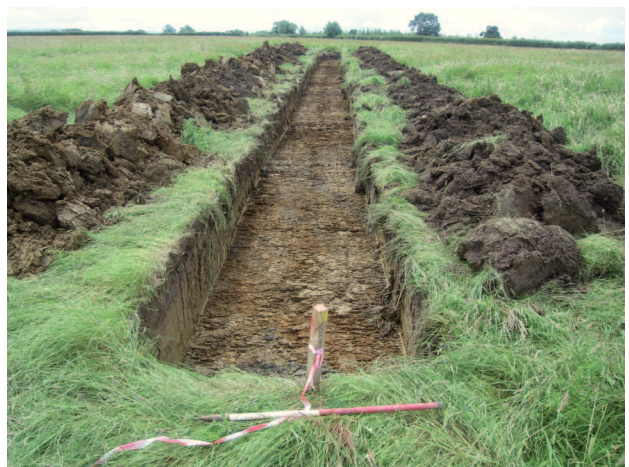
Figure 8: Plan, section and photographs of Trench 4

3.7.1 Trench 4 was orientated North-East - South-West, it was 1.6m wide and 36m in length. It cut through the ridge and furrow, which was present within the ploughsoil. The ploughsoil (0.5m thick) and the subsoil (0.2m thick) overlay the natural clay. There was

no archaeology present in the trench. An irregular shaped feature was investigated at the Northern end of the trench, this was a pocket of the natural grey clay that underlies the natural orange clay.

South-East facing photograph of Section 400

South-West facing photograph of Trench 4

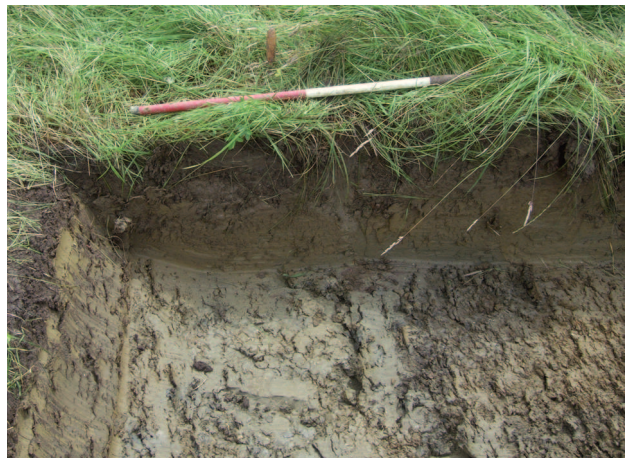
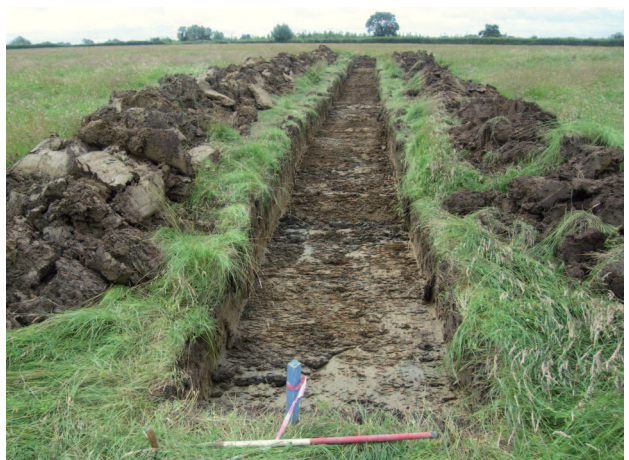
Figure 9: Plan, section and photographs of Trench 5

3.8.1 Trench 5 was orientated North-East - South-West, it was 1.6m wide and 36m in length. It cut through the ridge and furrow, which was present within the ploughsoil. The ploughsoil (0.3m thick) and the subsoil (0.2m thick) overlay the natural clay. There was no archaeology present in the trench.

View to South-East of Section 500

View to South-West of Trench 5

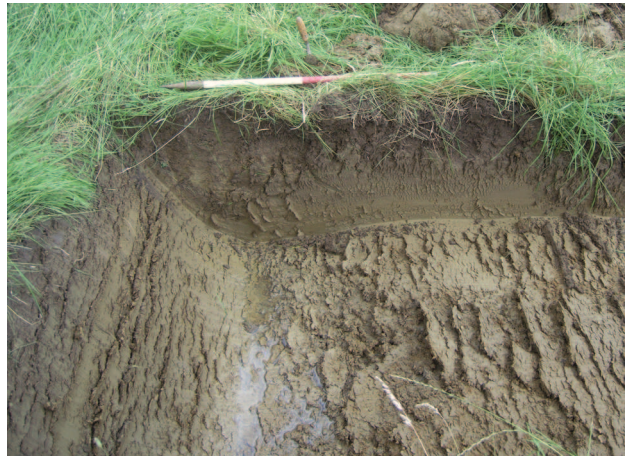
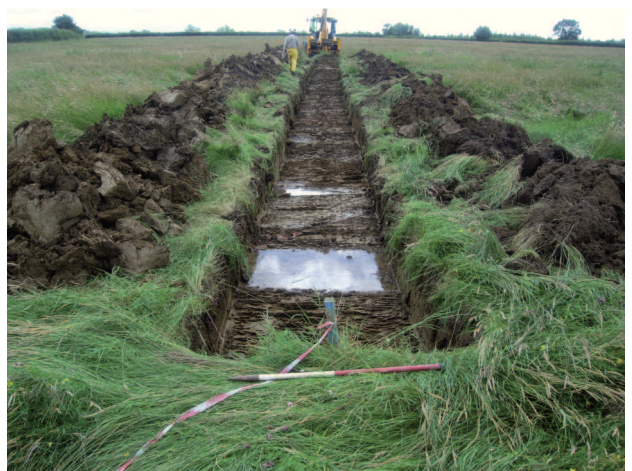
Figure 10: Plan, section and photographs of Trench 6

3.9.1 Trench 6 was orientated North-East - South-West, it was 1.6m wide and 36m in length. It cut through the ridge and furrow, which was present within the ploughsoil. The ploughsoil (0.4m thick) and the subsoil (0.2m thick) overlay the natural clay. There was no archaeology present in the trench.

South-East facing photograph of Section 600

South-West facing photograph of Trench 6
