Maulds Meaburn, Cumbria

Archaeological Watching Brief and Excavation

Oxford Archaeology North

July 2012

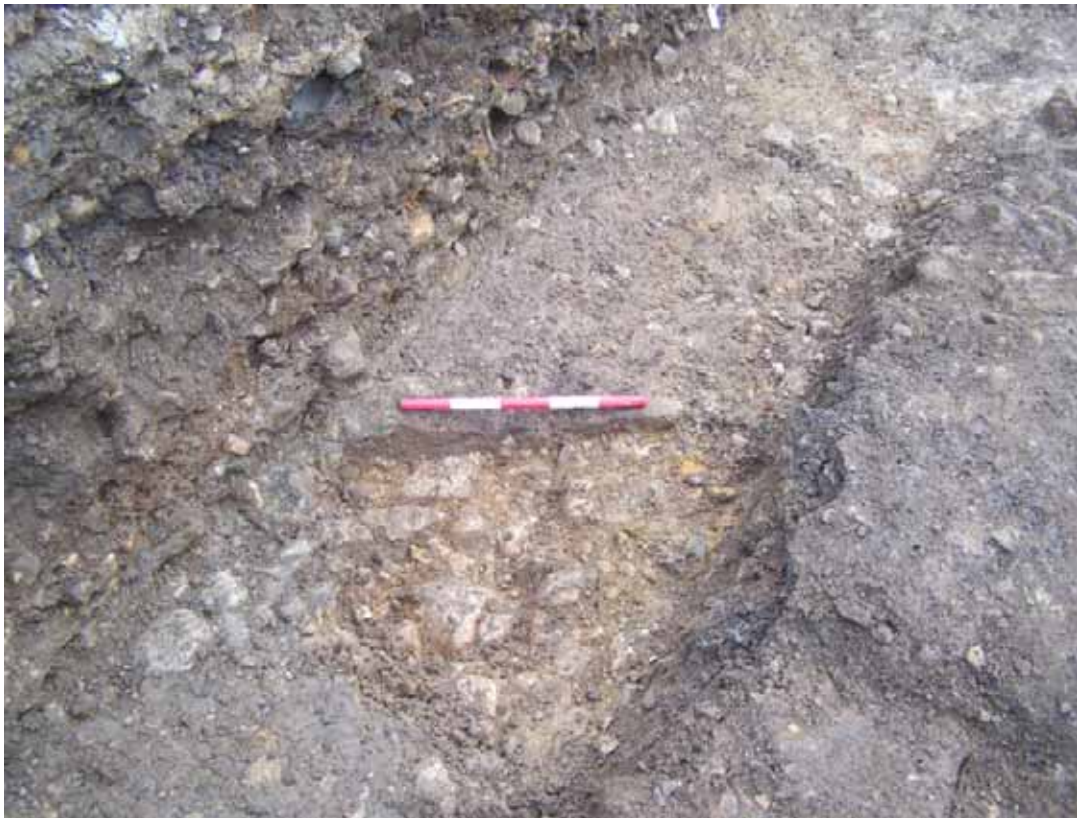
3.2.1 The stratigraphically earliest features recorded were a small ditch or gully (**139**), located in the extreme north-east corner of the trench, and what may have been either the southern terminal of a second ditch, or a pit (**164**), which extended into the site from the north (Fig 2). Both these features had been dug into the natural gravels (**137**). Ditch **139** was 0.6m wide and 0.1m deep (Pl 1), and was aligned north-west/south-east, roughly parallel to the tail-race itself (SG **168**; *Section 3.5*). The latter lay *c* 3.5m to the west, though the two features had no direct stratigraphic relationship. Because of its location, within the extreme north-east corner of the site, the ditch was traced for only 1.5m, but extended north-west and south-east beyond the limits of the investigation. It was filled with mid-grey silt (**138**), from which a small fragment of fourteenth-sixteenth century pottery was recovered. The ditch was ultimately sealed by deposits associated with the earliest of the two phases of cobbled road surface (SG **172**; *Section 3.3*). Its precise significance remains unclear, but it could conceivably represent part of a medieval property boundary or field boundary. However, the presence of a single medieval sherd in the fill does not prove a medieval date for the feature.

Plate 1: Ditch 139, fully excavated, looking south

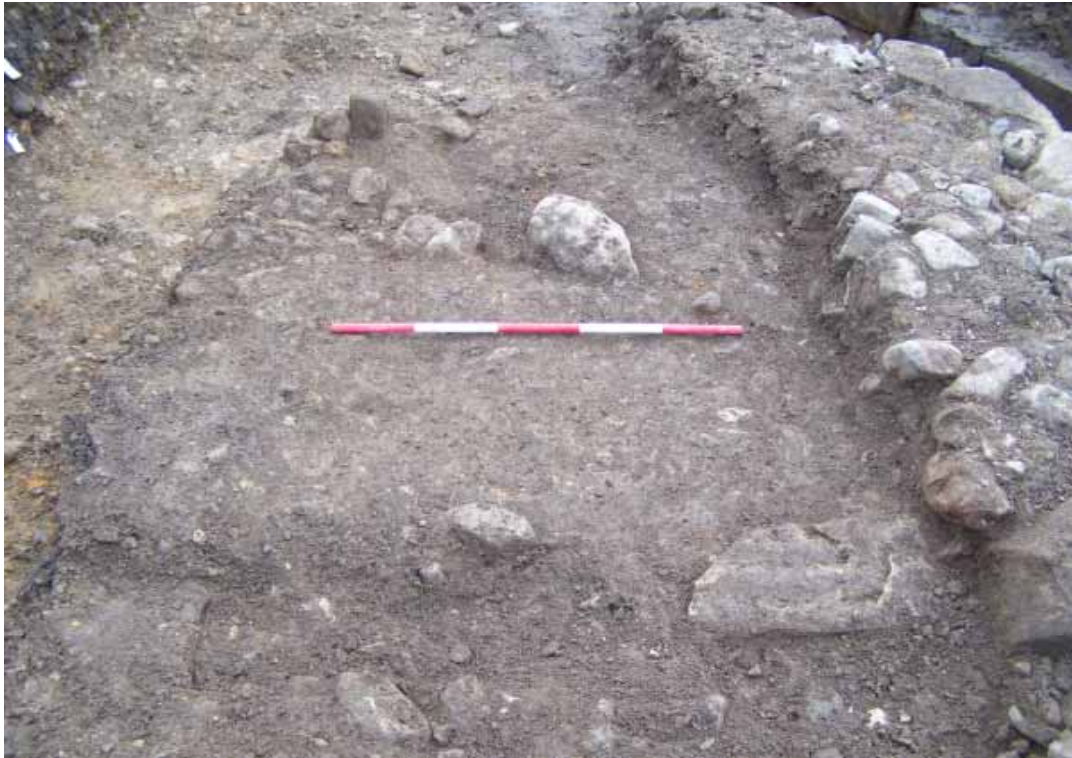
- 3.3.1 Ditch **139** (*Section 3.2.1*) was sealed by a deposit of grey-brown sandy gravel (**136**; not illustrated), up to 0.15m thick, which lay directly above the natural gravel. This was in turn overlain by a 0.2m-thick layer of compacted material (**135**; Pl 3) comprising blue-grey clay mixed with degraded shale and stone fragments. These deposits were confined largely to the area beneath the later cobbled road surfaces (*Section 3.3.2*), and it is possible that they represented the remains of a road or track surface that pre-dated the earliest cobbling, though this is far from certain.

Plate 3: Putative surface **135**, looking south

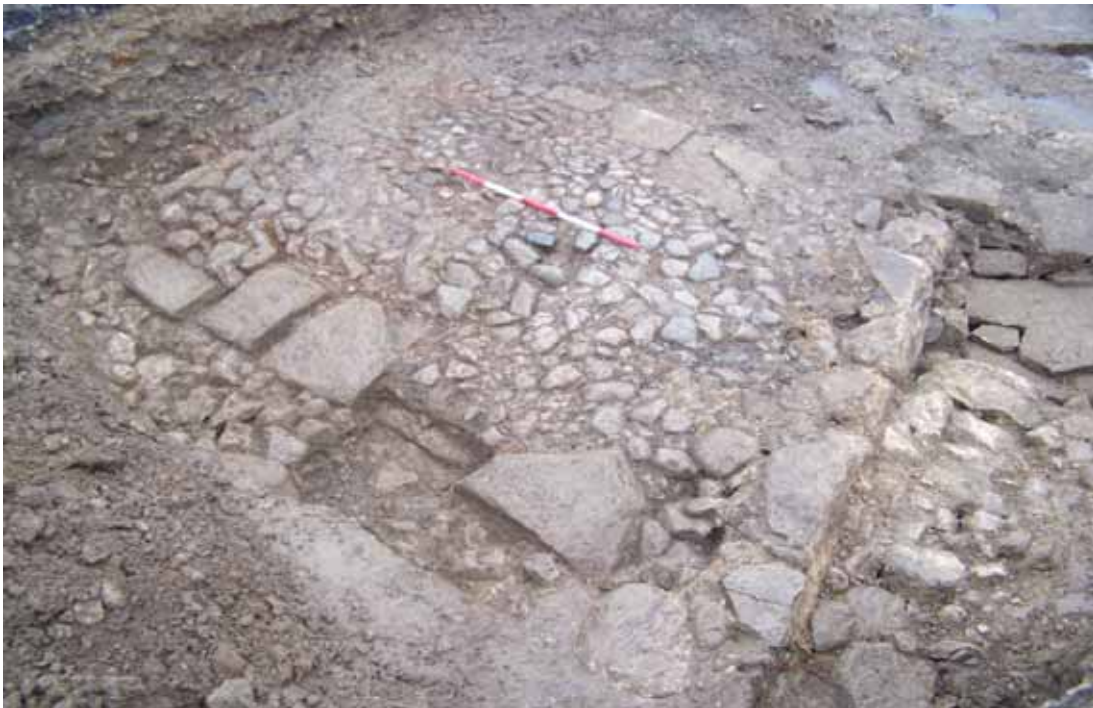
- 3.3.2 Directly overlying **136** was a well-laid cobbled surface (**123**), up to 0.3m thick (Fig 2; Pl 4), edged on the north and south by kerbs constructed of large, roughly-squared sandstone slabs and blocks (**122**). In total, the surface of this east/west-aligned road or lane (SG **172**) was approximately 2.4m (or around eight feet) wide, including the kerb stones. Later, however, the road appears to have been widened, which was effected by the laying of another cobbled surface (**124**) on the north (Fig 2), beyond (but abutting) the northernmost kerb. This surface was located on the extreme northern edge of the site, and extended beyond the investigated area in that direction, so the full width of the road at this time is not known, though it was in excess of 3m. The primary cobbled surface, together with deposits **135** and **136** beneath it, yielded no dating evidence, but nineteenth-century pottery came from the road widening (surface **124**), and this deposit also sealed feature **164**, which itself contained pottery of nineteenth-century date (*Section 3.2.2*).

Plate 4: Primary road SG 172, looking south-east, showing cobbled surface **123** and stone kerbs **122**. Note removal of road surface on the west (right) by disturbance associated with maintenance of tail-race SG 168

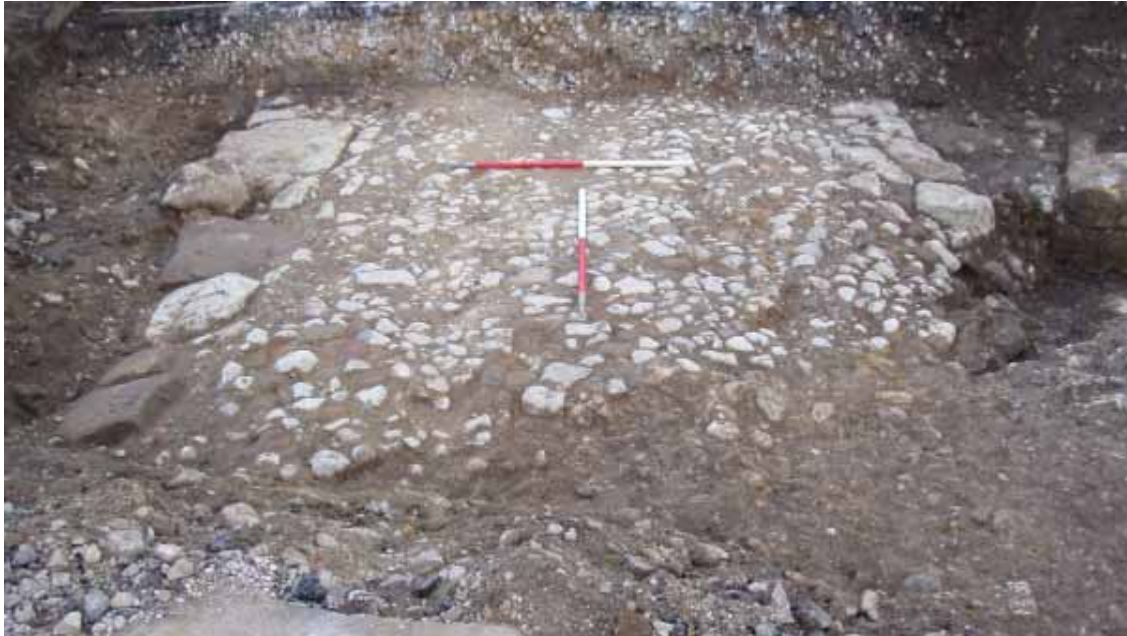
- 3.4.1 Overlying SG 172 was a 0.2m-thick deposit of clay-sand and cobbles (**126**; not illustrated), which also extended (as deposit **116=125**) up to 1m south of the road's southern kerb (Fig 2). What may have been a fragment of the same deposit (**129**) was also recorded on the extreme western edge of the trench. With the exception of **129**, which was both stratigraphically isolated and truncated by later disturbance associated with refurbishment of the tail-race (Section 3.5.4), this material was in turn overlain by a new road surface (SG 169; Pl 54) of cobbles (**105**), up to 0.2m thick, edged by stone kerbs (**106**, **107**). In this phase, the road, though very similar in character to the construction of primary road SG 172, was considerably wider, at *c* 3.8m, including the kerbs. Two parallel wheel-ruts (**113**), 2.2-2.4m long, 80-120mm wide and 0.1m deep, were visible in the surface of the cobbling (Pl 5), aligned east to west and set 0.9-1m apart. These had been infilled with a stony deposit (**115**), probably to effect a repair to the road surface. Finds included nineteenth-

Plate 5: Road SG 169, looking east, showing cobbled surface 105 and stone kerbs 106, 107. Two parallel wheel ruts (113) are just visible in the road surface

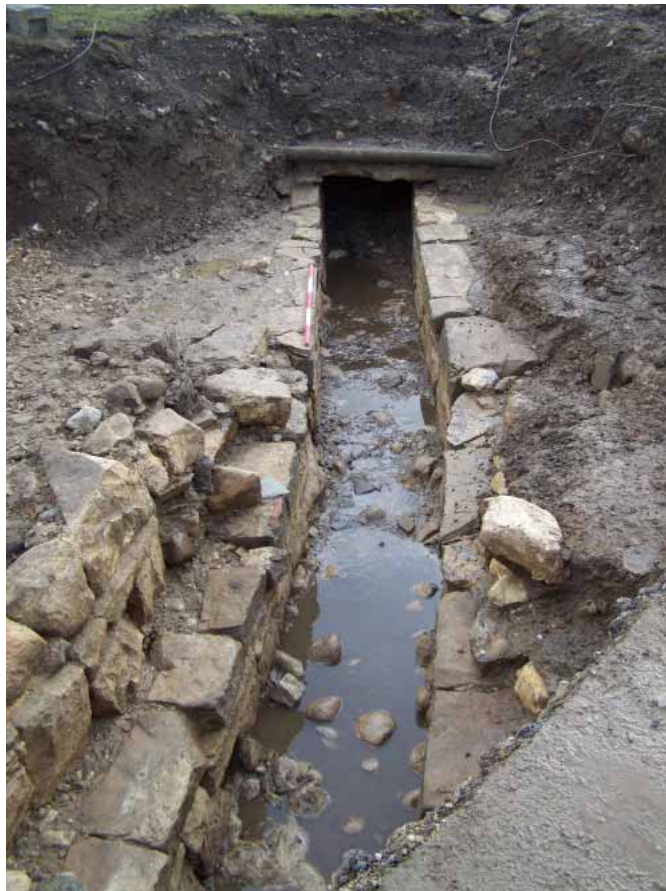
3.5.1 The tail-race for the corn and saw mill at Maulds Meaburn ran diagonally, north-west to south-east, across the entire site, a distance of *c* 7m, and was fully exposed within the excavated area. Although the mill itself is known to date back at least to the late seventeenth century (*Section 1.3.9*), the precise date at which the excavated segment of the tail-race was constructed is unclear, since later disturbance, seemingly associated with a nineteenth- or twentieth-century refurbishment of the feature (*Section 3.5.4*), had removed all primary stratigraphic relationships between the surviving fabric of the race and the adjacent archaeological deposits, including those associated with roads SG **172** and SG **169**. However, the channel itself proved to be generally well preserved (Fig 2; Pl 6), its sides lined with up to three courses of unmortared, dressed, sandstone blocks (**170**, on the eastern edge of the channel, **171**, on the west; Fig 3). The largest blocks used (mostly, but not exclusively, in the lower course) measured up to 1 x 0.4 x 0.3m, but most were smaller, with considerable variation evident in both size and shape. Internally, the channel was 0.6-0.65m wide and up to 0.6m deep, and it had been capped with large, roughly-dressed, rectangular sandstone slabs (**134**; Pl 7). Most of the latter were 1-1.2m long, 0.35-0.4m wide, and 0.1-0.2m thick..

Plate 6: The tail-race for the former corn and saw mill (SG 168), looking south-east, with capping stones removed, showing stone lining 170/171

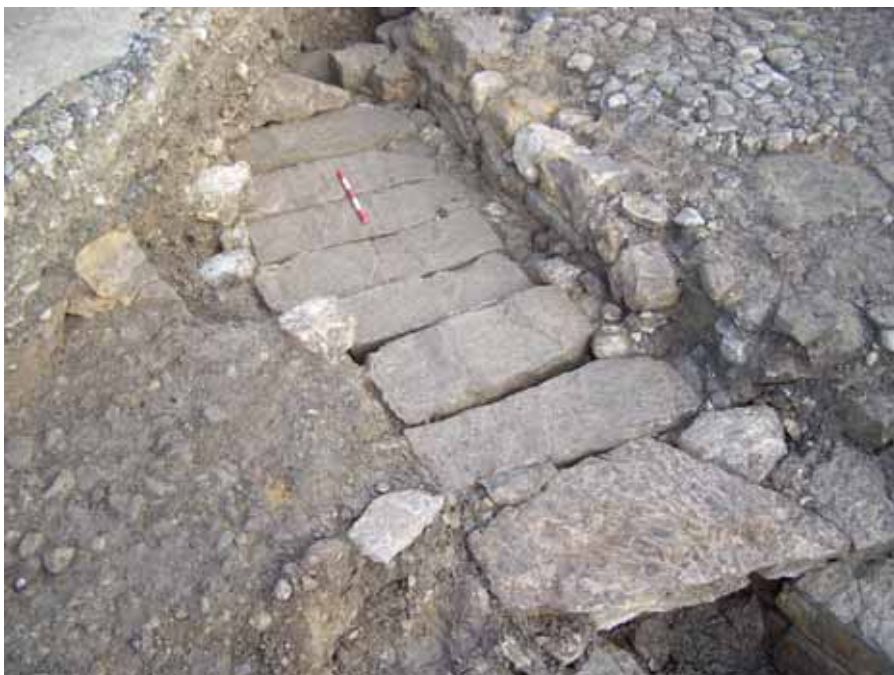
Plate 7: Tail-race SG 168, looking north-west, showing capping stones 134

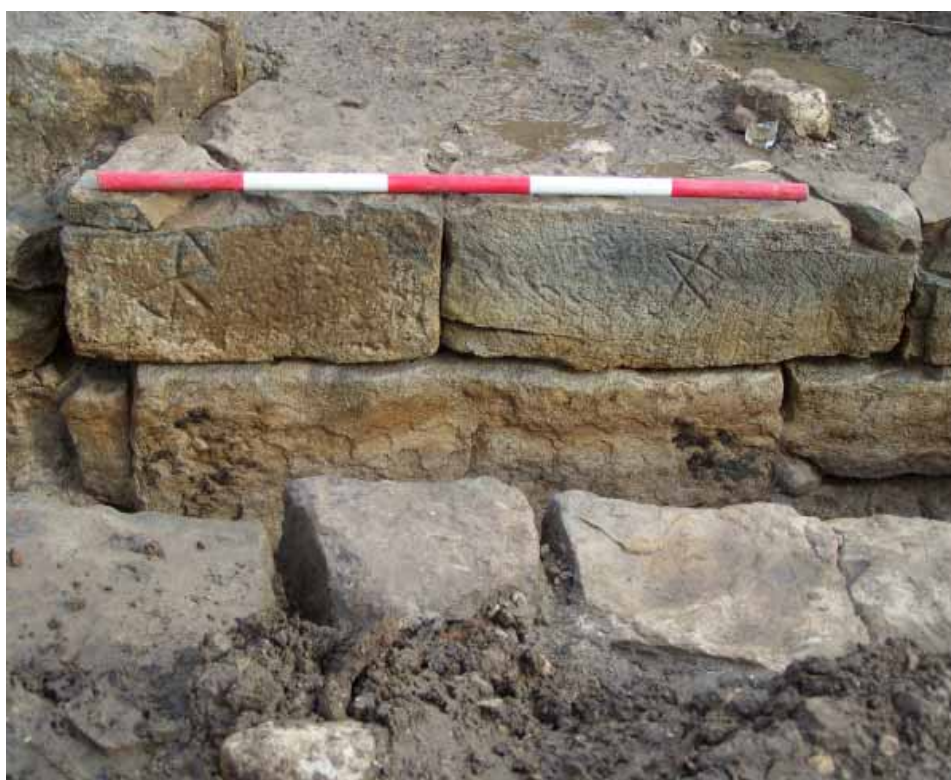
- 3.5.2 In the stonework of the the channel's eastern edge (*170*), two masons' marks were recorded on adjacent stone blocks that had been built into the uppermost course (Fig 3: Pl 8). It is of some interest that identical marks are visible on the masonry of Low Bridge, which spans the River Lyvennet only 30m or so west of the excavation (*Section 5.3.3*). The bridge dates to the seventeenth century, and what may be some of the original stonework is visible in the arch on the north side of the bridge. It was, however, extensively rebuilt in 1853, and much of the extant masonry clearly dates to this period. Unusually, masons' marks of the kind found in the tail-race occur on both the putative seventeenth-century masonry and on the nineteenth-century work. The possible reasons for this are discussed elsewhere (*Section 5.3.3-4*), but, in terms of dating the construction of the tail-race, it means that it is not possible to know whether the masons' marks indicate a definite nineteenth-century date for the surviving stonework, or if the extant channel is potentially much earlier.

Plate 8: Masons' marks on stonework (*170*) in the eastern side of the tail-race channel (SG *168*)

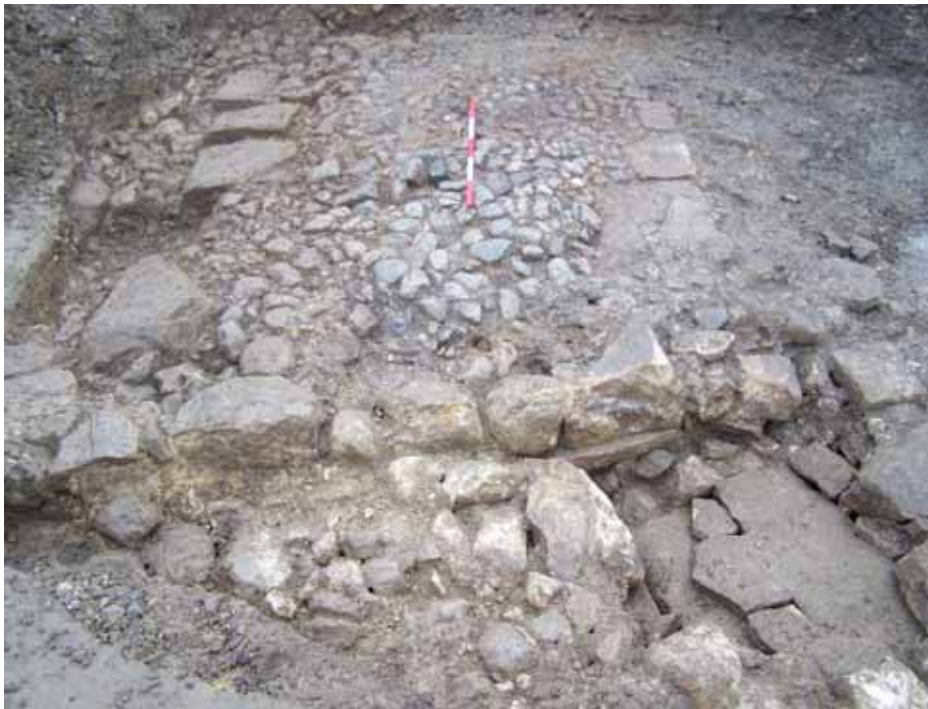
- 3.5.4 The late date of the channel silts accords with the stratigraphic evidence from within the excavated area, which demonstrated that the exposed section of the tail-race was refurbished at a relatively late date, certainly no earlier than the nineteenth century, and quite possibly during the twentieth century, perhaps even immediately prior to the construction of the modern tarmac road. To access the channel, a trench (*118*), up to 2.5m wide was dug along the line of the tail-race, down to the top of the capping stones (Fig 2). This cut through the cobbled surface and kerb stones of road SG *169*, the latest of the two

Plate 9: Disturbance to road SG 169 caused by a late refurbishment of tail-race SG 168, looking east. Note stone 'lining' 119 on the east side of cut 118, and rubble fill 121 overlying the tail-race capping stones (134)

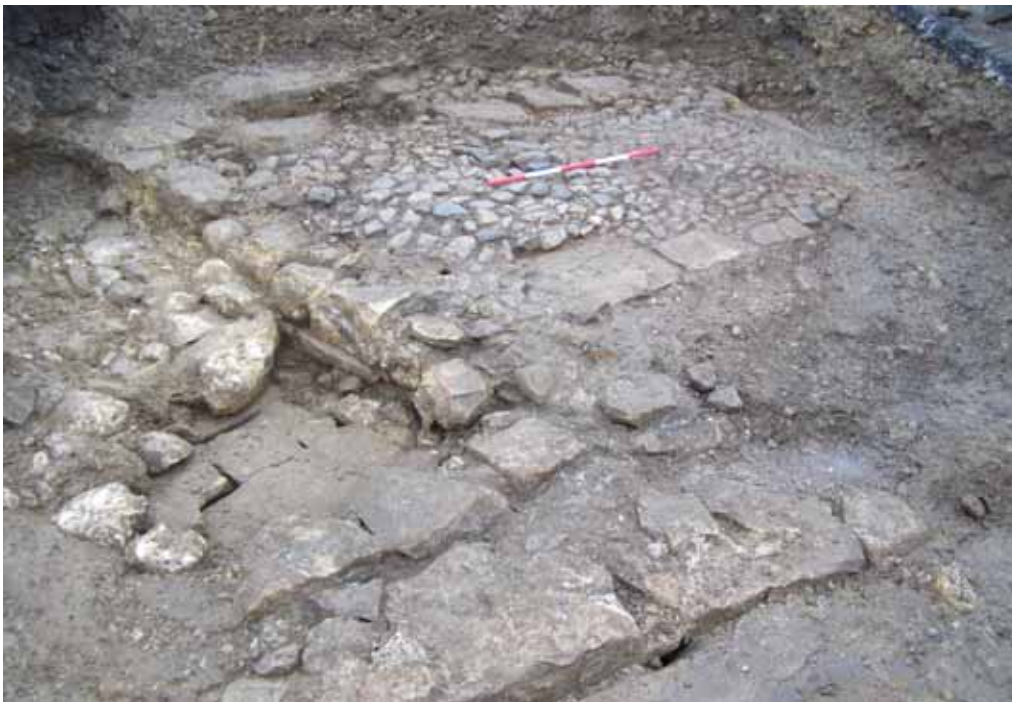
- 3.5.5 A poorly preserved, east/west alignment of large, roughly-hewn, sandstone blocks (114), bonded with a pale lime mortar, also crossed the line of the tail-race, immediately south of 117 (Fig 2; Pl 16), and was traced, east to west, across most of the excavated area, a distance of *c* 4m. This feature was up to 0.6m wide, with the individual stone blocks measuring up to 0.9 x 0.6 x 0.3m, and somewhat resembled the stone kerbs of roads SG 172 and SG 169 (Section 3.3.2; 3.4.1), though it was located approximately 1m south of those features, and was clearly constructed late in the stratigraphic sequence. It may have been related to the construction of the modern tarmac road, perhaps defining or retaining

Plate 10: Late disturbance to tail-race SG 168, looking north-east, showing stone 'lining' 119, and rubble fill 121 over capping stones 134. Note dressed blocks (117), possibly retaining 121 on the south, and (foreground) linear stone feature 114, a possible early revetment of the modern road

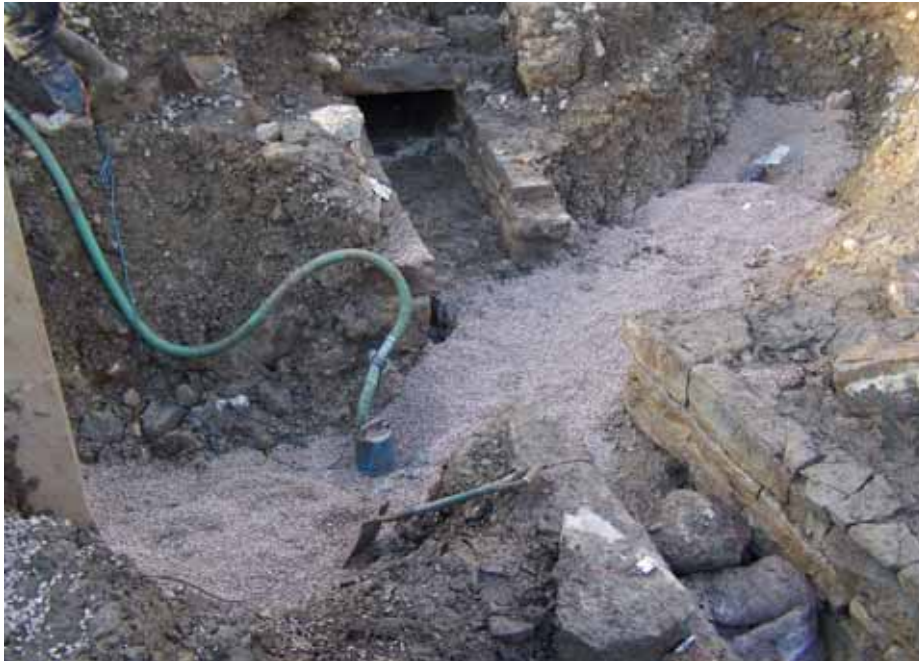
Plate 11: Construction of pipeline across the tail-race channel (SG 168)

- 3.6.1 Upon completion of the archaeological excavation, the new pipeline was inserted across the tail-race of the former corn and saw mill (P1 11). Following completion of this, and in accordance with English Heritage's requirements, the lining and capping of the channel were carefully rebuilt, utilising, wherever possible, the original materials (P1 12; P1 13). Finally, the modern road surface and adjacent ground were reinstated above the monument.

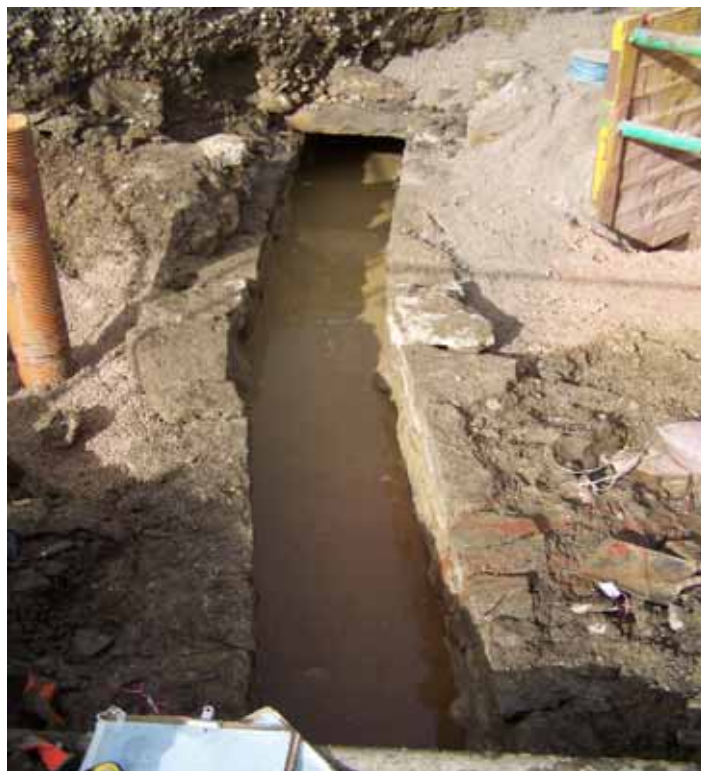
Plate 12: The stone lining (170/171) of tail-race channel SG 168 rebuilt following insertion of pipe

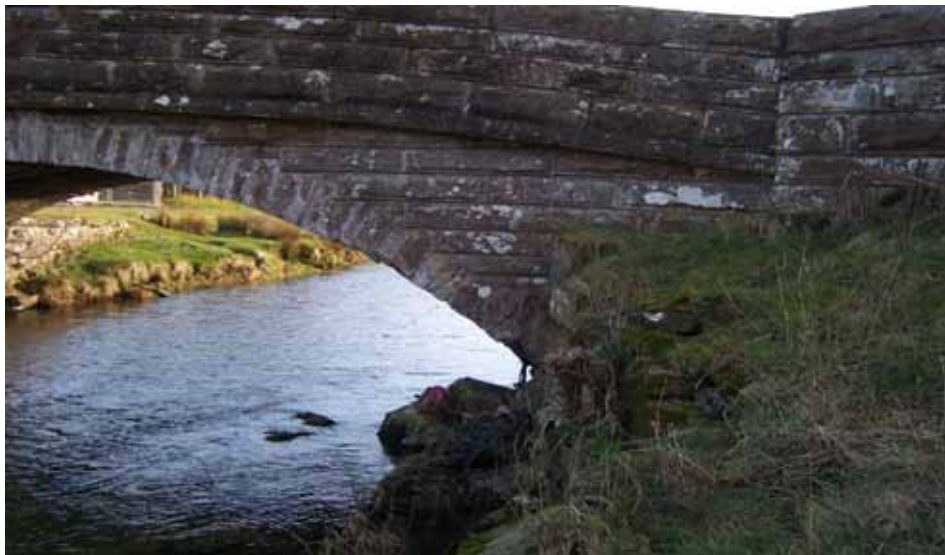
Plate 14: Low Bridge from the north, showing possible seventeenth-century masonry in this side of the arch
