Pipe Trenching in Pump Court- Middle Temple, Corporation of London

Archaeological Watching Brief Report

June 2013

**Client: Estate's Office, The
Honourable Society of the
Middle Temple**

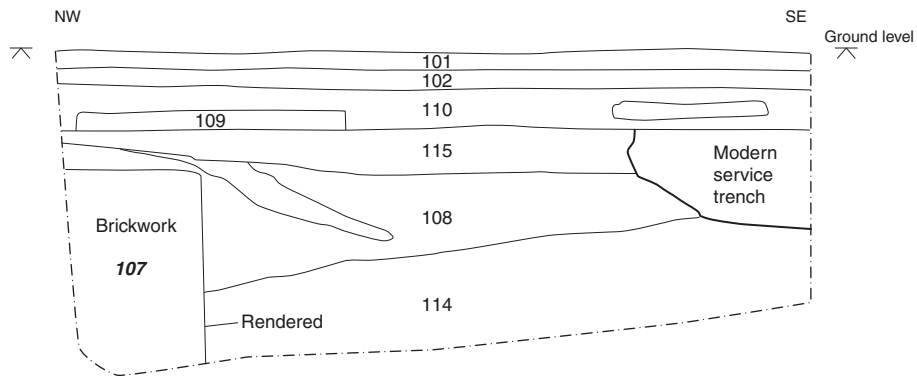
Section 101

- 3.1.8 South-east of Wall 107 a layer of light grey-brown demolition debris containing red brick fragments and lime mortar (114) abutted the east face of wall 107 at the base of the trench (Fig. 4, Section 101). The full depth of this deposit was not recorded but in section it was at least 0.4m deep. Layer 114 and the top of wall 107 were overlaid by a loose deposit of broken red bricks (108). The bricks were clean with no evidence of mortar adhering to them; also contained within this deposit was a lens of plaster or possibly lime mortar tipping down to the south-east. A clay pipe bowl manufactured between 1840-1860 was also recovered from this deposit.

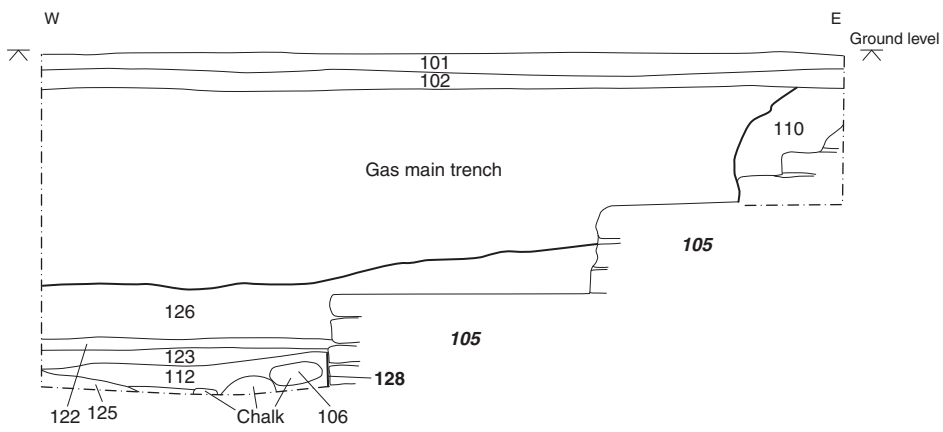
Section 102

- 3.1.7 Approximately 2m west of Section 102, layer 126 was cut by a 0.2m deep cut (117), which was only exposed within the northern side of the trench, and was not recorded in section. This contained two courses of a single skin of plain red bricks 0.17m x 0.11m x 0.06m in size (113). This wall appeared to have been constructed using poor quality or broken bricks, and was obviously not meant to be seen. The upper courses of this feature had been truncated by modern service trenches.

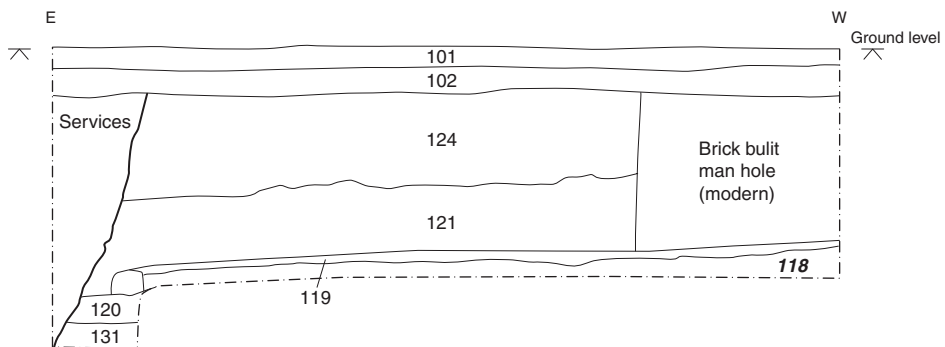
Section 103

- 3.1.12 At the western end of the trench a layer of light grey-brown silty clay mixed with fragments of bricks (131) was observed at the base of the deepest part of the excavations (Fig. 4, Section 103). Above this deposit was a 0.15m deep layer of mid-grey silt containing small fragments of red brick and flecks of lime mortar (120). Built

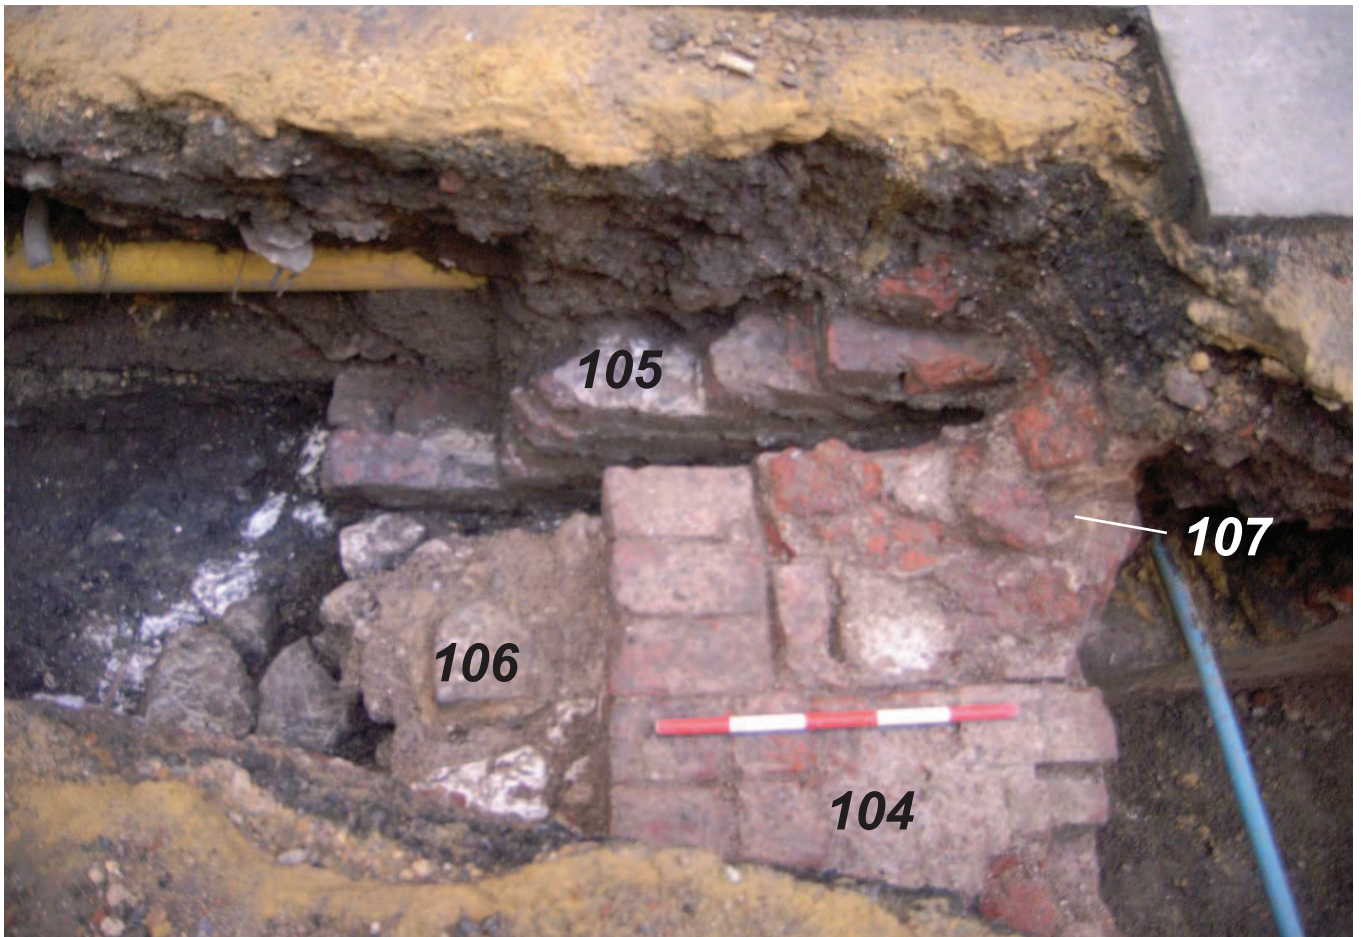
Plate 1: Walls 104, 105, 106 and 107

- 3.1.2 Constructed directly upon the truncated remains of 106 was a north-south aligned brick wall (104) (Plate 1). This had been built using un-frogged handmade red bricks measuring 0.21m x 0.11m x 0.06m in size, laid using English Stretcher bond and bonded with a lime mortar. Only two courses of this wall survived, suggesting that it had later been reduced in height.

- 3.1.4 A later construction cut (111) some 0.4m wide had been excavated into the east face of wall 104. This appeared to cut 106, but the limited depth of excavation at this point left this uncertain. Constructed within this feature, and running off to the east, was a brick wall using red un-frogged bricks 0.22m x 0.105m x 0.6m in size, laid using English Stretcher bond and a lime mortar (107) (Fig. 3 and Fig. 4, Section 101). The southern face of this wall had been rendered using a lime plaster which showed traces of greyish-green paint. This plaster continued over the eastern face of wall 104, suggesting that the constructors of wall 107 had made use of an existing wall to form a corner enclosing a probable cellar (116).

- 3.1.5 Cutting walls 104, 106 and 107 was a foundation trench (128) aligned east-west, which turned northwards after 1.6m, forming a corner. Built within this was brick wall (105), using un-frogged red bricks measuring 0.22m x 0.105m x 0.6m. This had been laid using Bastard English bonding and a lime mortar.

- 4.1.4 Walls 104, 105, 107 and 130 are all constructed from bricks dating to the 17th century. Wall 104 appears to pre-date the rest and may perhaps form part of the north range of Pump Court which was demolished in 1627. If so, however, this must have been a recent addition to this building. If this interpretation is correct, then walls 105, 107 and 130 may relate to the 1628 rebuilding (see paragraph 4.1.1) The position of these walls seems to correspond to part of the range shown on the 1677 map (see Fig. 5). The relationship between walls 104 and 107 suggests that this later rebuilding may have made use of parts of the earlier buildings. The rendering of the east and south faces of walls 104 and 107 respectively suggest that it may have formed a corner of a cellar. It is possible that walls 105, 107 and 130 belong to the buildings of Pump Court that were destroyed by fire in the winter of 1678. Although no obvious signs of burning were observed, the presence of layers of demolition debris such as 112, 114, 124, 129 and 131 may indicate that the fire-damaged building were demolished and the material used to backfill the cellars and level the site.

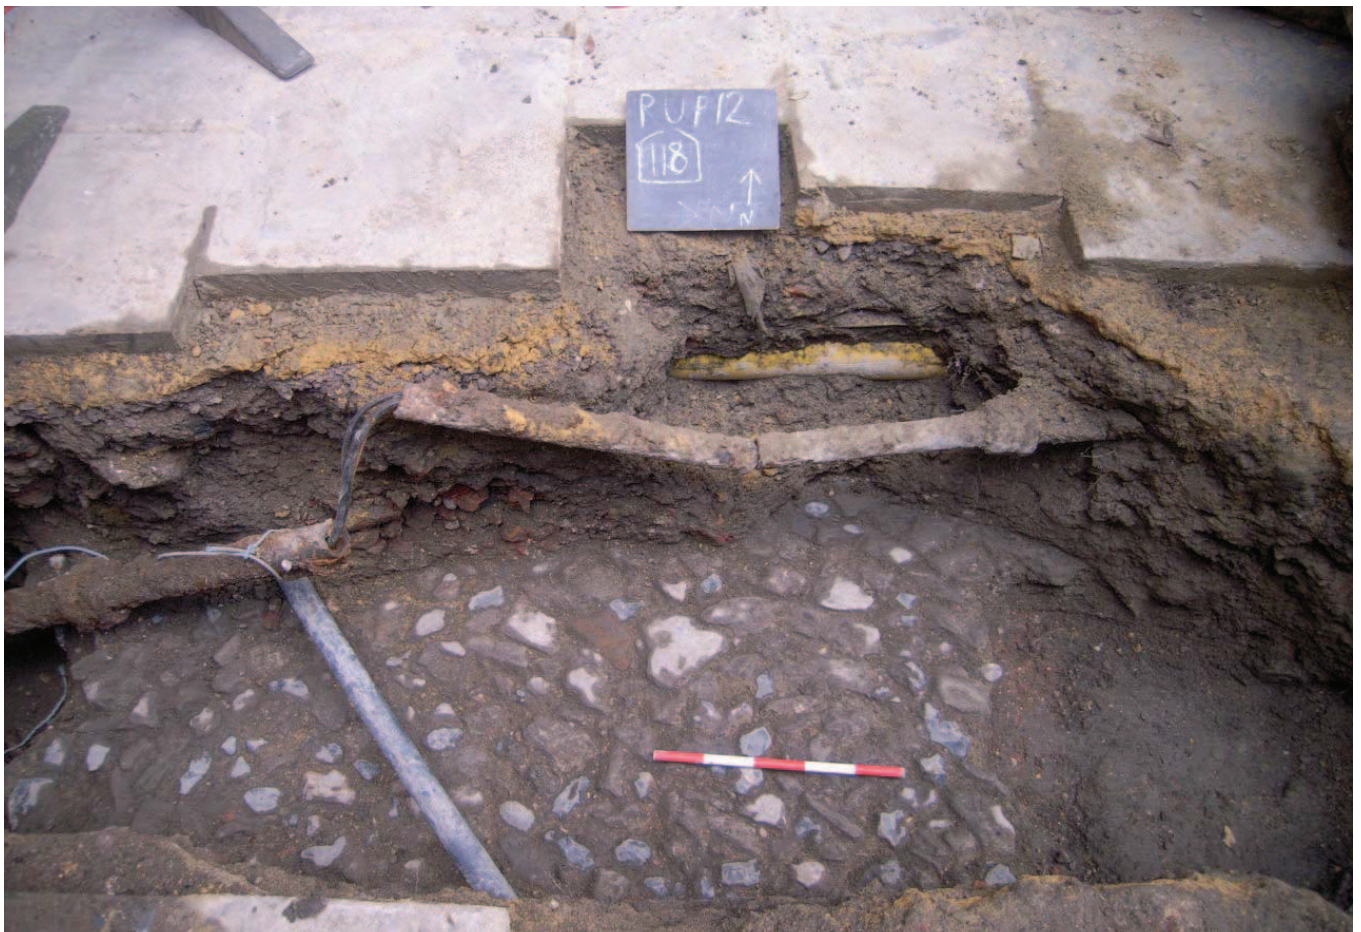
Plate 2: Cobbled surface 118

directly upon 120 was a cobbled surface (118) (Plate 2). This had been constructed using roughly trimmed flint nodules between 0.1m and 0.15m in size impressed into the surface of layer 120. On the west side it was truncated by a modern service trench.

- 4.1.3 Due to the disturbance caused by modern service runs there is no stratigraphic relationship between the cobbled surface 118 and the brick walls. The pottery and clay pipe fragments in the occupation layer 119 that overlay the cobbled surface could only provide a late 16th or 17th century date. This probably indicates that the surface and the brick walls were contemporary
