# St Michael's Close Fringford Oxfordshire

# Archaeological Watching Brief Report

# **Client: Anglian Water**

In March 2013 Oxford Archaeology carried out an archaeological watching brief during the construction of a new water pipe and storage tank by Anglian Water at St Michael's Close, Fringford, Oxfordshire (NGR: SP 6080 2905). No archaeological deposits were observed, and there were no finds.

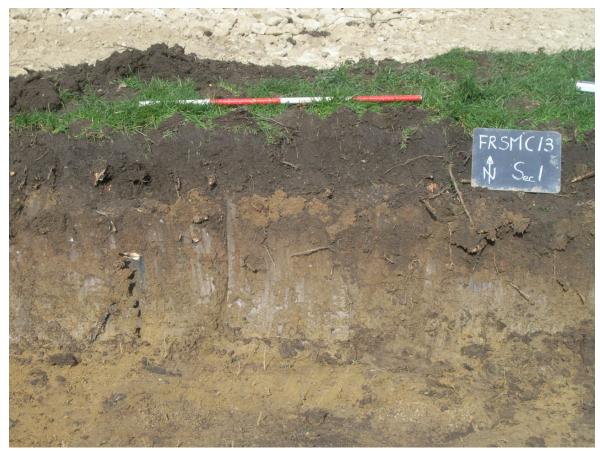
Plate 1: Sequence of deposits in storage tank area

- 3.1.1 The area for the base of the new storage tank was stripped first, followed by the excavation of the new pipe trench and associated manholes, working from west to east (see Figure 2). The work was carried out using a 13-ton mechanical excavator with a toothless grading bucket, in spits approximately 0.2m deep.
- 3.1.2 The excavation for the tank base was approximately 14m in diameter and 1m deep. Topsoil (layer 1) was a friable dark brown silty loam with occasional gravel and small stone inclusions, and was generally 0.25m deep. This overlay a reddish-brown clayey silt (layer 2) up to 0.4m deep, with some sand and gravel inclusions, which may represent an earlier ploughsoil, though no finds were recovered from it. This in turn overlay a yellowish-brown silty clay with occasional gravel (layer 3), which represented

the undisturbed geology, and continued down below the base of the trench. No finds were seen in any of these deposits.
