Merton Meadow Hereford

Archaeological Evaluation Report

July 2013

Client: CgMs Consulting

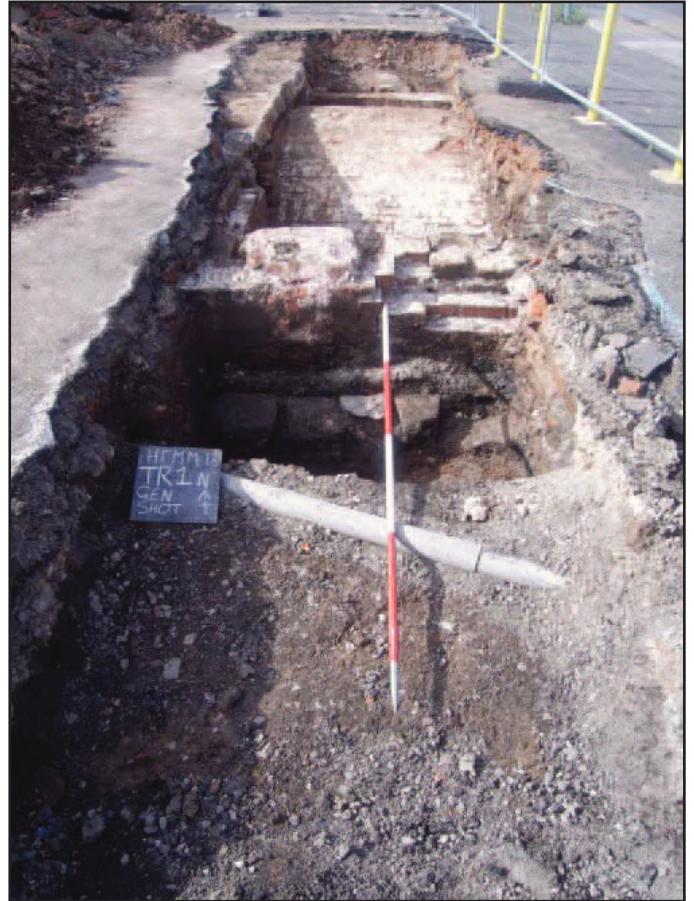
Plate 2: Trench 1, view to north

- 3.4.3 Towards the north and centre of the trench was an arched culvert, 106, constructed of brick and orientated west-east, and would once have carried the Widemarsh Brook. Only the upper surface of the culvert was revealed, and the northern end abutted walls 107 and 108 (see above). To the south the culvert abutted stone wall 105 (see below), which may have formerly demarcated the southern edge of the channel.

- 3.4.4 Wall 105 was orientated west-east, with a return to the south at its western end, and was constructed of roughly hewn, randomly coursed limestone blocks. The wall may have demarcated a building, with the north-south element also defining the edge of the channel prior to the construction of brick culvert 106. Wall 105 was abutted by a further west-east aligned wall 103. Wall 103 was also constructed of roughly hewn sandstone blocks, randomly coursed. Towards the eastern edge of the trench the wall survived to a height of around 500mm (revealed height), but to the west of the trench it was lower, an area interpreted as a doorway.

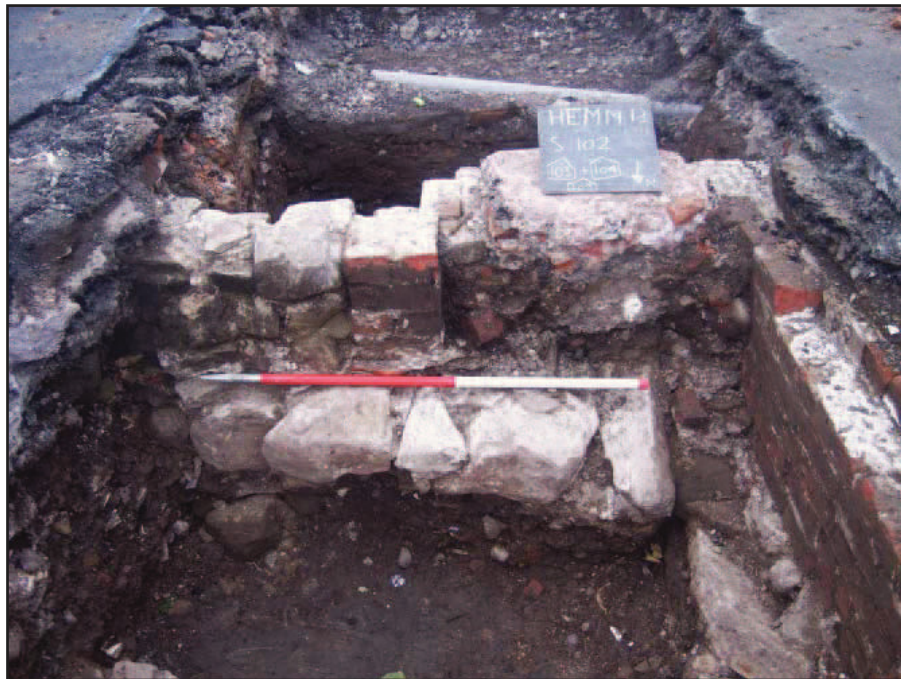
Plate 3, Trench 1, Section 102

- 3.4.5 Parallel to wall 103, and situated around 100mm to the south, was a further west-east aligned wall, 102. This wall was also constructed of roughly hewn sandstone blocks the upper two courses of which were visible. Walls 102 and 103 clearly represent different phases of building, but both were post-dated by the same deposit (113 below), and no relationship between the two structures was present at the depth to which the trench could be safely excavated. Wall 102 was constructed directly upon a layer of mid greyish brown sandy clay, 118, which contained pottery with the broad date range of 1700-1800, and overlay a further layer of silty clay, 119, which remained unexcavated. Any relationship between layer 118 and wall 103 could not be established without the removal of wall 102.

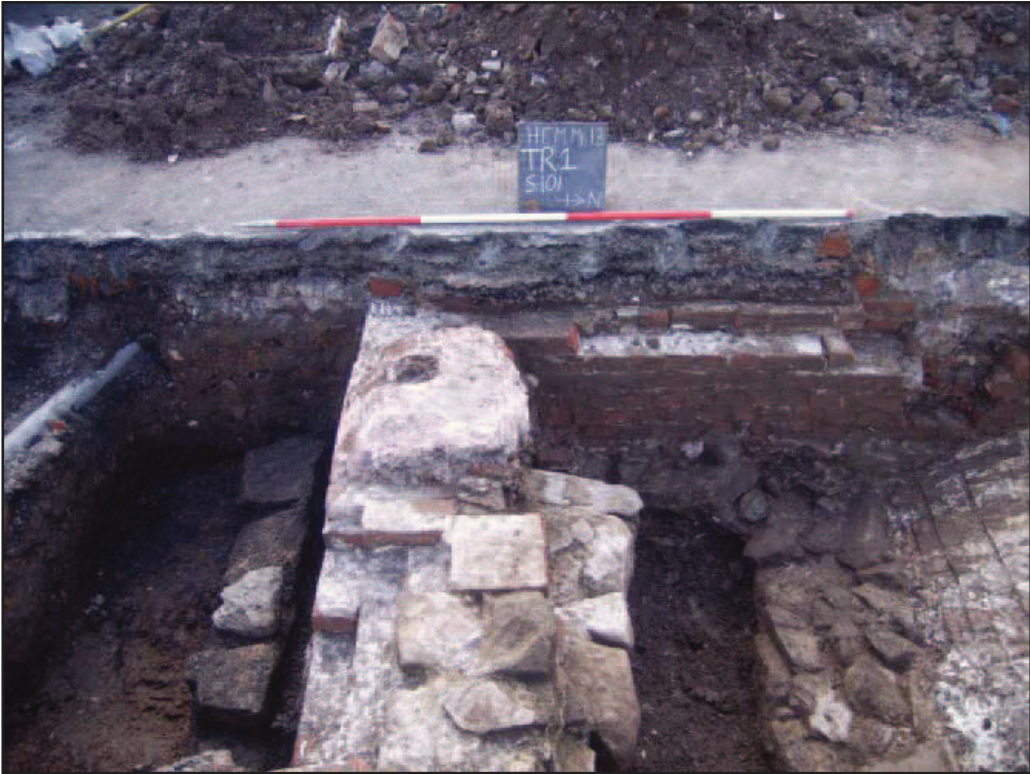
Plate 4, Trench 1, Section 101 (detail)

- 3.4.7 The area of doorway within wall 103 was blocked up by the west-east running part of an 'L' shaped brick wall, 104, which also turned to the north to run parallel with the western edge of the trench where it also overlay wall 105. Up to seven courses of brick were noted, each brick measuring 9" by 4.4" by 3.75", and bonded with a light whitish grey lime mortar with charcoal fleck inclusions.

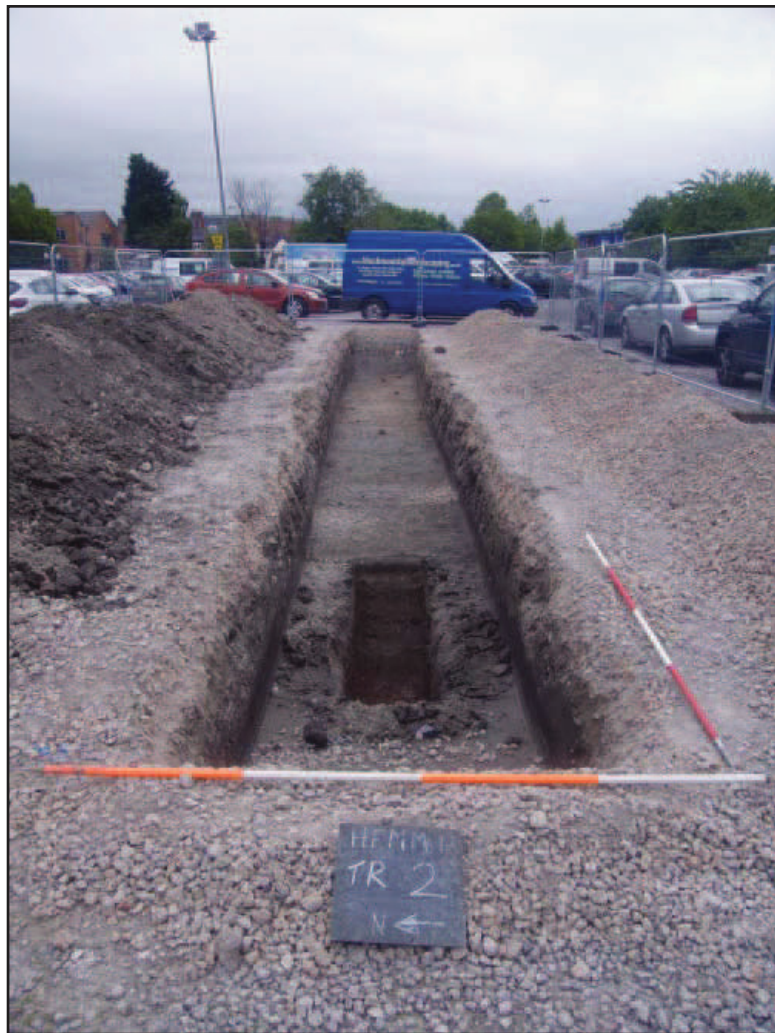
Plate 5, General shot of Trench 2 showing sondage through channel sequence

- 3.5.1 Trench 2 (Fig, 3 Plan 200, Fig. 4 Section 200, Plate 5), contained two potential channel deposits, 202 to the east of the trench, an mid orange brown clay (which was not

investigated), and 203/205 to the west which was investigated by machine sondage. Both of the channels overlay the natural gravels 204.

- 3.5.2 The western channel contained two fills (Fig. 4, Section 200), the upper fill 203 which was a dark grey green deposit with a slight resemblance to peat, which overlay 205, consisting of fairly fine mid to dark grey gravels. No finds were recovered from either deposit. The interface between the two deposits was horizontal within the area of sondage. An environmental sample was taken from both the upper and lower parts of 203 (see Appendix C). Deposit 203 was overlain by car park make up layer 201, which was sealed by the compacted gravel surface 200.
