Cousin Lane Stairs City of London

Archaeological Watching Brief Report

April 2011

Client: Fugro Engineering
Services Ltd

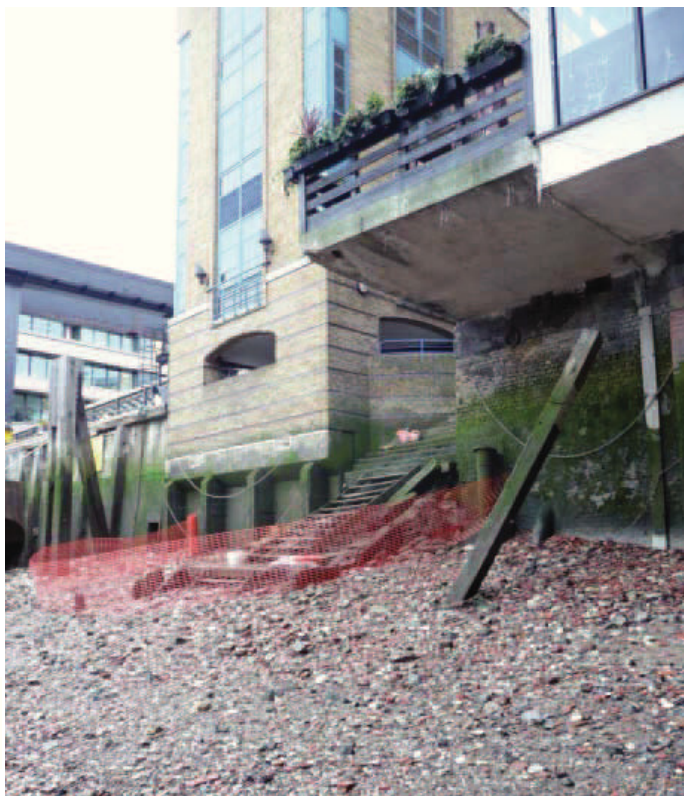
Plate 1: Site viewed from the south-east

- 1.2.1 The site lies within the City of London on the stairs at the end of Cousin Lane (TQ 32526 80689) and the foreshore of the River Thames (Plate 1).
- 1.2.2 The geology of the area is alluvial sands, clays and peats overlying clays, silts and sands of the London Clay Formation (Geological Survey of Great Britain 1981).
- 1.2.3 Most if not all of the invasive activity took place within deposits brought into site as part of riverside maintenance, presumably at some time during the late 19th or first half of the 20th century.

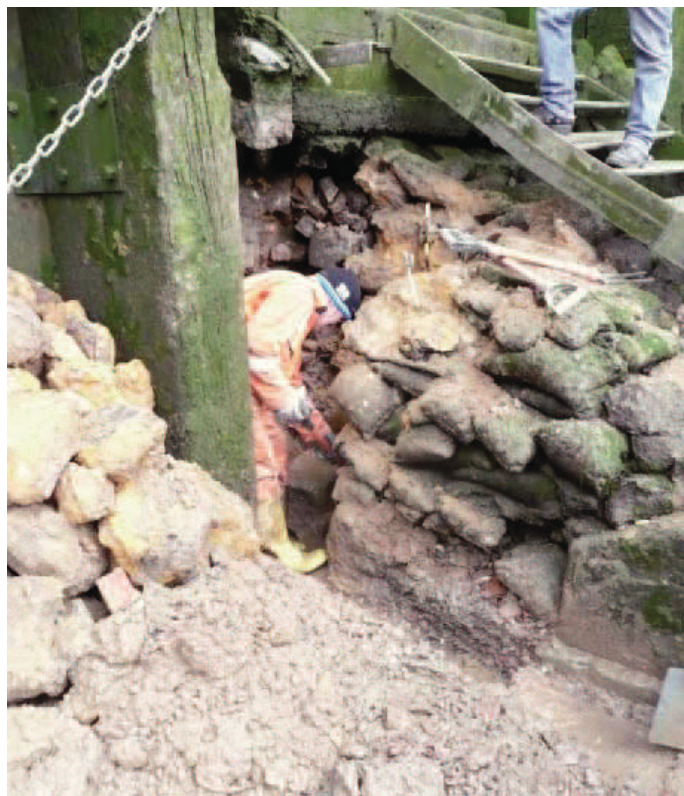
Plate 2: Working in TP01

- 3.1.2 TP01 was positioned directly up against the riverside front at the north-west corner of the steps. Below around 1.5 m of fairly concreted sand bags, a deposit of concrete, stone and shell sat over the brick core of the steps (Plate 2). At the western edge some of the original basal stone steps survived and this greatly hampered the excavations. Under this were foreshore deposits consisting of sand/gravel/flint cobbles with numerous inclusions of bone, late post-medieval tile/construction/building material (CBM) and a mix of modern finds including plastic, metal, a windscreen-wiper, glazed ceramics and glass. Clearly the deposits directly below the damaged steps had been reworked by tidal action.

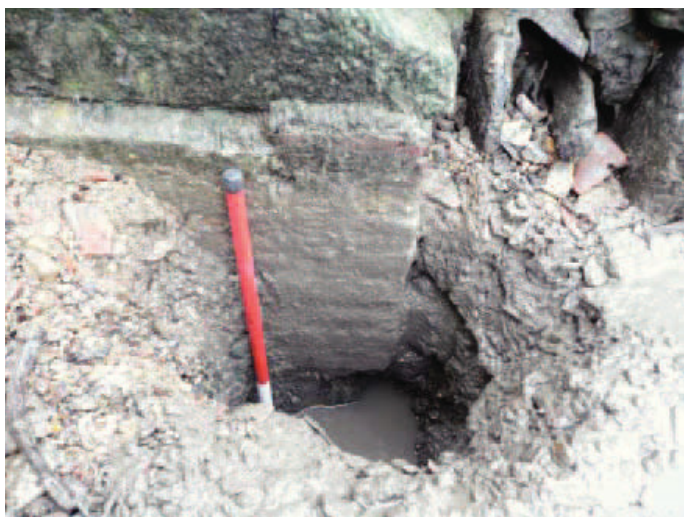
Plate 3: TP02

- 3.1.4 TP02 and TP03 were located around 0.4 m apart. TP02 encountered a timber obstruction at 1.15m, which wouldn't allow a window sample to be done. TP03 was therefore excavated for the window sampling core. Both test pits revealed a brick-built plinth underlying the stone steps to a depth of 0.6 m. Working in conjunction with this was a set of wooden piles and beams. More beams and posts were identified around 0.3 m west of the steps and may have formed part of a groyne. The deposits surrounding the brick plinth in TP02 were identical to those found in TP01 and included the discovery of a 1973 one pence piece from around 1m down, again showing the high degree of tidal reworking (Plate 3).

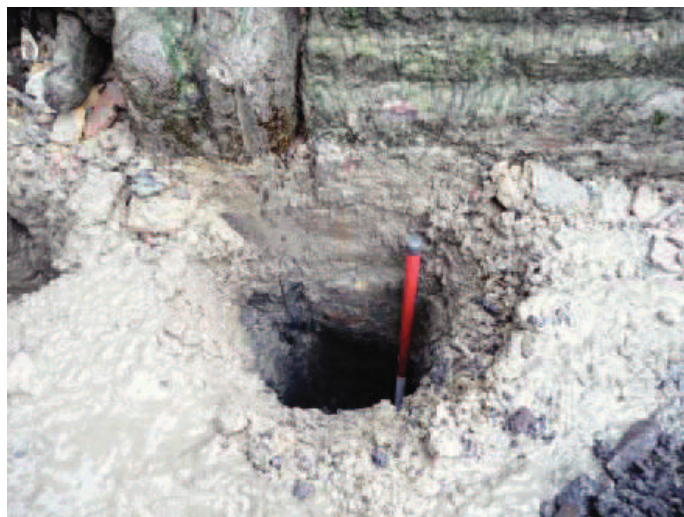
Plate 4: TP03

- 3.1.5 TP03 revealed a very different sequence below an initial 0.5m of typical foreshore deposit (Plate 4). Here a deposit of very dark grey-black silty clay material very much like a garden or night soil, containing large quantities of late post-medieval or early modern ceramics, glass and tile, was found in and around the wooden piles and brick steps. This material resembled an intentional backfill and may have been used to fill in or make-up the ground around the steps after or during their construction. The steps at this end also differed in that here, the brick plinth was tiered slightly and although this may have been for display, it is almost certain that this was for increasing the support given by the foundations on the riverside end of the steps, the place most vulnerable to erosion.
