28-29 Belmont Wantage Oxfordshire

Archaeological Watching Brief Report

April 2013

Client: Hanbury Development Ltd

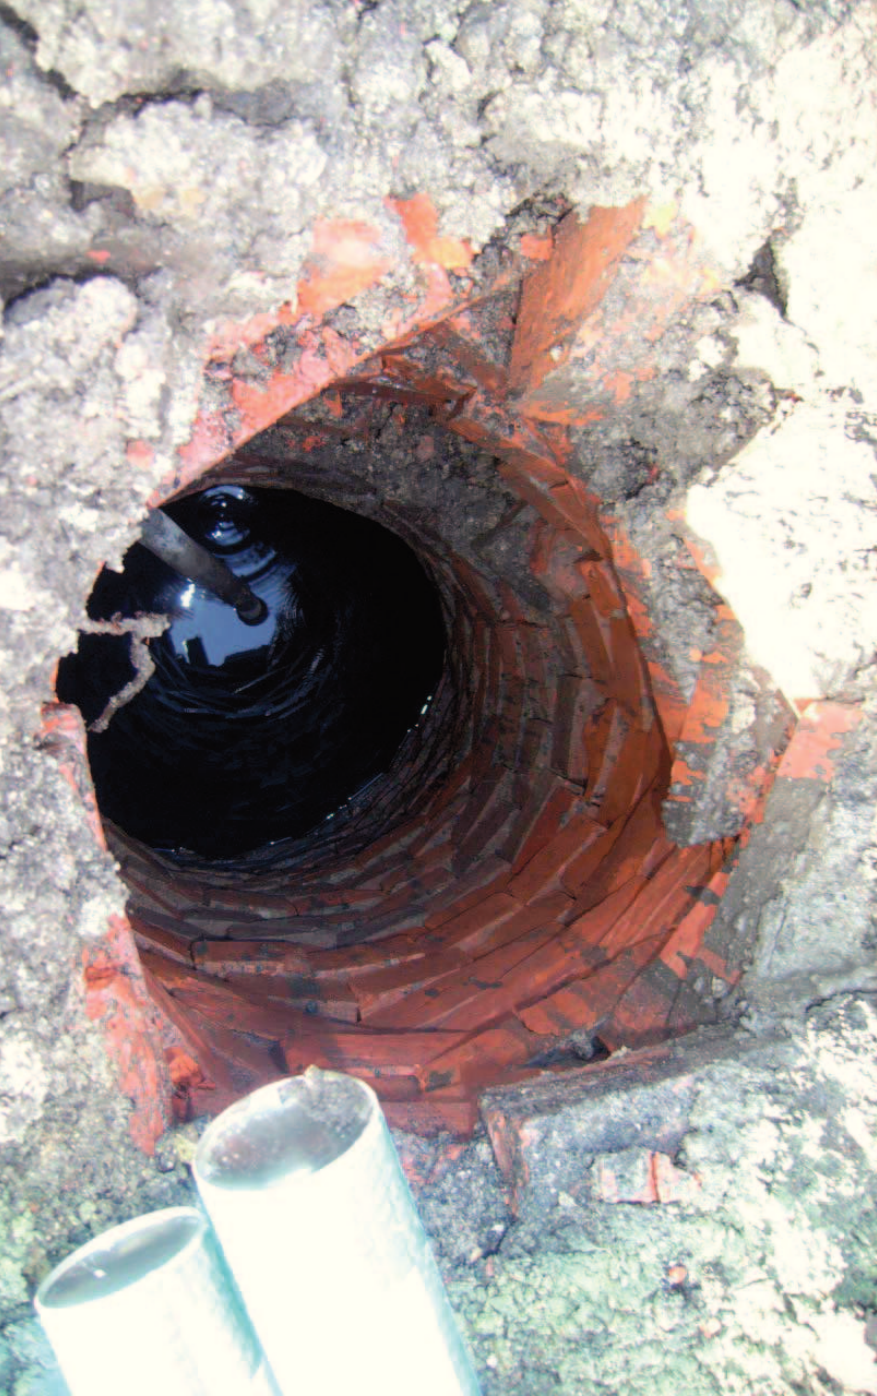
Plate 2: Well 5

- 3.1.9 As elsewhere on the site this was overlaid by the topsoil, (1), 0.25m in depth.
- 3.1.10 In the centre of the northern edge of plot 2, the top of a brick lined well (5) was exposed during the topsoil strip (Fig. 2). This feature was circular in plan and was constructed using a plain machine made red brick, 0.225m x 0.110m x 0.07m in size (Plate 2). These had been laid without using mortar tangentially around the circumference of the well. The cut (6) for the well shaft was exposed during later machining was seen to be approximately 1.2m in diameter and was probed to a depth of 3.4m below the garden level. The remains of a lead suction pipe could be seen rising up the side of the well before turning through 90 degrees and running out eastwards through the top courses of the brickwork. The style of construction and brick size would suggest a mid to late 19th century construction.

- 4.1.4 The size and style of the bricks used in the lining of well 5 suggests that it was probably contemporary with the construction of the demolished houses.
