St Mary's Church
Wendover
Buckinghamshire

**Archaeological
Watching Brief Report**

March 2011

Issue No: 1
OA Job No: 4926
NGR: SP 871 073

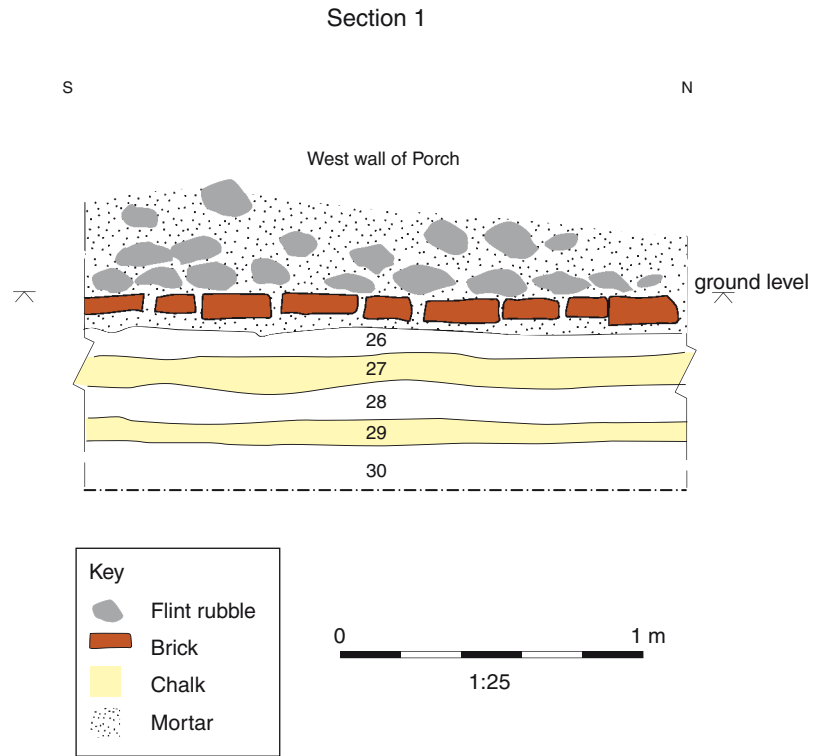
Figure 3: Section 1

- 3.3.20 Overlying the western half of porch layer 26 was a 0.14 m deep layer of compacted chalk (27) (Fig. 3). This layer was very even and may represent a path leading up to the original south door of the church. This was overlain by a 0.1 m deep layer of light grey

- 3.3.21 A second 0.1 m deep layer of compacted chalk (29) had been deposited over layer 28. This extended underneath the west wall of the porch but only intruded partway within the porch. This may represent a later path leading to the south door. Overlying this was a 0.2 m deep layer of light grey clay-silt (30), probably a redeposited lense of layer 26.
- 3.3.22 The construction cuts for the foundations of the east, west and north walls of the porch had been cut through this deposit and also layer 26, truncating burials 19 and 22 in the process.

- 4.1.11 Layers 27 and 29 are layers of compacted chalk and are only found on the western side of the porch. They also run under the west wall of the porch suggesting that they are not related to, and predate, the construction of the porch. It is possible that they represent two phases of a path that lead up to the south door of the church from the

west. The layer of material separating them (28) is probably a layer of churchyard soil (similar to 26 and 30), possibly cast up when inhumations raised the ground level around the south door necessitating a newer, higher path.

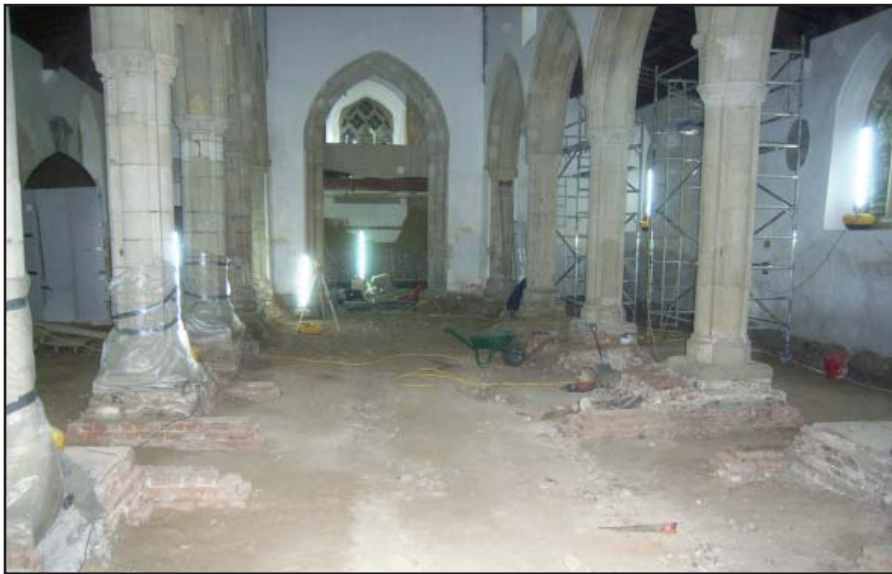
Plate 1: Interior of the Church following ground reduction

- 2.2.1 The watching brief observed all reflooring works that had the potential to affect or reveal archaeological deposits. This included the reduction of the ground level in the nave, aisles and south porch (Plate 1), the excavation of shallow foundation trenches for new sleeper walls, moving the font and constructing an associated new base, the excavation of service trenches for new wiring ducts, reduction of a brick burial vault, reduction of the floor level within the south porch and underpinning the south porch walls.

- 3.3.10 Layer 17 was also cut by the foundation trenches for brick collars or platforms built around the bases of the column piers (Plate 1). These were of a poor quality plain red brick bonded with lime mortar. As well as encompassing the flint foundations of the piers they extended lengthways by approximately 1.3 m to the west of each pier. The purpose of the collar around the pier bases was evidently an attempt to strengthen or support them but it was unclear what the purpose of the platforms were and they may relate to the Victorian suspended floor. Also cut into layer 17 were channels containing two brick ducts each approximately 0.5 m wide and 0.15 m deep. These ran from under the chancel area and along the north and south aisles. The eastern ends of these ducts immediately west of the chancel and Lady Chapel were smoke blackened suggesting that they were heating ducts and probably associated with the suspended floor.

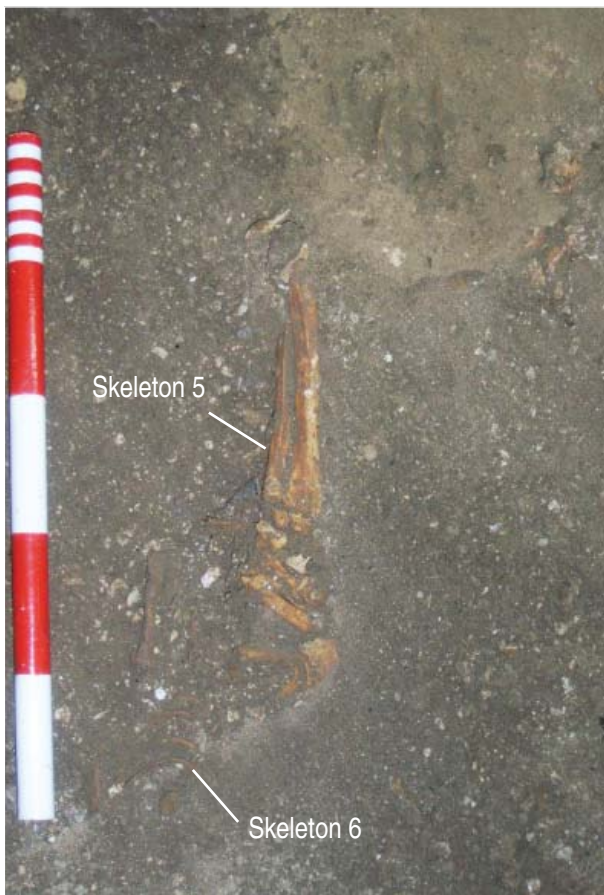
Plate 4: Skeleton 5 (right hand and forearm only),
Skeleton 6 (neonate)

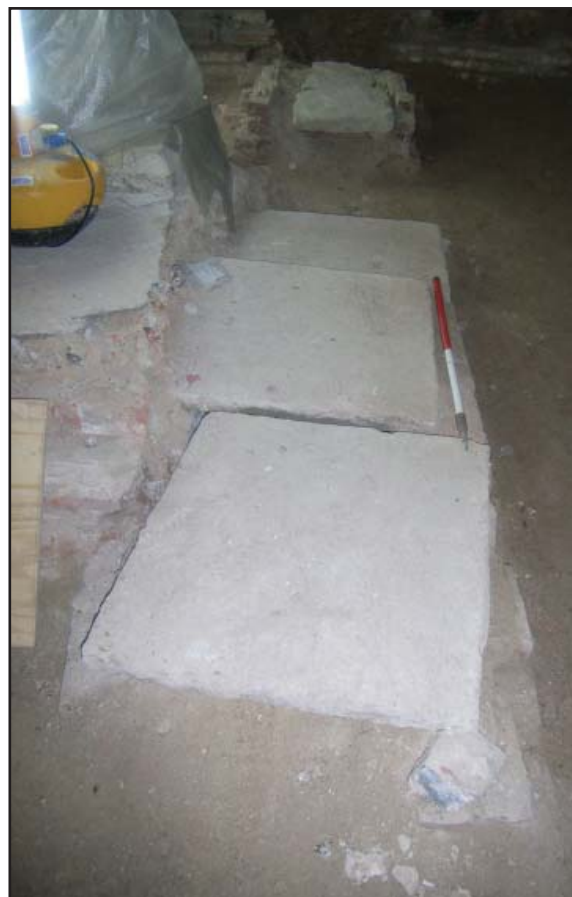
Plate 11: Brick shaft grave B1 prior to removal of capping slabs

3.3.5 As part of the works it was necessary to reduce the height of the large brick shaft grave (B1) in the southern aisle in order to pass the lintels supporting the sleeper walls above it (Fig. 2, Plate 11). This was done by removing the top two courses of brick of the grave. The grave was capped by three slabs of limestone, two approximately 1 m square and the third measuring 1 m wide by 0.6 m long. The slabs had been dressed on the upper surface, but the undersides were as quarried. The grave itself was coffin shaped and measured 2.02 m long internally, 0.49 m wide at the eastern (foot) end, 0.74 m wide at the widest part and 0.59 m at the western (head) end. It could be seen to be in excess of 0.8 m deep. The sides of the grave had been constructed in a plain machine made brick, 0.223 m by 0.105 m by 0.072 m, and lime mortar. The walls had been laid using English stretcher bonding and measured 0.223 m thick.

- 3.3.8 After removal of the two courses of brickwork the stone slabs were replaced.
- 3.3.9 A second smaller brick shaft grave (B2) measuring approximately 1.5 m long by 1.1 m wide was exposed between the previous shaft grave (B1) and the Lady Chapel (Fig. 2, Plate 14). This had been constructed using a plain hand-moulded brick measuring 0.24 m by 0.117 m by 0.055 m and lime mortar, and capped by three slabs of limestone, the largest measuring approximately 1 m² and the two smaller ones measuring 0.6 m wide by 0.35 m long. The walls were laid using English stretcher bonding. As with the previous shaft the top two courses of bricks were removed. Exposed within the rectangular shaft was a small (child's?) lead coffin. No coffin plate was observed within the shaft but the size of the bricks suggests a probable mid 18th century date.

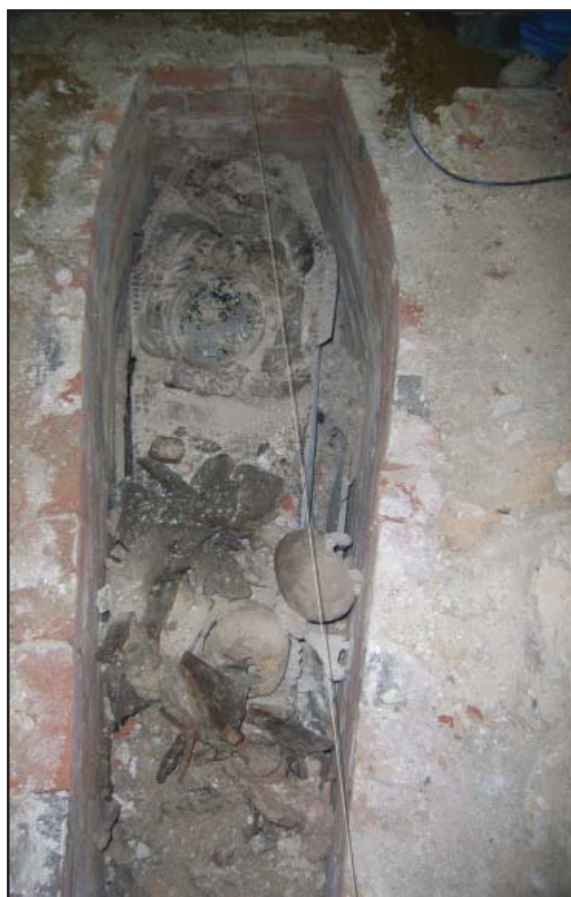
- 3.3.6 At the eastern end of the grave were the remains of disturbed burials, represented by disarticulated human bone (including two skulls) and coffin remains (Plate 12). The coffin remains comprised decomposed fragments of wood covered in black fabric, fastened with brass dome-headed studs. At the western end of the grave was an embossed tin breastplate depicting two figures, possibly angels, holding bunches of laurel, or possibly ears of wheat, with foliage below and an urn underneath a crown supported by angels, at its head (Plate 13). The centre of the plate had been enameled or painted black and had the lettering "Mrs Eliz. Edmonds died March ...7" painted on in white. The style of this breastplate does not appear to match any in the catalogue of coffin fittings from Christ Church, Spitalfields (Reeve and Adams 1993, Appendix D), or any others in Oxford Archaeology's catalogue of coffin fittings. This breastplate has therefore been assigned the new code WESTMC1 (Plate 13).

Plate 12: Brick shaft grave B1 after removal of capping slabs. Note the disarticulated bone at the foot end of the grave. (View west)

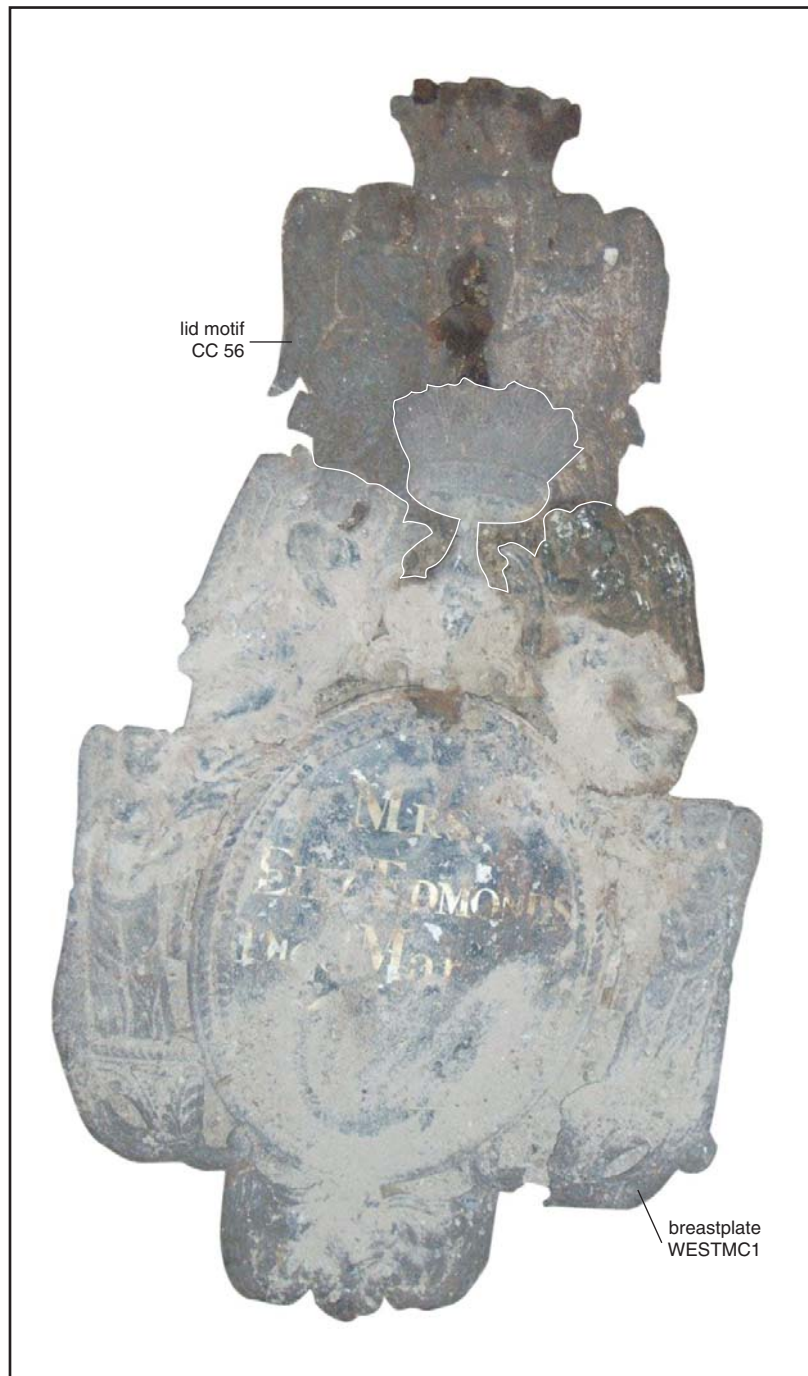
- 3.3.7 Breastplate WESTMC1 rested directly above an intact wooden coffin with a lid motif depicting what appeared to be a crown held by angels on either side. This appears to be identical to the Christ Church Spitalfields CCS6 lid motif (Reeve and Adams 1993, Appendix D). This lid motif was in a much poorer condition than WESTMC1 above. The coffin was only partially observable but looked to be single-break in shape (widest at the shoulder), with lead sides. The wooden lid was covered in black fabric secured with brass dome-headed studs. The studs were arranged in a double-row pattern around the edge of the lid. No other coffin fittings were visible.

Plate 13: Breastplate WESTMC1 and lid motif CCS6 from brick shaft grave B1

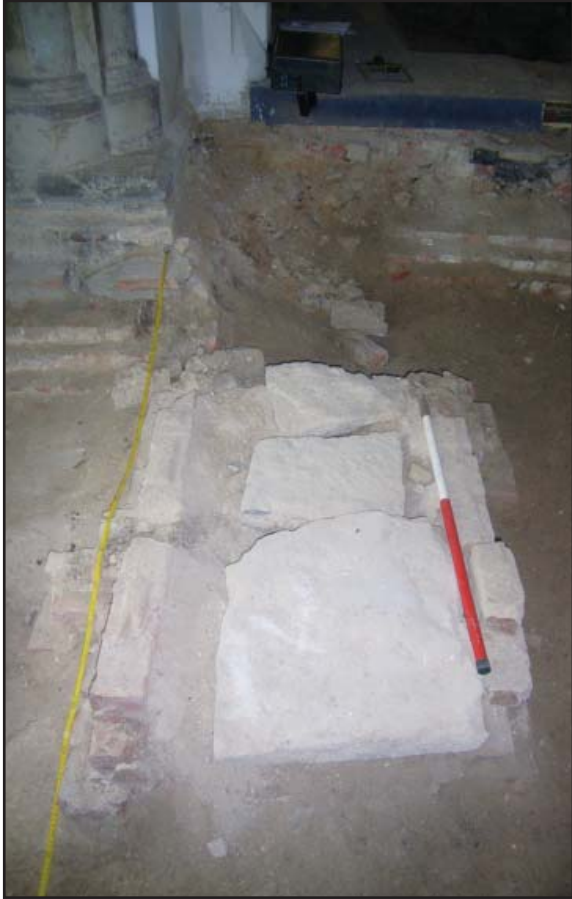
Plate 14: Brick shaft grave B2 (view east)

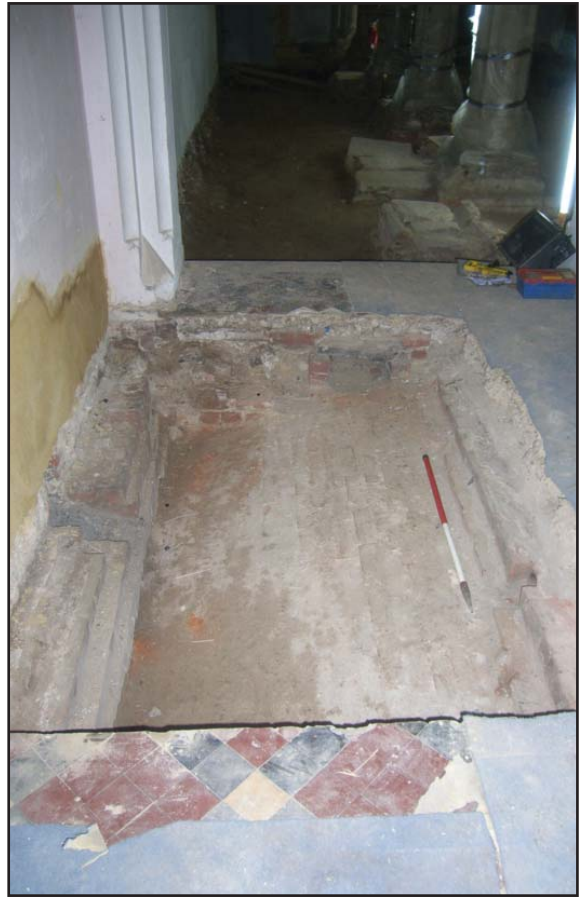
- 3.3.14 Part of the 19th century glazed tile floor within the south-west corner of the Lady Chapel was removed as part of the works. This exposed a loose mixture of rubble and soil, which sealed the top of a barrel vaulted brick burial chamber (C1) (Fig. 2, Plate 15). This measured approximately 3.2 m long by 2.3 m wide and had been constructed with a plain hand moulded brick (0.23 m by 0.12 m by 0.07 m) and lime mortar. The interior of the vault was not visible. The size of the bricks suggest a late 18th or early 19th century date.

Plate 15: Brick barrel vault C1, in Lady Chapel (view east)

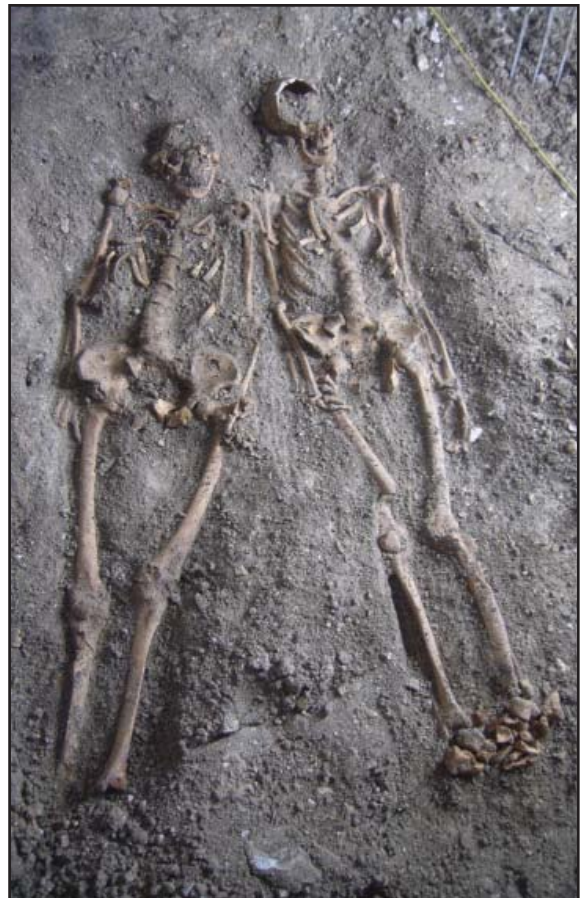
- 3.3.18 In the centre of the porch a sequence of burials was exposed. The earliest, burial (23), had been truncated and was represented by the right leg and arm only, that of an adult male. Immediately north of this was the supine (lying on their back) skeleton of an adult female (21). This had been disturbed along its northern edge by a later inhumation of a supine adult male (20) (Plate 17).

Plate 17: Skeletons 20 (right) and 21 (left)

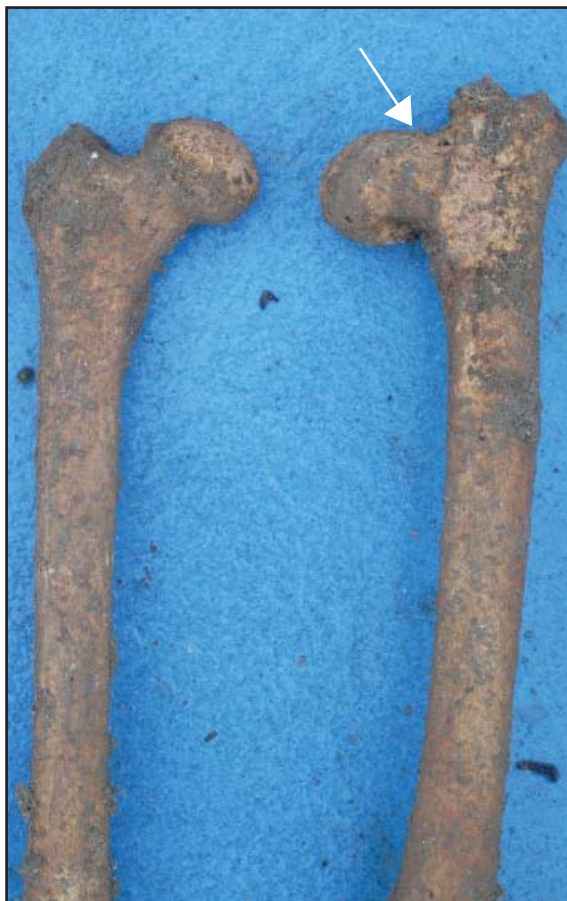
Skeleton 21, an older adult female, had a healed, but malaligned, fracture of the left femoral neck (top of the thigh bone, at the hip) (Plate 18). The amount of healing indicates that the injury had occurred a long time before death. Irregularity in the shape of the greater trochanter (at the top of the femur) probably represents muscle/soft tissue damage incurred with this injury. A direct blow to the hip (e.g. falling onto the hip) may have been the cause (Galloway 1999, 174). It is also worth noting that the left leg bones in this individual were of equal size and robusticity to the right leg bones. This suggests that use of the injured leg was not restricted, once the fracture had healed. Often in cases of severe trauma, use of the affected limb is restricted and as a result, the muscles, and subsequently the bones, atrophy (wither).

Plate 18: Left and right femora from Skeleton 21. Note the abnormal angle of the left femoral head due to a healed fracture of the femoral neck (arrowed)
