6 Dorchester Road Drayton St Leonard Oxfordshire

Archaeological Evaluation Report

June 2013

Client: Mr and Mrs M Emmett

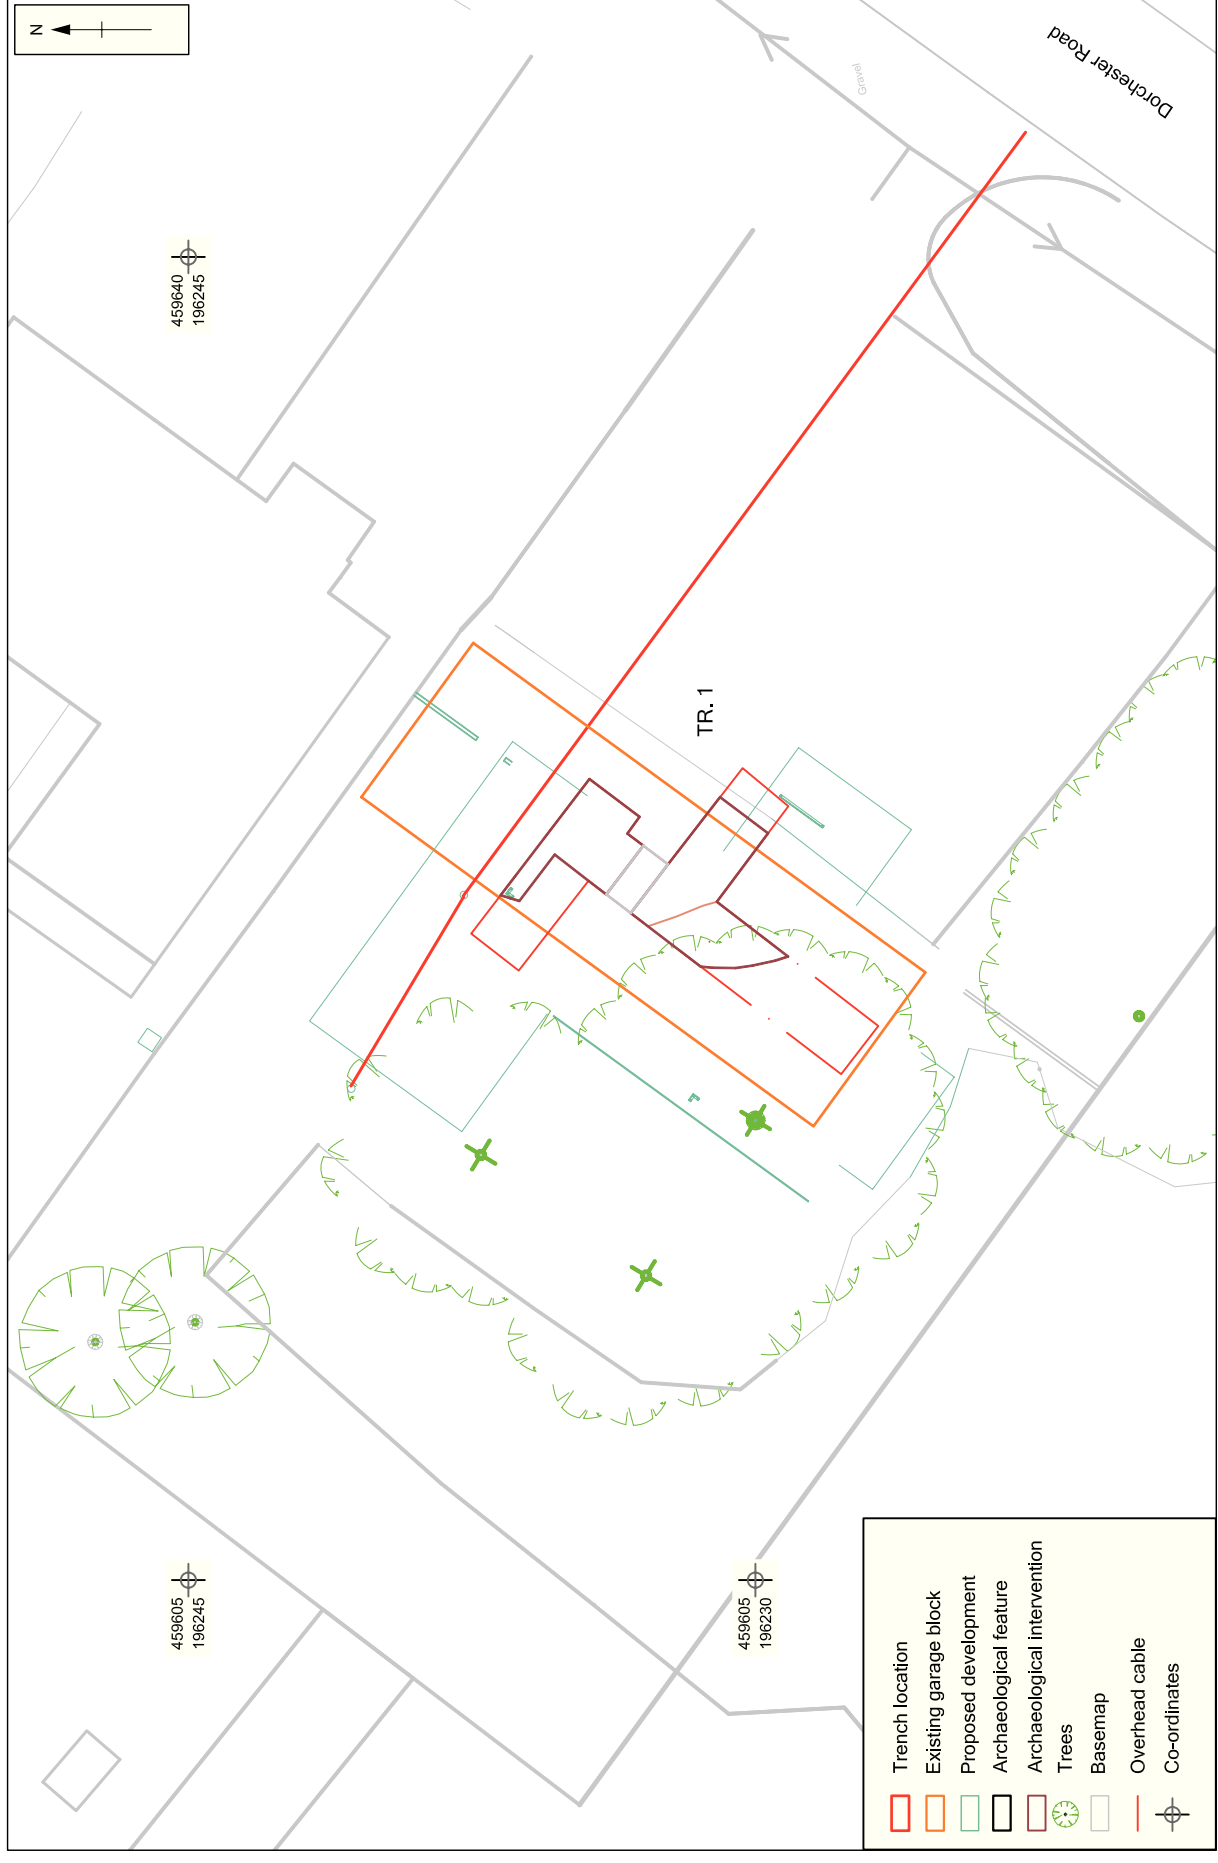
Figure 3: Trench location plan.

- 2.4.2 One trench was opened, 10m long with two arms of 3.40m and 1.60m protruding from it (Figs 3 and 4; Plates 1-3). As the brief had requested, the trench was laid out within the footprint of the proposed new house, but the detailed layout was constrained by existing below-ground services and overhead cables.

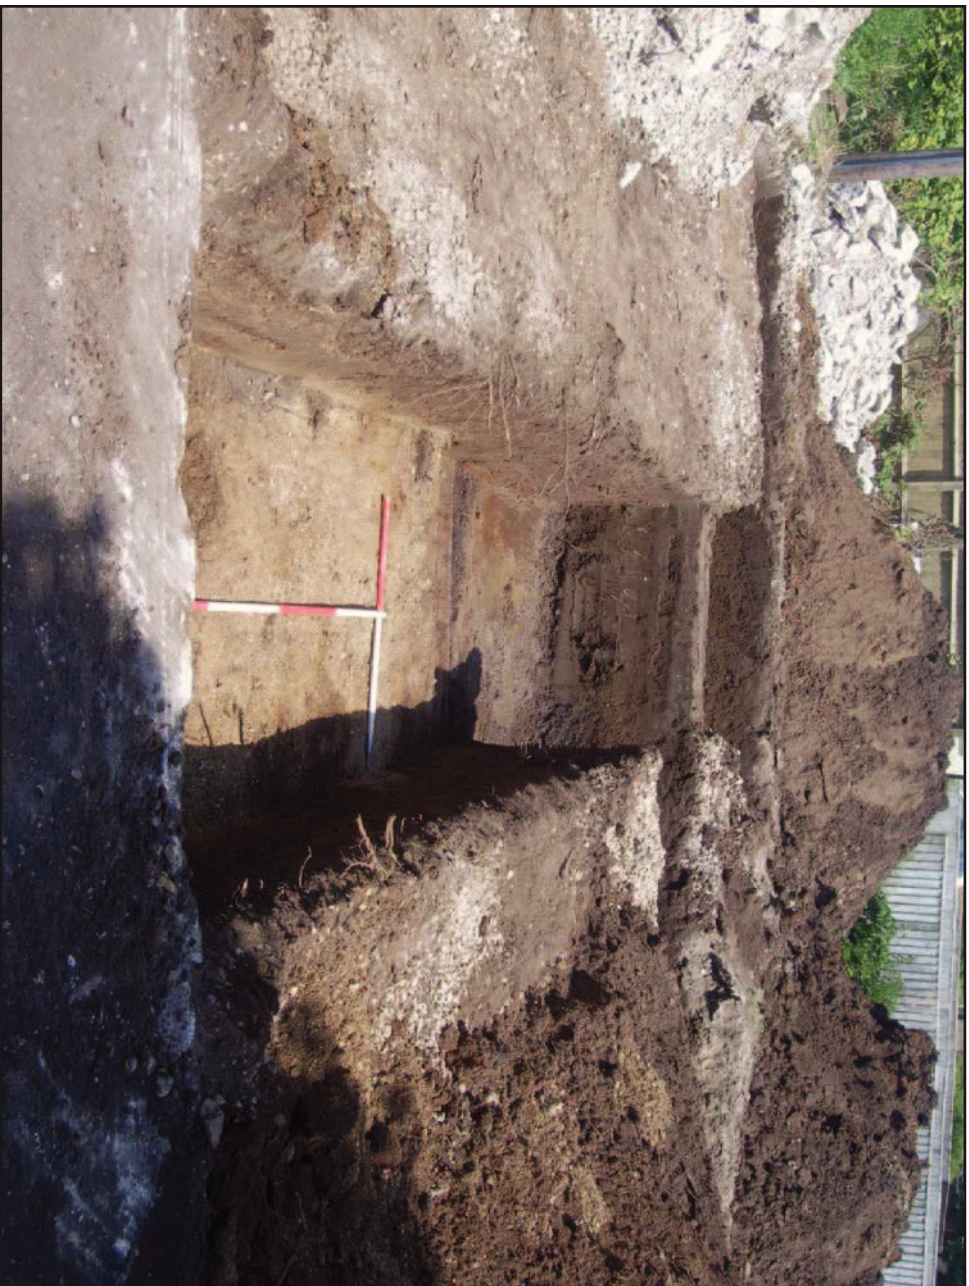
Plate 1: Trench looking north-east after machining

- 3.3.1 A single pond feature (107) filled the eastern part of the trench, but was not fully revealed within it (Fig. 4; Plates 1-3). This measured at least 8m east-west by 4m north-south, with a steep north edge and a shelving west edge, presumably for access. The base was flat, and the maximum depth observed was 0.70m. The cut contained two fills (103) and (106) (Fig. 5), the upper of which contained a single sherd of post-medieval pottery.

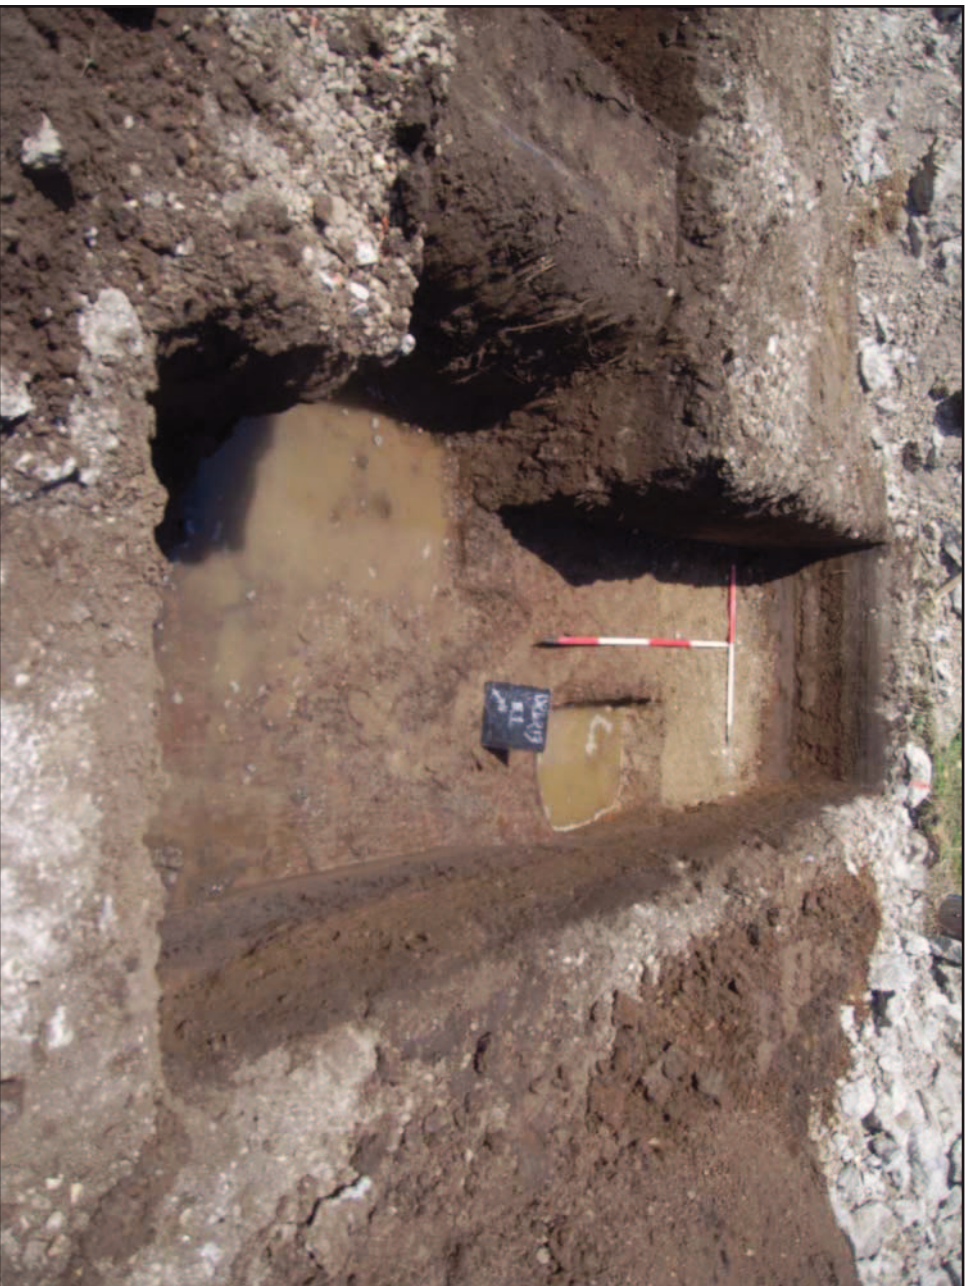
Plate 2: East end of trench looking north-west

- 2.4.5 It was decided to carry out further excavation towards the presumed centre of the feature, in order to establish whether the depth of the feature, and the fill sequence, was constant across the area of the trench. As groundwater was entering the feature as

hand-excavation proceeded (Plates 2 and 3), making detailed observation and recording of the fills difficult, it was decided to excavate these further slots by machine under close archaeological supervision, and to sort the spoil on the side of the trench. A single sherd of pottery was recovered from the upper fill, and an environmental sample was taken (see Appendix B).

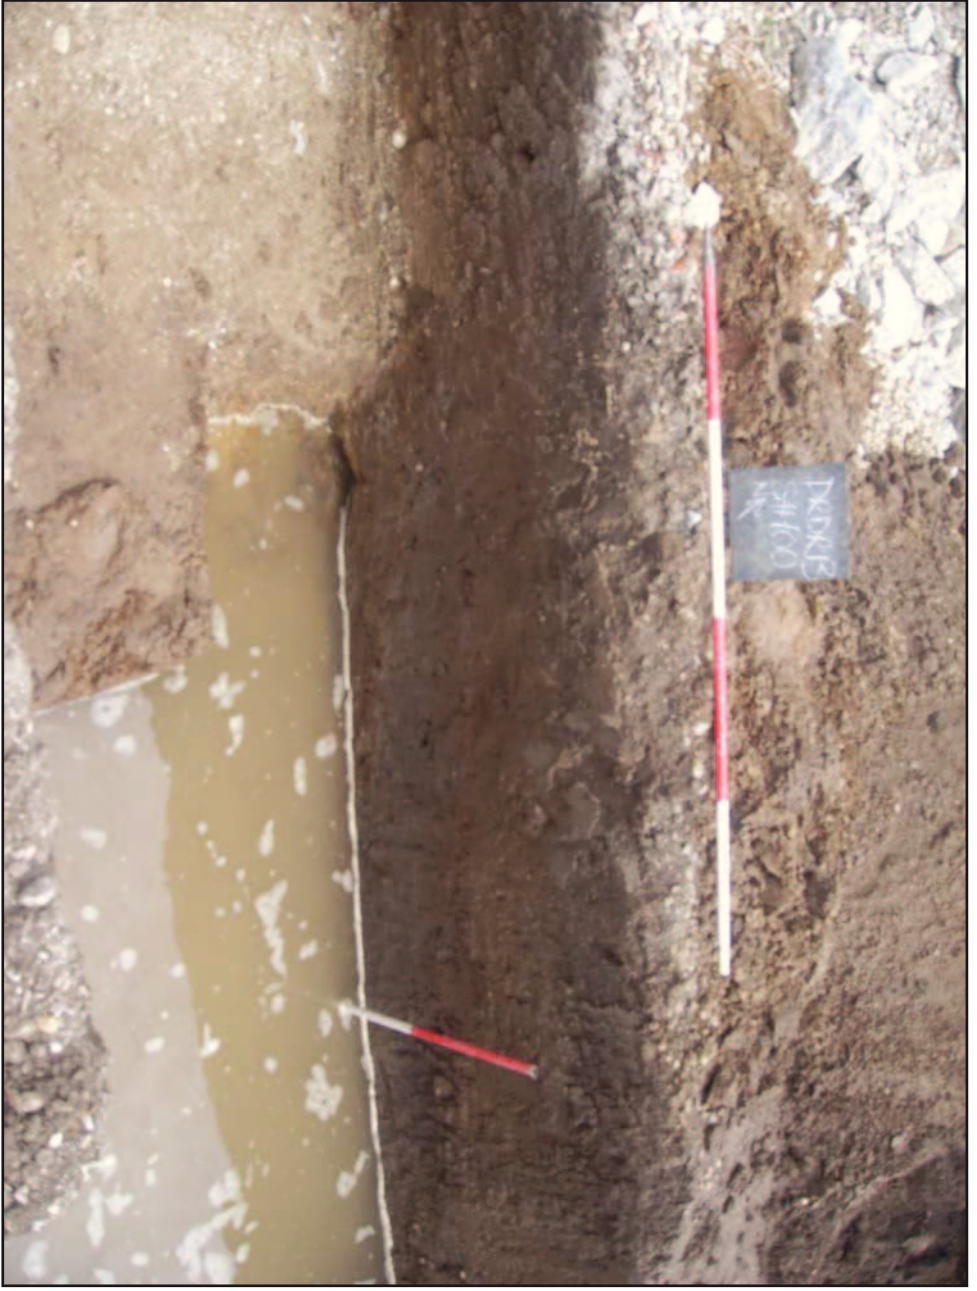
Plate 3: Section 100 showing pond cutting gravel, looking north-east
