New Mini Plant BMW Factory Cowley Oxford

Archaeological Watching Brief Report

March 2013

Client: BMW (UK) Manufacturing Ltd

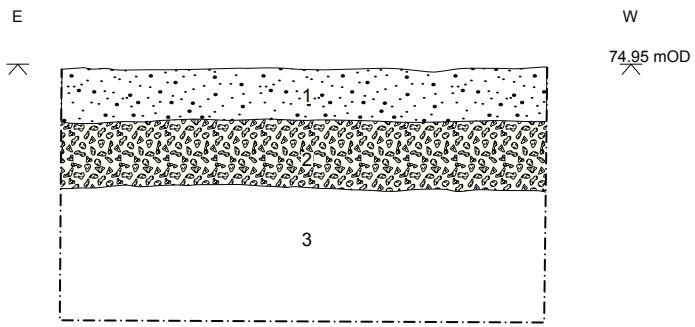
- 3.1.2 Zone A was located along the south-western boundary of the development area and measured approximately 165m by 15m. At the start of work it was covered by a concrete and tarmac road surface.
- 3.1.3 Within the area of Section 1 (Fig. 3a), a reddish-brown silt clay (3) was encountered at a level of 0.4m below the road level. Directly overlaying this was a 0.22m deep layer of crushed sandstone (2) forming the base for the road, a concrete slab 0.18m thick (1).
- 3.1.4 At Section 7 (Fig. 3c) a sterile orange-brown sand (35) was encountered at a depth of 0.5m below the road surface. The sand was overlain by a made ground sequence of modern deposits variably comprising slag, sand and silt (34, 33 and 32) in turn overlain by a layer of crushed sandstone (31), a continuation of layer 2. The concrete road surface (30) was built directly upon this layer.

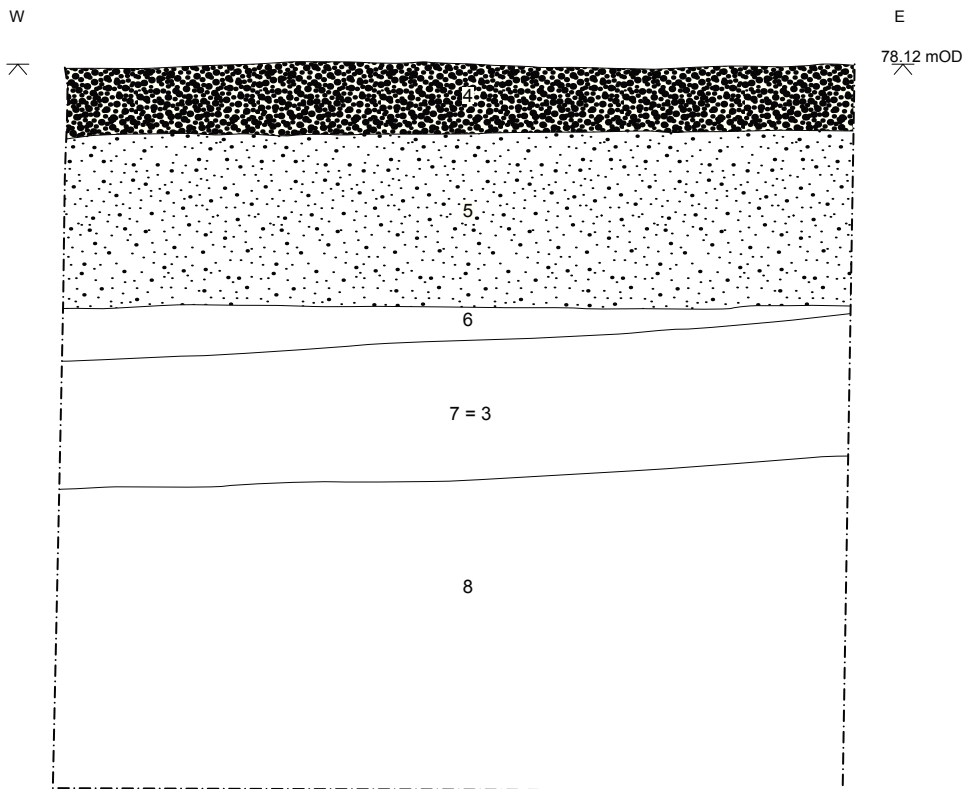
- 3.1.5 This area formed a terrace approximately 3m higher than Zone A and measured approximately 170m by 35m. Prior to the start of work it was used as a car parking area with a tarmac surface. The sections were exposed when the perimeter concrete retaining wall was demolished.
- 3.1.6 The natural sand and ragstone deposits (8 and 22) were observed at a depth of 1.2-1.4m below the parking area (Fig. 3a Section 2 and Fig. 3b Section 4). Overlying the sand was a layer of reddish brown sandy silt clay (7 and 21) up to 0.4m in depth, a layer (64) also recorded in the base of Section 14 (Fig. 3f). This deposit probably represents a surviving soil horizon that had suffered relatively little truncation prior to the current development. However, no archaeological features or deposits were identified at this level.

- 3.1.7 The buried soil horizon was overlain by a 1m thick sequence of made ground deposits comprising variably silt, sand and mixed stone/rubble (6, 20, 19), crushed stone sub base material (17) and parking surfaces comprising concrete and tarmac (18, 16, 5, 4, 63, 62). Towards the north-western limits of this area the parking surfaces had been overlain by a 1m thick layer of made ground comprising sand mixed with brick, concrete and tarmac fragments (61). A landscaping layer topsoil 0.2m deep (60) had been laid over this (Figs 3f Section 14 and 3i Section 21).

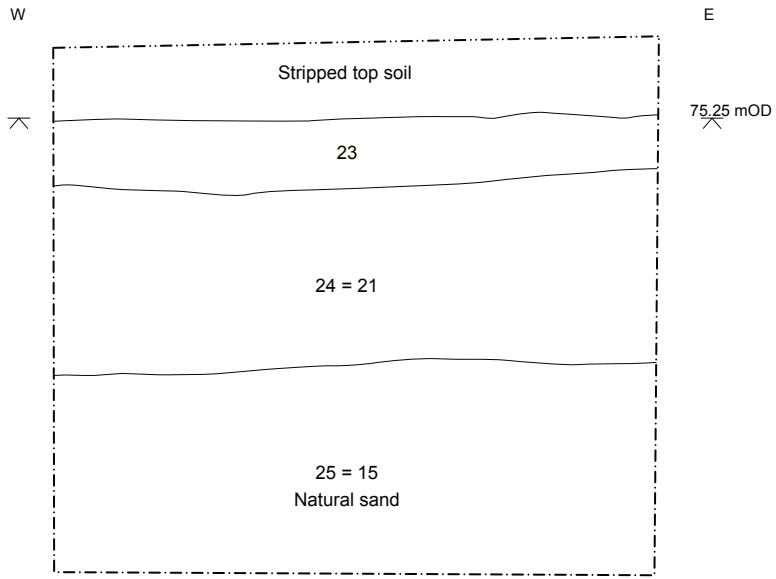
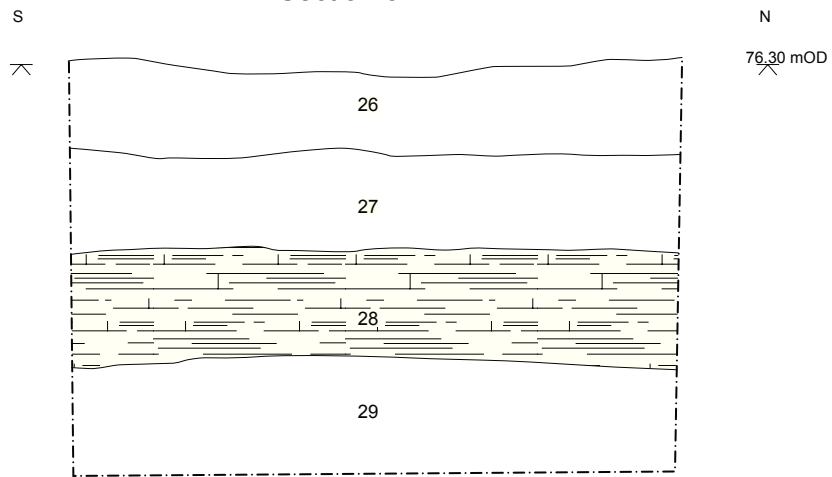
Figure 3c: Sections 5 - 7

- 3.1.13 Natural sand and ragstone geologies (15, 14, 8, 25, 29, 28, 68, 74) were encountered across the whole area during the reduction of the ground to the current construction level. Directly overlying this within Sections 5, 6, 12 and 16 (Figs 3c, 3e and 3g) was the pre industrial soil horizon comprising a reddish brown silty clay (24, 27, 55 and 71). This deposit survived to a thickness of 0.25-0.5m. A sequence of modern made ground deposits (11, 12, 13, 26, 32, 66, 70, 73) and hard surfaces (9, 10, 67) sealed the geology and soil horizon with later topsoil and turf (65, 69, 72) laid over some areas of surfacing associated with more recent landscaping.

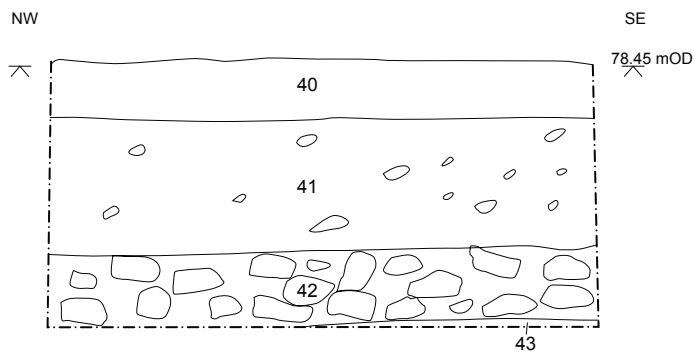
- 3.1.8 This zone consisted of a roughly triangular area 170m long and 50m wide at its widest point. The zone sloped down from north-west to south-east and was mostly grass with paths and areas of hard standing.
- 3.1.9 Two sections (Figs 3d Section 9 and 3h Section 20) were exposed and recorded. Both demonstrated that a sequence of modern made ground sand, silt and rubble deposits and surfaces were laid directly over sand (77) and ragstone (76) natural geological deposits. No evidence of comparatively undisturbed pre industrial soil sequences were observed in this area.

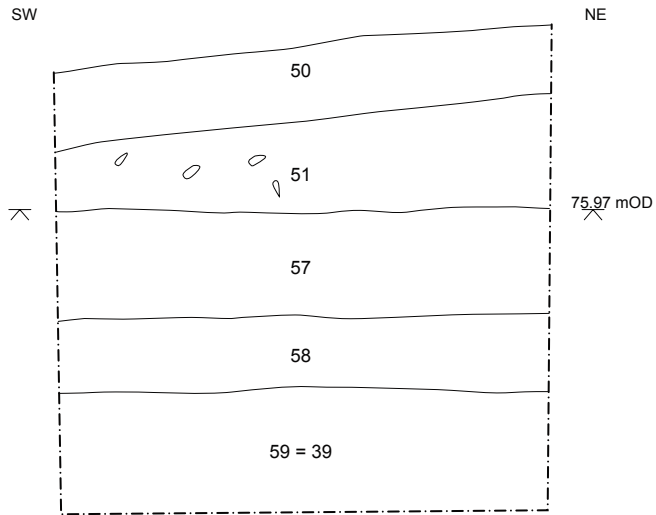
- 3.1.11 Sterile orange natural sand (39, 49, 52 and 59) was recorded across this area at a depth of 1m below the current ground level overlain by mixed made ground deposits comprising clay, silt, sand, rubble and topsoil an turf. Only at one location, Section 13 (Fig. 3f), was there a variation to this sequence with the relatively undisturbed reddish brown silty clay soil horizon (57) present above the sand geology and buried by the made ground. This represents an isolated survival of the pre industrial soil horizon within this zone although no archaeological finds were encountered in association with this.

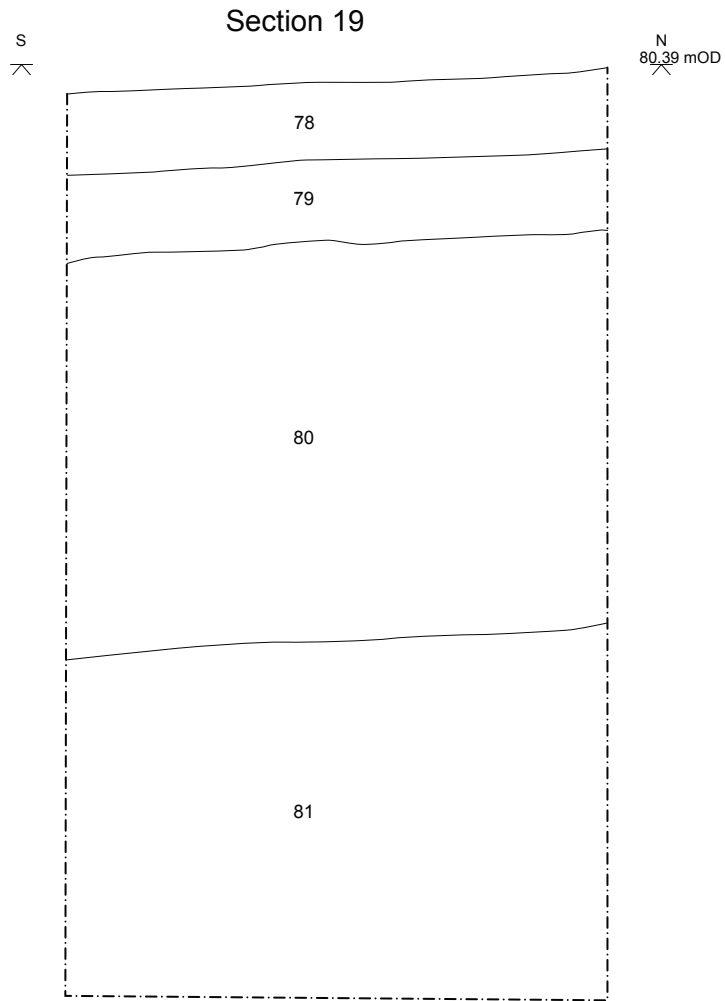
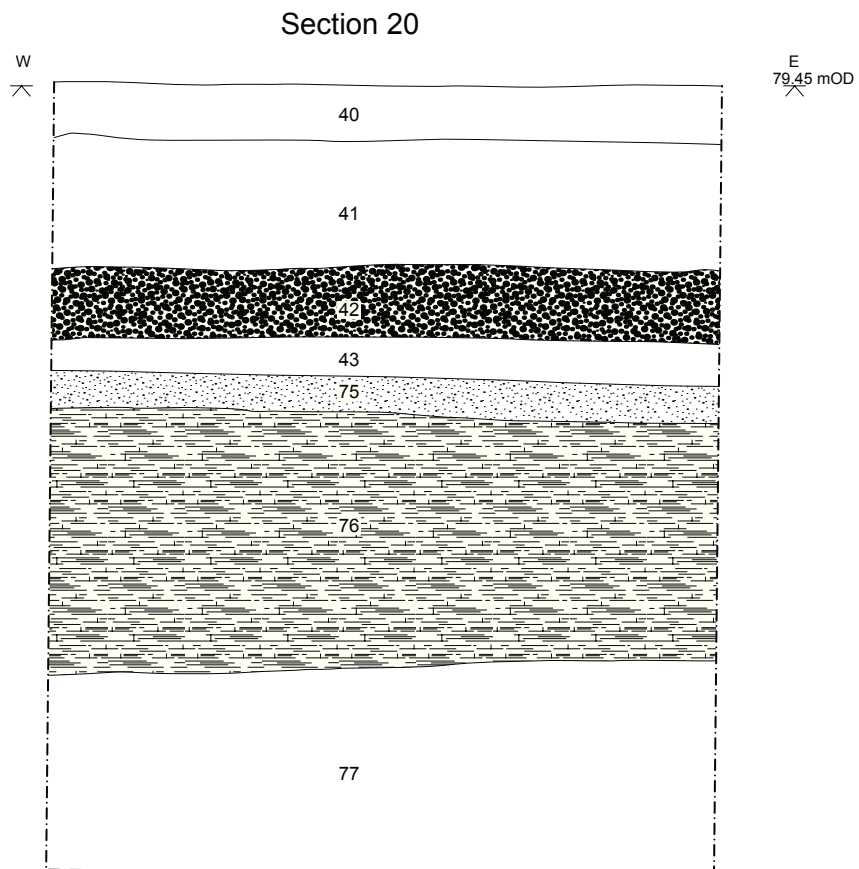
Figure 3h: Sections 19 - 20

- 3.1.14 This zone comprised open factory buildings built on a concrete platform at the same level as Zone B. Immediately prior to the fieldwork the buildings had been demolished and the concrete platform and associated below ground structures were removed.
- 3.1.15 Natural sand and ragstone (81 and 80) was revealed across the zone during the ground reduction and this was directly overlain by a relatively shallow (c 0.5m thick) sequence of made ground and demolition debris deriving from the recent removal of the concrete surface. The area had clearly been subject to disturbance and removal of any pre industrial soil sequences as part of the former constructions.
