Document Title: Beckton Sewage Works, Precipitation Lanes and Re-Aeration Lanes

Document Type: Historic Building Recording

BECKTON SEWAGE WORKS

HISTORIC BUILDING INVESTIGATION AND RECORDING

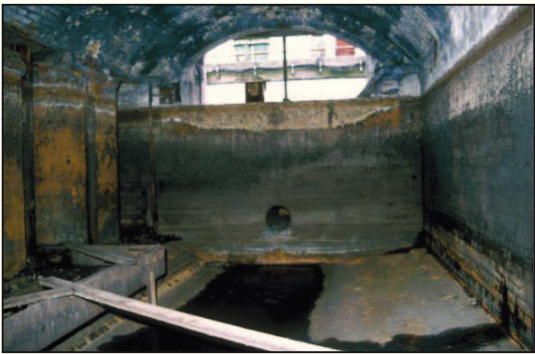
Plate 3: East termination of precipitation lanes

lanes have a kink in their alignment at the eastern end so that they subsequently run in a west-east direction as they meet the later re-aeration lanes. The precipitation lanes are accessible through six rectangular openings where it is possible to see the construction of the brick arches (Plate 1). The south-western length of the lanes is covered with earth and there are small rectangular brick vents located on this surface spaced at c.26 m intervals (Plate 2). The lanes also extend further to the east and this section is covered by a concrete walkway. The lanes terminate at the east end as they meet the weir chamber (Plate 3).

- 4.2.10 The eastern end of each precipitation lane is blocked by a concrete wall that is thought to be contemporary with the construction of the re-aeration lanes (see Plate 3). This has been built to a height of 2.43 m and has a circular hole (diameter 0.40 m) located near its base. A penstock is evident on the east elevation of the wall that was used to control the flow of material into the weir chamber. These are considerably smaller in size than those located at the south-west termination of the channel. Due to health and safety restrictions it was not possible to gain these measurements. The penstocks are iron and operated by small hand wheels located at ground level. The weir chamber is part of the 1960s re-aeration lanes and the penstocks were added at a later date in conjunction with this construction (Plate 12).

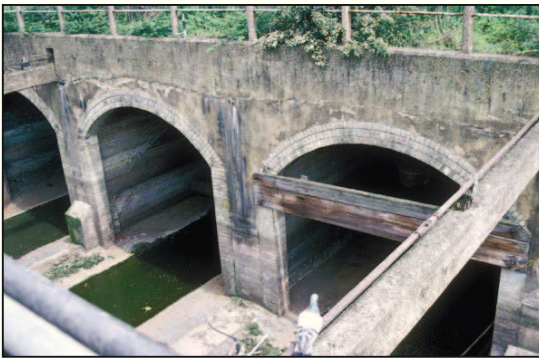
Plate 7: Precipitation lanes west facing arches

- 4.2.13 Iron cables operate the box weirs from the valve house (see §4.5.1) and these are evident running from the valve house and following the same alignment as the lanes. This area was stripped prior to demolition, and it was possible to see the cables running just below the ground surface in brick troughs that are 0.70 m in width and c. 0.50 in height (Plate 16). The cables run across the open rectangular areas on iron bars and are incorporated into the cement work above the brick arches (see Plate 7).

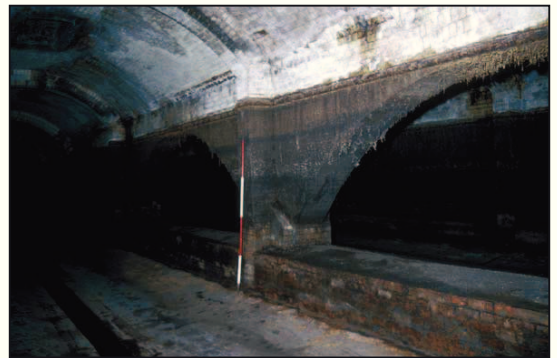
Plate 8: Internal north view of open arches dividing precipitation lanes

- 4.2.8 Internally, the lanes are divided into pairs with a central division of open arches extending the full length (Plate 8). The two outer walls are solid brick elevations although there is one infilled arch on each of the outer walls at the opening of the channel (Plate 9). There are small brick partition walls running between the central open arches at a height of 0.50 m. These sit on the concrete floor surface and are in places intercepted by small rectangular wooden gates that can be lifted up by handles. These would have permitted flow between the lanes during cleaning (Plate 10).

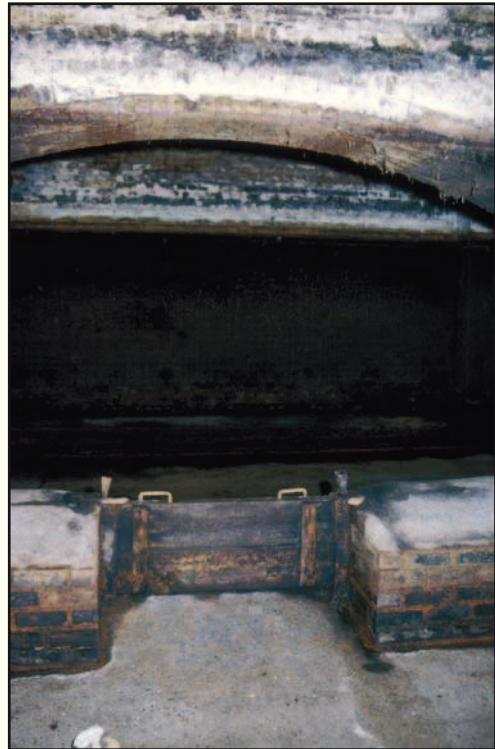
Plate 10: Internal north view of precipitation lanes showing partition walls and wooden gates

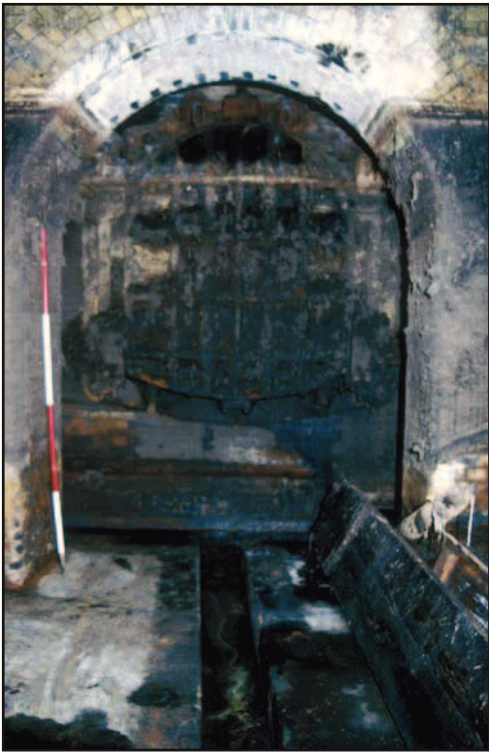
Plate 11: Penstock at south-west termination of precipitation lane

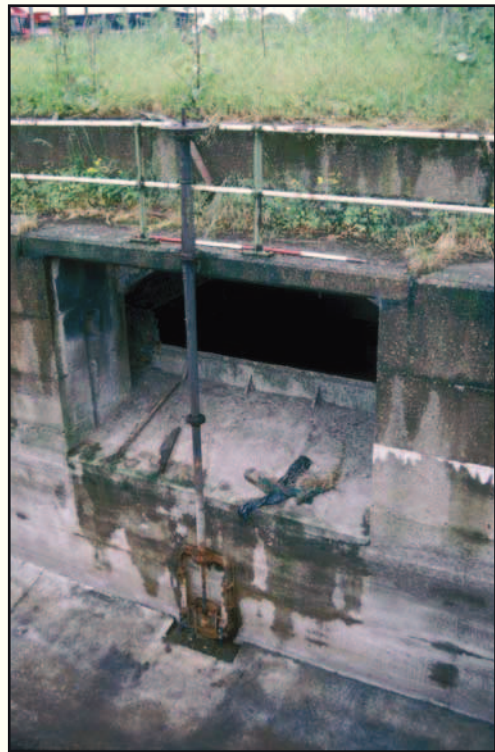
Plate 12: South-west view of weir chamber penstock

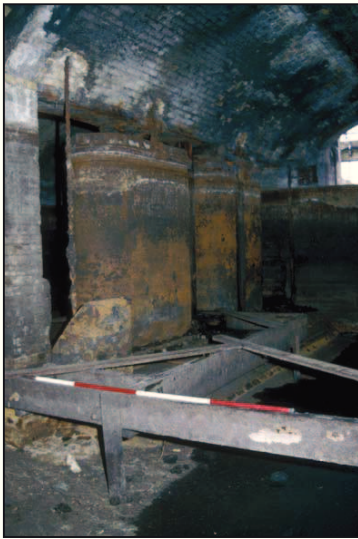
Plate 13: North-east view of box weirs at east termination of precipitation lanes

- 4.2.11 Iron box weirs are housed with the channel and used to control the flow of material from the precipitation lanes. At the east end of the tunnel, these are positioned beneath the internal arch of lanes 1 & 2, 3 & 4 and 5& 6 (Plate 13). These measure 2 m by 1.62 m and 0.60 m in depth. They are bolted onto an iron base, which sits on a brick platform that is 0.30 m in height and 1.40 m in length. There is also a large counterweight (1.59 m by 0.73 m) directly to the west of the penstocks. Large chains extend down through the brick arch from above to the top of the box weirs. These box weirs are hollow and once full of material would have been lowered by the chain into north/south running culverts. It is thought that they would have been suspended at different levels according to the type of material. For example, sludge is heavier and therefore the box weirs would be lowered further to allow this material to enter the culvert. The chains are operated by a hydraulic cable, leading from the valve house.

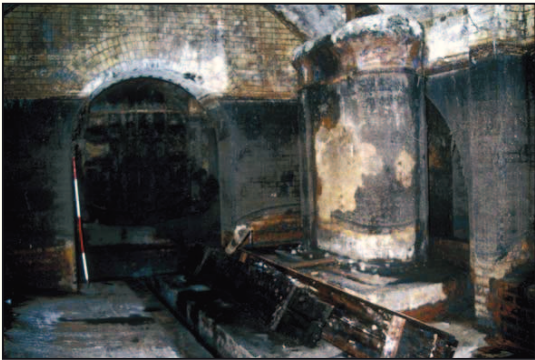
Plate 15: Box weir located at south-west termination of precipitation lanes

- 4.2.12 The south-western stretch of the lanes houses two box weirs under the central arches. These are of a construction as described in §4.2.11 (Plate 14). There is further box weir located at the south-west termination of the tunnel. This is considerably larger and sits on a brick platform in front of the penstock and to the north of the central division (Plate 15).

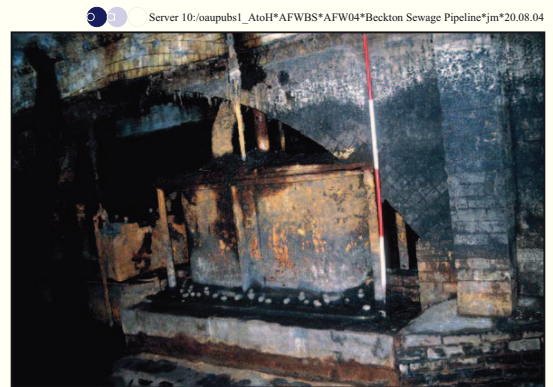
Plate 14: North view of weir located in south-west length of precipitation lanes

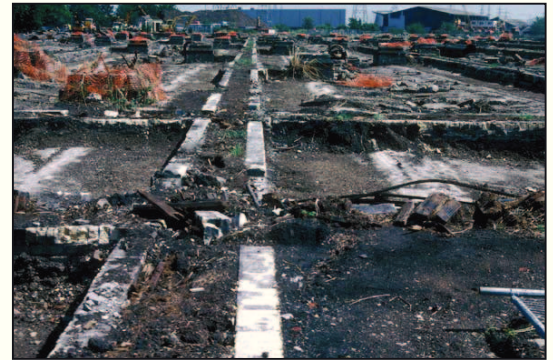
Plate 16: East view depicting brick troughs above precipitation lanes (taken during demolition works)

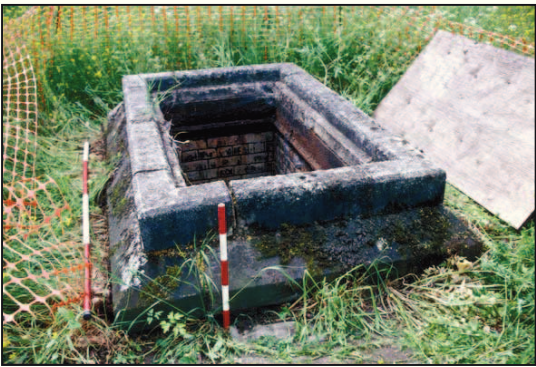
Plate 17: West view of vent above precipitation lanes

- 4.2.15 Ventilators are located at ground level in order for light and air to enter into the precipitation lanes through the roof (Plate 17). These are brick rectangular constructions that sit on an outer brick plinth. The top of the vent measures 1.20 m by 2 m and there are two stepped courses of brick 0.80 m in depth. The total internal depth of the vents is 1.22 m. They are spaced at c.26 m alternating between each pair of lanes. These vents were covered with boards and presumably they originally had some covering, although no hinges are evident.

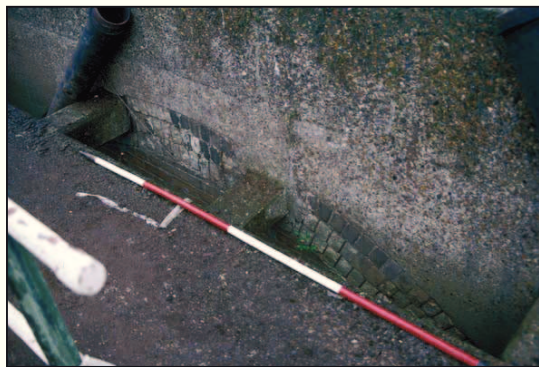
Plate 18: North-east view of blocked precipitation lane arch at east termination of re-aeration lanes

- 4.2.16 The original outer brick wall of the precipitation lanes is also evident running roughly east-west along the 1960s re-aeration lanes. The precipitation lanes in this area have largely been destroyed, and this evidence shows the original alignment of them. The brick wall is also extant at the north end of the site and provides the outer wall to the weir chamber. At the east termination of the re-aeration lanes it is possible to see the brick arches of the precipitation lanes. These would have formed the east termination of the lanes prior to their demolition in this area in the 1960s (Plate 18).

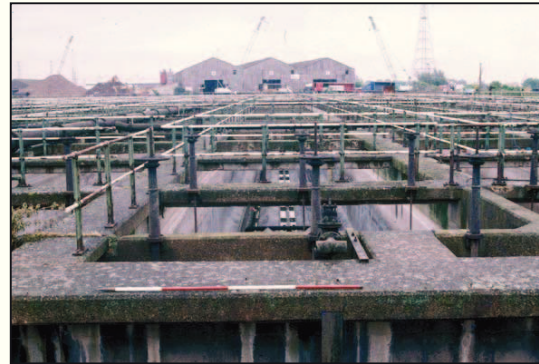
Plate 20: East view of re-aeration lanes

- 4.4.2 The layout of the thirteen lanes is roughly in an east-west alignment (Plate 20). At their western parameters they meet the weir chamber and earlier precipitation lanes, and to the east the Barking Creek. Fig 10 shows the section of the re-aeration lanes that were constructed from reinforced concrete. The purpose is to introduce oxygen into the treatment process to sustain the beneficial bacteria that consume the pollutants. Each channel houses three streams that dip in the centre to make a pointed triangular base (Plate 21). Circular iron discs run along this base through which, it is thought, air is ejected. The lanes measure 4.15 m in length, 4.65 m in width and each individual stream measures 1.55 m in width. The ten southernmost lanes are of a different construction, with an additional higher level of lanes at the west end (also detailed on Fig. 8). It is thought that the re-aeration lanes utilised the foundation of the earlier precipitation lanes and were constructed above this (OA 2003).

- 4.4.3 There is a criss-cross of walkways and supports that run between and over the re-aeration lanes (see Plate 20). The width of the walkways between the lanes is 0.98 m and those run over the lanes are 0.75 m. There are also horizontal structural supports between the lanes (0.31 in width) that are at the same level as the walkways. A number of these carry pipes thought to transport the material below to the streams. The walkways and supports cross the lanes alternatively, and at the beginning of the south end of the lanes the distance between the two is 1.77 m. Following this, the distance increases to between 4 and 4.5 m. There is iron fencing running along and across the lanes, with green upright supports and two sets of white rails.

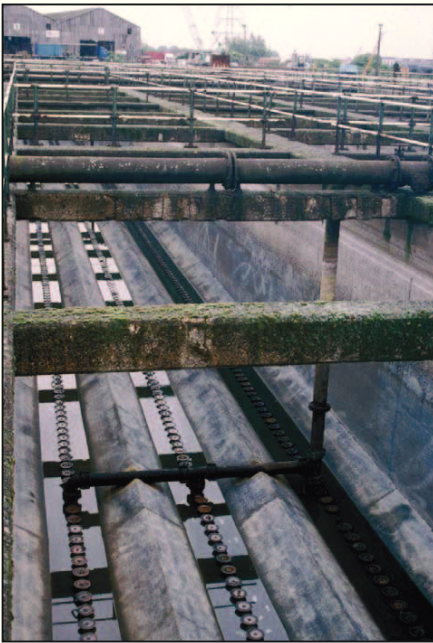
Plate 21: East view showing base of re-aeration lanes

- 4.4.4 Pipes (with valves) that would have carried material for the streams, run across and along the walkways and platforms (Plate 21). Each lane has three pipes running vertically into the streams and overhead these measure 0.25 m in diameter and 0.16 m as they extend into the streams. A horizontal pipe extends across the three streams at the bottom of the channel attaching onto the circular discs. The pipes run from a pumping house that is thought to be located to the west of the site. The pipes were visible during the watching brief following the stripping of the ground in the area of the precipitation lanes. The pipes run overland in a north-east/ south-west alignment and then turn at right angles to run in a south-east direction and then underground in a south-west/ north-east alignment. Five pipes run into the re-aeration lanes. During the demolition of the precipitation lanes it was possible to see the pipes running along the top. The 1960s concrete was laid on top of the precipitation brick arches and the pipes housed within this.

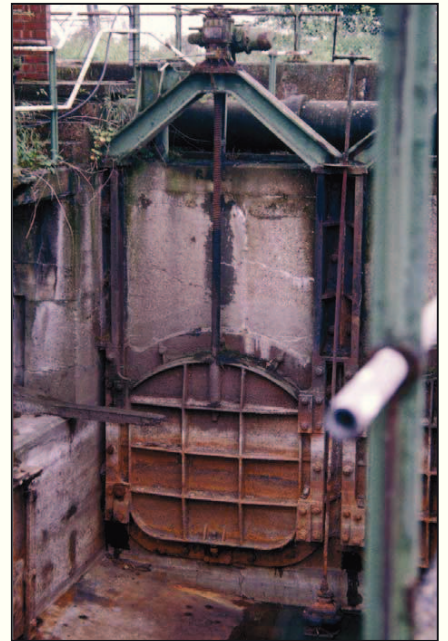
Plate 23 North view showing weir chamber penstocks

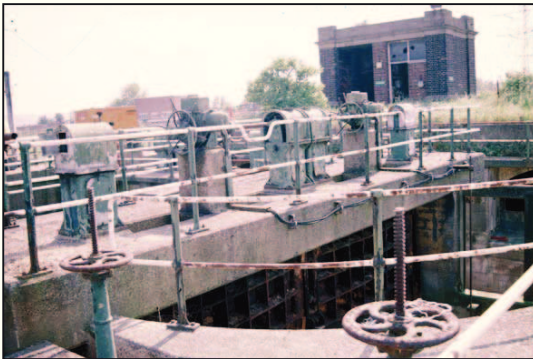
Plate 24: West view of venturi channel penstocks

- 4.4.7 Two larger penstocks are located at the west end of the venturi channel (Plate 24). A further two stand at right angles to these, as the venturi channel curves to the north. This means that the two most southerly re-aeration lanes are shorter in length. At the base of the channel and located just to the south of the penstocks are two circular brick walls that surround drainage lanes. A penstock once located at the south end of the tunnel has been cemented shut at a later date and it is no longer *in situ*. The extant penstocks are operated by hydraulics and a gauge of the same construction to the weir chamber penstocks is extant.

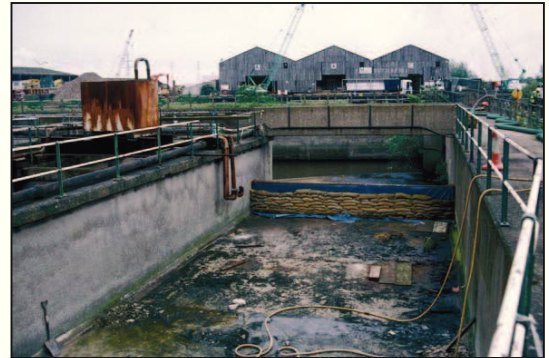
Plate 25: East view of venturi channel

- 4.4.8 The venturi channel was used to monitor the flow of material and runs in a south-east/north-west alignment (Plate 25). It is constructed from reinforced concrete (width 6.9 m) and extends from the weir chamber to the Barking Creek. Directly to the north are the huge sludge tanks and there is a concrete walkway (width of 2.80 m) with rails separating these two areas. Two large culverts run beneath the venturi channel to the effluent channel. It is thought that this latter channel follows the same alignment as Barking Creek and runs out to sea.

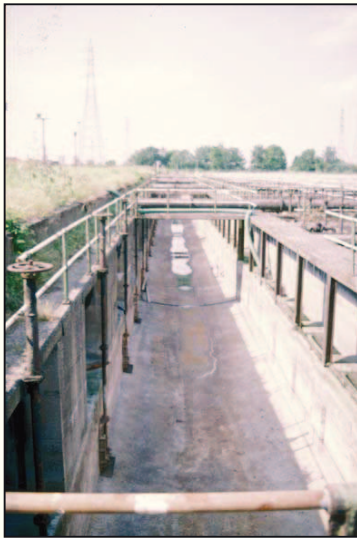
Plate 26: South view of weir chamber

- 4.4.9 The weir chamber is located between the re-aeration lanes and the precipitation lanes running in a roughly north-south alignment (Plate 26). It is constructed from reinforced concrete and is 12.2 m in length and c.4 m in width. The penstocks at the north and

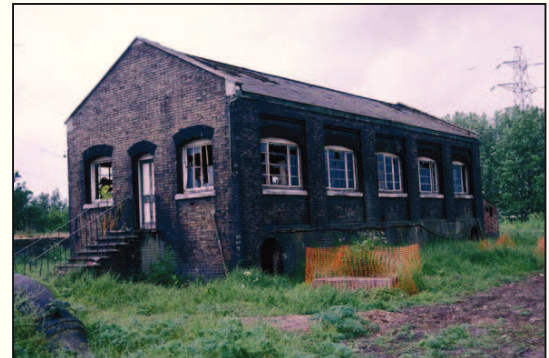
Plate 27: North view of valve house

4.5.1 The valve house is a rectangular yellow brick structure in a north-west/ south-east alignment measuring 15.2 m by 6.7 m (Plate 27). It is a single phase building thought to be contemporary with the construction of the precipitation lanes (1880-1890s). The structure is located to the south-west of the site close to the west end of the precipitation lanes and the Northern Outfall Sewer. The purpose of the building was to control the box weirs through a series of internal levers.

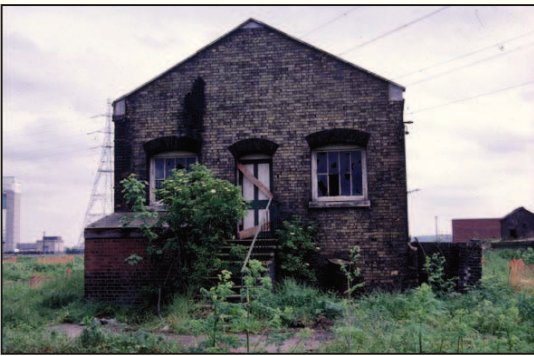
Plate 28: Valve House, south-west elevation

4.5.2 The building is single storey with a half basement. The roof is grey welsh slate with brick gables. There is a lean-to at the north-west elevation and one at the south-west elevation (Plate 28). The building has two wood panelled doors at the north-west and south-east ends. The doors and windows have finely rubbed gauged brick rounded heads over the doors and windows (Plate 29). There are concrete steps with an iron baluster leading up to the doors. Windows are extant on each of the elevations with two located at the south-east end and north-west ends. These are eight light windows with top hinges. The five located on the longer elevations have twelve lights with four outer side openings. There is a large concrete slab footing at the north-west end.

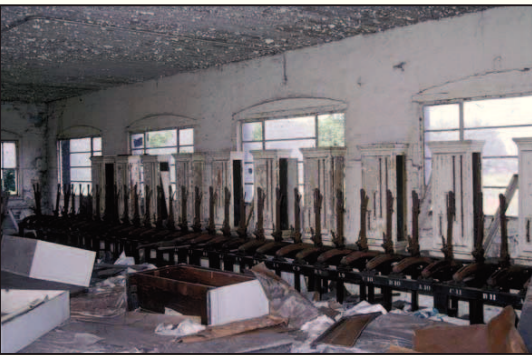
Plate 30: Internal north-east view showing upper room of Valve House

4.5.3 Internally, the upper room is brick painted with a plank boarded ceiling and a later rubber floor. There are levers along the north-east elevation housed in thirteen wooden boxes with gauges and each box has corresponding three levers that are labelled 'C1 - B1 - A1- C2 - B2 - A2', etc. (Plate 30). The mechanisms for these levers are housed within the basement that leads out of the building along the alignment of the precipitation lanes (Plate 31). Undergrowth cover at the time of the site visit made it difficult to ascertain the exact orientation as they leave the building.

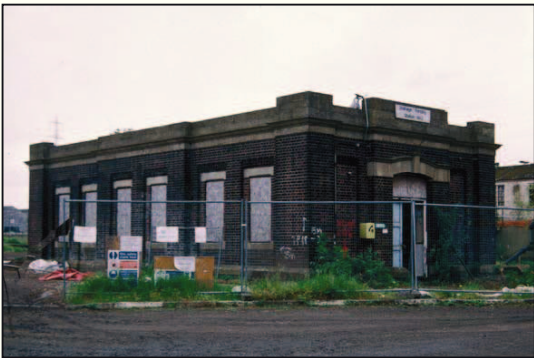
Plate 32: South-east view of Drainage Pumping Station no.2

4.5.4 Drainage pumping station no.2 is located directly to the north of the east end of the precipitation lanes (Plate 32). This building is thought to date from the early 20th century thus being later in date than the valve house and precipitation lanes. Its purpose was to pump material throughout the re-aeration lanes for treatment. This is a brick-built structure with a rectangular footprint measuring 14.6 m by 7.2 m in an east-west alignment. The building is single storey with a brick foundation and a flat concrete roof. There are six windows located on the north and south elevations and a further two windows at the west end of the building. The windows are uniform measuring 1.8 m by 0.89 m, with an iron frame and six lights (Plate 33). These have a brick surround with a concrete lintel across the window. There are two entrances to the building with the main entrance located at the east end of the building. This has a wood panelled double door and the wooden sign 'Drainage Pumping Station No.2' located above the door. The door has a brick surround with a concrete lintel above the door (Plate 34). The single secondary door is located on the west elevation that is also wood panelled measuring 2.05 m by 0.82 m.

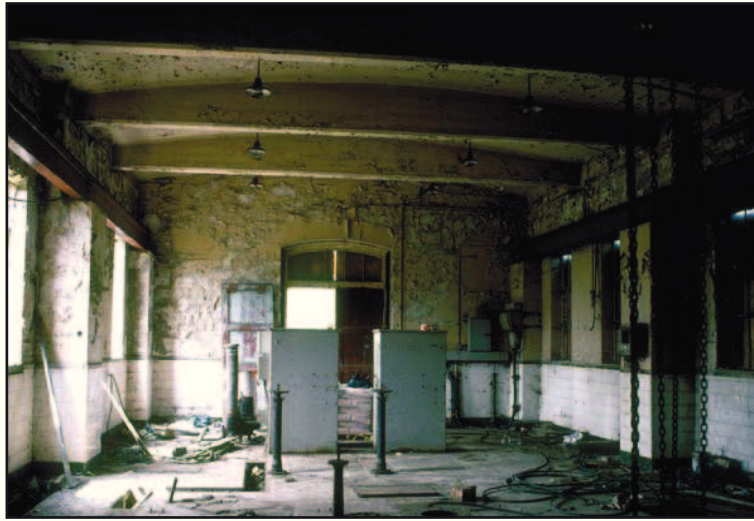
Plate 35: Internal west view of Drainage Pumping Station no.2

4.5.5 Internally, the floor is concrete and the west end of the building once housed six pumps. The walls are plastered and painted with tiling at the lower elevation and there are electric light switches located on these elevations (Plate 35). It is thought that six pumps were housed within the building although these are no longer extant and the foundations for the structures are the only surviving evidence. There is concrete *in situ* (in particular to the east) overlying the concrete floor, which would have been the foundations for the pumps. There are six square platforms measuring 0.55m²

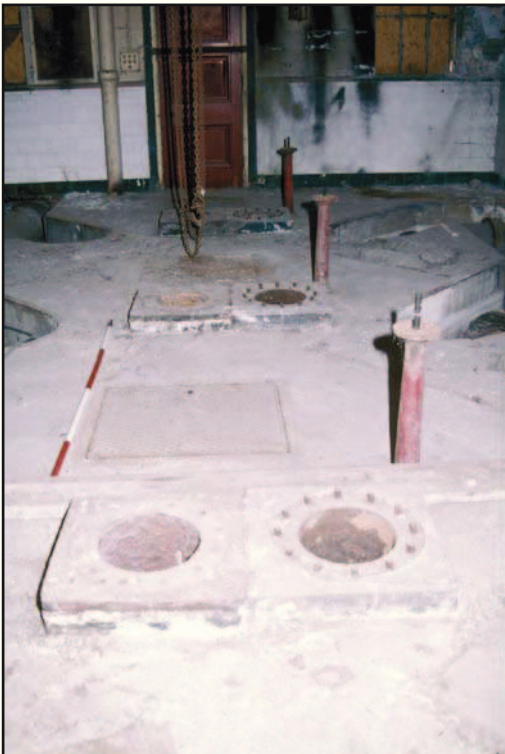
Plate 36: Internal east view of square platforms within Drainage Pumping Station no. 2

(organised into three sets of two) from which pumping pipes were thought to have once extended vertically. These are no longer extant although the circular footprints are clearly visible on the surface of the platform (Plate 36). There are three iron uprights to a height of 0.6 m extant at the south-west edge of the pairs of platforms. These lie within two recesses to the north and south at a depth of 0.56 m. These house iron pipes that extend externally beneath the walls of the building (Plate 37). The north pipe (7.25 m in length) extends out of the pump house beneath the north elevation and the west pipe (7.25 m in length) extends beneath the west elevation. The pipes are 0.42 m in width.

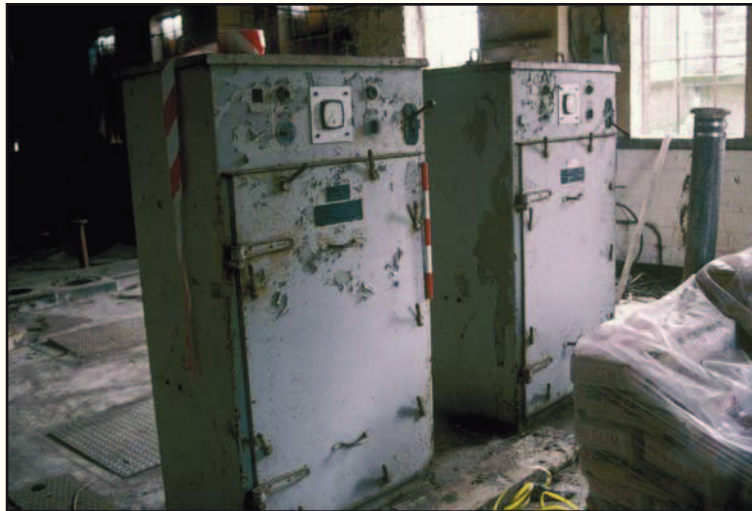
Plate 38: Internal east view of controls boxes within Drainage Pumping Station no. 2

- 4.5.6 At the east end of the building are two control boxes for the pumps measuring 1.62 m by 0.52 m and at a height of 0.93 m (Plate 38). These are cast iron with an on/ off lever and a gauge with 1-10 specifications. It is thought these were used to control the pumps and alter the level of material being pumped into the lanes. There are two iron rails running the length of the building above the windows. A further two iron cross rail run along these rails on two wheels extending across the width of the building. Two chains and hooks on a pulley wheels hang from these cross rails that were thought to have been used to hoist machinery needed during the operation of the pumps.

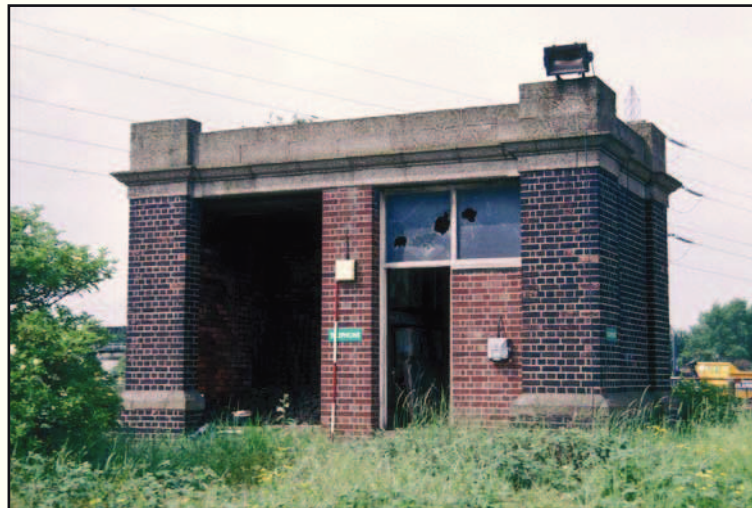
Plate 39: South-west view of Penstock Controller House

- 4.5.7 The penstock controller house is located at the south end of the re-aeration lanes (Plate 39). The building is of the same construction as the pumping house and thought to be of a similar date. This is a single-storey brick and concrete structure (3.95 m by 5.55 m) that is divided into two equal sections. The south section contains sample pots for testing the material and the north section houses the machinery for operating the large penstocks located at the west termination of the venturi channel. This machinery has a gauge and three push buttons labelled: Raise, Master Stop, Lower. There are four sets of these buttons, presumably to operate the four penstocks associated with the venturi channel. There is also a telephone within the structure and the plastic sign 'Telephone' is extant on the exterior of the building.

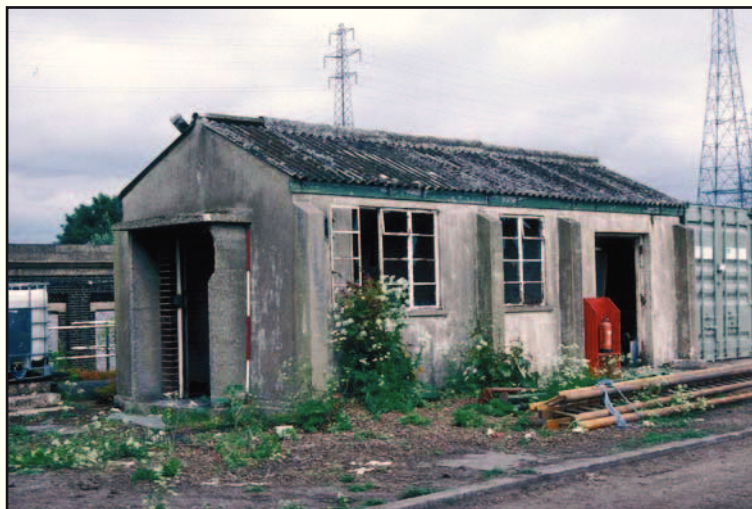
Plate 40: North-east view of administration building

- 4.5.8 An administration building is located directly to the south of the pumping house (Plate 40). This is single storey in elaborate 1960s concrete structure with an asbestos roof. It has small buttresses and crittal-type windows. There are four windows and two doors and the building is internally partitioned. The building contains an administration room and a toilet and is thought to have been used as an office/ staff room during the operation of the sewage works.
