# Coopers Road Estate Southwark London SE 1

## Archaeological Evaluation

**Document Title:** Coopers Road Estate, Southwark, London SE1

Site Code: CRJ 01

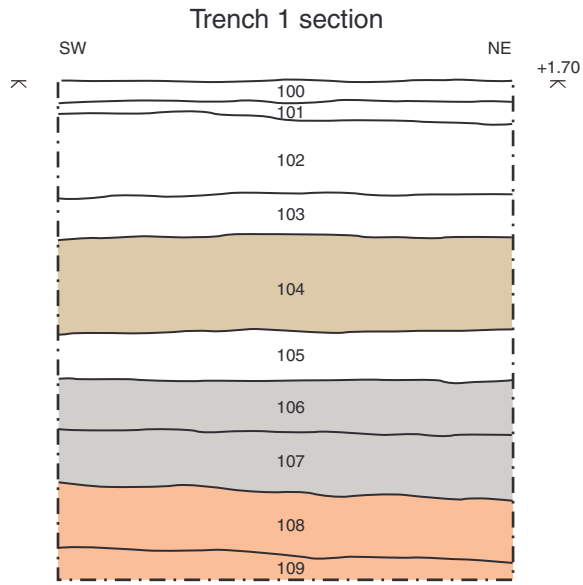
Figure 3: Sections

Trenches are located on fig. 2, with representative sections through trenches 1, 2,3 and 4 shown on fig. 3.

- agricultural soil (post-medieval)
- peaty material
- sands/gravels

scale 1:50

- 7.1.3 The underlying natural (108) consisted of banded orange- yellow sand and yellow-brown sandy gravels, which occurred consistently across the whole site. Within trench 1 these deposits were encountered at a depth of -0.95 m AOD.(fig. 3).

- 7.1.4 A 0.8 m thick layer of dark grayish black peaty clay and silty peat (107, 106) overlay the natural sand and gravel with its upper surface at -0.30m AOD. These deposits were carefully inspected but no human activity was evident.

- 7.1.5 The peat was sealed by a 0.35 m thick layer of brownish yellow clay (105) and up to 0.6m of brown-gray silty loam (104) which probably represents a former cultivation horizon.

- 7.1.6 Layer 104 was overlain by modern made-ground deposits (103, 102, 101), which containing much brick, metal and Victorian/modern pottery, and up to 0.35 m of topsoil.

- 7.1.10 The overlying stratigraphy of the trench was similar to that of trench 1 (fig. 3), although the peat deposit (206) overlying the natural gravel was much thicker at up to 1.8 m (upper surface -0.45 m AOD). No indication of human activity was evident within this deposit.
- 7.1.11 Layer 206 was overlain by 0.50 m of clean yellow brown clay (205) and up to 1.00 m of pinkish brown silty clay loam (204). These layers were clean and closely inspected but no finds were recovered.
- 7.1.12 Layer 204 was heavily truncated by the insertion of modern services and overlain by to 1.86 m of made-ground deposits containing 19<sup>th</sup>/ 20<sup>th</sup> C pottery and other debris.

- 7.1.13 Trench 3 was aligned WNW- ESE within the center of the site and measured 23 m long by 4 m wide. The trench was machined with a stepped section and revealed the underlying natural gravels within the bottom of the lower trench (fig.3).
- 7.1.14 The underlying sand and gravels were found at a depth of 1.4 m beneath the present ground level (+1.05 m AOD).
- 7.1.15 The natural was overlain by up to 0.6 m of reddish brown sandy silt (302). This is similar to other probable cultivation horizons found throughout the site. This layer was cleaned and carefully inspected but no finds were recovered.
- 7.1.16 Layer 302 was overlain by up to 0.5 m of modern made ground and the present topsoil.
