Church Farm Lewknor Oxfordshire

Archaeological Watching Brief Report

January 2011

Archaeological watching brief

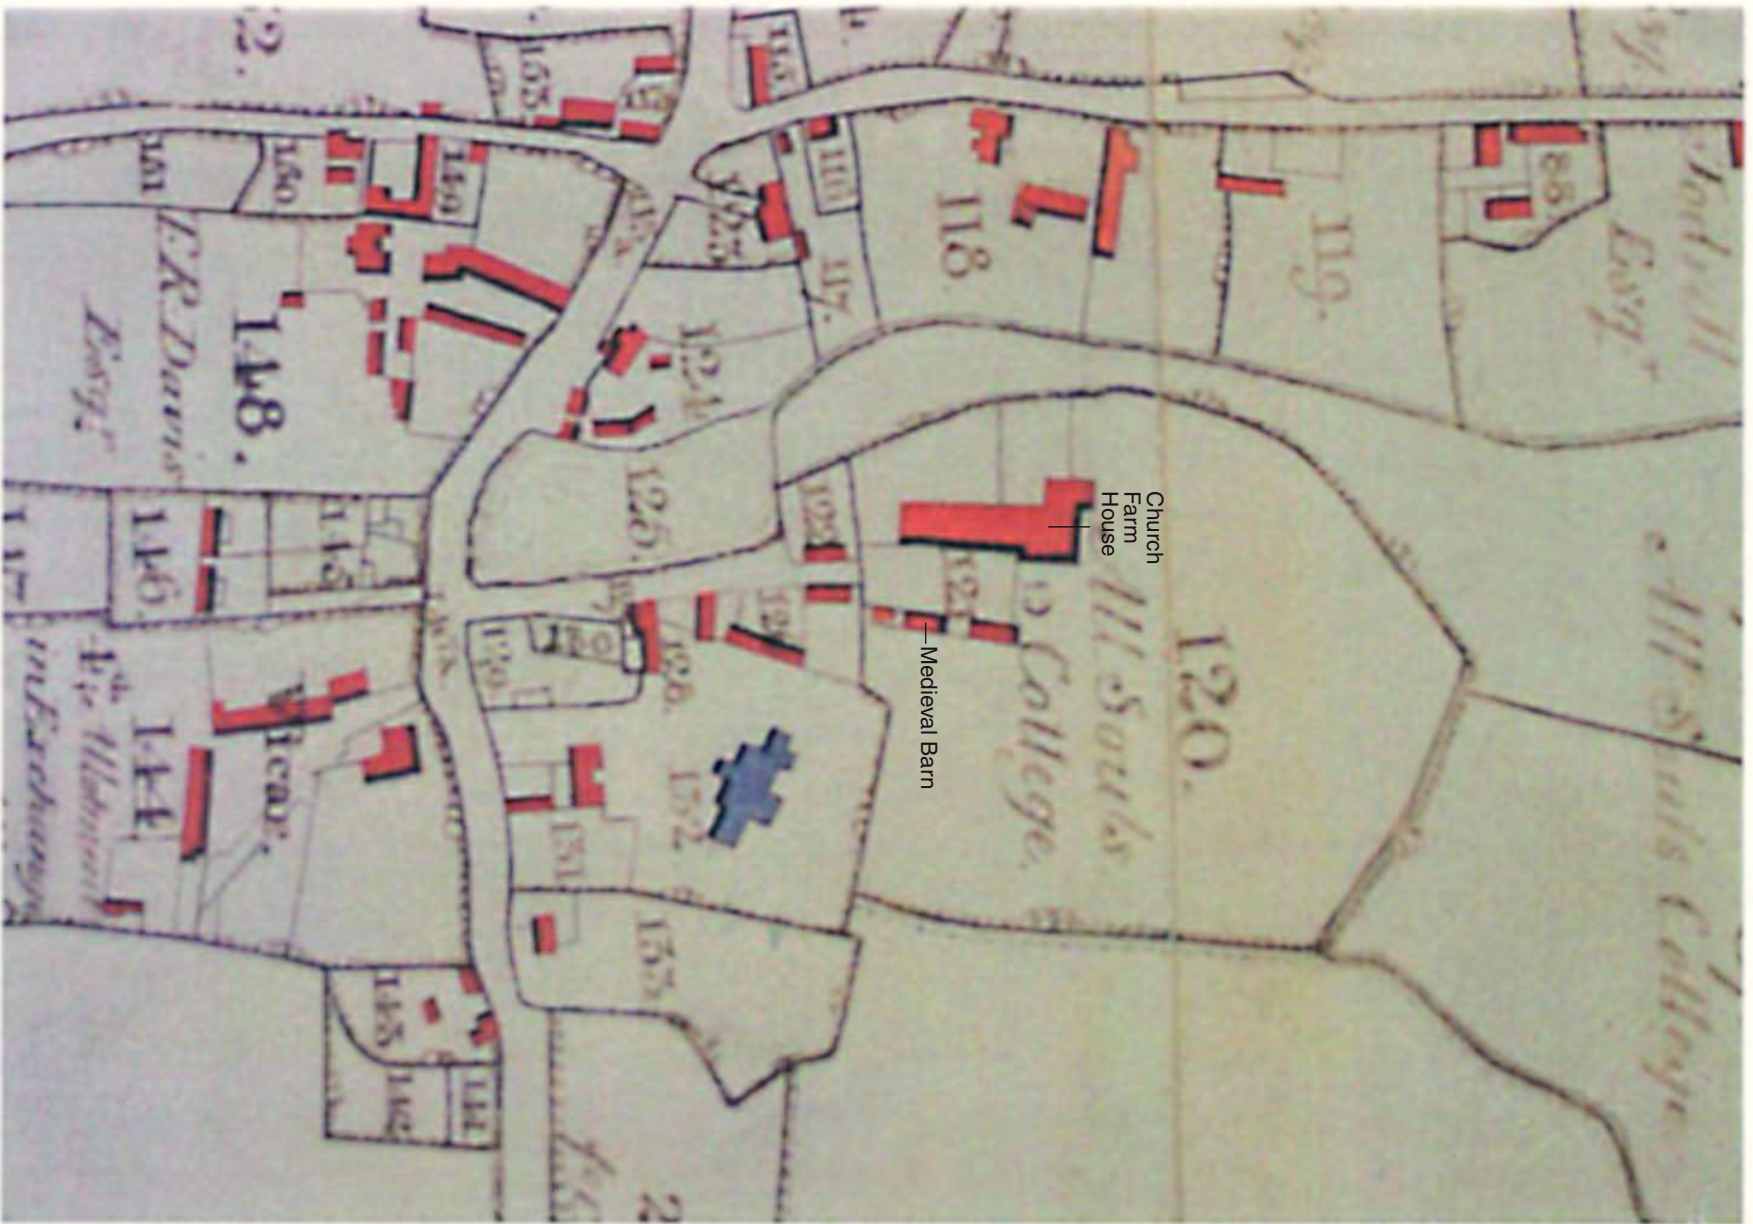
Figure 2: 1815 Enclosure map

- 2.3.5 The 1815 Enclosure Map shows a building on broadly the same footprint as the barn although it appears to be smaller than the current building and it is difficult to compare with absolute precision the layout of the buildings in Church Farm at this date with those existing today. It is clear from the Enclosure Map that in 1815 the farmyard included a long range of buildings which extended south-east from the farmhouse towards the granary (this area is largely outside the current development site. The east to west stable range is not shown on the map although there is a boundary indicated along this alignment connecting with the north-west corner of the barn. There appears to have been an east to west track immediately north of the barn (similar to today) and the stables were almost certainly constructed immediately north of this soon after 1815. The map shows a north to south building detached from the barn but immediately to the north of it, broadly on the footprint of the eastern part of House 4 being constructed in the current development. There is no building shown on the western part of House 4 although there is a boundary indicated in this location which appears to have separated the farmyard to the south from the field to the north. Both areas are shown to have been owned by All Souls College, Oxford. The map does not appear to show any buildings in the location of Houses 1, 2 or 3 which are being constructed in the current development.

- 4.4.2 As detailed above in the historical background there is a view of Lewknor dated 1764 which shows a thatch-roofed building in the vicinity of the west range of House 4. The 1815 Enclosure Map appears to confirm that by this date this building had been demolished but by the 1881 OS map it had been replaced by a further building (probably the same one that survived until the current development).

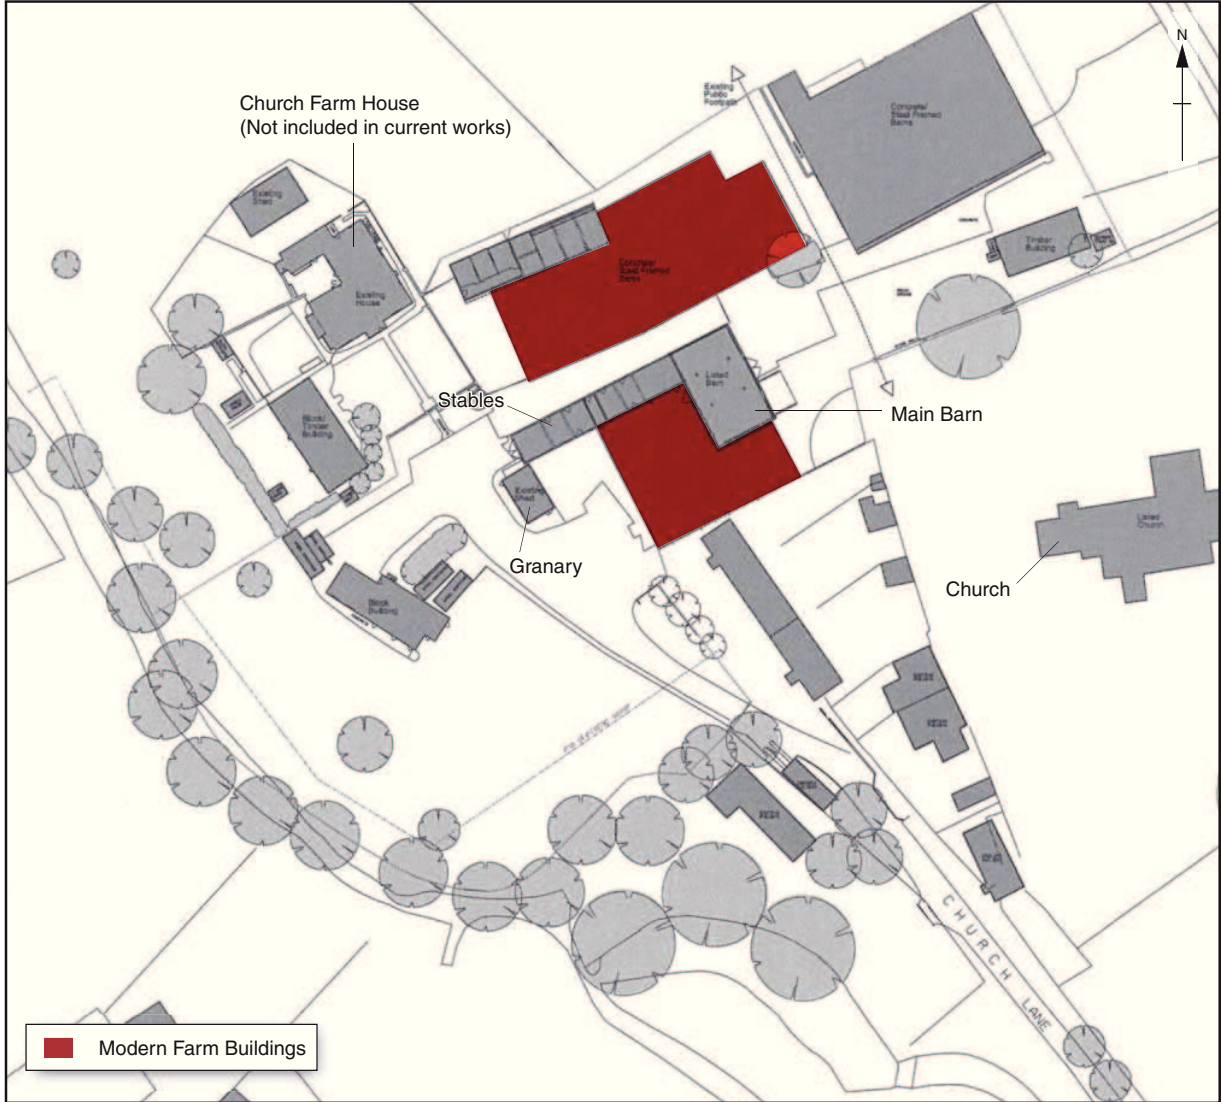
Figure 4: Site plan prior to current works

- 3.2.1 Prior to the start of the works in the current development the relatively historic buildings on the Church Farm site comprised the farmhouse towards the north-western corner (not included in current development) a stable range to the south-east of this (orientated SW to NE), adjoining granary at the south-west end and the main barn (Grade I listed) at the north-east end. Between these buildings there were a number of large modern farmyard sheds and the complex has remained in agricultural use until recent years.

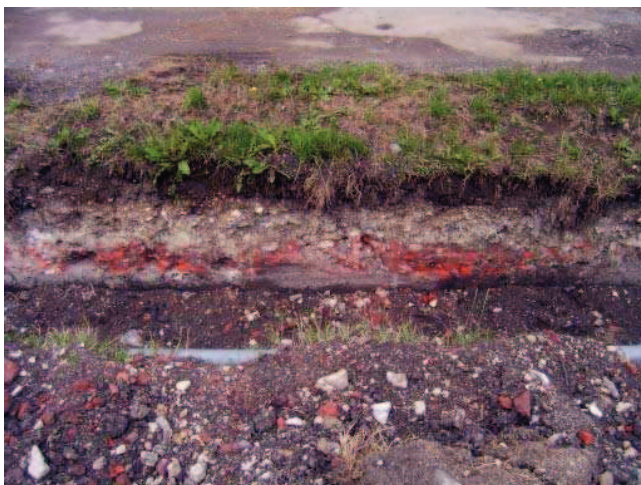
Plate 1: West side of Service Trench A to east of Houses 1-3

- 4.5.1 The main service trench which was observed (**Trench A**) started at the southern end of the site, approximately 100m west of the barn, and ran northwards towards the house. At the gateway of the house, it changed course and ran eastwards (**Trench B**), through the modern outbuildings and five metres from the north wall of the medieval barn. At the north east corner of the barn it changed course again and ran alongside the east wall where it terminates at the east entrance. This was opened and observed in July 2009.

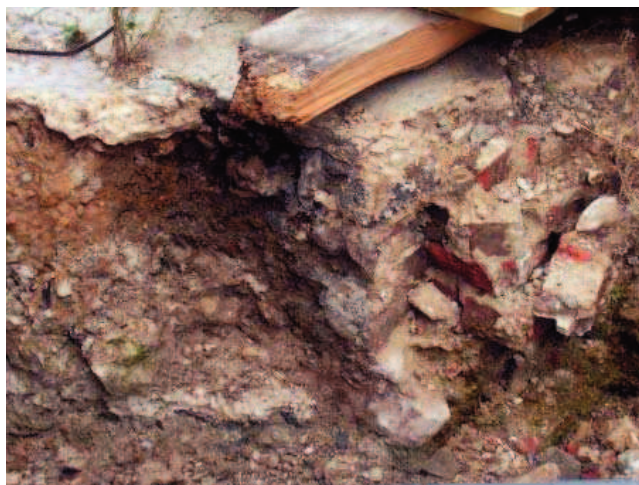
Plate 2: Construction feature in Service Trench B to north of barn

- 4.5.8 There did however seem to be a construction feature directly across from this at the north side of the trench. Here there was evidence of a wall or foundation made up of roughly coursed and irregular red brick and flint with a loose friable grey mortar, the face of which faces west where the trench turns. It is likely to be the foundation for a now demolished, more modern outhouse rather than a foundation for the medieval barn.

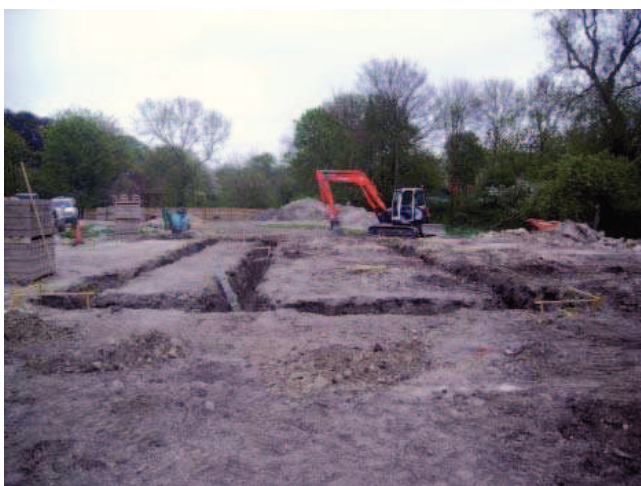
Plate 3: General view of excavations for House 3

- 4.3.3 No archaeological features were encountered in any of these trenches. The topsoil was disturbed in places and there was evidence of rooting. There was ceramic building material inclusions forming c.1%. The trenches were c.0.7 – 1 m deep and the soil was loose silty and grey-brown in colour.

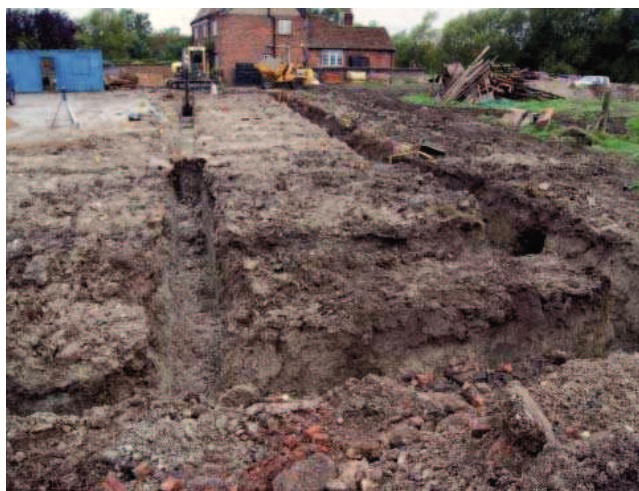
Plate 4: General view from east of excavations for House 4

- 4.4.3 **Foundation trenches for House 4**
- 4.4.4 A series of strip foundations, c.1.25 m deep x 0.8 m wide were excavated for the new building. These followed the outline of the new house and included seven further trenches in the narrower western part of the building and five in the wider eastern part.

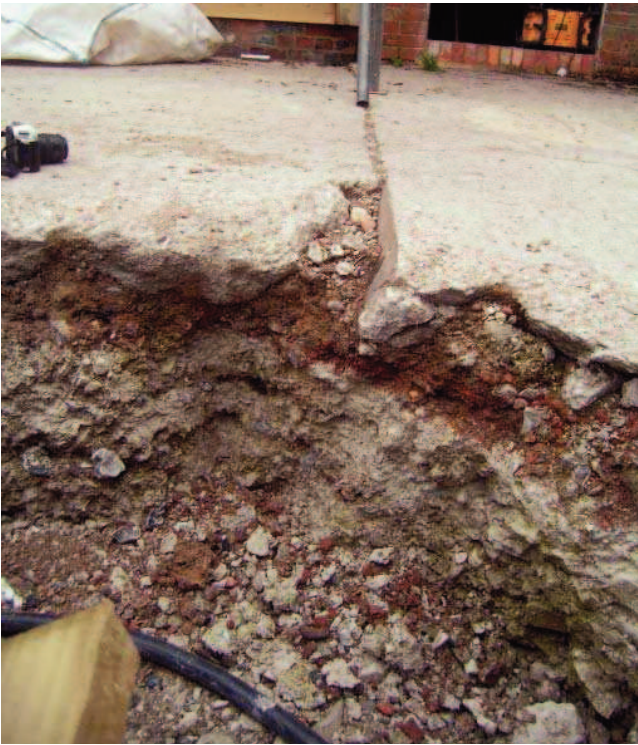
Plate 5: South side of Service Trench B immediately to north of junction between stables and medieval barn

- 4.5.6 Trench B was mostly made up of compacted redeposited natural with a dark friable layer of asphalt over it.
- 4.5.7 The trench made a dog-leg turn adjacent to the north west corner of the medieval barn. No evidence could be found in the south side of the trench of foundations for the possible fourth bay of the medieval barn. The stratigraphy shows compact, possible redeposited natural with a thin layer of red brick rubble over it. Above this is a layer of modern cement.

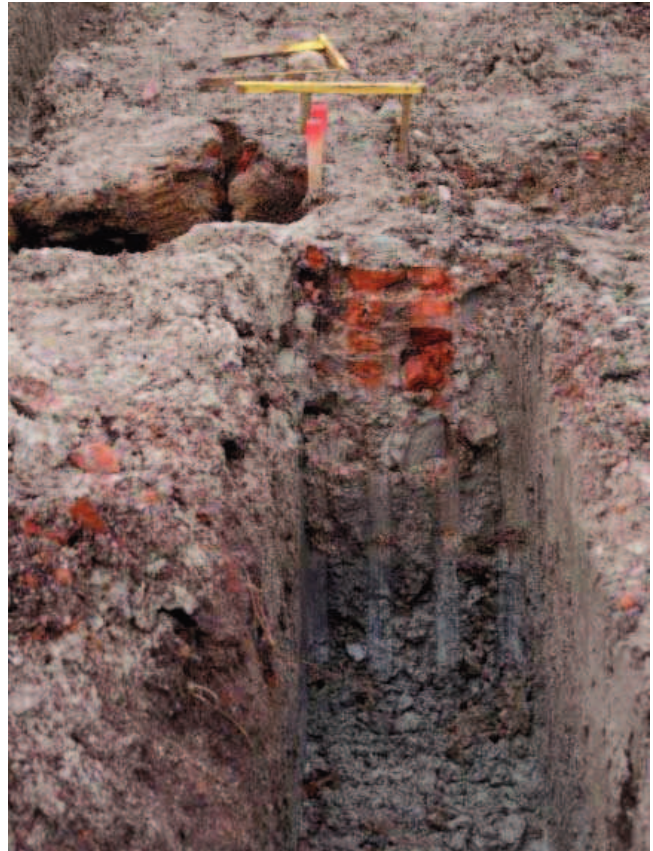
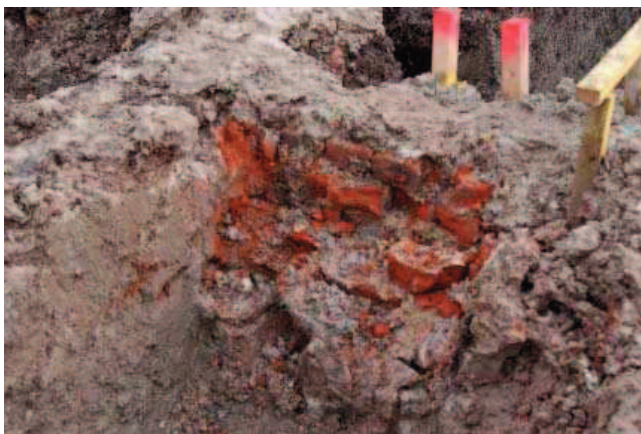
Plate 8: Stub of brick wall towards centre of excavations for House 4

- 4.4.11 Further to the east, at a point which is c.1 m to the west from the inner junction between the two ranges of House 4, a small stub from a brick wall. The stub appears to survive from a north to south wall and it may have continued south beyond the line of the current works. The footing comprises four courses of red brick, constructed with lime mortar and set directly on a chalk foundation. The brickwork strongly appears to be of 19th (or possibly late 18th) century date.

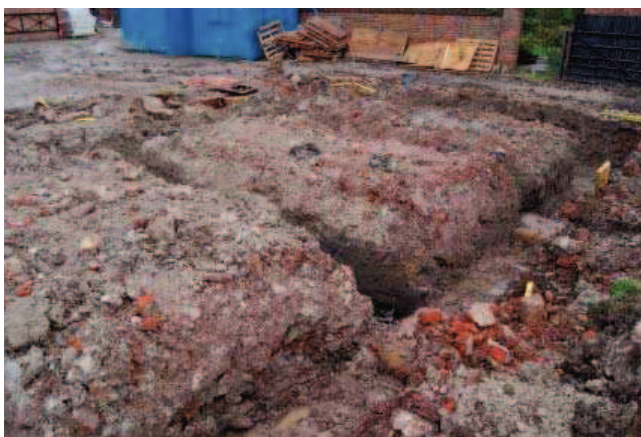
Plate 11: Trenches at west end of House 4

- 4.4.8 Towards the western end of the north branch of trenches were three concrete foundation pads within the base of the trench. Each of these was c.40 cm x 40 cm. Towards the western end of House 4 the trenches comprised a redeposited chalk layer (c.25 cm deep) above a dark grey clay soil above a very dark brown/black soil.

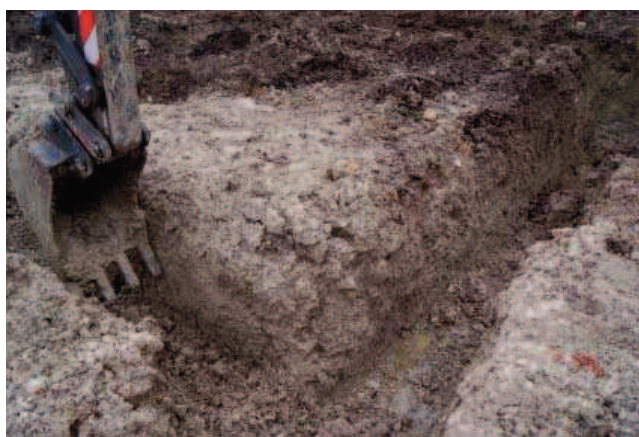
Plate 12: Trenches at east end of House 4

- 4.4.6 Towards the northern end of the east range (ie towards the NE corner of the house) there was a slightly deeper topsoil (c.40 cm) than towards the south-eastern corner. This area is immediately adjacent to an area of fields and was presumably once arable. Below the overburden is the same light grey chalky clay.

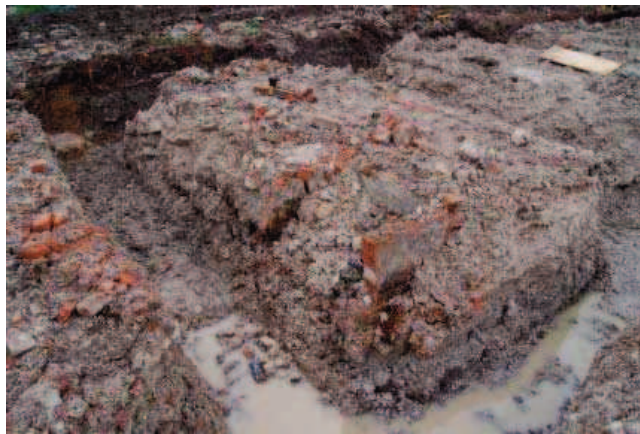
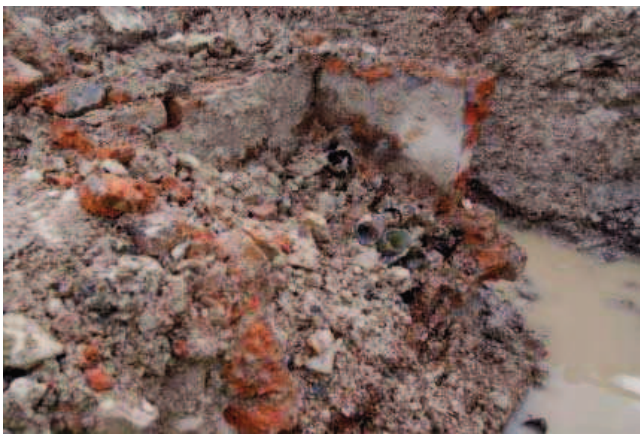
Plate 14: View from south of trenches in House 4 including remains of WC

- 4.4.10 Towards the south-western corner of the foundation trenches was a modern drain and a short distance towards this (c.1.3 m NE from SW corner of House 4) were the remains of what appears to have been a WC or small outhouse (see Plates 14, 15). This was a single-skin brick-lined structure, c.1.5 m x 75 cm in plan and with a cement skim render to the inner faces. The structure comprised two identical chambers (two WC's?) and the brickwork appeared to be of probable late 19th century date. The bricks have frogs and they are bonded with an ochre colour cement mortar which is distinct from the grey skim which forms the inner lining. A considerable number of broken bottles had been deposited within each chamber and at c.60 cm below the current ground level there is a brick base. This structure almost certainly survives from the building which is shown in this location on the 1881 OS map.

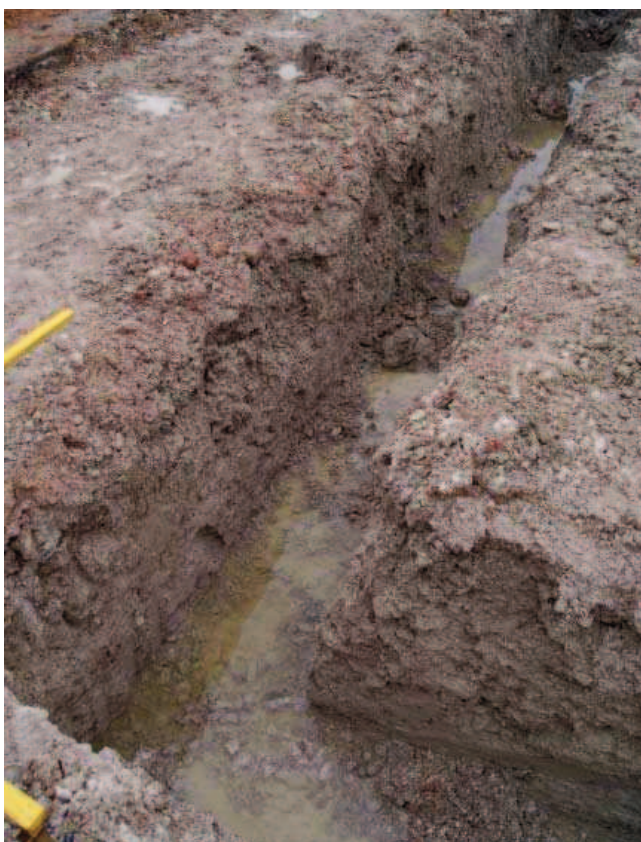
Plate 19: Foundation trench at south-west corner of East Range of House 4

- 4.4.16 The other post whose top was exposed was towards the south-western corner of the east range of House 4. This was not removed but its form appeared similar to the pair of posts referred to above. As the ground level in these areas was not being reduced it was not possible to investigate further the areas around and beneath these posts. However, the fact that post-medieval bricks were found beneath one (and that this brick may have been reused) suggests that the posts relate to post-medieval buildings, possibly one of those shown on the 1764 view (see Fig 3)
