Cedars Park Cheshunt

**Archaeological Investigation and
Recording of Structural Remains**

April 2008

Client: Borough of Broxbourne

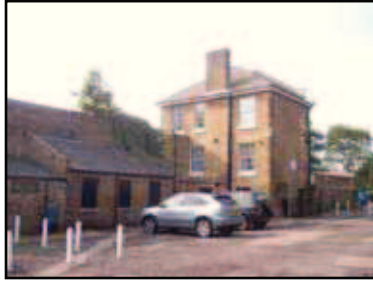
9.04

The Cedars and Associated Buildings -This was named after two large Cedar trees which it is assumed were part of the original planting scheme for the palace gardens. It is believed to have been built around 1768 when Old Palace House was built (Page, 1912). Today only parts of this building remain as the middle section appears to have burnt down/ removed therefore separating the now Cedars Park Tea Room to the west and the main house to the east. According to OS Map evidence this appears to have happened between 1898 and 1935. The Cedars roughly overlies the south wing of Theobalds Palace along the same east-west alignment. It appears from early OS Map evidence that the grounds of The Cedars ran southwards from the old palace site overlying the Great Garden.

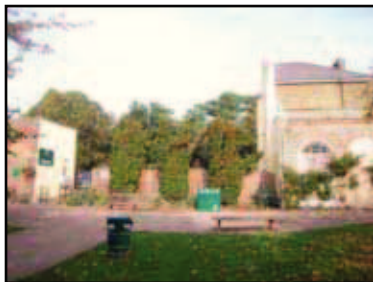
9.05

The Cedars as it stands today is a three storey brick built building with a grey slate tiled pitched roof. It has a single storey brick built projection on the southern elevation facing out towards the park. This projection is of the same design and construction as the Tea Room to the west. It has three arched windows, the central window also includes a single stone step suggesting that it was once a doorway out into the garden. At present these windows/doorway are boarded up. As seen in the Tea Room to the west, 8 courses from the top along the length of the southern elevation is a slightly protruding decorative three course band of red/orange bricks which are seemingly softer in texture. It is likely that these are re-used bricks from the palace complex. These bricks are also seen in the relieving arches of the windows. To the east on the southern elevation is the remains of an orangery or greenhouse. This appears to be a later construction as it uses yellow London brick. This is also largely boarded up at present.

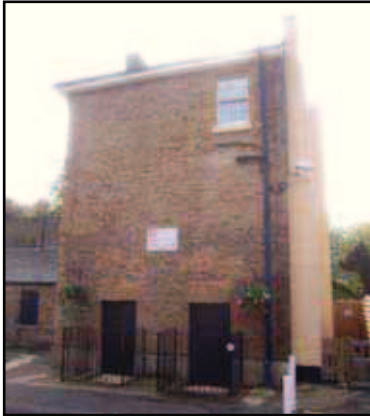
9.0.6

The western elevation of The Cedars is rendered cream but it is worth noting that soft red/orange bricks were apparently discovered behind this render during recent repair works (pers. comm., 2007, Adrian Hall, Parks Manager). There are two black circular tie plates in the central part of this elevation, one above the other. These can also be seen on the eastern elevation.

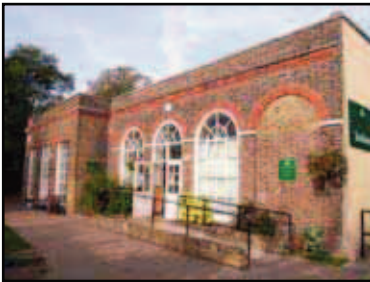
9.0.8

The eastern elevation has two doorways on the ground floor also with rubbed brick lintels. There are two sash windows on the first floor, and three on the second floor. At the southern end of this elevation is a small two storey structure which drops down to a single storey lean-to type structure with a slate tiled roof. Further east this then drops down to a smaller but similar structure. These are currently used as store rooms but also contain original ovens and may have been associated with the kitchens of The Cedars. The southern wall of these structures forms the northern wall of the greenhouse/orangery.

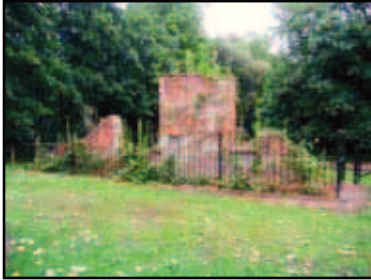
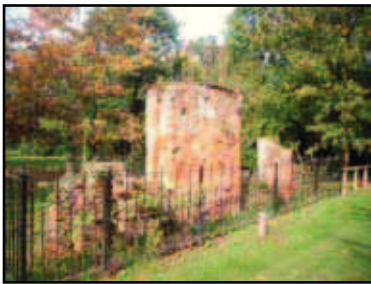
9.0.11

Old Palace House - Constructed in 1768 (Page, 1912), it was on a roughly north-south alignment and incorporated in its structure several fragments of the original palace fabric, notably a window in its west front. This building burnt down in the 1960's but a fragment of surviving wall can still be seen (Wall 25). From early OS Map evidence it appears that the estate grounds of Old Palace House run westwards from the site of the Theobalds palace and incorporated the now dry boating lake. This lake may be shown on the Thorpes map of 1611 but it is certainly present by 1785. The grounds appear to include the western half of the Great Garden contemporary with the original palace.

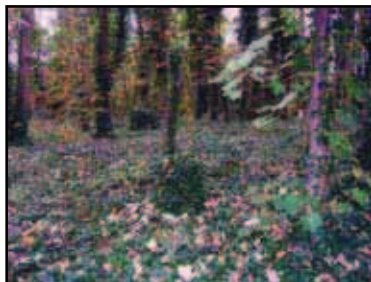
9.0.13

Jacksons School - This was named after a Reverend J Oswald Jackson. According to OS Map evidence it was demolished sometime between 1898 and 1935. The entrance gate and blocked openings/doorways however can still be seen in Wall 1. It is also evident that walls 1, 2, 12, 13, 14, and 23 marked the outer boundary of the school grounds. Wall 22 was also associated with Jacksons School. The area associated with Jacksons School appears to overlie the old palace Kitchen Garden, the Old Privy Garden, and the Stable Yard. It is currently overgrown with dense vegetation, ivy, and mixed woodland.

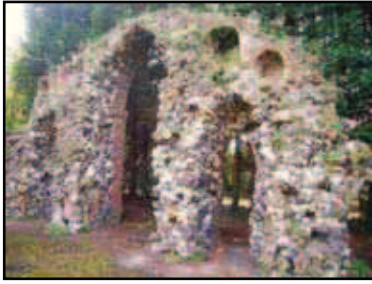
9.0.14

The Grotto/Arch. At the southern end of the park opposite The Cedars is a large late mid to 18th century grotto. It is constructed with a red/orange brick built core and faced with flint and rubble. The tall middle section has 3 pointed-arch openings surmounted by

five small round-headed brick niches in an arch profile. There is a flint arched niche on east side and two domed free-standing pavilions set forward to the east and west. These have triangular-arched openings. The east pavilion has a rail about 1m above the floor. There is rough paint below it while above it the walls are rendered and painted. The interior of the west pavilion is not rendered but the walls are painted. The remains of wall footings to the east of the grotto and a gateway at the southern end of wall 8 also have large flint and rubble inclusions intended to give the whole area a consistent feel.

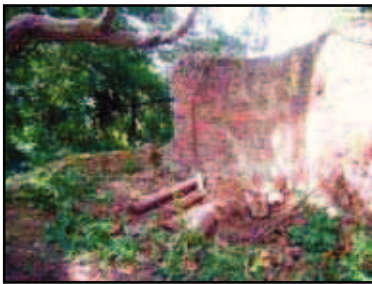
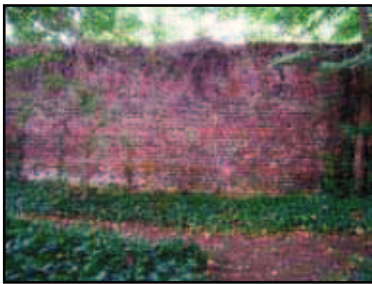
9.0.15

Wall 1 is between 2.4m and 2.6m high on an east/west alignment. It is approximately 130m long. The bricks are soft reddish orange and appear to be hand made measuring 240mm x 55mm. The mortar is soft, creamy and lime based with coarse sand and grit inclusions. The 7 lowest courses of this wall step out 1 brick width on its southern elevation. To the west end of the wall where it joins wall 12 there are the remains of a small bastion. 8m from west end visible in the south elevation is a blocked opening 0.8m wide and 1.1m high. Along whole stretch of this wall the top 8-18 courses have been replaced with a harder brick. The mortar is still lime based but much harder. These repairs probably took place around the time of Jacksons School using this part of the site. The wall appears to be present on John Thorpe plan of 1611 and therefore seems likely to be contemporary with the first phase of building.

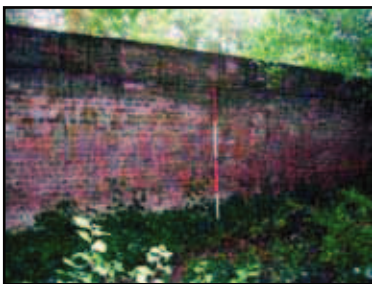
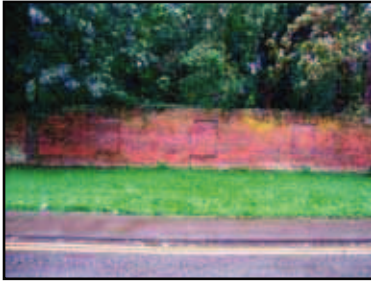
9.0.16

Wall 2 is of same construction as Wall 1 and almost certainly contemporary. It averages 2.65m high and is approximately 120m long on an east-west alignment. Jacksons School gates are incorporated into wall 1 and 2 separating the two. It may have been inserted when the school was built, however it may have also been present during the primary phase of building providing access to the stable area. 1.55m to the east of the school gates is a blocked doorway which is 1.15m wide. There are four buttresses on the south elevation towards the eastern end which appear to be modern. The bricks vary, some soft, some hard, all with a hard, cream coloured lime mortar. They measure 220mm x 55mm x 95mm. The north elevation shows three distinct sections; the eastern end uses soft deep orange/red bricks (225mm x 60 x 100mm), with a soft lime mortar and four blind windows measuring 1.4m x 0.9m, the middle section uses a number of brick types, mainly headers which are hard red/purple

measuring 120-180mm x 100mm x 55mm, the western section again uses mainly headers with soft orange red bricks measuring 220mm x 55mm x 100mm. The east end of this wall has been cut by the road entrance to the park. There is a modern buttress on the south elevation at the east end. The top 5 courses at this end are built with a yellowish purple brick (measuring 230mm x 60mm x 100mm) with cement mortar and post-date the buttress. The wall has been extensively re-pointed to the east end. What appears to be the original mortar is a yellow, soft, sandy, lime mortar with large grit inclusions. It joins wall 3 at its east end and is present on the Thorpe plan of 1611.

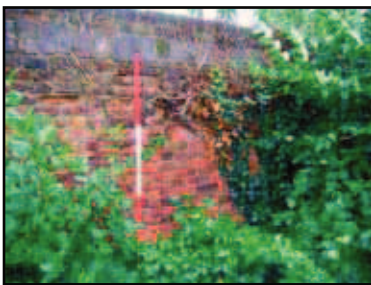
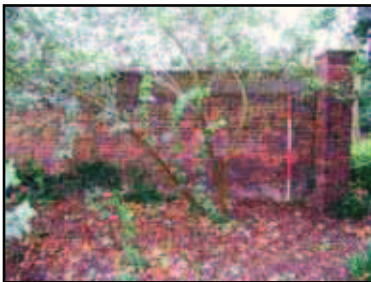
9.0.17

Wall 3 butts wall 2 and averages 2.10m high on a north-south alignment. It is 56m long. Only the west facing elevation is visible as there are gardens and residences to the east. What appears to be the original build uses soft red bricks measuring 220mm x 55mm x 100mm. The top 5-6 courses have been rebuilt using some original bricks and some hard purple bricks measuring 210mm x 55mm x 100mm. The new build uses hard cement mortar with large grit inclusions. The primary mortar is soft, creamy, and lime based. There is a blocked doorway 1.03m wide approximately half way along the this wall. It butts wall 2 at its northern end and wall 4 at its southern end. The wall seems to be relatively early in date but does not seem to be present on the Thorpe plan of 1611. It is however present on the 1785 map of Cheshunt.

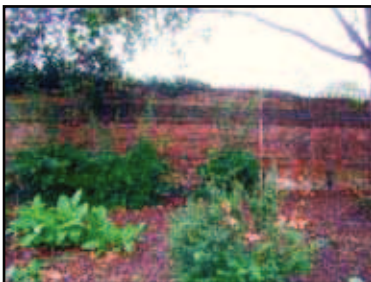
9.0.18

Wall 4 averages 2.2m high and is approximately 39m long on a roughly east-west alignment. It is similar in construction to wall 3. The bricks are the same throughout, hard reddish/purple, measuring 240mm x 65mm x 110mm with soft, gritty, lime mortar. The bond is irregular. This wall joins wall 5 to the east. It does not seem to be present on the 1611 map and first appears on the 1785 map.

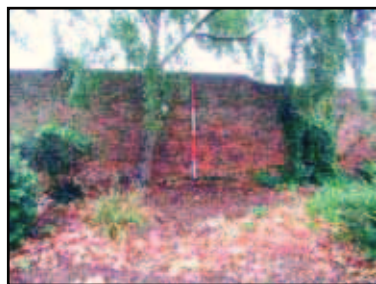
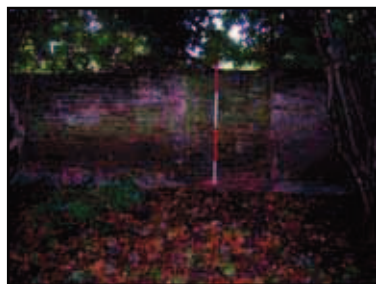
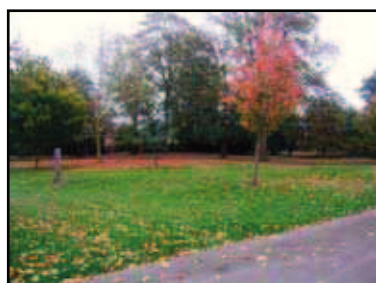
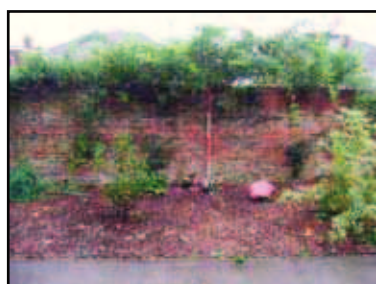
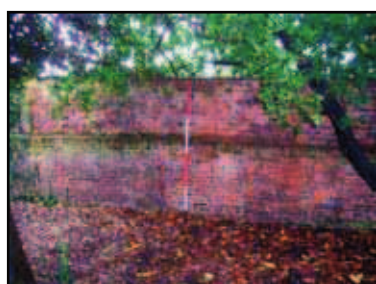
9.0.19

Wall 5 averages 2.2m high and is approximately 30m long on a NW-SE alignment. It is similar in construction to wall 4 and leans slightly to the NE. The bond is mainly headers but there are more stretchers in the top 8 courses. The whole wall has been re-pointed with cement mortar. It steps down to the south east end where it joins Wall 6. This wall first appears on the 1842 Tithe map.

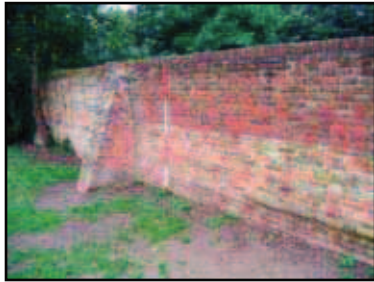
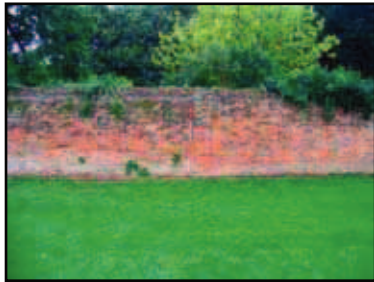
9.0.22

Wall 8 is 2.5m high and 131m long on a north-south alignment. The top 14 courses have been rebuilt using hard yellow London brick with cement mortar. The lower

courses have a soft, gritty, creamy lime mortar. These bricks are orange red, some hard and some soft but all measuring 220mm x 60mm x 100mm. The wall has been re-pointed using cement mortar on both elevations but is more heavily re-pointed on the west elevation. This wall does not appear to be present on the 1611 plan but does seem to be marked on the 1785 map.

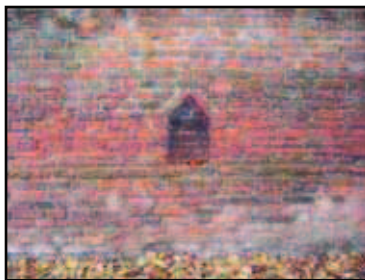
9.0.24

Wall 10 is approximately 2.8m high and 56m long. The top 7 courses at the east end are modern. The lower bricks are orange red and quite hard measuring 240mm x 55mm x 110mm. The primary soft lime mortar has been re-pointed with gritty lime mortar which is harder. On the north facing elevation the bottom 11 courses step out 1 course. The general bond of this wall is irregular. There are 2 niches in the north facing elevation which are 0.30m wide and 0.55m high. The bricks around these niches measure 230mm x 55mm x 110mm and the mortar is yellow, hard, sandy, and lime based. These niches were bee boles, common features where bees would be housed in the skeps. That they housed beehives associated with an orchard (Andrews, 1993). This wall is bonded into wall 11 at its western most extent. It seems to be present on the 1611 plan however this depends of the accuracy

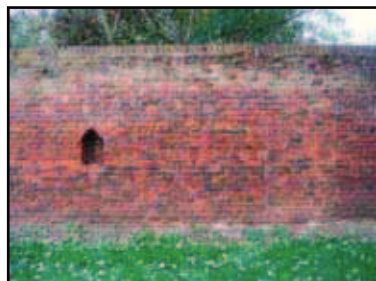
of the map. It is definitely present on the 1785 map.

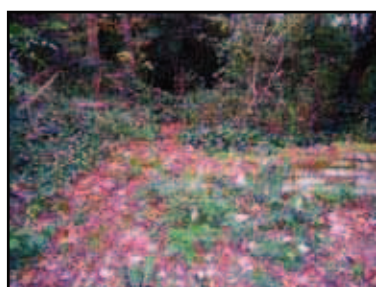
9.0.25

Wall 11 is approximately 2.4m high and 132m long on a north-south alignment. It has a short section of curved wall where it meets Wall 10. This may indicate the position of an earlier bastion as seen in Wall 1. The curved part soon turns into modern brick repair for approximately 20m. The original part of this wall is similar to wall 10. The bricks measure 230mm x 50mm x 110mm. The top 2-3 courses are modern. There are 6 niches as seen in wall 10 on the east facing elevation. A blocked opening measuring 1.8m x 0.9m can be seen to north of the southern most niche. The bond is irregular, but some parts are English bond. In parts this wall has been heavily repaired. The mortar is soft lime based and parts have been re-pointed with a harder gritty cream coloured lime mortar. This wall is present on the 1611 plan.

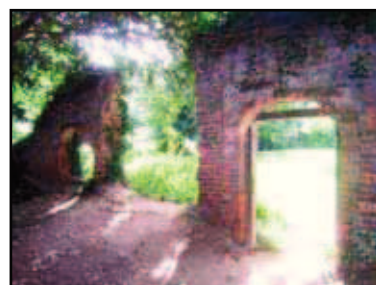
9.0.26

Wall 12 is on the same alignment as wall 11 but is obscured by dense vegetation. It is 29m long. At its northern most end however it can be seen to join Wall 1 at the bastion. It is butted by Wall 13 and therefore sequentially earlier. It appears to be present on the 1611 plan.

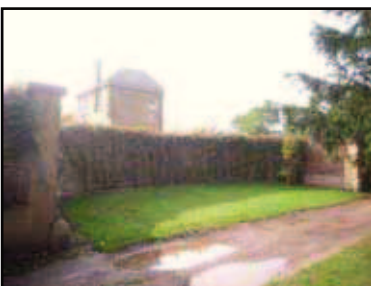
9.0.27

Wall 13 butts wall 12 and is approximately 86m long on an east-west alignment running towards the site of Old Palace House. The bricks are orange/red in colour and soft in texture. They measure 235mm x 110mm x 50mm. The mortar is lime based, cream in colour, and very soft. At its highest point this wall is 3.3m high but averages 3m. 14m from its western end is an opening which appears to be a later door inserted through an existing doorway. The frame is softwood but the door itself no longer exists. This feature measures 2.1m high and 1.3m wide. To the east of this there is a section of the wall missing which would have formed another opening. Only a small fragment from the segmental arch and one jamb survives before another opening with a segmental arch lintel at 19m from the wall's most westerly point. This also has a segmental arch and is similar in construction to the doorway mentioned earlier but appears to be a window inserted through an earlier opening. It measures 1.3m high and 1.60m wide each of these features appears to have been within a deeper section of wall and each has

carefully formed sloped bricks at the jambs. If these were always garden walls they could have had shell enclosures or a hood around the feature. The wall graduates down to ground level at its eastern end. This wall appears to be visible on the 1611 plan and is definitely present on the 1785 map. It seems to mark the southern boundary wall of Jacksons School along with wall 14.

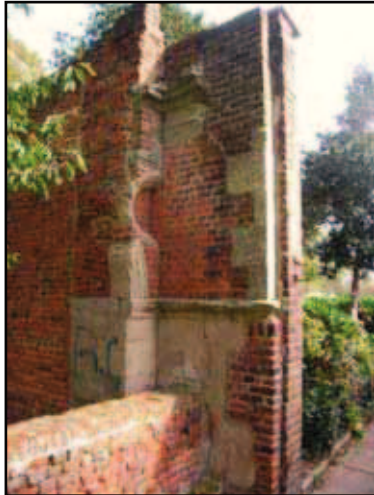
9.0.31

The red brick wall aforementioned is on a north-south alignment. It is 4m long and approximately 3m tall at its southern end but graduates down to ground level to the north. This wall seems to butt what appears to be a small section of the original 16th Century palace to the south, however it is possible these two walls are contemporary. The bricks within both these walls are soft red/orange and measure 240mm x 110mm x 55mm. The mortar is lime based, cream coloured and very soft.

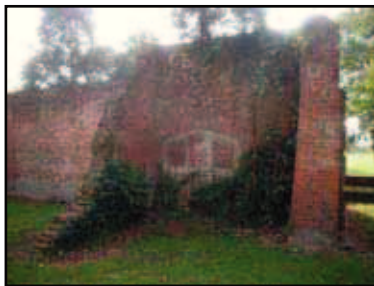
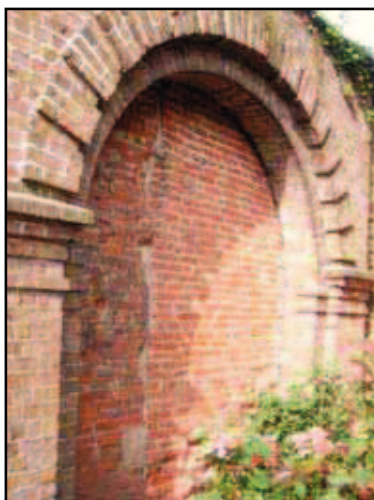
9.0.32

The small section of palace wall mentioned above is approximately 4m long on an east-west alignment. It is 3.5m high. Within this section is a blocked arch window with two stone mullions. The arch measures 1.89m high and 2.20m wide. The window itself measures 1.06m high and 2.01m wide. It appears that this is an original palace feature however is uncertain whether it is in situ or if it has been re-used. This wall joins another red brick wall to the west but the relationship is obscured. This wall is on a north-south alignment and has a short section of red brick wall abutting it to its southern end. A large decorative Victorian arch in London brick has been placed up against the eastern elevation of these two walls. On the south-western elevation there are several architectural stone fragments, almost certainly from the primary palace structure. These appear to have been re-used rather than in situ.

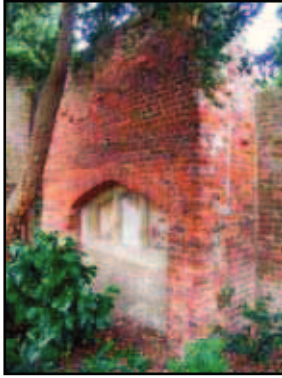
9.0.34

It is not possible to discern this area on the 1611 plan however it is likely that parts of it relate to the primary phase of the palace. On the 1785 map it is

possible to see a building in this direct location.

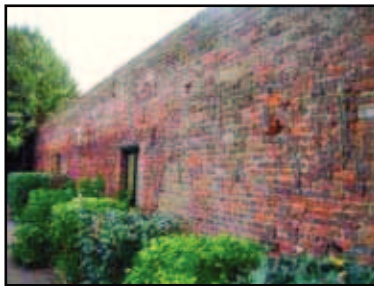
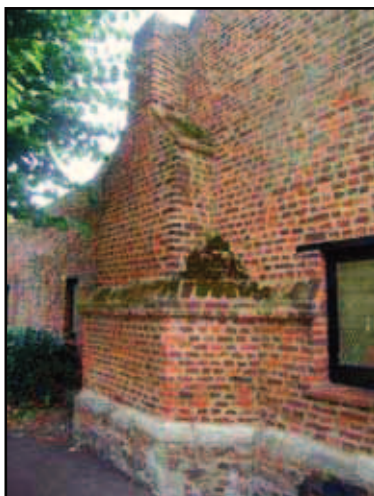
9.0.36

Wall 18 (& Associated Buildings) this wall is 31m long on a roughly north-south alignment and forms the western wall of 'Pets Corner'. This wall appears to be contemporary with the palace. The bricks are red/orange in colour measuring 230mm x 110mm x 55mm. The mortar is lime based, soft, and cream in colour. It has however been heavily re-pointed in places with a similar mortar which is much more gritty. Four small windows have been inserted and the top 11 courses have been replaced, or the wall has been extended in height. There is a string course (sandstone and possibly clunch in places) seven brick courses up from the ground at the south western corner. After this string course the brickwork steps in slightly. At 1.6m up from the ground there is another string course, this time in brick. This appears to be an original feature.

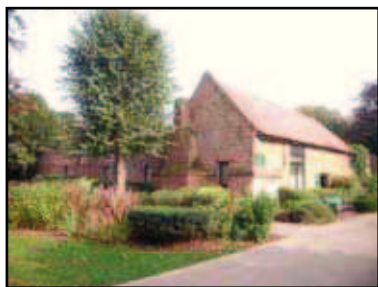
9.0.37

The most interesting feature of this wall is a **chimney stack** at its southern end. It is believed that this was originally an original bay window from the southern wing of the palace. If Sir John Summerson is correct in his reconstruction of the palace then this is a reasonable assumption.

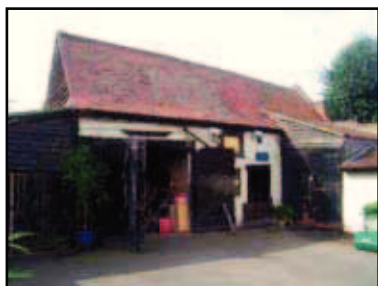
9.0.38

A red/orange brick building with red ceramic roof tiles extends eastwards from this bay window/chimney stack. It currently contains three rooms divided by two internal partition walls. On the 1883 OS Map however it shows just two rooms. The eastern room is currently used as a general storage area. It has a small window on the southern elevation and large wooden double doors on the north facing elevation. The middle room is used to gain access into 'pets corner' from the park. It has one door on the southern elevation and a door and small window on the northern elevation. The internal walls are exposed brick. The furthest west room is used as a park office. There is an inserted window on the southern elevation.

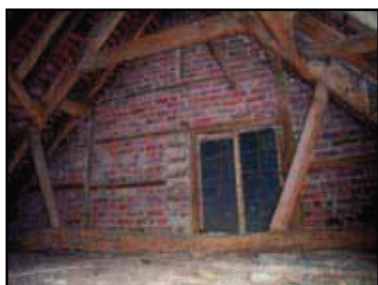
9.0.39

The whole building is single storey with an attic space above. The attic partition wall dividing the western room and middle room has an inserted window suggesting that the middle room was also added at a later date. It has a timber trussed roof with tie beams, staggered purlins, collars, and raking struts. The roof has had some recent work but appears to be 17th century in date. The roof was constructed using elm and now suffers from woodworm.

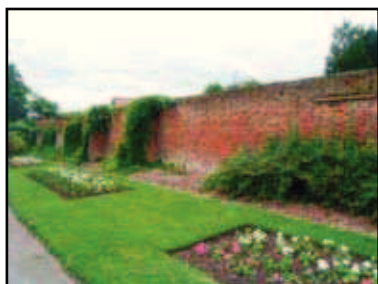
9.0.40

This wall appears to relate to the primary palace structure and seems to be marked on the 1611 plan as a wing protruding to the south. According to Summerson (1959), this was an open gallery built c.1572-73.

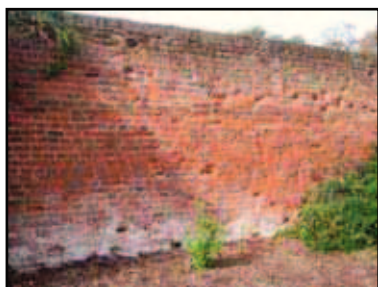
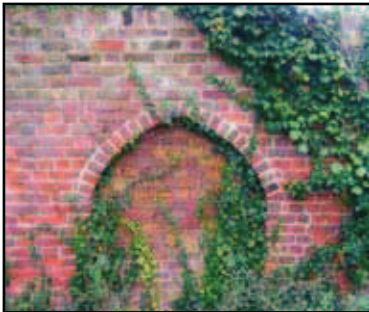
9.0.41

Wall 19 marks the eastern boundary of 'Pets Corner'. It is constructed with red/orange bricks measuring 230mm x 110mm x 55mm with a soft textured, cream coloured lime mortar. The top course uses yellow/purple London brick. It is 2.1m high and 43m long and had been extensively re-pointed with concrete in the same style as Wall 21. There are four London brick buttresses on its eastern elevation. The southern half of this wall appears to be more modern, perhaps being heavily repaired during the park refurbishment in the 1960's. It is feasible that at least part of this wall is marked on the 1611 plan although it is not possible to be certain. It is however marked on the 1785 and 1842 maps and is seen to be separating the grounds of The Cedars to the west, with the grounds of Thorpe House to the east.

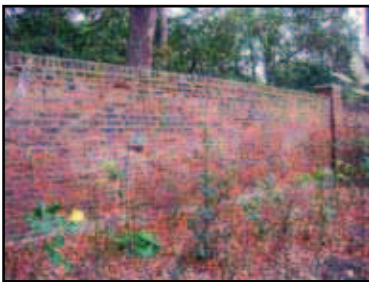
9.0.42

Wall 20 butts Wall 10 and runs southwards on a north-south alignment. It is 48m long. The bricks are red/orange in colour and measure 210mm x 60mm x 100mm. The mortar is a hard, gritty lime mortar, re-pointed in parts with cement mortar. There are several patches of modern repair. At the southern most end there is a blocked arch. The blocking bricks are yellow/purple London bricks and the arch is 1.2m wide and 1.8m high. At this end the wall has been cut and straightened off. It does not appear to be present on the 1611 plan, however it does seem to be marked on the 1785 map. It appears to be associated with the grounds of The Cedars.

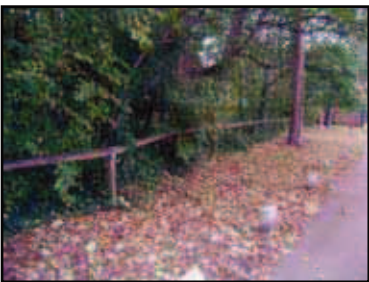
9.0.44

Wall 22 is a short section of wall on a roughly east-west alignment which is visible for approximately 10m. It returns to the north at its eastern most extent as wall 23 and both walls use the same bricks which measure 235mm x 110 x 65mm. It is associated with Jacksons School is at present largely obscured by dense vegetation and first seems to appear on the 1842 map although it may also be present on the 1785 map. It may also relate to an earlier phase.

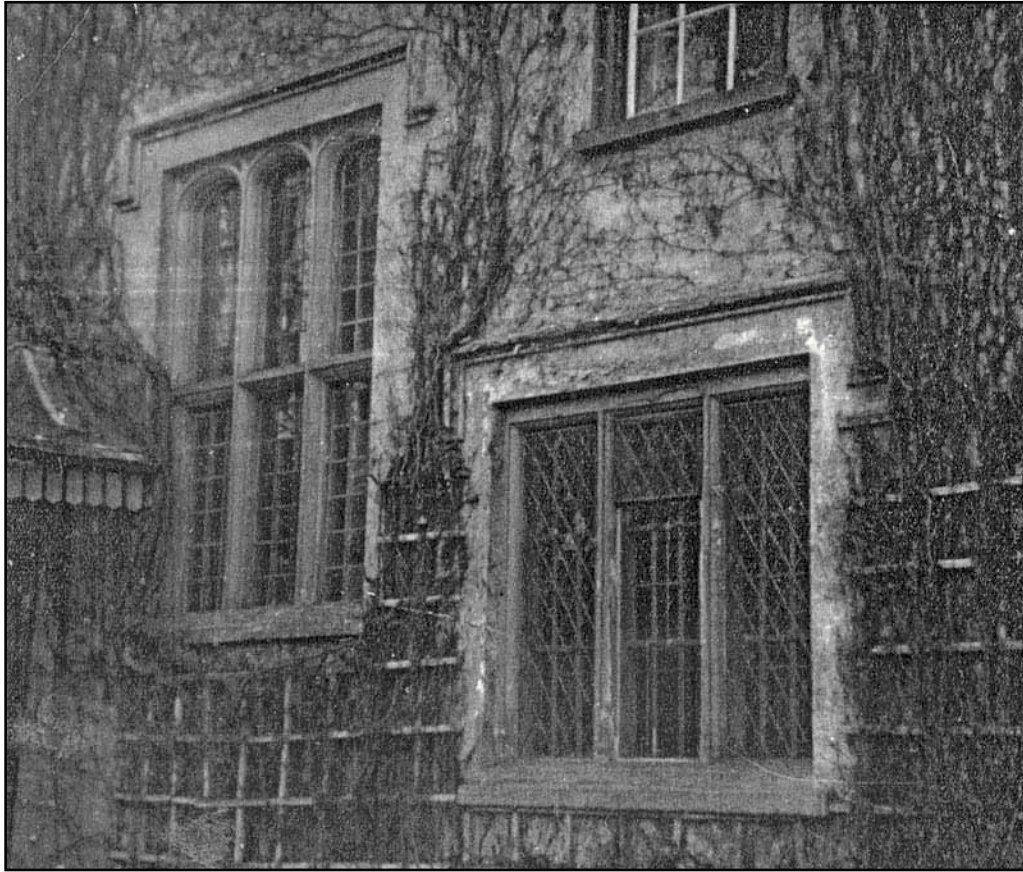
Plate 6: Mullioned windows of Old Palace House c.1968

which can be seen at Plate 6. This fragment can still be seen today despite Old Palace House burning down in the 1960s. One of the other houses was called The Cedars (Plate 7) and a large part of this survives today which gives the park its name.
