Scylla Road Heathrow London Borough of Hillingdon

Archaeological Evaluation Report

Scylla Road, Heathrow, London Borough of Hillingdon

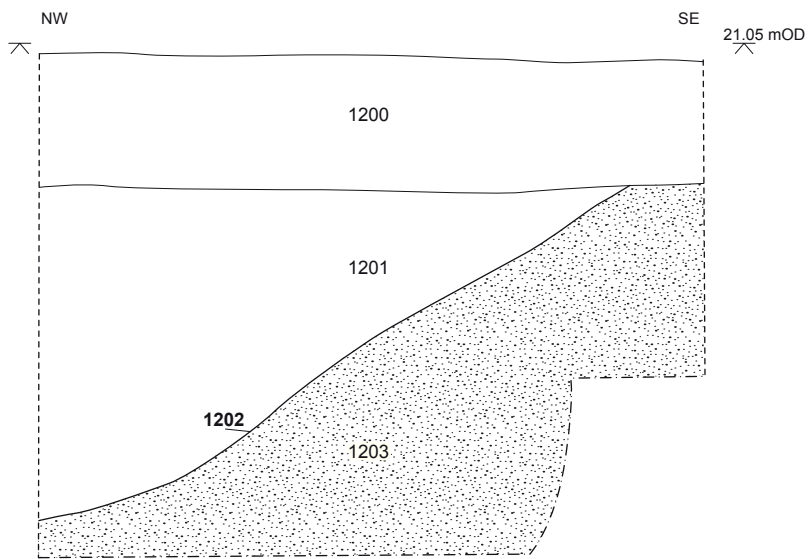
Section 1200

- 3.2.8 Within Trench 12 a clear cut edge (1202) was recorded sloping down from undisturbed levels of gravel from the east to the base of the trench (Fig. 3 section 1200). At the deepest point the trench depth was in excess of 2 m and natural gravel was not evident indicating deep truncation at this location. Similarly within Trench 15 only a limited area of natural gravel was revealed with the trench abandoned at 2 m deep.
