# Real Tennis Court

## Hampton Court Palace

### Historic Buildings Recording and Archaeological Watching Brief

January 2012

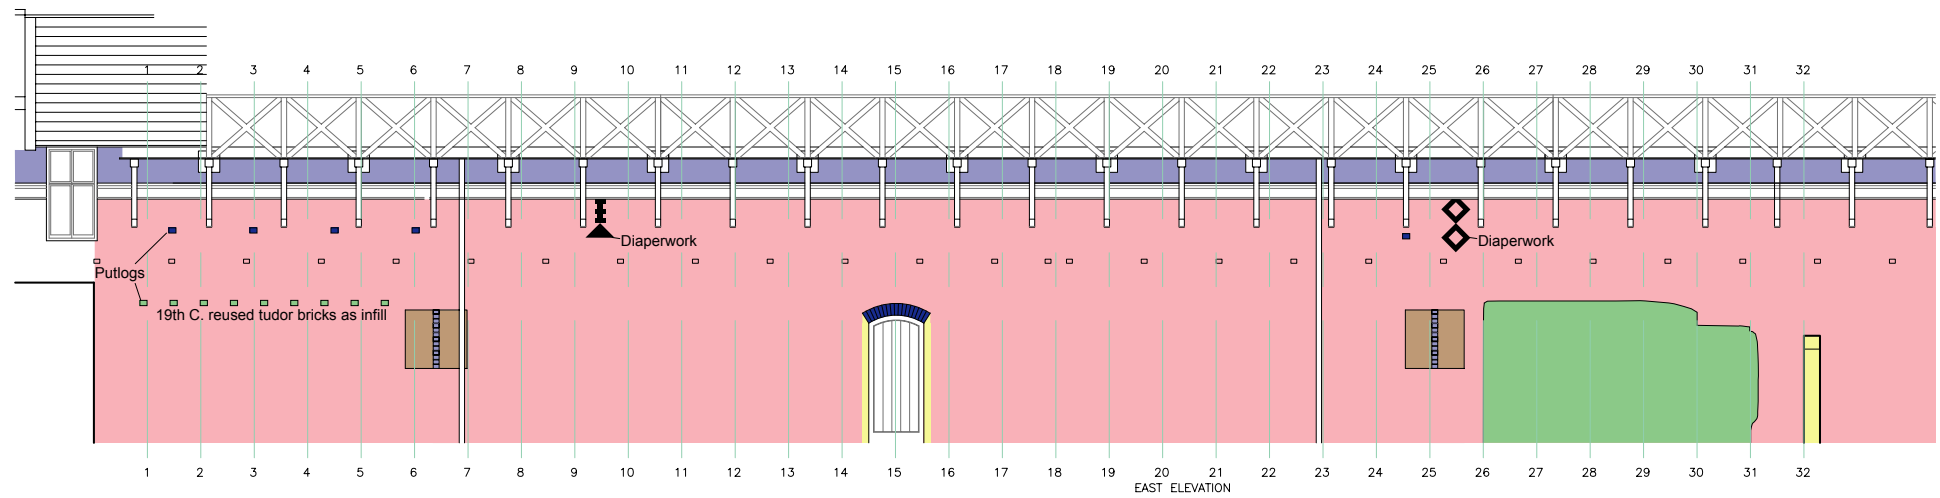
- Key
- C19th - Type Q bricks
  - C19th - Type T bricks
  - C18th - Type O bricks
  - C18th - Misc.
  - Late C17th - Misc.
  - C16th - Type C bricks

Figure 3: Eastern elevation of tennis court (adapted from a drawing provided by Historic Royal Palaces)

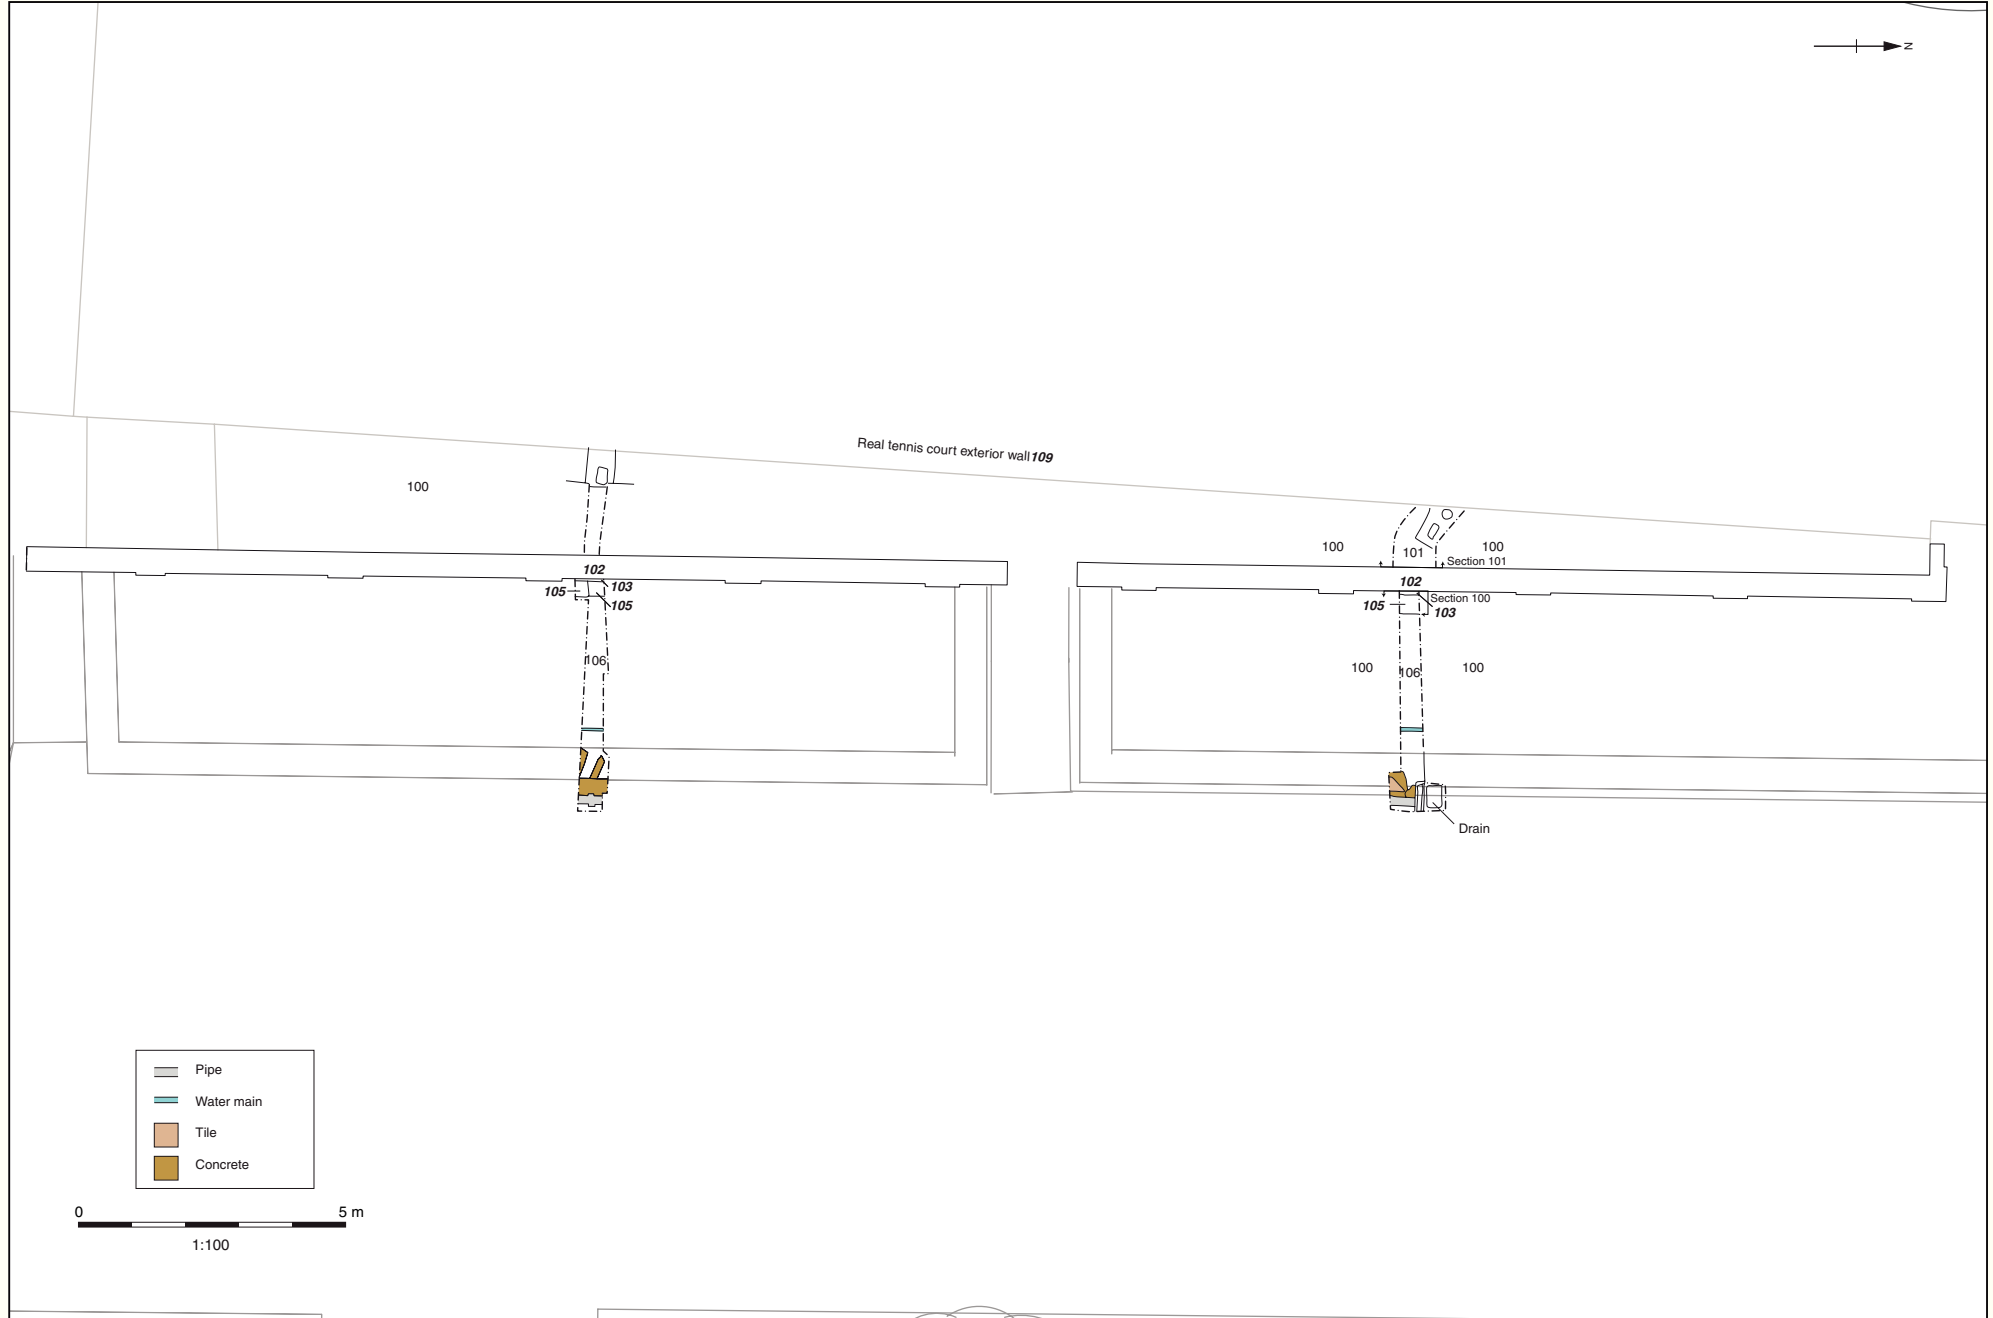
Figure 3: Watching brief trench location plan

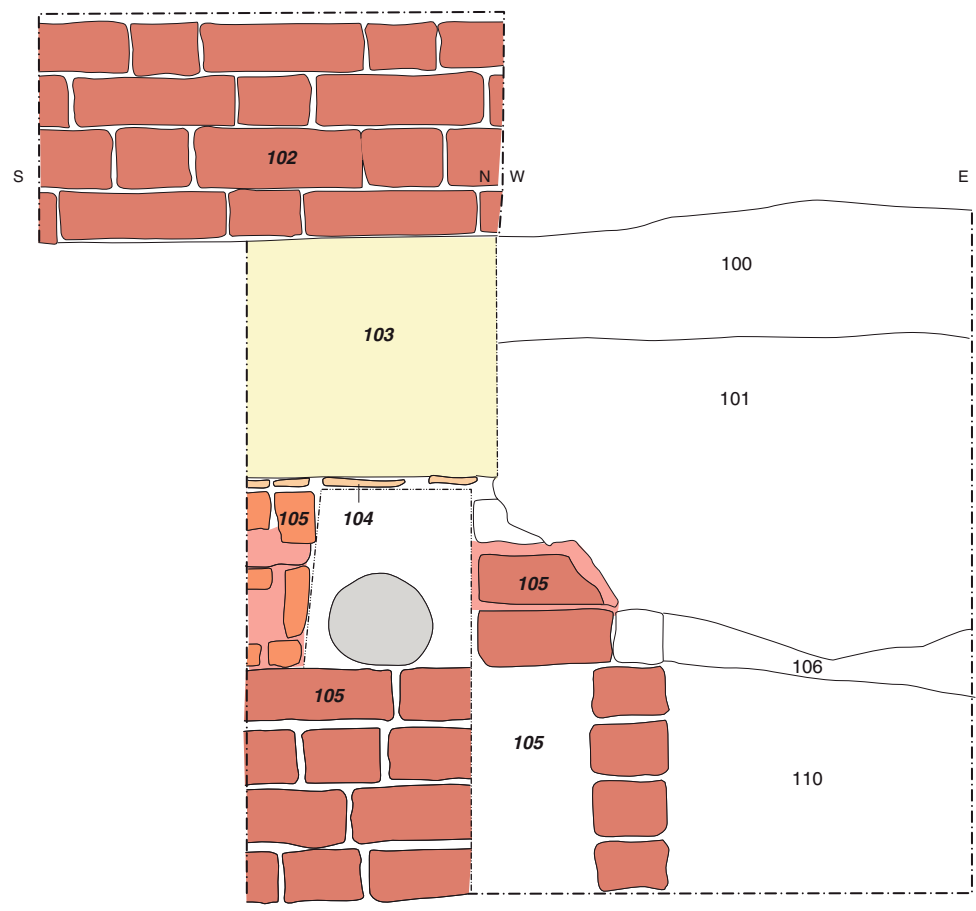
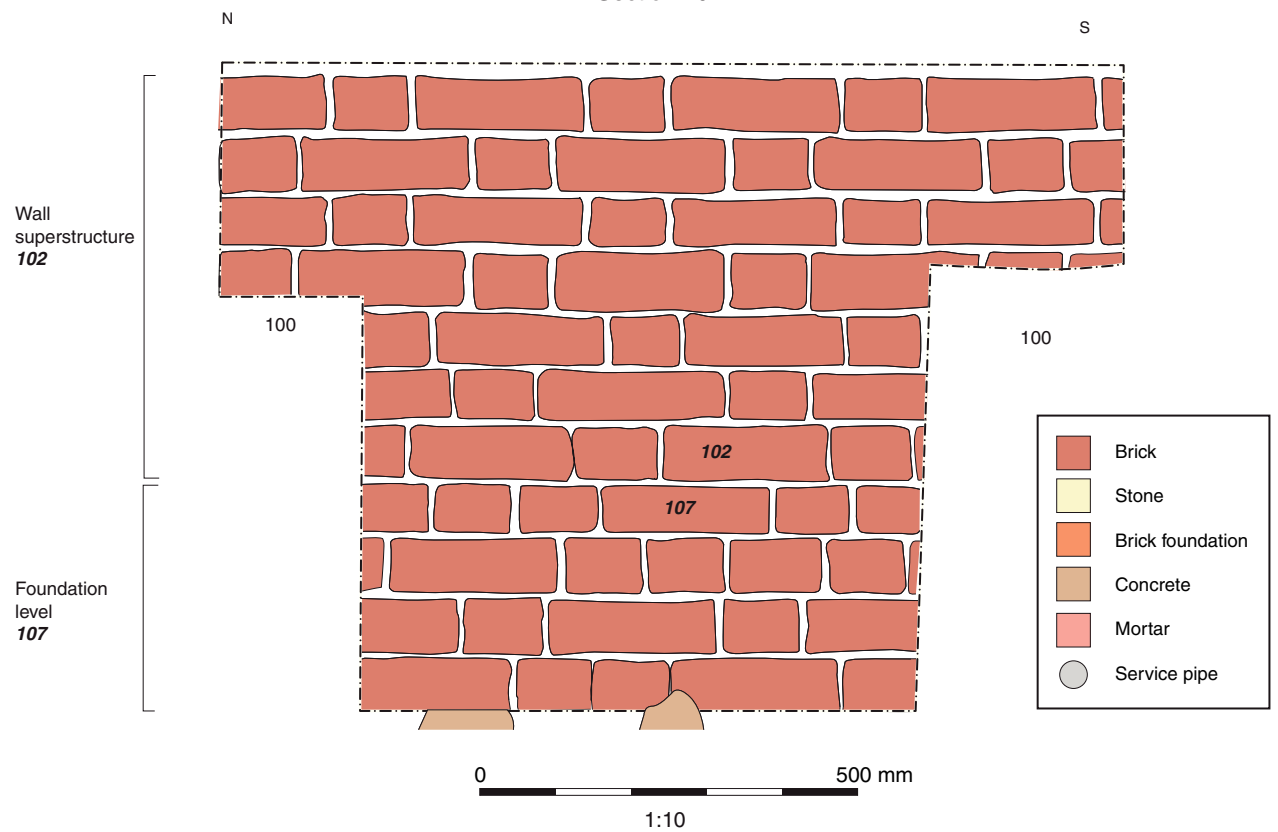
Figure 4: Watching brief elevations

- 4.3.4 On the interior aspect of the wall (west Facing) the foundations (107) were seen to be flush with the walls superstructure and the bricks were laid in a variation of a Flemish bond using a sandy brown chalk and lime mortar. On the exterior aspect (east facing) the foundations formed a small buttress (105) which extended 0.26 m from the base of the wall.

- 4.3.5 On the exterior aspect of the wall the brick foundation was overlain by a single course of tiles (104). These were orange in colour and varied from 90 mm to 120 mm in length and were 10 mm thick. Many of the tiles appeared to have been broken prior to having been utilised within the wall.

Exterior aspect of wall  
Section 100

Interior aspect of wall  
Section 101

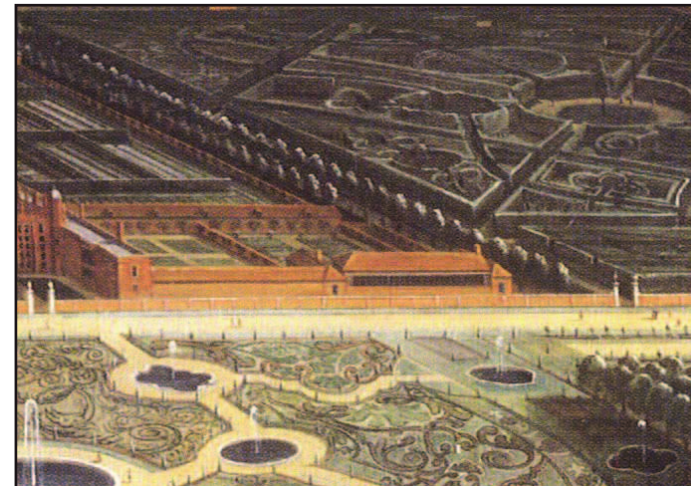
Plate 4: Detail from Hampton Court by Leonard Knyff c. 1712-13 showing 1699 brick wall on the east elevation (after Thurley, 2003)

- 2.2.4 In 1699 the floor was relaid in stone and the lodgings and access gallery were refitted. The east front of the palace was under construction using orange/red coloured stock bricks with stone dressing and a new garden wall was built in this style in front of the existing east elevation of the access gallery and tennis court.

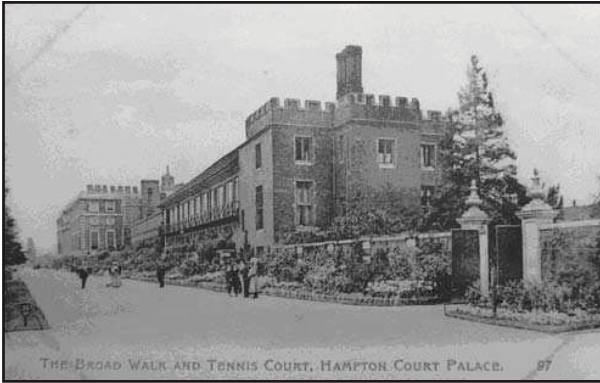
Plate 8: Late 19th/early 20th century photograph of Broad Walk showing the tennis court

- 2.2.6 By 1818, the tennis court required a major overhaul. The roof was retiled and cornices repaired. The interior was repainted and a new floor was laid. Previously unglazed (as seen in Plate 8), the east upper lights were glazed in 1883/4 and the west lights were glazed in 1843. HRH Prince Albert was a frequent player of tennis during the mid 1850s and a locker in the changing room still bears his name plaque. In 1927 the internal stonework was rendered.

- 3.4.3 Across the elevation the brickwork and mortar is marked with small holes which are evidence of former foliage cover on the elevation. Some 19th and early 20th century images show the foliage in situ, later removed and replaced with small trees within the corridor between garden wall and the tennis court elevation (Plate 8).

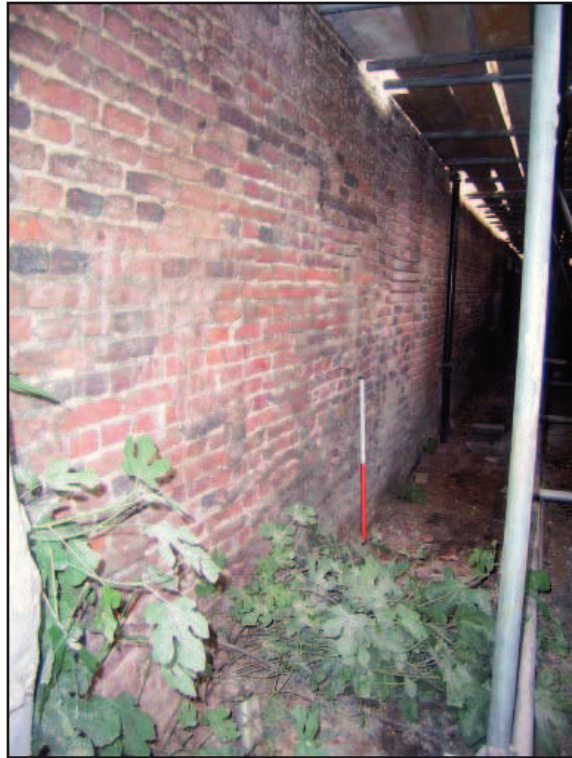
Plate 9: Lower section of east elevation prior to works

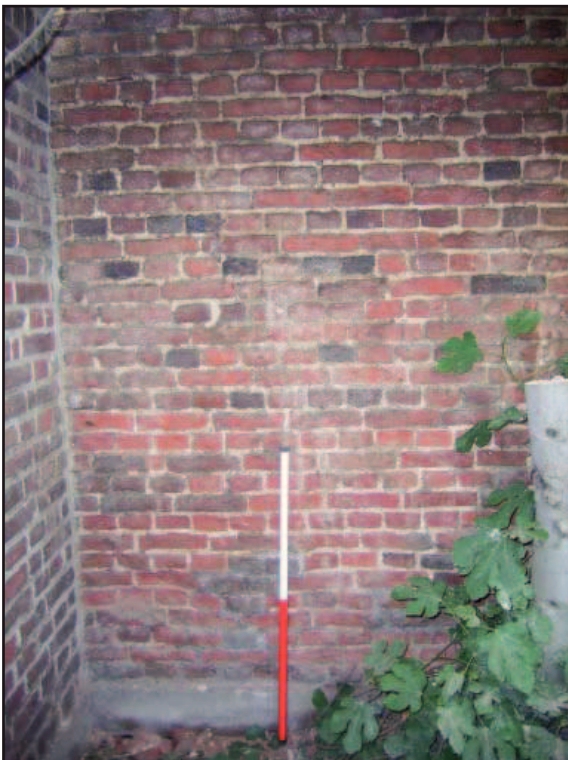
Plate 10: Tudor brickwork at south end of elevation

- 3.5.1 The majority of the lower brickwork appears to be from the Tudor construction of the open tennis play. These bricks are orangey red to dark red in colour measuring approximately 228 x 55-58 x 101-106mm and an arris to arris measurement of 256-260mm. The bricks are laid in an English bond with a fairly thick cream coloured lime mortar with small gritty and medium sized lime inclusions. The brick type is similar to other Tudor bricks used at the palace,

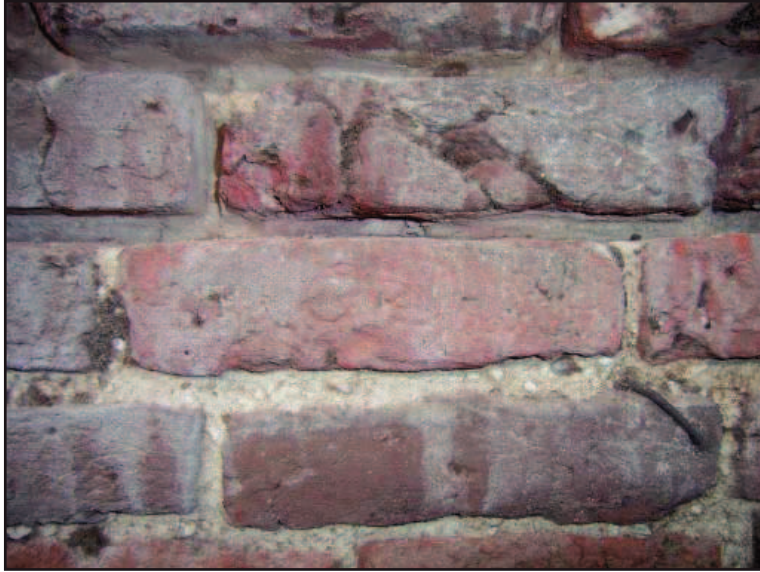
Plate 12: Graffito inscription on Tudor brickwork

- 3.4.10 As with other parts of the palace the accessible lower brickwork has a number of graffiti inscriptions, most of which date to the late 19th /early 20th century and are usually in the form of initials and year.

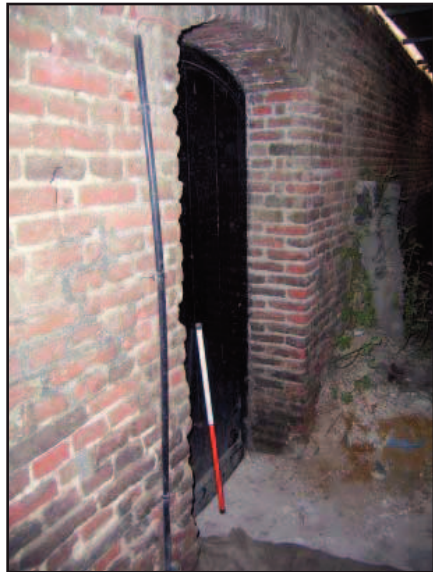
Plate 14: Doorway

- 3.4.5 Centrally placed on the elevation is a doorway leading into the viewing corridor for the tennis court. This doorway is likely to have been inserted in the late 17<sup>th</sup> /early 18<sup>th</sup> century as part of the works to the tennis court with some later rebuilding of the arch lintel in the late 18<sup>th</sup> / early 19<sup>th</sup> century. The entrance can be seen on the plan of the tennis court drawn by Thomas Fort c. 1718 and the corresponding opening in the Broad Walk wall is depicted in a drawing by Spyers

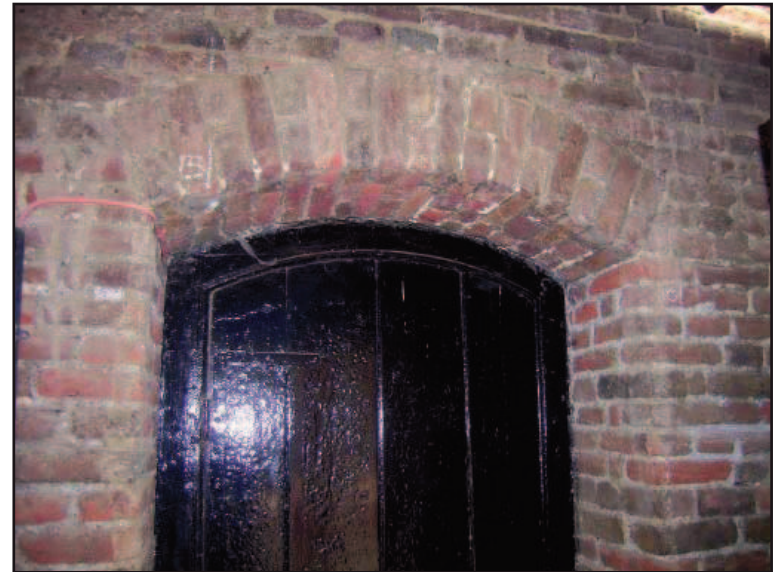
Plate 15: Detail of rebuilt arch lintel

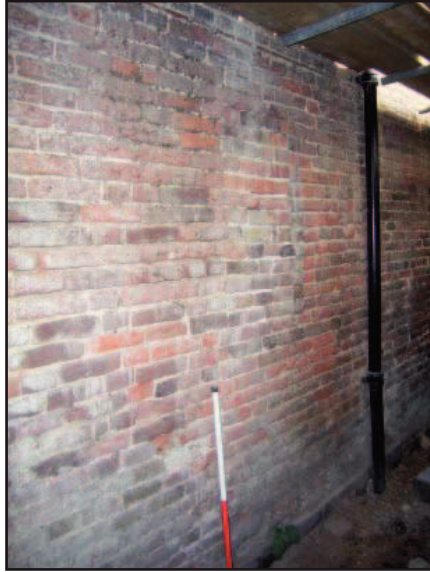
Plate 16: Infilled window opening to south end of elevation

- 3.5.4 On the lower section of the elevation are two areas of window infill. As well as some reuse of early brick and some later mortar repairs the bricks primarily measure 210 x 65 x 100mm and their pinky yellow colour is consistent with Type O London stock brick of the mid 18<sup>th</sup> century. The central stacked header infill appears to be later in date and possibly uses Type Q bricks (late 18th/19th century) suggesting there were two phases of infill.

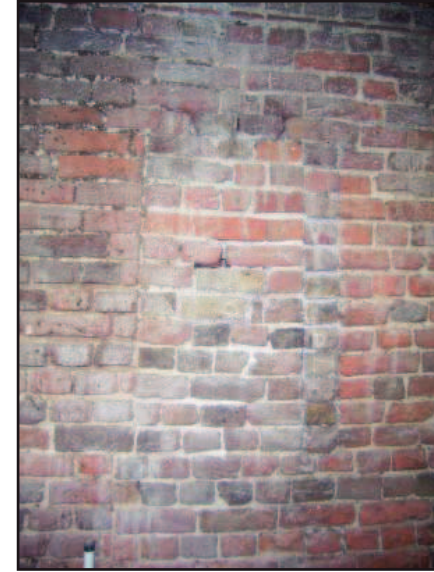
Plate 17: Detail of infilled window opening to south end of elevation

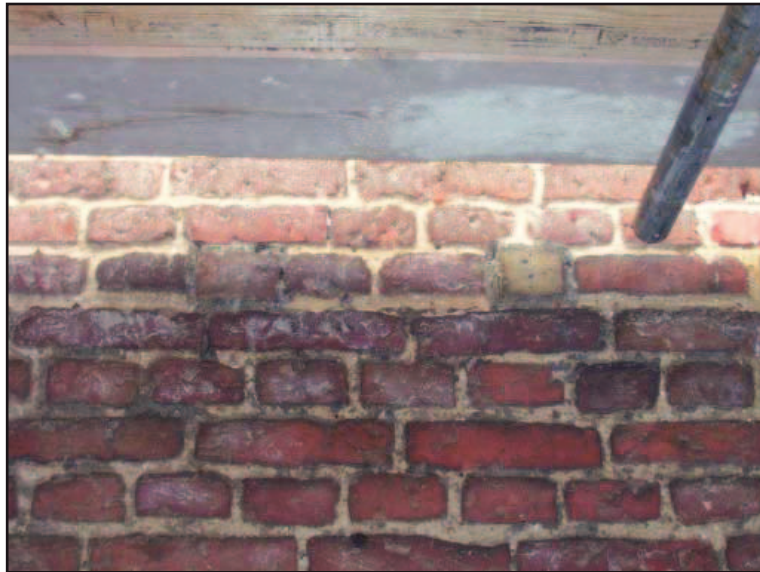
Plate 18: 18th/19th century putlog set within primary Tudor brickwork

- 3.4.4 Two different levels of putlogs were observed on the elevation. The lower level putlogs being evenly spaced six stretchers apart and infilled with reused Tudor bricks and have a distinct red coloured mortar pointing (Plate 20). The upper putlogs are infilled with yellow 18th century stock bricks and are evenly spaced every twelve to fourteen headers apart, the mortar is a grey coloured black ash mortar with stone inclusions. These putlogs are clearly the result of two different phases of works during the 19th century. The upper putlogs with yellow brick infill probably to the early 19th century and are possibly connected to the tile replacement works of 1818. The lower putlogs were probably infilled in the late 19th century, possibly relating to the insertion of the glazed upper lights in 1883. The red colour mortar was probably achieved to match the elevation which may have been painted red at that time as many elevations were painted to make the Palace more Tudor in appearance for the increasing amount of visitors. The red coloured mortar has been seen in occasional brick replacement by the author elsewhere in the palace (Chapel Court and Base Court) and so must have been a standard repair solution for this phase.

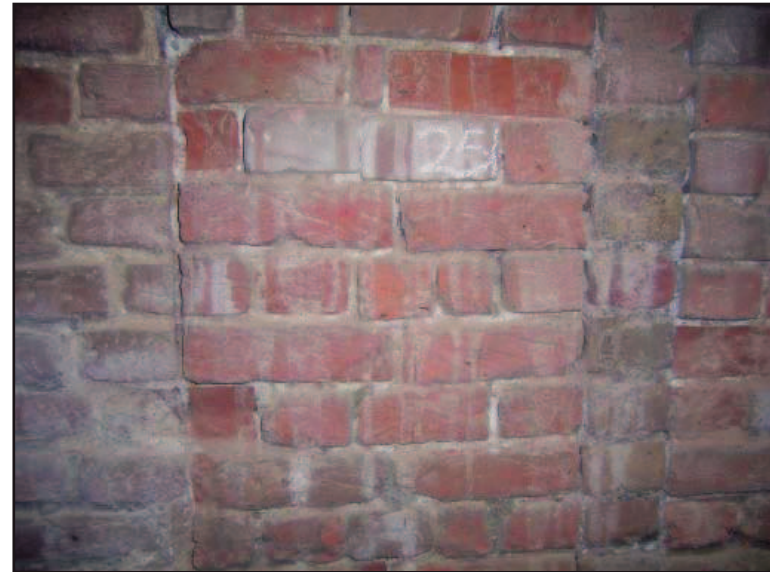
Plate 19: Infilled window opening to north end of elevation

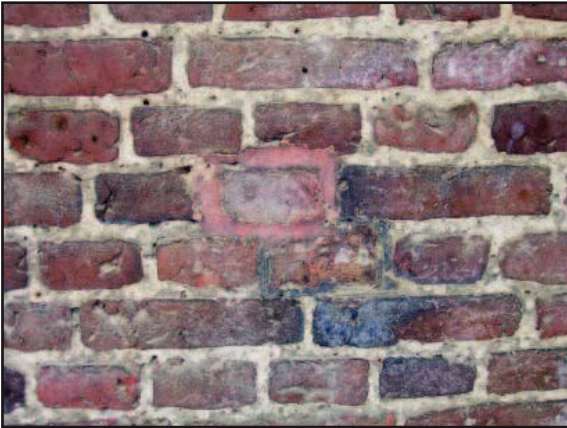
Plate 20: Mortar repairs

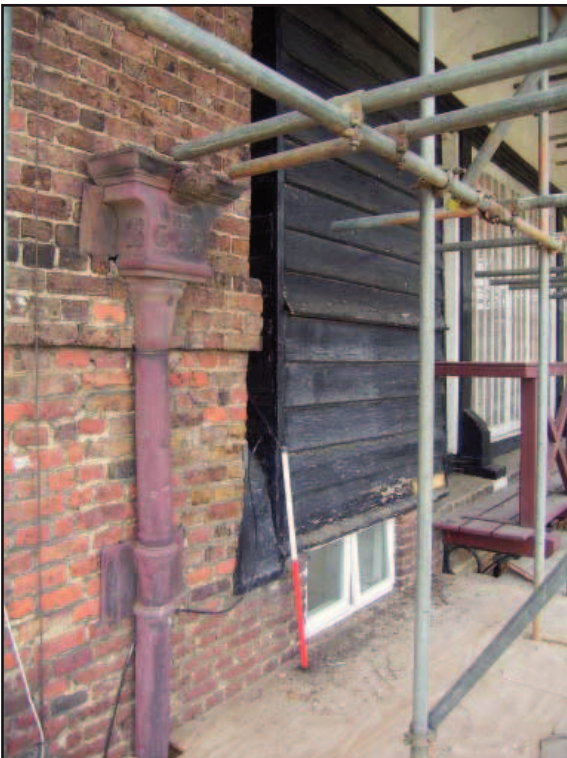
Plate 22: View of 19th century windows and adjoining brickwork

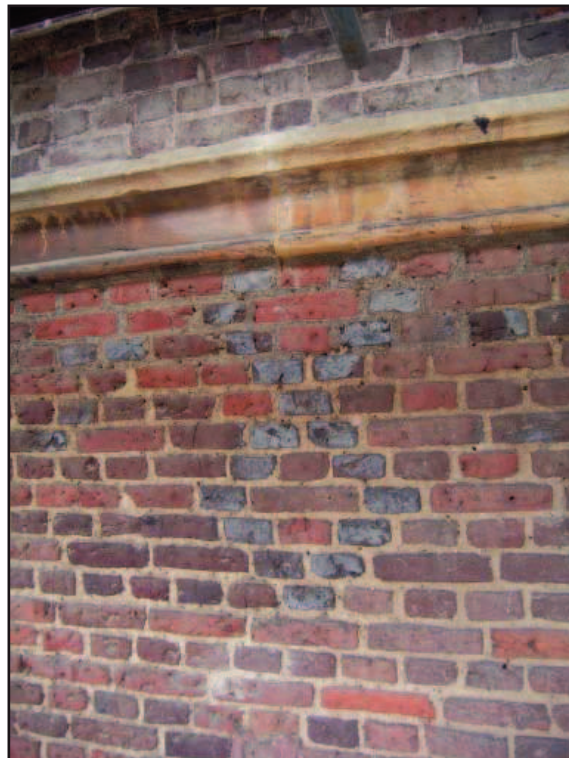
Plate 23: Open diamond diaperwork detail

- 3.5.2 The vitrified bricks within the elevation mostly have no discernible pattern, however, on the upper level of the brickwork two areas of diaperwork in the Tudor brickwork are clearly seen. The southern diaperwork is a section of solid lozenge shapes and the northernmost diaperwork is a section of open lozenge diaperwork. The open lozenge design is a typical design for later diaperwork (Smith 1992, 24) and this style can be seen throughout Hampton Court, particularly within Base Court. Both sections of diaperwork are truncated at the top by the windows and balcony added in 1699. The presence of a small section of diaper decoration does not suggest that the pattern initially covered all of the elevation at the time of construction and areas of partial diaper pattern can be seen throughout the palace. White (2005) has argued that the diaperwork was laid out using available vitrified bricks and the patterns ended when available bricks ran out. The finished elevation would probably have had diaperwork painted on covering the brickwork underneath the painted surface. Several examples of painted decoration have been found at Hampton Court, the most preserved being the east elevation of the chapel which was enclosed by the Wren rebuilding works in the late 17th century (Thurley 2003). No evidence for painted decoration was found during the survey, however it is likely that this elevation was initially painted as it would have been visible from the palace grounds.

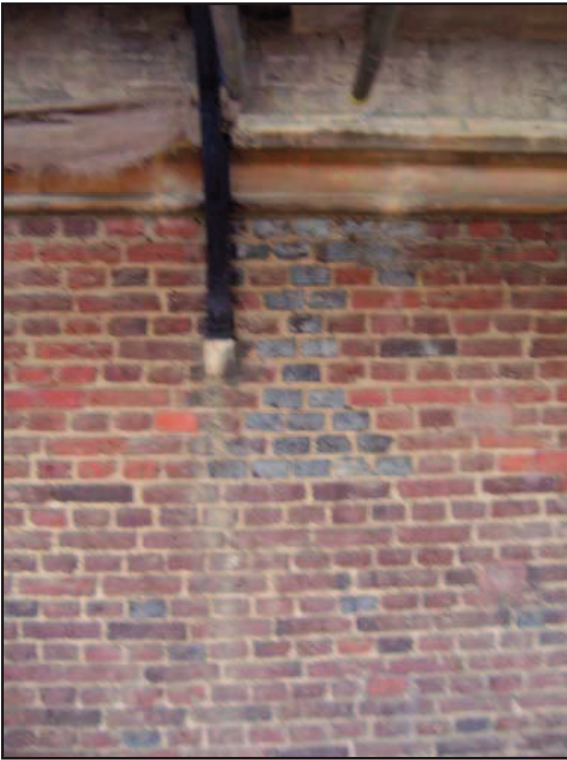
Plate 24: Closed diaperwork detail

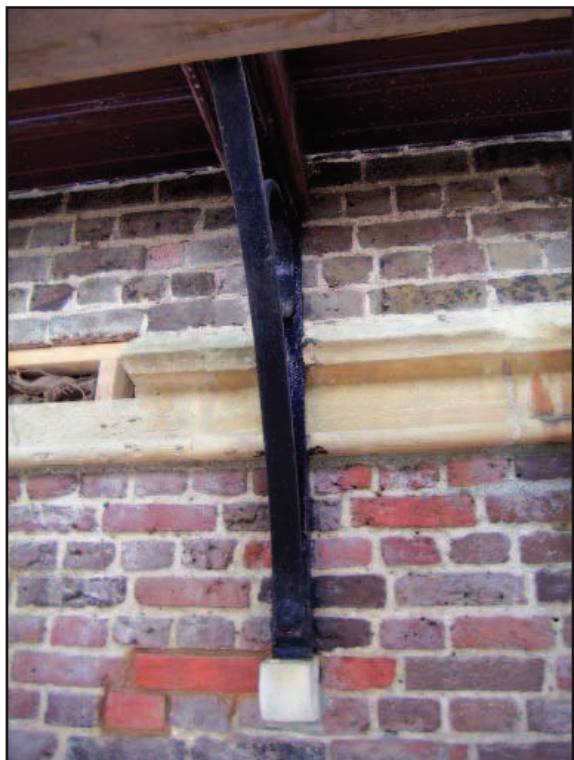
Plate 25: Iron balcony support inserted into stone string course

- 3.4.9 The string course is cut at intervals to allow for the iron balcony supports which in turn sit on a projecting stone which is grey/white in colour. Above the stone string course is a brickwork level with five courses of 18/19<sup>th</sup> century brickwork laid in a Flemish bond followed by a wooden balcony and large clerestory windows with timber boarding to the south end.

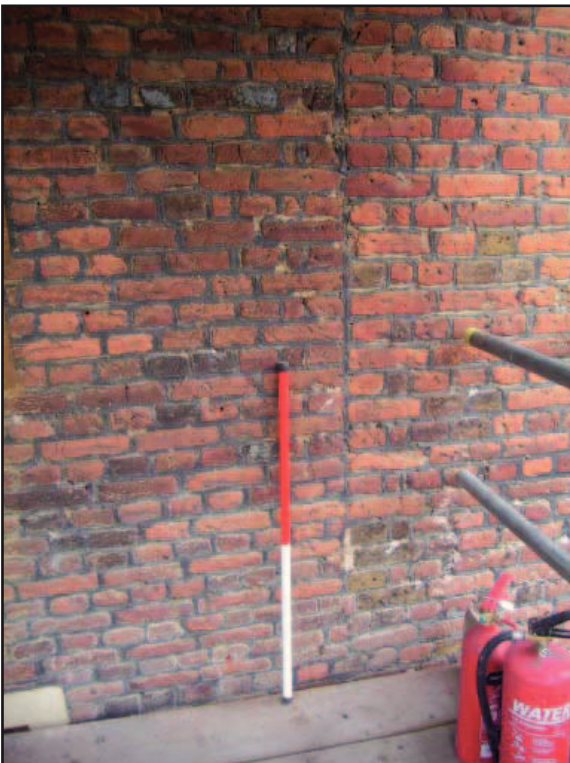
Plate 26: Straight joint showing extension to tennis court range

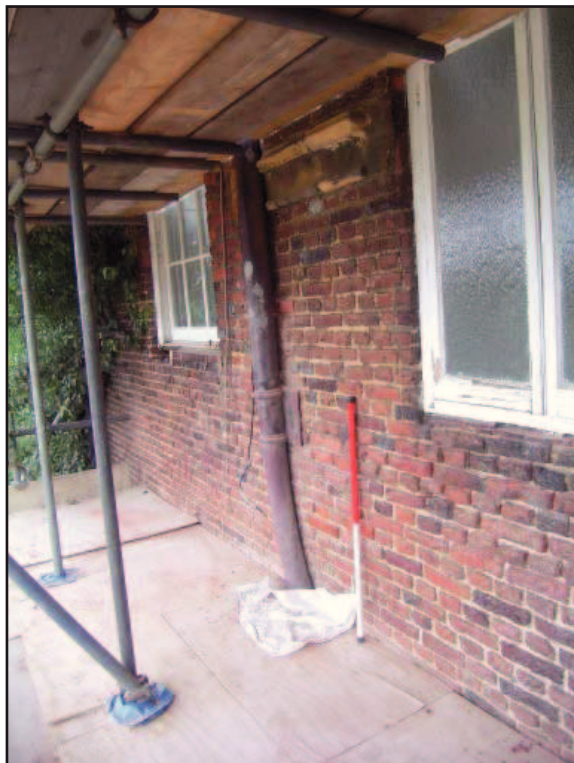
Plate 27: Inserted windows and truncated stone string course to south of tennis court range

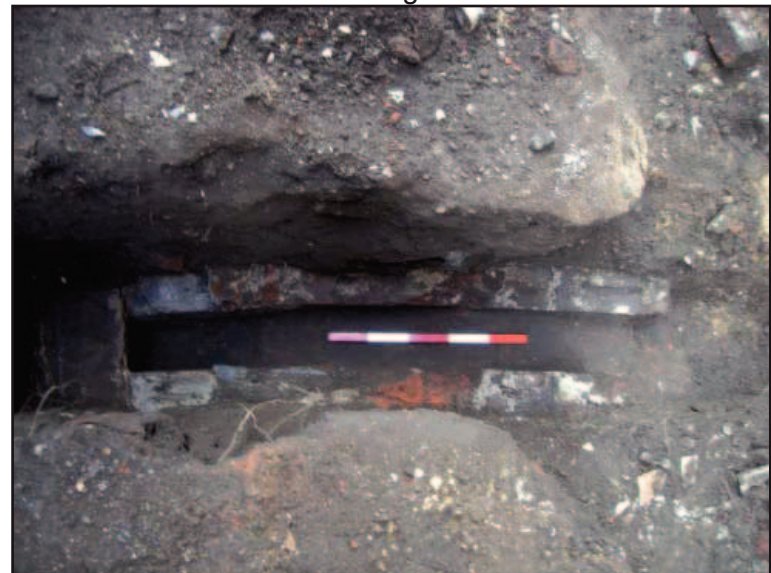
- 4.3.7 During the excavation of the southern trench a Victorian drain (108) was identified running between the tennis court and enclosure walls. One course of tile and up to two courses of brick remained. The bricks were orange in colour and unfrosted, measuring 230 mm long, 110 mm wide and 85 mm deep and formed the sides of the structure. The tiles were also orange and measured 300 mm in length. These formed the base of the drain. The drain survived to a length of 1.95 m and was a minimum of 0.38 m wide and 0.20 m deep.

Plate 31: Archaeological watching brief - drain 108
