## Base Court Tudor Door Opening and Gate Hanging, Hampton Court Palace

### Watching Brief and Historic Buildings Recording

**Client Name:** Historic Royal Palaces  
**Document Title:** Base Court Tudor Door Opening and Gate Hanging, Hampton Court Palace  
**Document Type:** Watching Brief and Historic Building Recording, Client Report  
**Issue Number:** 1

**OA Job Number:** 4608  
**Site code:** HCP72  
**Invoice code:** HCP72BS

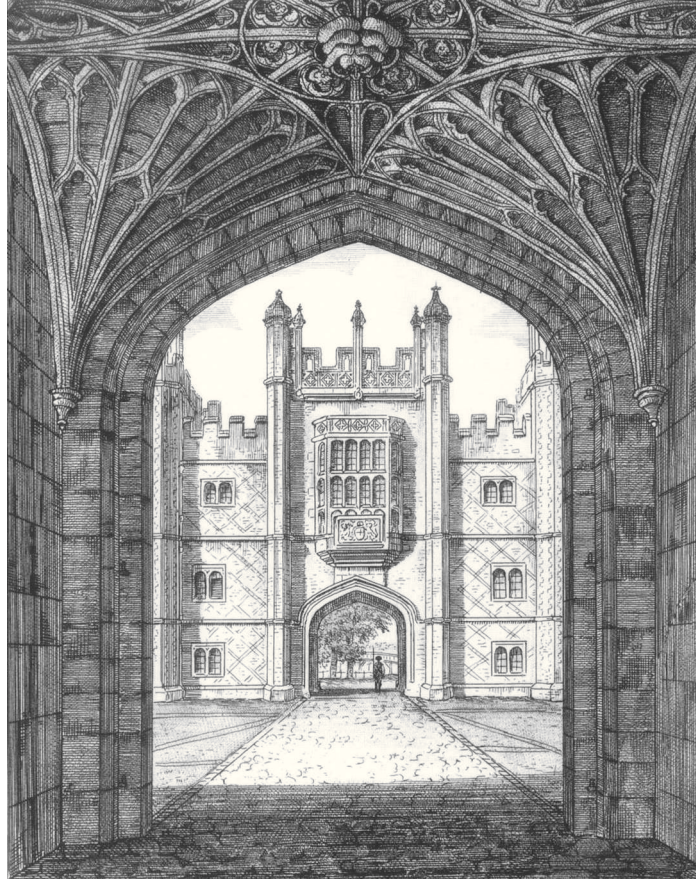
Plate 1: Interior of Anne Boleyn Gate showing pintles of former gate (anon. 1800) © Historic Royal Palaces

3.2.2 There are three remaining iron fittings inserted within the stonework on the inner jambs of the archway. Two pintles are set within the northwest jamb and one within the south west jamb – all are of indeterminate date. The worked stone on the archway of the gatehouse was examined and identified by Robin Sanderson in September 2008. It was determined that the upper parts of the archway below the springing joint on both jambs are of Caen stone which probably dates to the original construction of the gatehouse in the early 16th century. Beneath this are quoins of Wheatley limestone which is difficult to date accurately due to its extensive use within the palace; however the appearance suggests that it is a later repair to the archway stonework and therefore post Henrician but pre 19th century in date. The lower quoins are of Bath stone and probably of 19th century date. The upper pintles on the north west jamb has a patchy white mortar surrounding it and the lower pintles has a small section of Bath stone adjacent suggesting these were either later insertions or reset. Bath stone is typically used in 19<sup>th</sup> century repairs and refenestration at the palace suggesting that, for a short time, gates may have been hung in the 19<sup>th</sup> century.

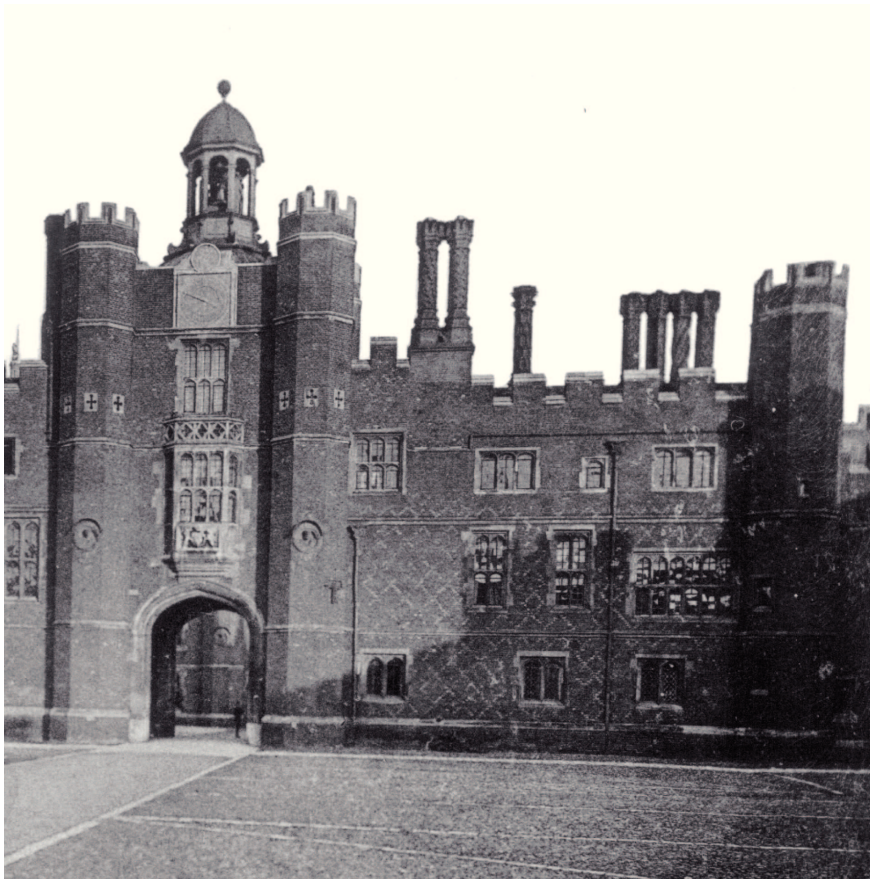
Plate 4: Detail from photograph of east range of Base Court showing blocked doorway with recent addition of plinth (pre 1891) © Historic Royal Palaces

- 4.1.1 A blocked doorway in the east elevation of Base Court has been depicted in many drawings and sketches from the 18th century onwards (Plates 2 & 3) and a scale drawing of this section of the east elevation featured in AW Pugins *Specimens of Gothic Architecture* (Plate 4). The door was part of the original Wolsey build of the courtyard ranges and was thought to have fallen into disuse following the addition of a stair turret to the elevation shortly after completion of Base Court in 1522. From the pictorial evidence and the type of bricks used as infill it is clear that the doorway was initially bricked up in the late 17<sup>th</sup>/early 18<sup>th</sup> century with the stonework remaining exposed. During the 19th century the stone was removed and the void was infilled with brick and a brick and stone plinth was later added.

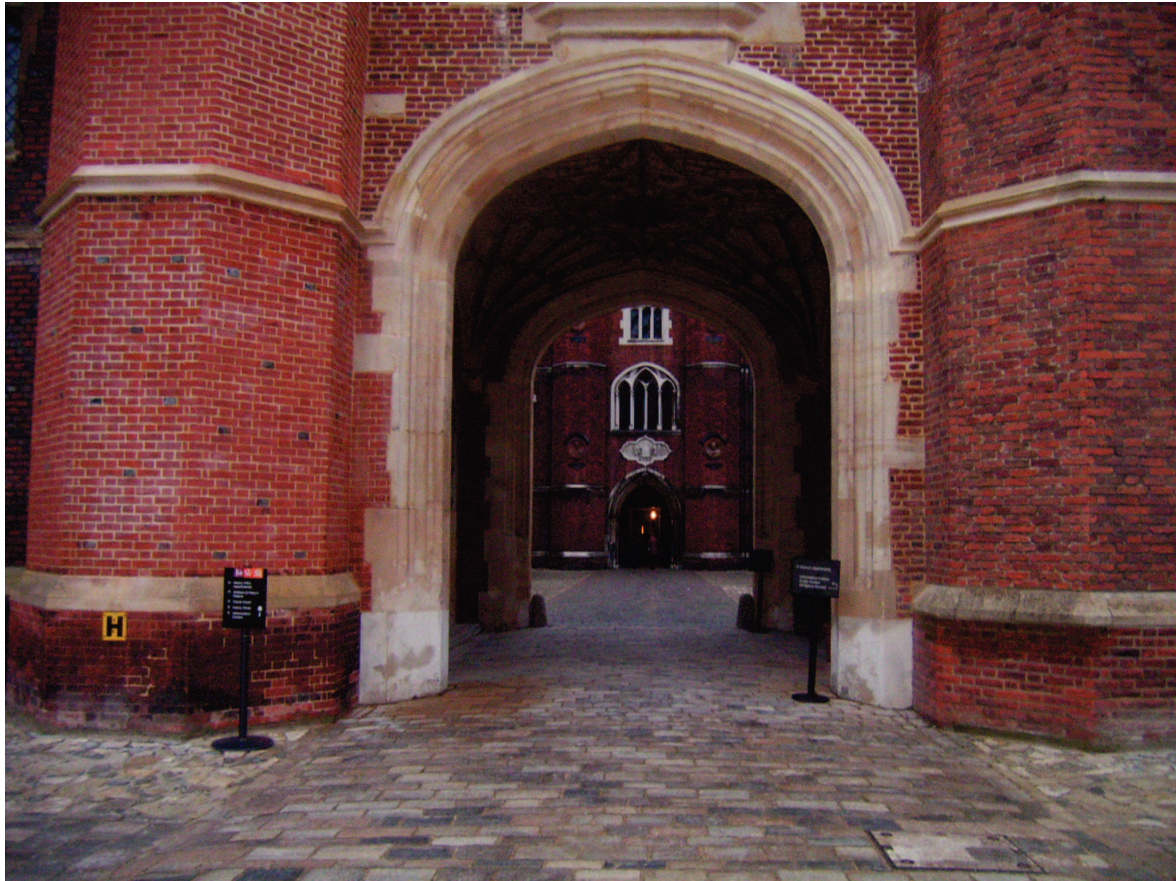
Plate 5: West elevation of Anne Boleyn Gatehouse

3.2.1 The installation of new oak gates on the west elevation of the Anne Boleyn gatehouse (Plate 5) involved the insertion of new pivots and slots into the ground beside each jamb. An area beside each jamb was excavated to a depth of 330mm and 380mm in order to ascertain if the works were likely to damage any archaeology beneath.

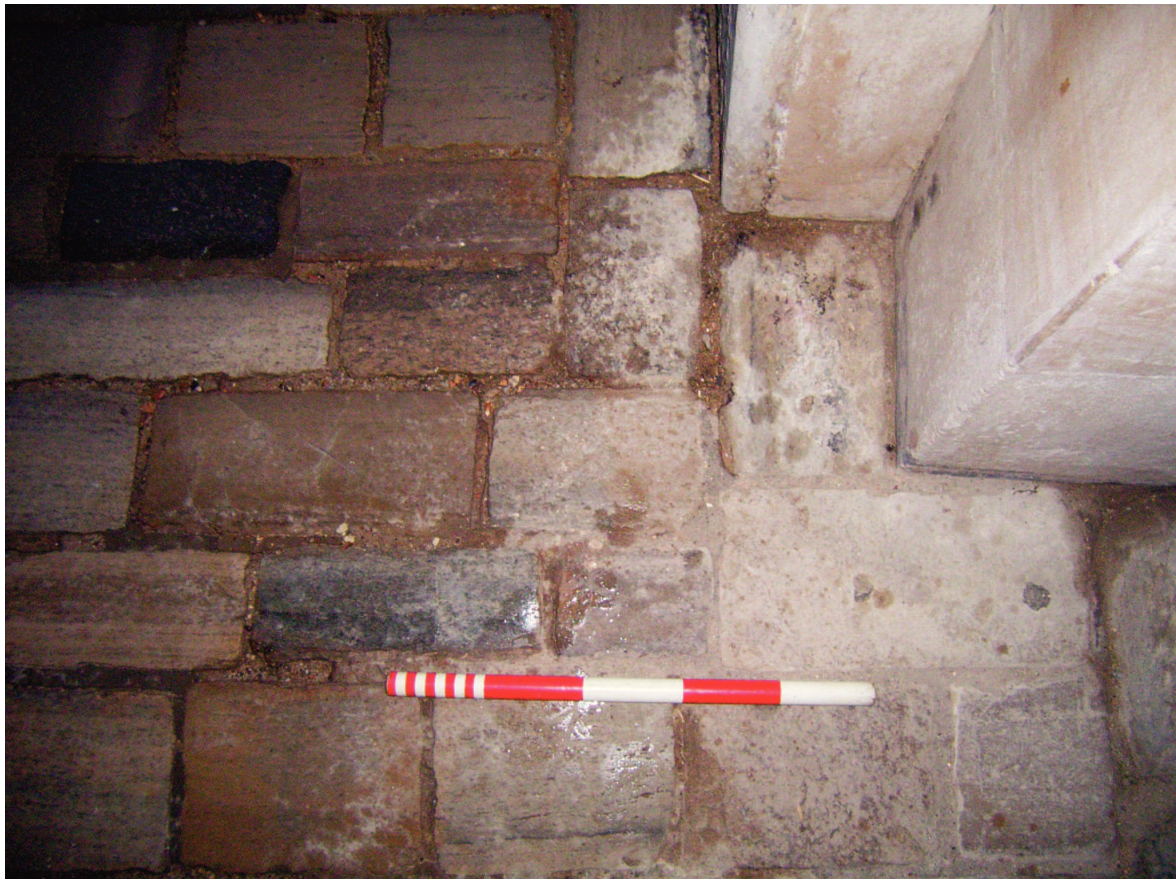
Plate 6: The northwest jamb granite setts prior to removal

3.2.3 The flooring and material beside the northwest jamb was removed to a depth of 380mm, beneath this the underlying material consisted of a compacted brown, sandy layer with frequent rubble stone inclusions. Three fragments of generic post medieval flat clay roof tile and one fragment of salt glaze stoneware pottery were

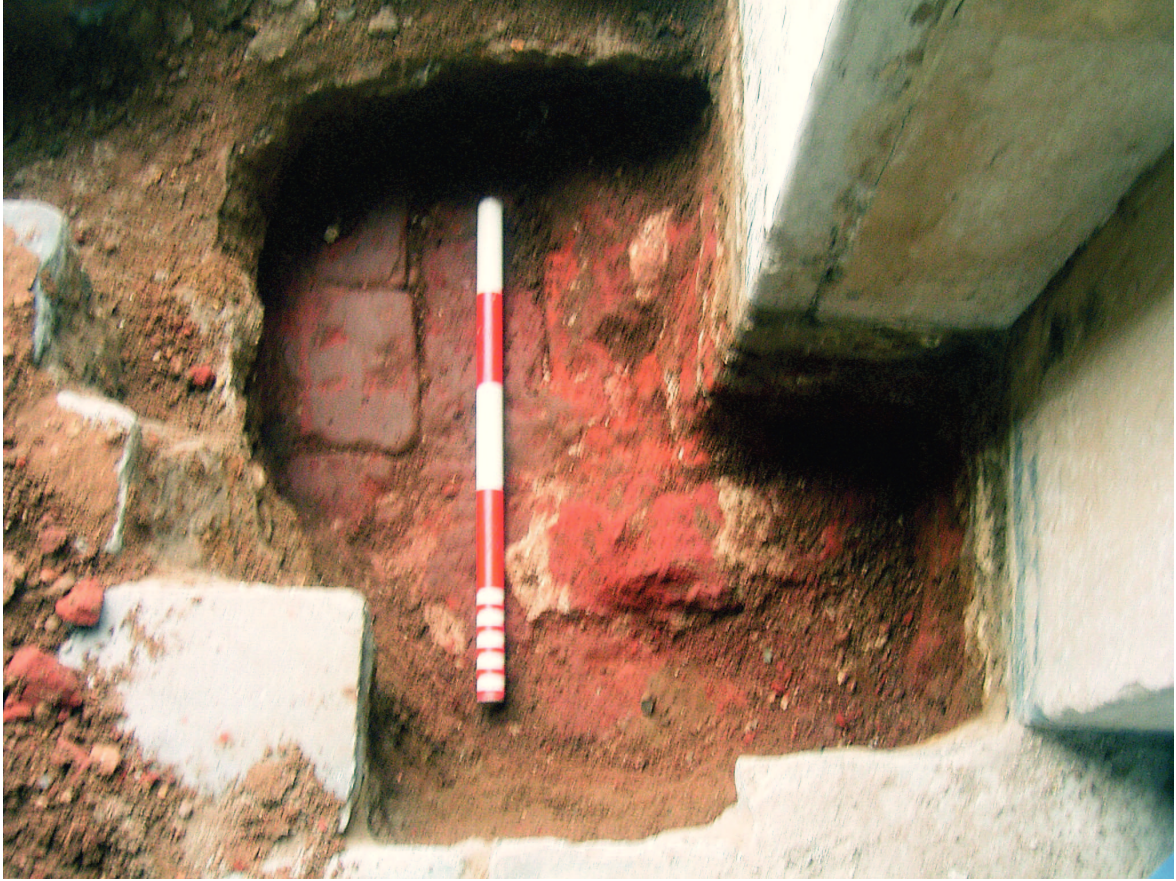
Plate 7: The northwest jamb following removal of material

- 3.2.4 The dressed stonework for the arch continues down from ground level to a depth of approximately 150mm and beneath this are three courses of brick footings which project outwards from the base of the stonework by approximately 80mm (Plate 7). The bricks are a deep red colour and measure 235 x 115 x 58mm, which, when compared to the Hampton Court Brick Typology (English Heritage, 1991) which is characteristic of Type T brickwork (19th century). The mortar is a creamy white colour with irregular inclusions. At approximately 380mm depth there was a level surface of red brick of a similar size to the footing, however there were no full measurements visible for analysis.

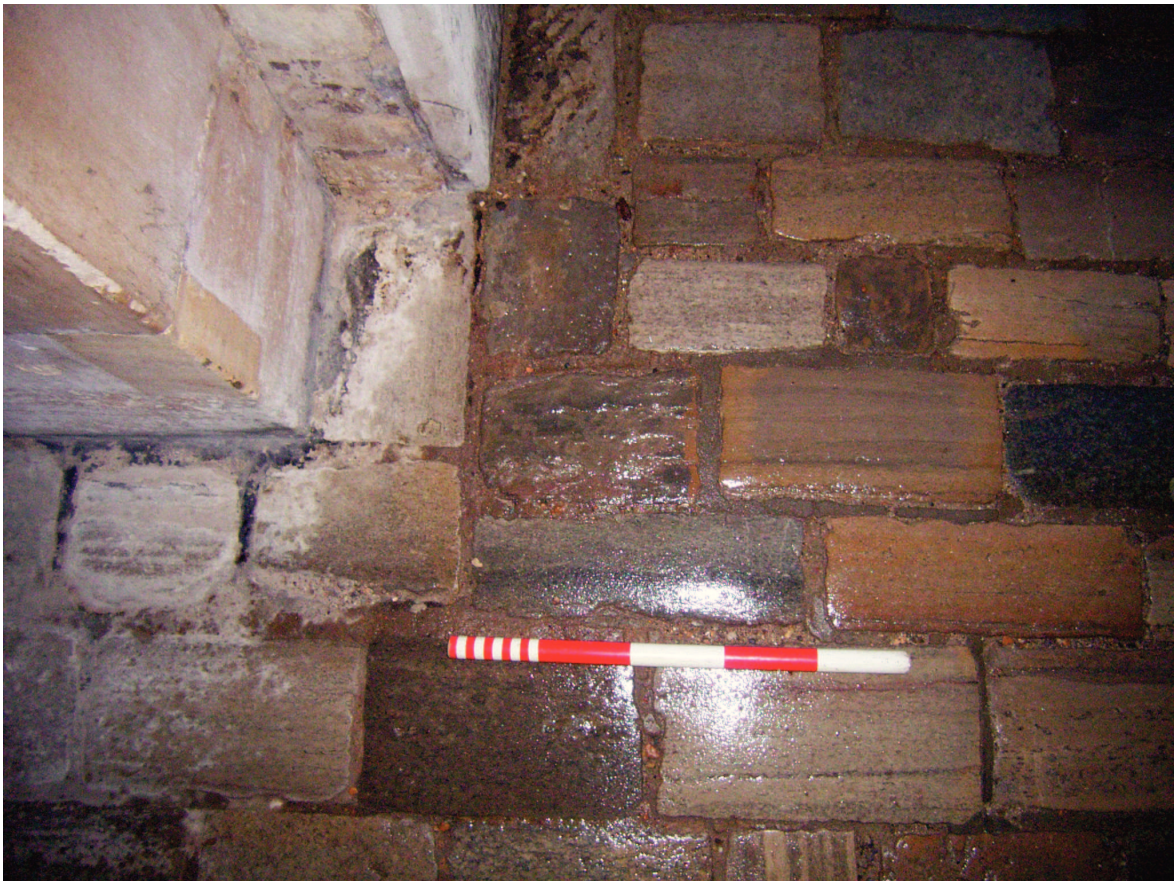
Plate 8: The southwest jamb granite setts prior to removal

- 3.2.5 As with the northwest jamb, below ground level by the southwest jamb has the same sandy brown coloured fill with rubble inclusions, which was excavated to a depth of 330mm (Plate 9). The brick footing protruded 100mm from the lowest stone quoin and it is possible that the same flat surface as seen by the northwest jamb exists; however this was unseen.

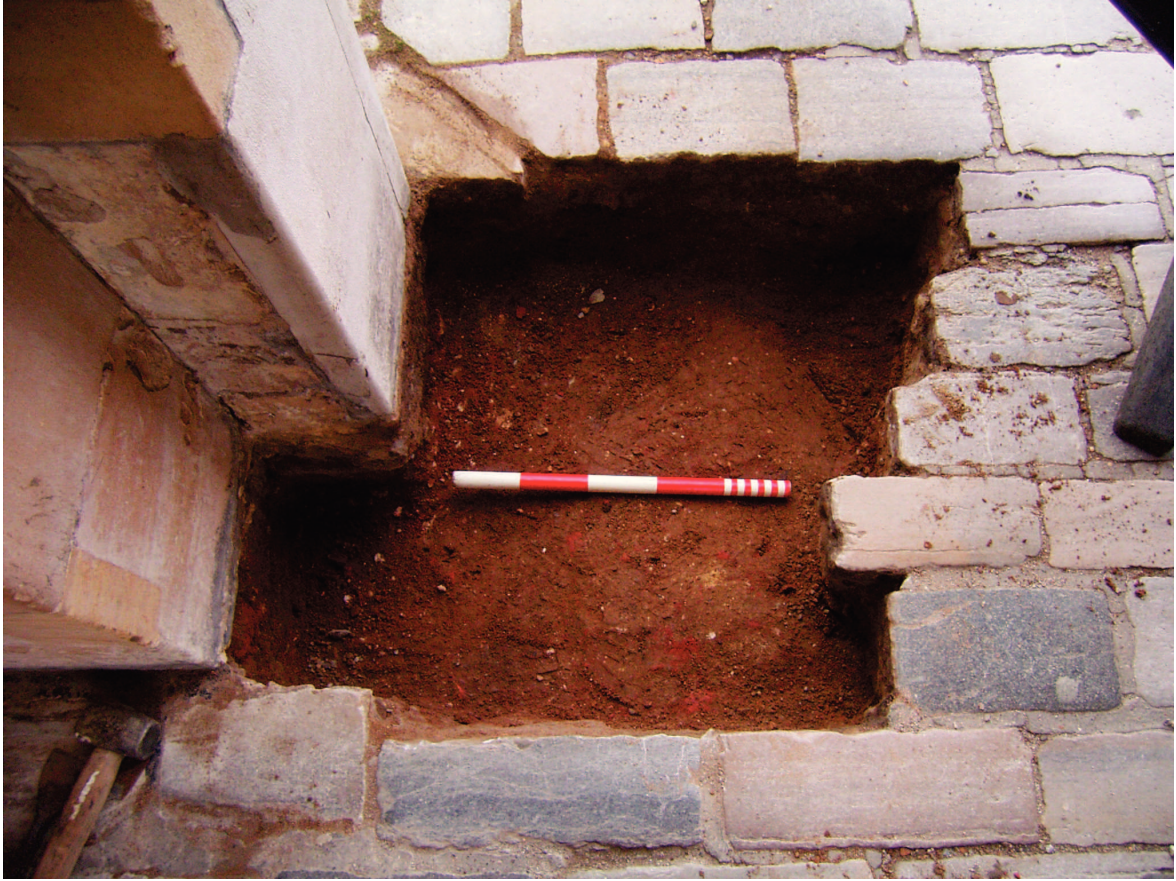
Plate 9: The southwest jamb following removal of material

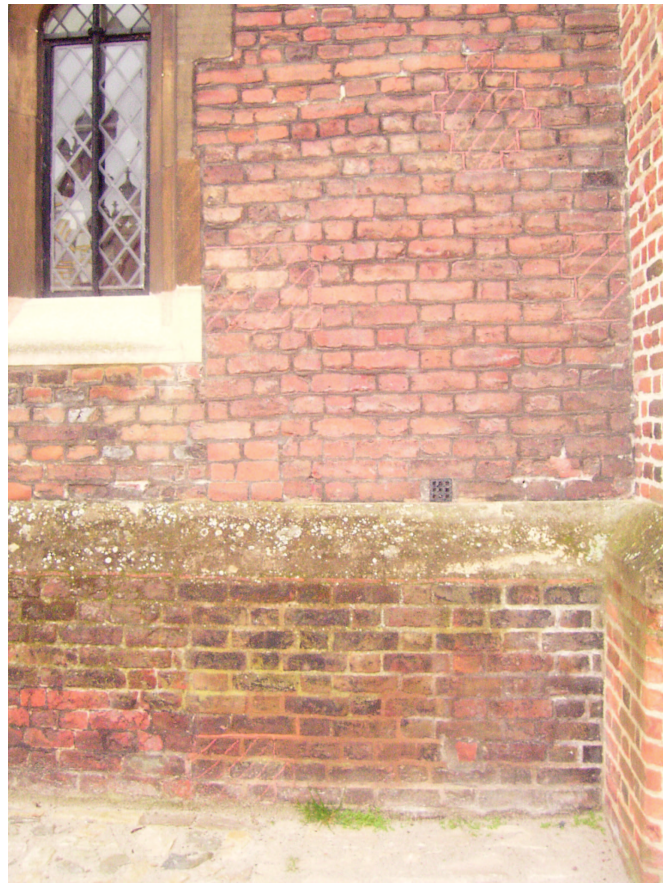
Plate 10: The brickwork covering the blocked doorway prior to removal

- 4.2.1 The archaeological recording was in the form of a watching brief during the removal of the face brickwork (Plate 10). The surrounding Tudor brick is Type A

- (Early Wolsey building phase), brown/orange coloured and laid in an English Bond with a cream coloured lime mortar used for bedding. The infill brickwork is laid in a varying Flemish bond with obvious areas of further infill and patch repair. The elevation has been repointed with black ash pointing, probably during the 19th or early 20th century.

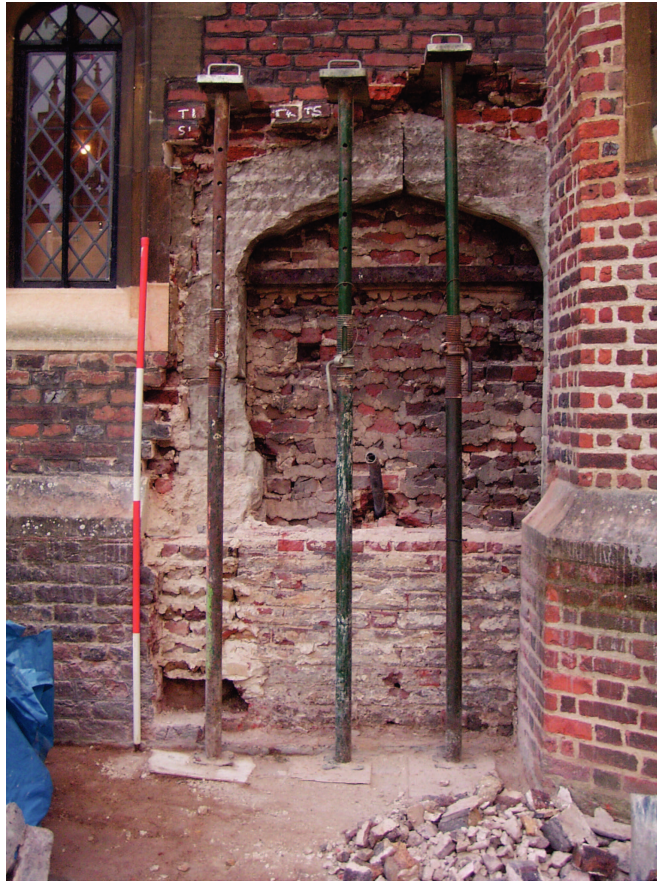
Plate 11: Following removal of facing and topmost infill brickwork

- 4.2.2 The brickwork over the stone arch and jamb was of facing brick with a rubble/half brick layer behind. The removed brickwork covering the area within the stonework had been identified on the Hampton Court brick typology as Type I Wren stock bricks which have a distinct plum colour. However these bricks have a colour more suggestive of Type H, which date to the same period as Type I - the late 17th/early 18th century. The brickwork covering the area in front of the stone doorframe is a mix of Type A Wolsey bricks and late 17<sup>th</sup>/early 18<sup>th</sup> brick. There are occasional single and small patches of 19th century bricks, which are most comparable with Type T, distinctive through the deep red colour. The mortar included chips of Reigate stone from the reduced face of the stonework behind indicating the 19<sup>th</sup> century refacing was completed quickly and in one phase.

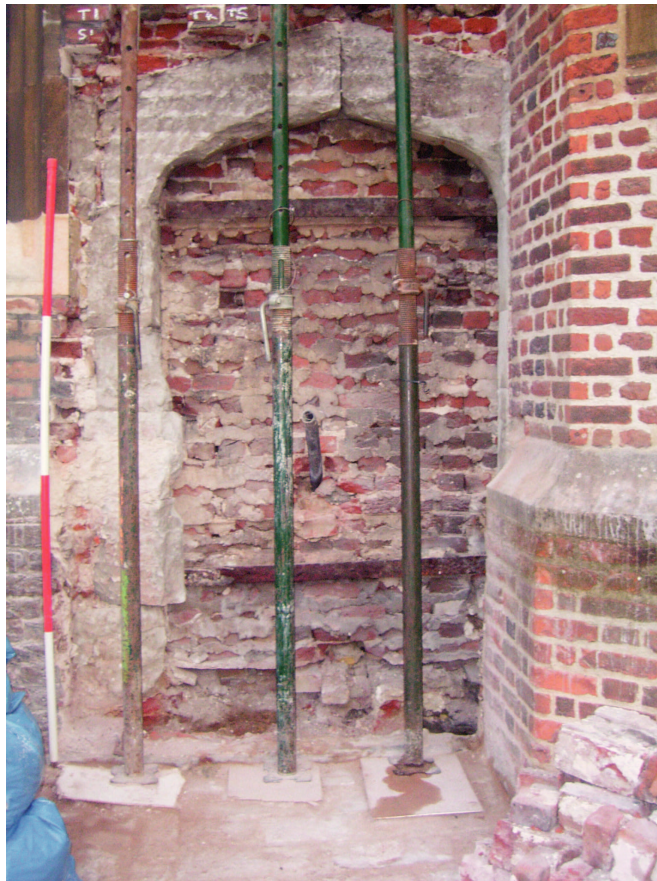
Plate 12: Following removal of all brick infill

- 4.2.4 Following the initial investigation the face brickwork was fully removed to reveal the doorway which had evidently been blocked from behind the door initially (Plate 12). The brickwork used in this rear infill was a mix of 16th, 17th and 18th century bricks indicating that the doorway had been used for much longer than initially thought. Two bricks within the fill were thought to date to the pre Wolsey building phase of the palace, both were orange/brown in colour and cut to shape with an angled corner section. Only one brick was whole and this measured 242 x 127 x 65mm, the brick fragment had a header width of 127mm. The large size of these bricks is comparable with the earliest identified brick on the Brick Typology, Type A (Pre Wolsey and Wolsey). The general appearance and the close location of some pre Wolsey structures suggest that these bricks predate the construction of this range.

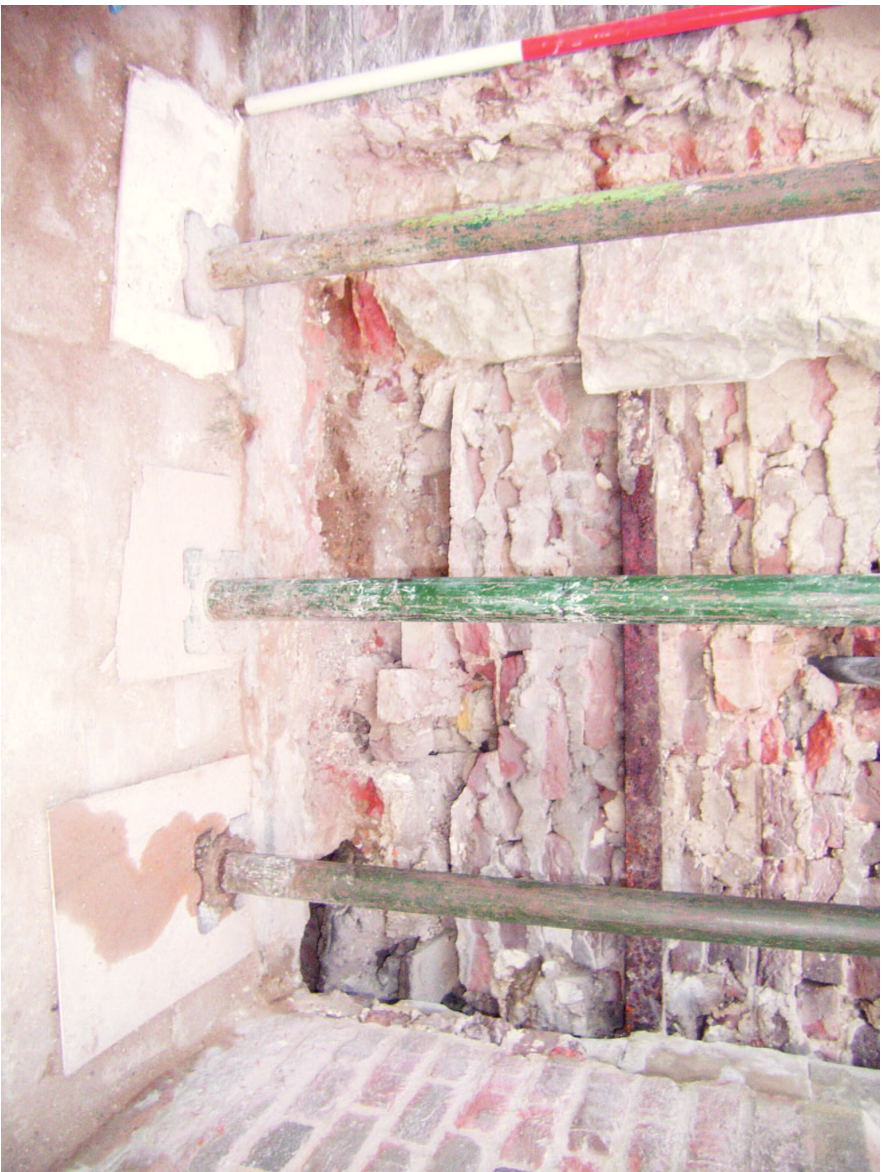
Plate 13: Detail of threshold

- 4.2.11 The internal brick blocking stopped 210mm above current ground level (Plate 13) and there were several tiles, including fragments of three Tudor 'black and white' Flemish style tiles. The presence of these tiles does not clearly suggest a 16th century floor level at this point, in fact it is likely to have been below the current ground level as evidenced by internal floor levels within the shop. It does however indicate the floor level at the time of blocking in, with the Tudor floor tile used as slip. This method was also used during late 17<sup>th</sup>/early 18<sup>th</sup> century works within the Royal Pew of the Chapel Royal at Hampton Court (OA 2009a). The primary threshold of the door was unclear with much alteration and debris and an opening beside the southwest jamb going into the vault below.

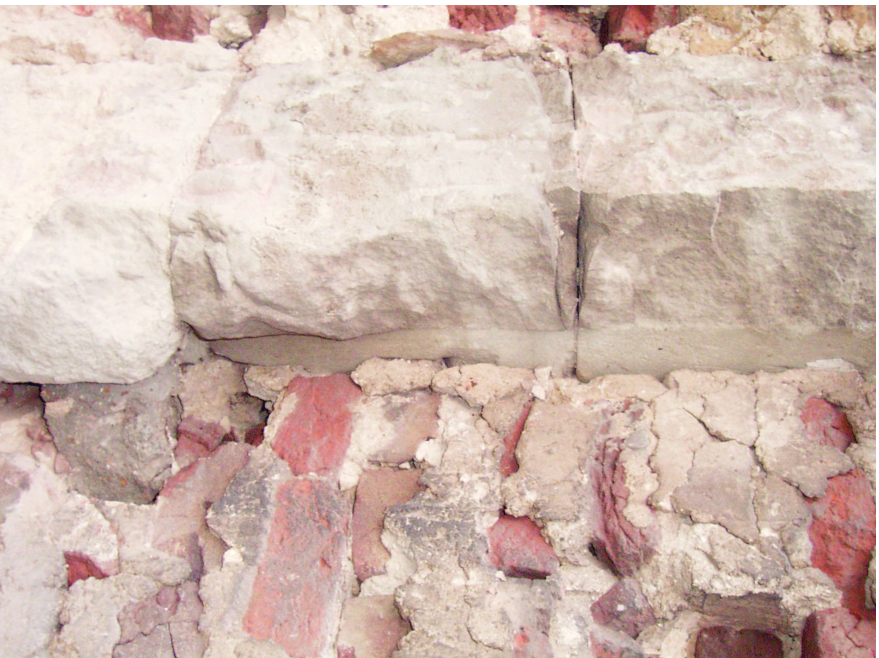
Plate 14: Detail of reduced stonework north-west jamb

- 4.2.12 The south western jamb is relatively intact, as the visible external face is protected by the adjoining stair turret, however the remaining stonework on the northwest jamb has had the face removed and large areas have visible tool markings (Plate 14). Several large pieces have fractured off, some of which were found within the void left by the disintegrating wood door. There is a large quantity of graffiti on both jambs, further indicating the door was at least accessible for a longer period of time than initially thought. The majority of the graffiti is formed of random incised marks some of which form patterns, the northwest jamb has the name 'THOMAS' inscribed and below this a depiction of a fish. The graffiti seems of the same type as seen in similar locations within the palace.

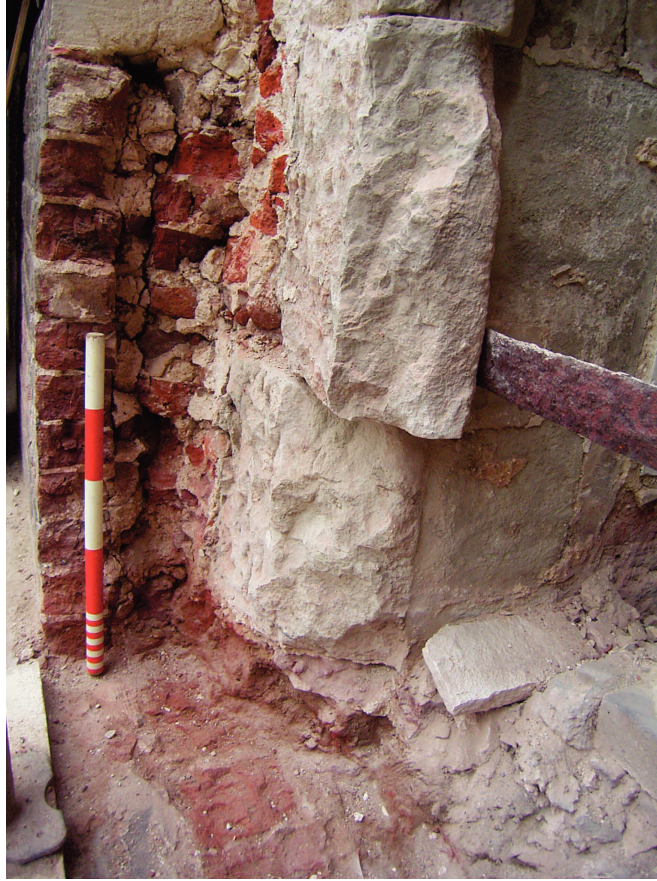
Plate 15: Detail of adjacent plinth northwest jamb

- 4.2.3 The plinth is a later addition built using Type Q bricks measuring 224 x 106 x 66mm, laid in Flemish bond and added to the doorway in the late 19<sup>th</sup> century. Behind this plinth was the primary infill brickwork, also laid in Flemish bond with bricks measuring 219 x 104 x 58mm (Plate 11). The bricks were a reddish rose colour and have a creamy coloured mortar and probably Type H or I dating to the late 17<sup>th</sup>/early 18<sup>th</sup> century. This brickwork ended in a straight joint beside the north west jamb. Below the north west jamb the brick infill was randomly laid with large amounts of mortar. The bricks were a mix of 19<sup>th</sup> century and 18<sup>th</sup> century bricks and brick fragments, this was probably added as part of the raking back works on the stone facing in the mid to late 19<sup>th</sup> century.

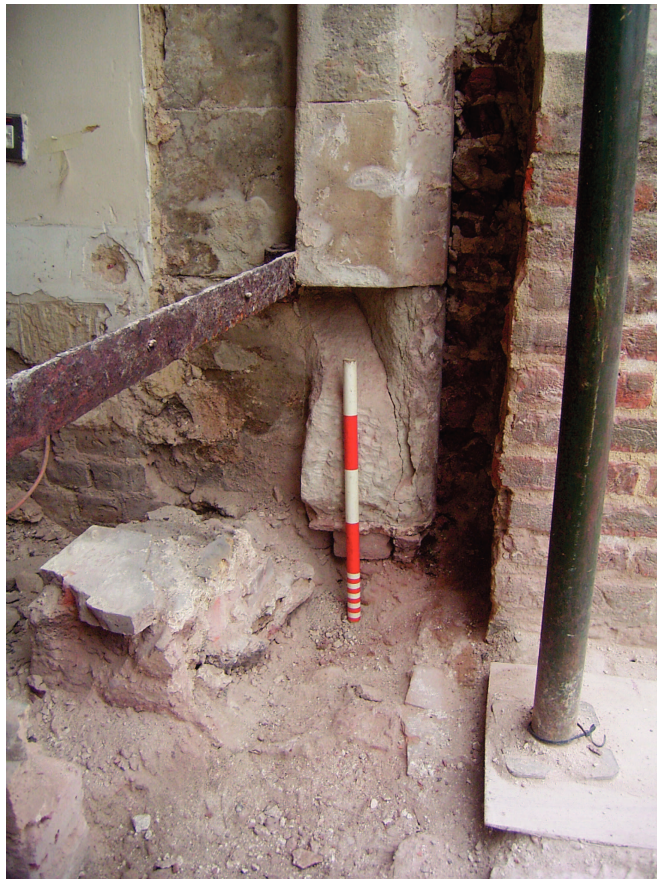
Plate 16: Detail of southwest jamb showing moulding and fractured stone

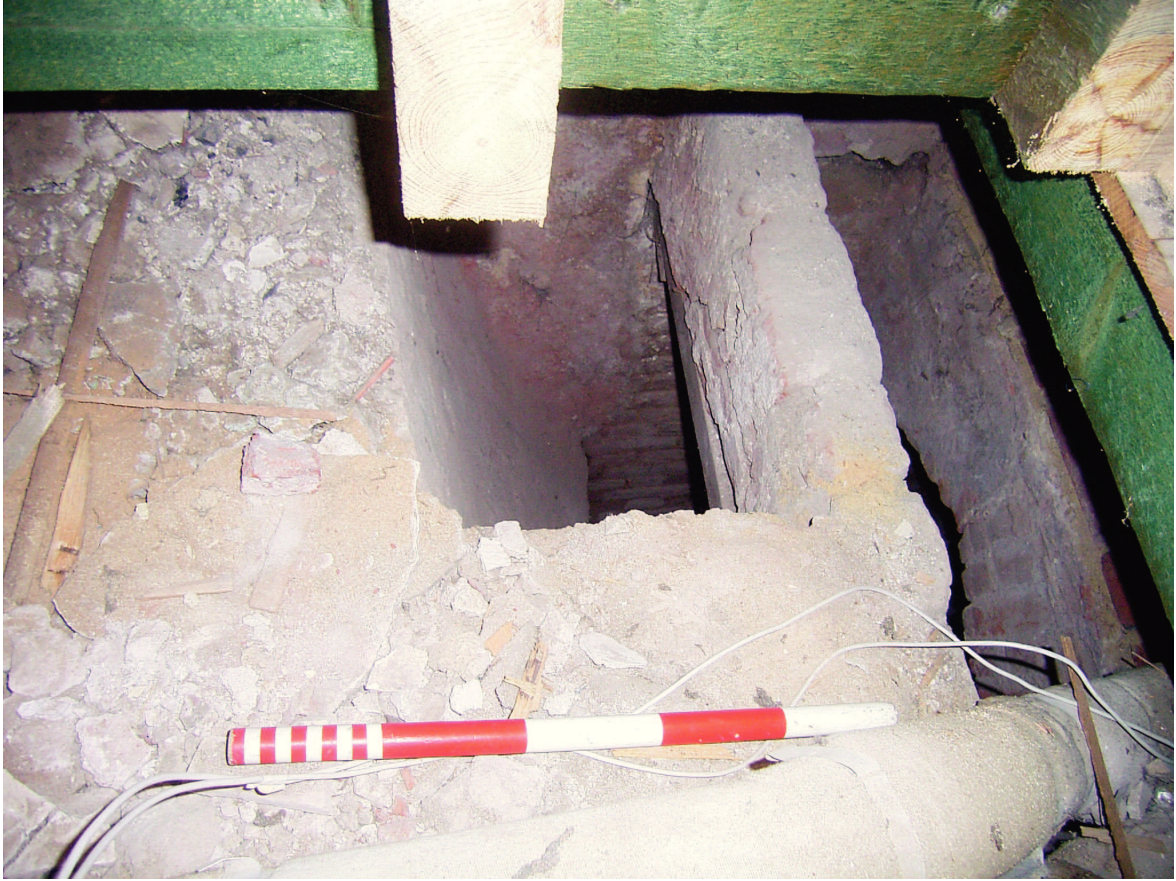
Plate 17: View of pre Wolsey vaulted area beneath floor within the shop

- 4.2.13 Beside the doorway within the shop the floor is formed of a raised wooden platform (Plate 17). Beneath the timber platform were a series of pipes, for utilities including an electric heater, which had been positioned within the door area. As part of the works the platform was opened up revealing the vaulted chambers underneath. This area was not fully investigated or recorded as it was not within the scope of works, however previous research and an excavation in 1966-7 has identified this area to

be part of the south front of Lord Daubeney's house, constructed prior to Wolseys grand building programme.

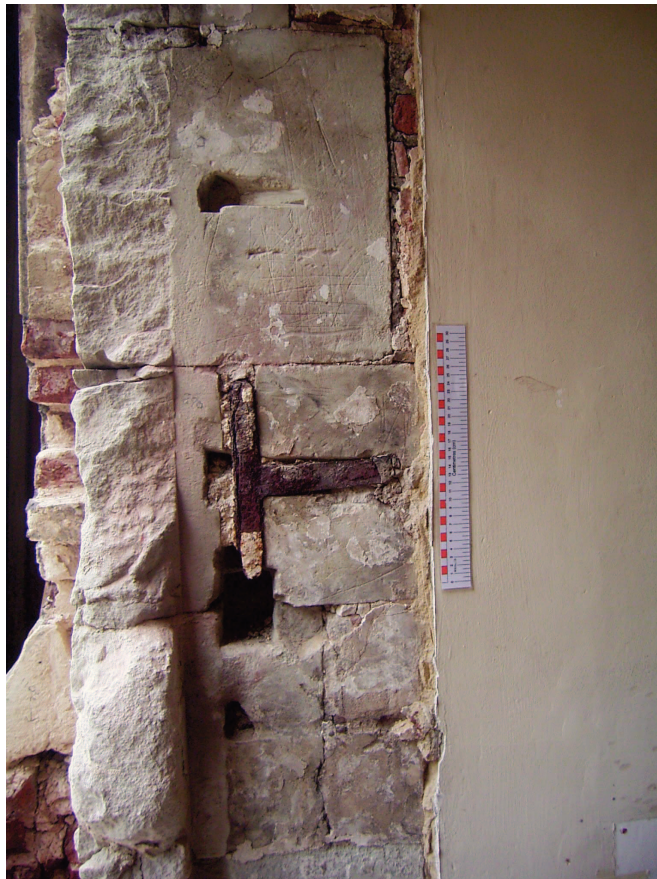
Plate 18: Detail of door fixing on northwest jamb

- 4.2.6 The door within the opening had been initially nailed shut as two nails were found set in the north western jamb beside the metal strap, the opening had then been bricked up from within the building. Two iron straps, complete with nails, were attached to pintles fixed to the stonework of the south west jamb (Plate 20), however no further furniture from the door was found within the loose debris suggesting the lock and handle on the door had been removed prior to blocking in. The inner face of the northwest jamb has a rectangular rebate, which was possibly used as part of the blocking with an inserted section of timber (Plate 18). Above this rebate is a T shaped iron fitting which probably was part of the latching system, this partly covers a further section of the rebate below which has been infilled with a lime plaster/mortar. The upper section of the jamb has a small opening with a sloped edge possibly for a metal bar. The southwestern jamb has a rectangular rebate matching that of the northwest jamb (Plate 19).

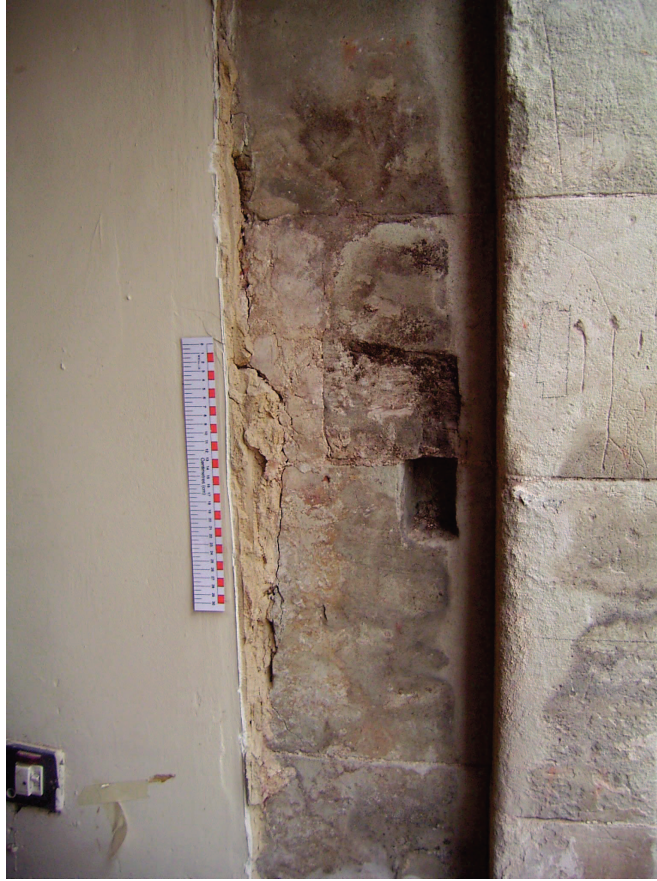
Plate 19: Detail of door fixing slot on southwest jamb

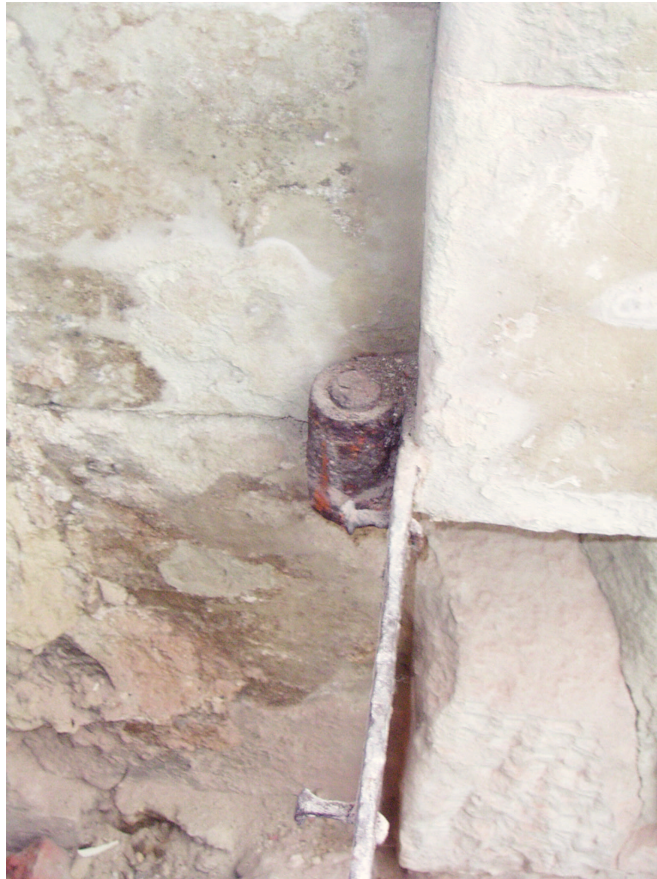
Plate 20: Detail of door lower pintle on southwest jamb

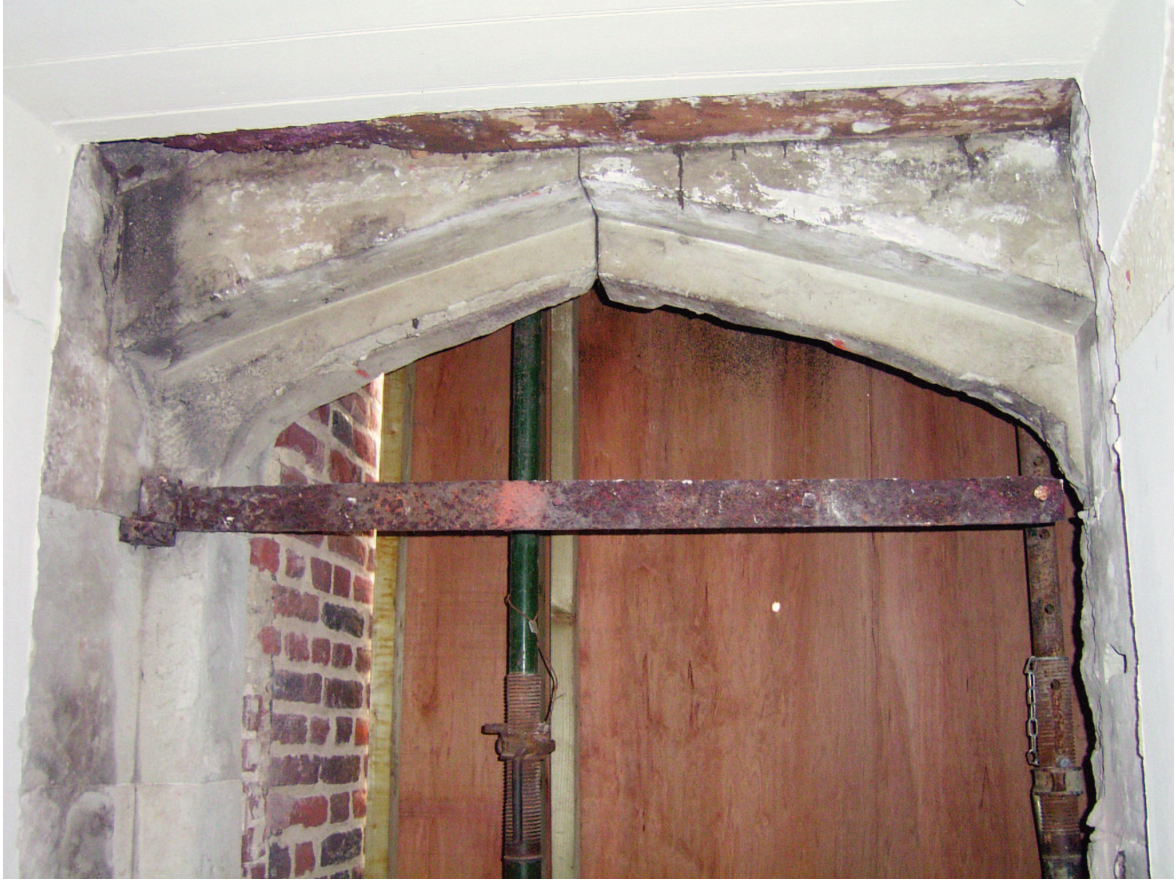
Plate 21: Detail of upper stonework from within shop

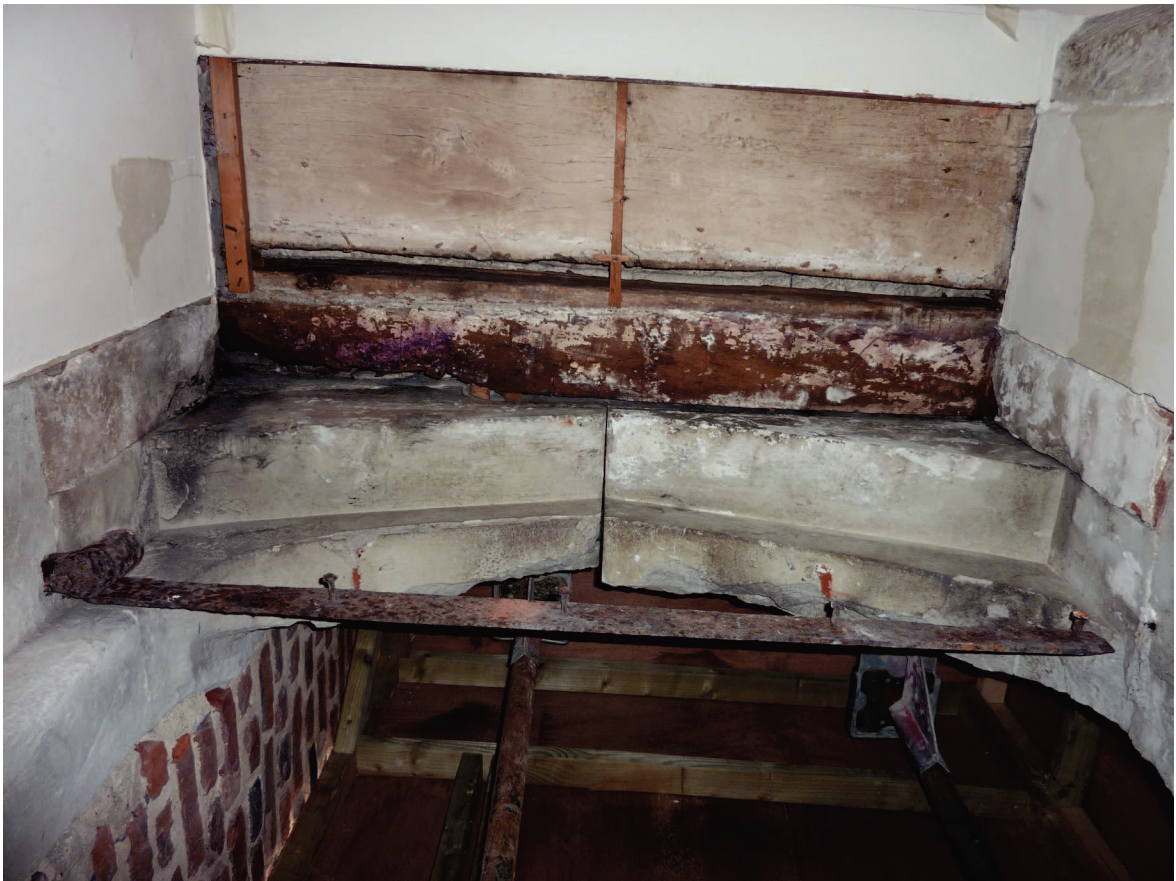
Plate 22: Detail of timber lintel replaced during works

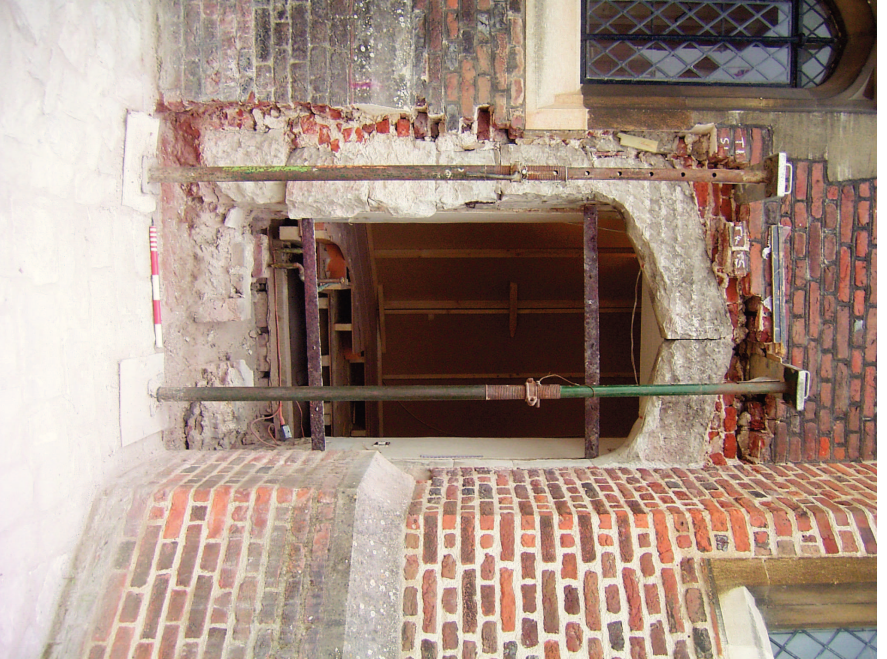
Plate 23: The doorway following removal of material
