HISTORIC ROYAL PALACES

HAMPTON COURT PALACE

GREAT HALL ROOF

BUILDING RECORDING AND INVESTIGATION

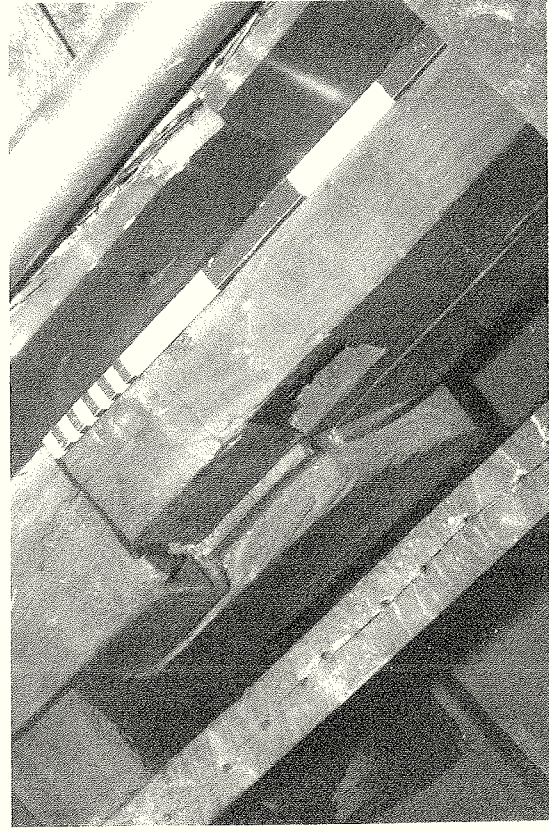
Figure 14: Detail showing large primary ridge-piece supporting smaller secondary ridge-piece (added when the louvre was removed)

As discussed above Phase 2 is the secondary ridge-piece, which was scarfed onto the larger primary ridge-piece to the east of the truss, when the louvre opening was filled.

- 5.1.2 The clearest piece of evidence was the secondary ridge-piece inserted within Bay 3 and scarfed onto the primary ridge-piece. That this section of ridge-piece was secondary was apparent from its smaller section, different profile and different rafter mortices from those in the primary ridge-piece. The cantilevered primary ridge-piece, supported in a slot rather than tenoned into the head of the king-post also provides evidence of the former louvre as do the contrast in mortices on either side of Truss 4. The mortices to the east of the truss suggest horizontally-set purlins which would have supported the louvre in contrast to the conventional angled purlins found on other trusses.

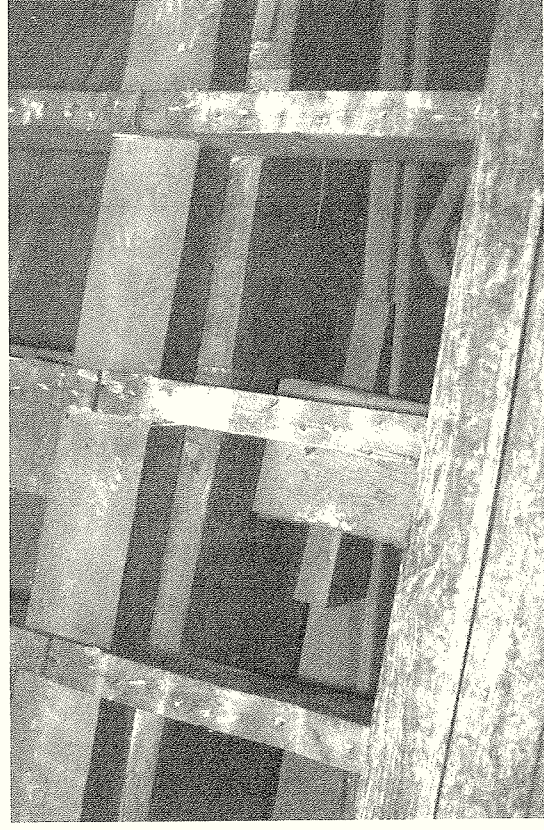
Figure 15: Detail of purlin adjoining west face of Truss 4

The main members of Phase 3 are the single purlin to each pitch, either side of Truss 4, centrally located between the outer purlin (wall-plate) and the king-post. Each purlin is tenoned into the principal rafter at the same angle as the rafter and measures c 19 (w) cm x 14 (h) cm in section. They strongly appear to be machine cut.
