# Great Hall Court Hampton Court Palace

**Archaeological  
Test Pit and Historic  
Building Recording**

March 2010

**Client: Historic Royal Palaces**

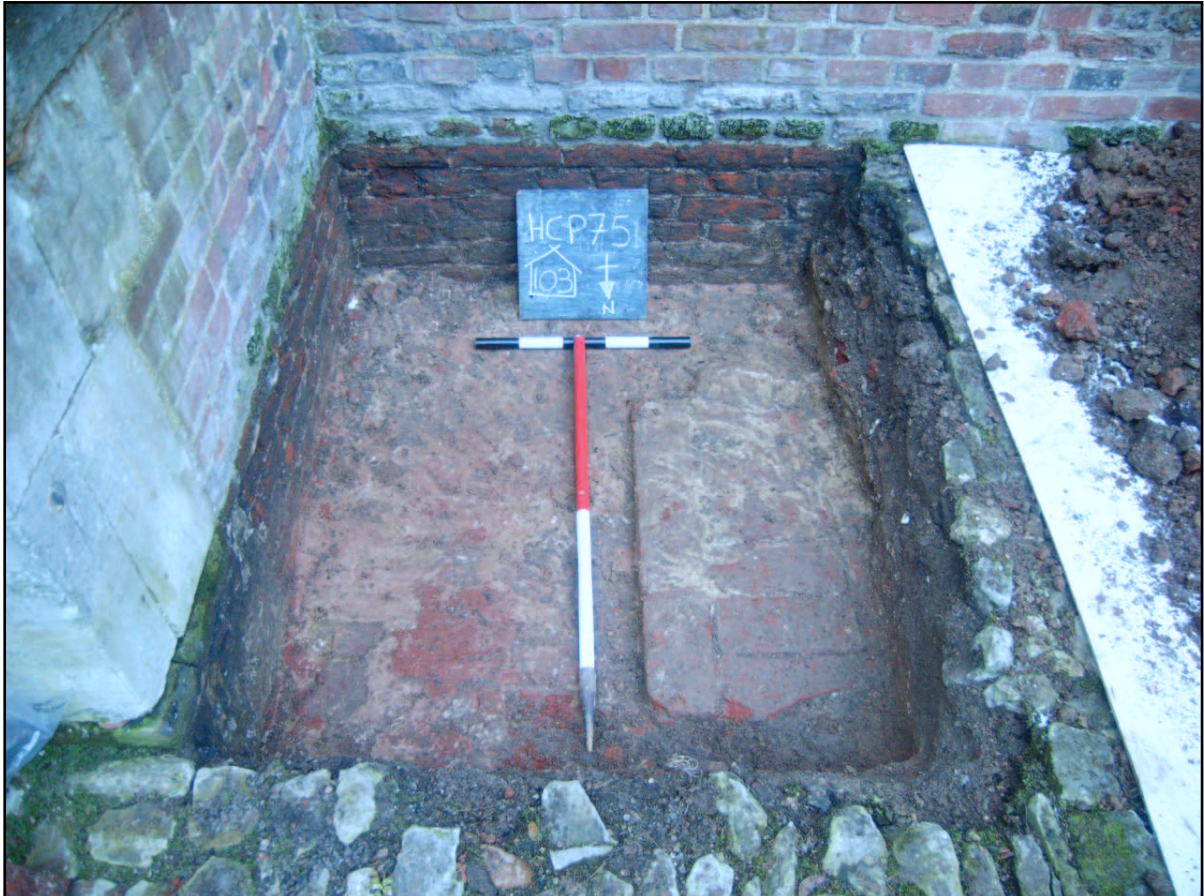
- 3.1.2 Abutting wall 103 on its east side and also appearing to butt the wall's south end, was another brick-built structure (108) (Fig. 3, Plate 1) covering the remainder of the trench. This also appeared to butt the north wall of the Great Hall (107) and to obscure double-struck pointing in that wall, so far as this could be observed without removal of structure 108. The bricks of 108, again of Type A, were packed very tightly against the Great Hall wall, and did not seem to be laid in any particular pattern, although this may have been obscured by the mortar which was not removed. The mortar was also similar to that described above for wall 103.

Plate 1: Trench shot showing *103* and *108*

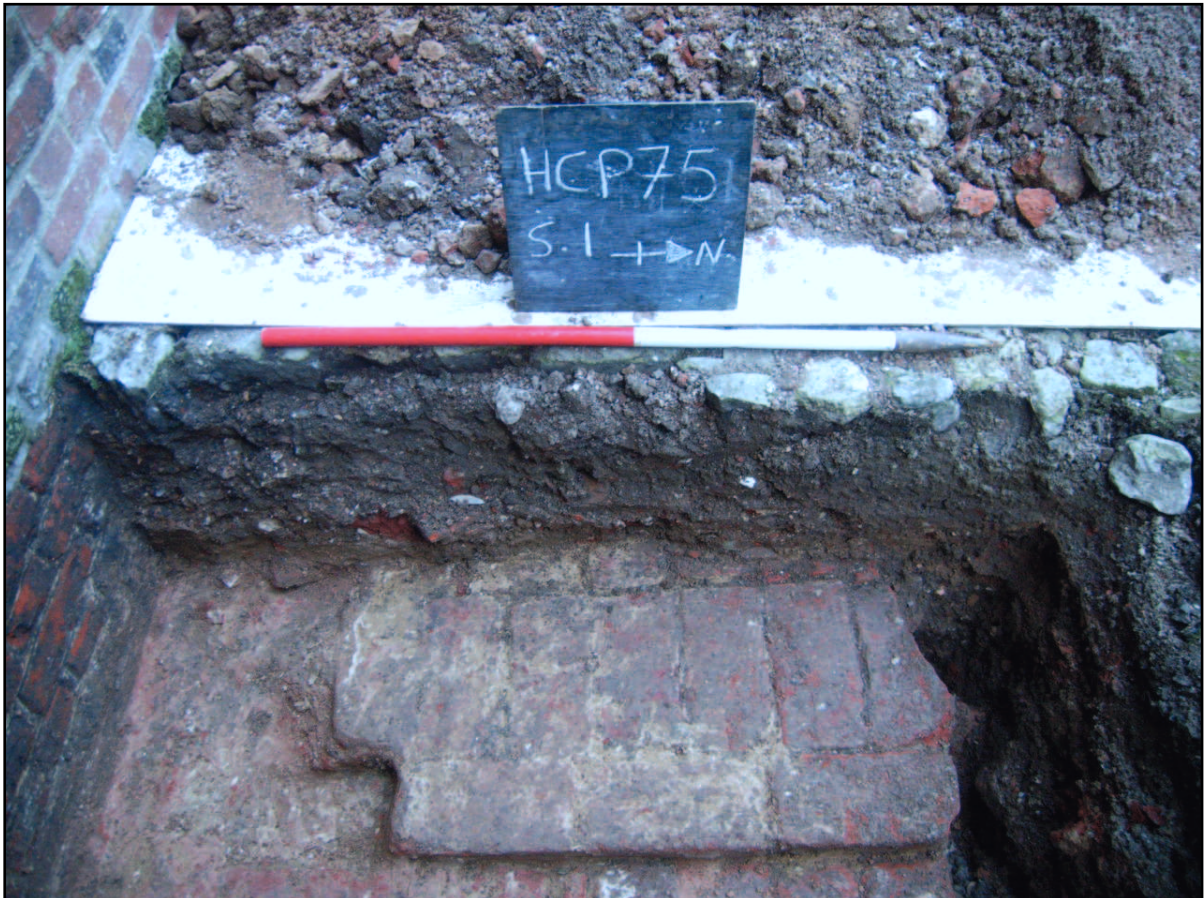
- 3.1.1 The trench consisted of 10 deposits including the current cobbled surface. The majority of these were levelling and make-up deposits overlying two brick structures, 103 and 108 (Fig. 3). Wall 103 was brick-built, measuring 0.8m north-south and 0.4m east-west within the trench, but continuing north and west beyond the limit of excavation. At its south end the wall appeared to end, with the rough nature of the end suggesting a cut or break (Plate 1). It was preserved to a height of at least 0.18m high where visible in the side of the later cut 109. The brick was sampled and matches reasonably well with Hampton Court Brick Typology Type A, Pre-Wolsey and Wolsey, as defined by Ford. This was supported by a mortar sample of a rich brown and sandy nature also considered typical of building work of this period, but the average width and length of the bricks is slightly smaller than those given for Type A. The only visible (east) face of the wall was laid as stretchers, while there are at least two rows of bricks laid across the wall, to the west of the face.

Plate 2: Section 1 and *103*
