Anne Boleyn Gatehouse Hampton Court Palace

**Historic Building Recording
and Investigation**

August 2009

Client: Historic Royal Palaces

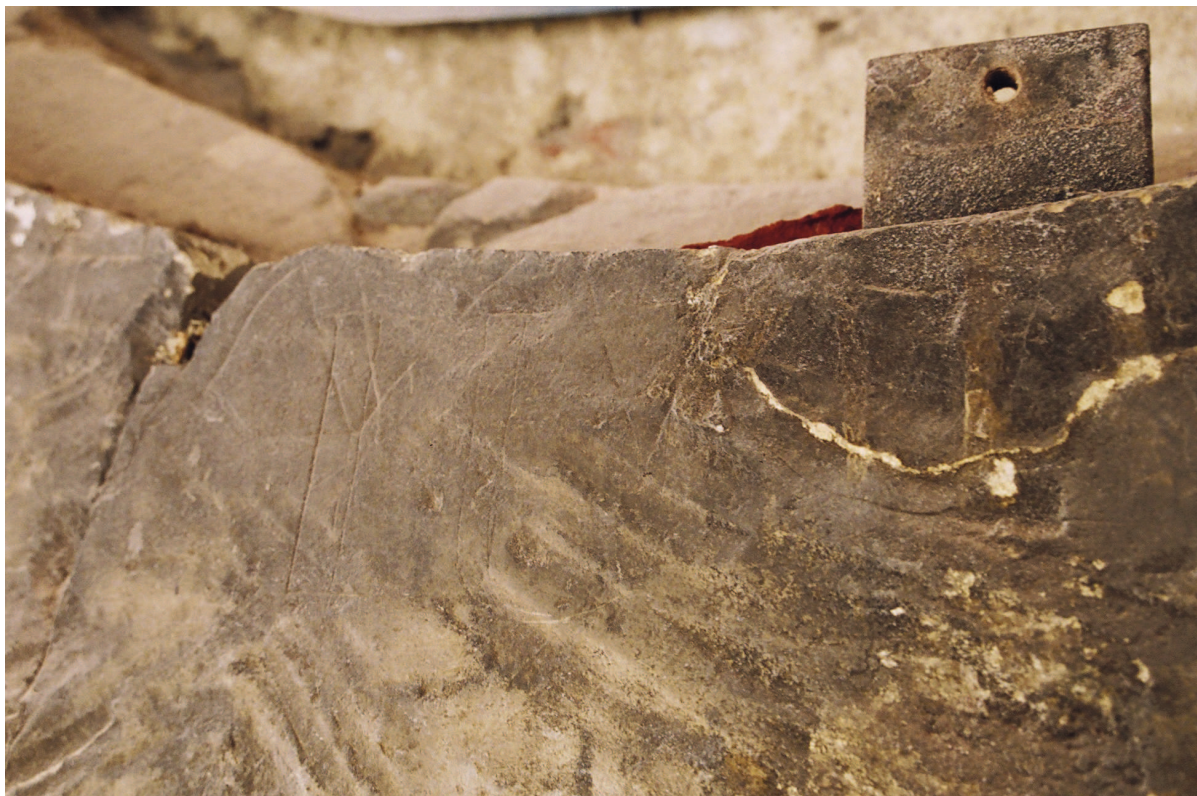
Plate 15: Astronomical clock - Henrician phase stonework hidden beneath dial

the Henrician phase of works. The outer ring has been partially cut by replacement Clipsham limestone inserted during the 1960s restoration works (Plate 15). The two inner rings which would have been hidden beneath the great dial are roughly cut with some chisel marks visible. On this face there are some incised markings which are roughly similar to some painted decorations on the great dial of the clock, in particular the symbol for Scorpio (Plate 16). It is not known why these incised marks are on the stone voussoirs as they would have been hidden by the dial; however it is possible they could be for setting the clock.

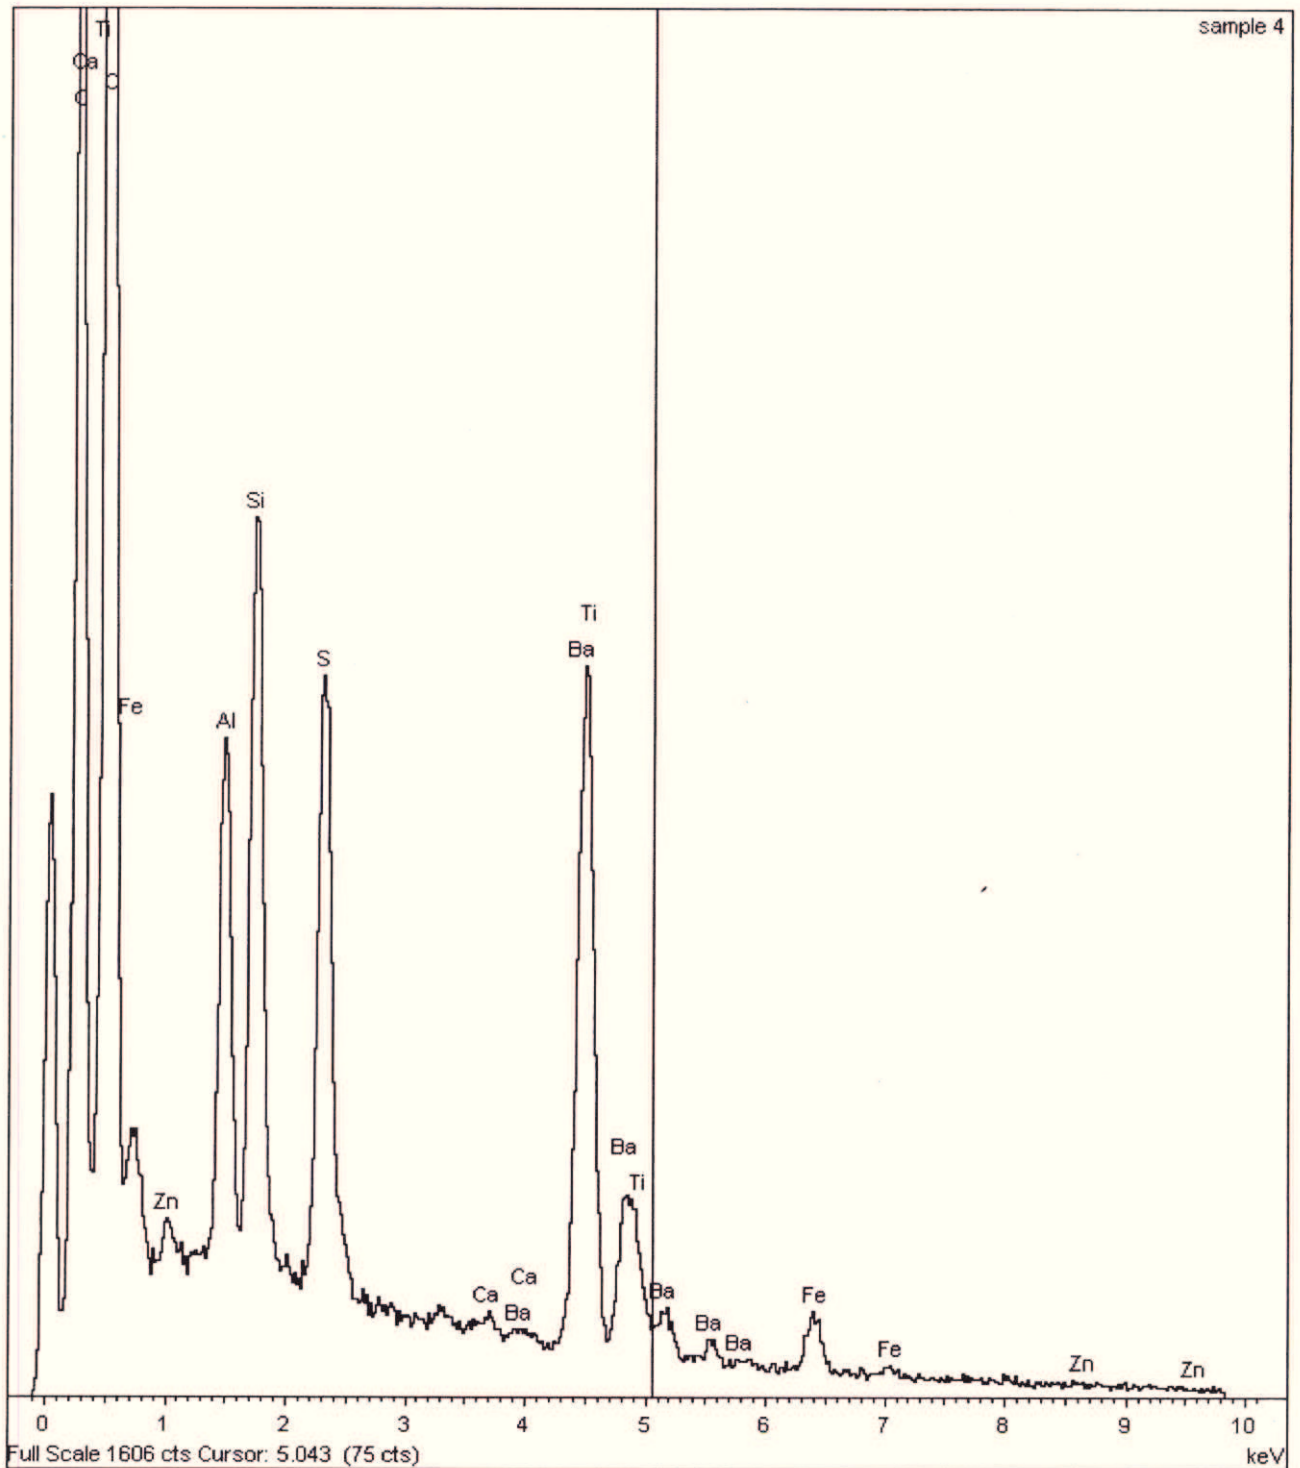
SEM ANALYSIS of the pink surface on the blue

The major feature in the spectrum is for titanium [Ti] from titanium dioxide white.

There is a significant amount of iron [Fe], despite the fact that no iron oxide pigments were present in the paint.

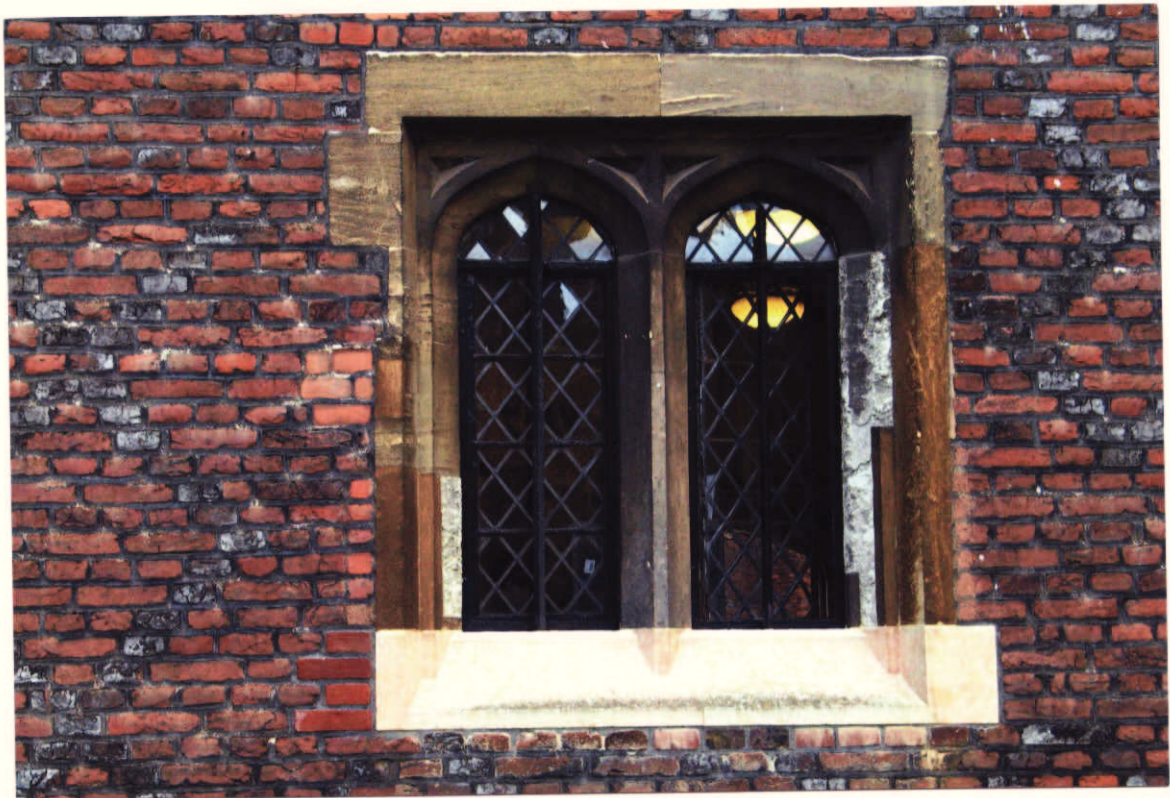
Plate 3. Base Court, ground floor window showing four phases of construction and repair. In order - Reigate stone (grey), Wheatley Limestone (grey-brown), Bath stone (brown), 20th century Bath Stoke Ground Base Bed (sill).

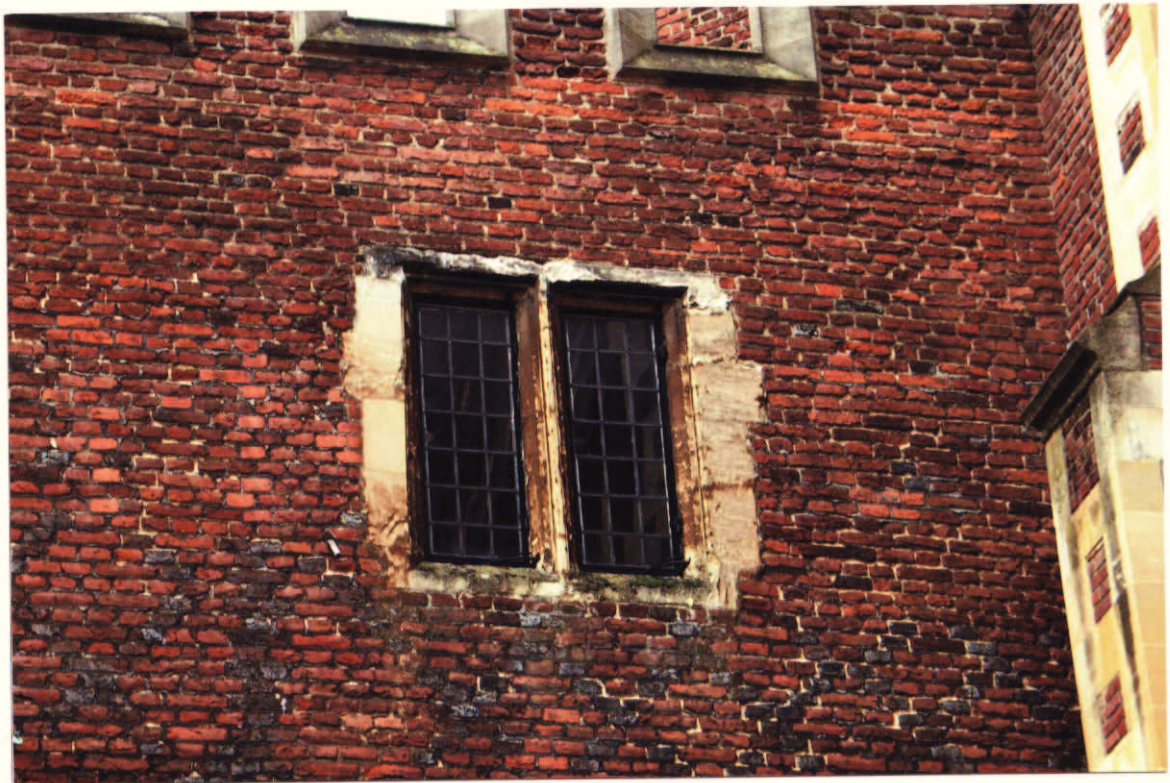
Plate 4. Clock Court, north-west corner 2nd floor window with Beer stone lintel & Bath stone jambs and sill.

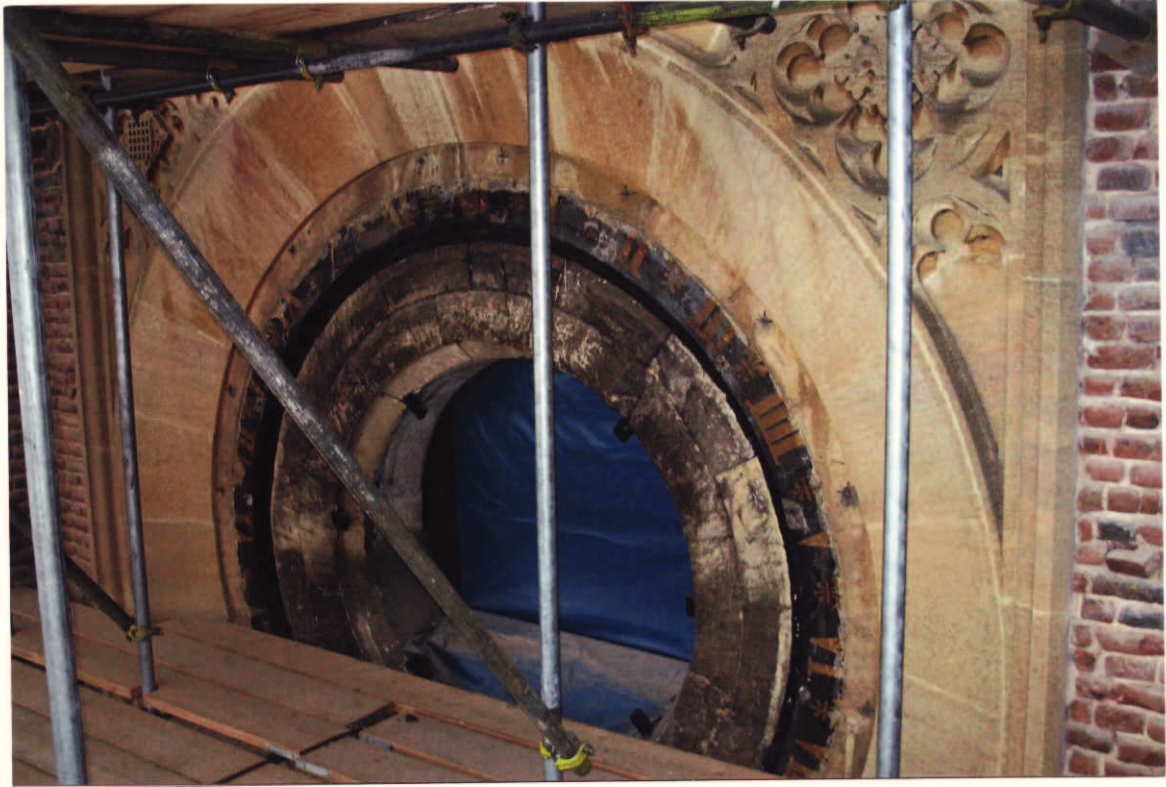
Plate 6. Astronomical Clock. Earlier dial of Caen stone normally hidden behind astronomical dial.

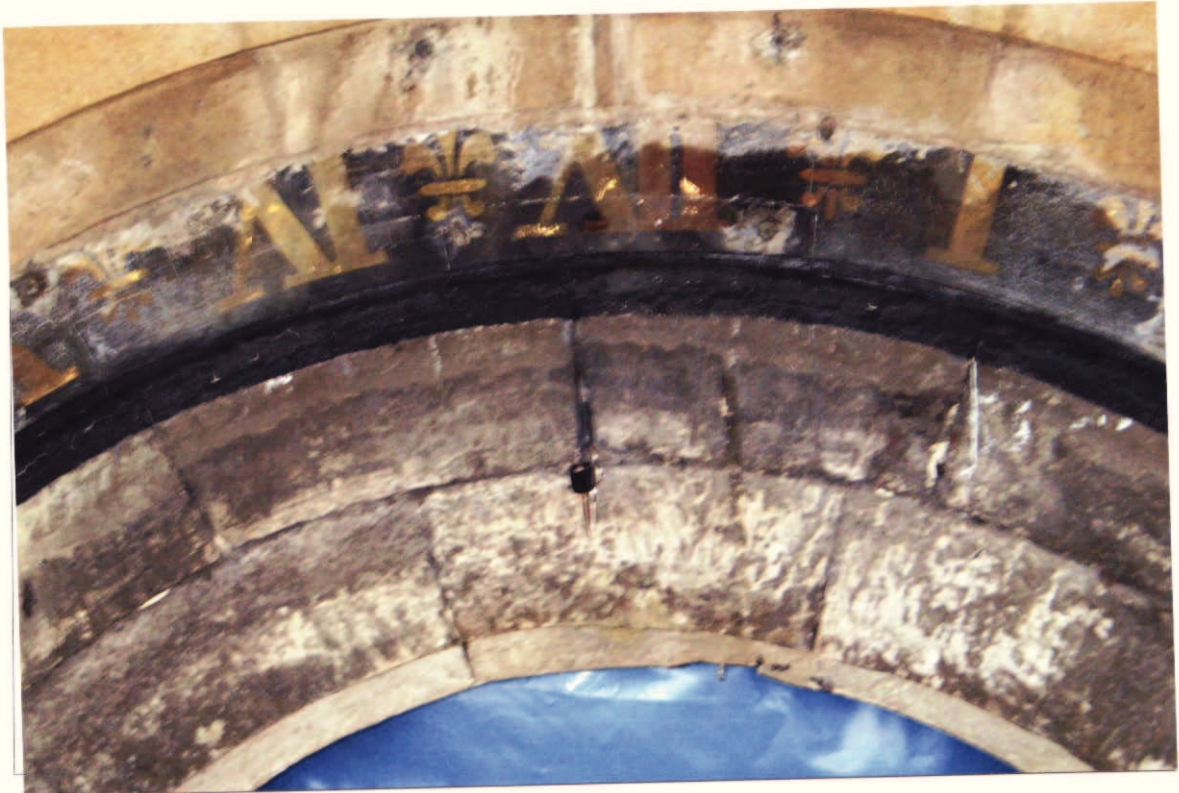
Plate 7. Detail of Plate 6. The yellow outer stone of the surround is a 20th century Clipsham stone restoration.

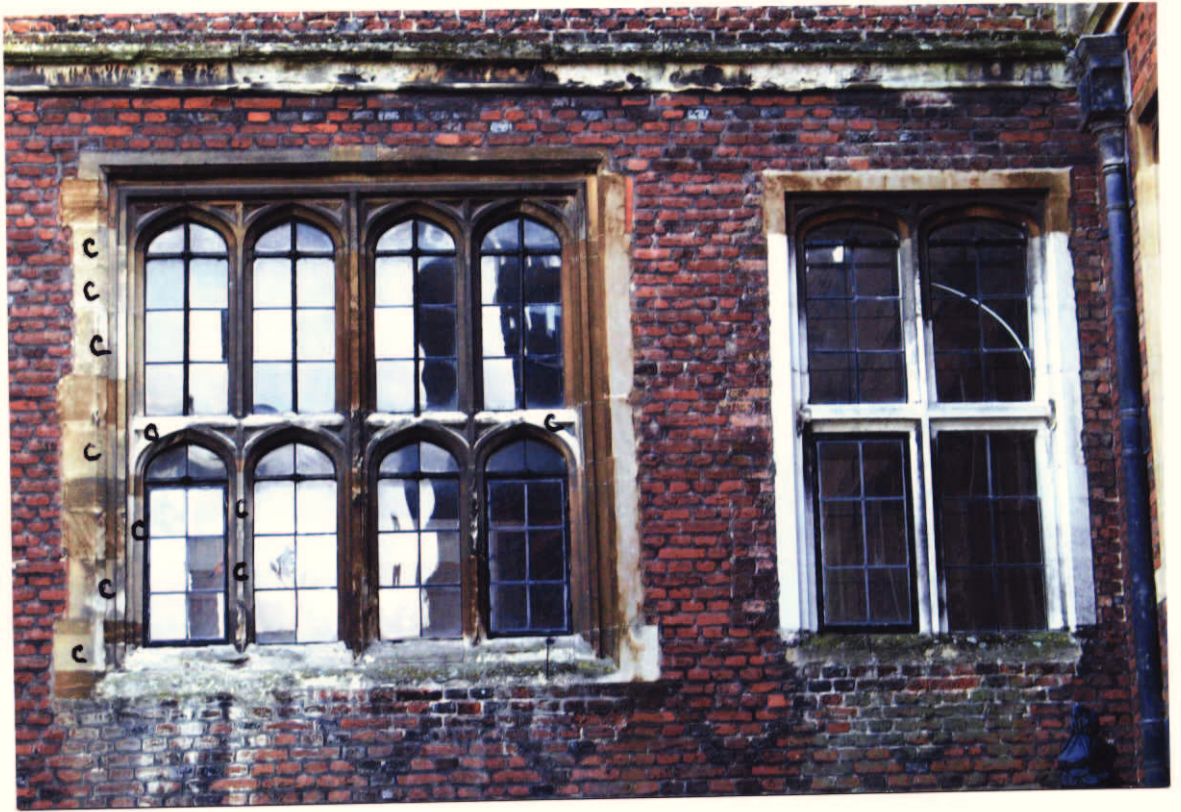
Plate 8. Base Court 1st floor windows at south end of range. Remnants of Caen stone (C) in jambs.

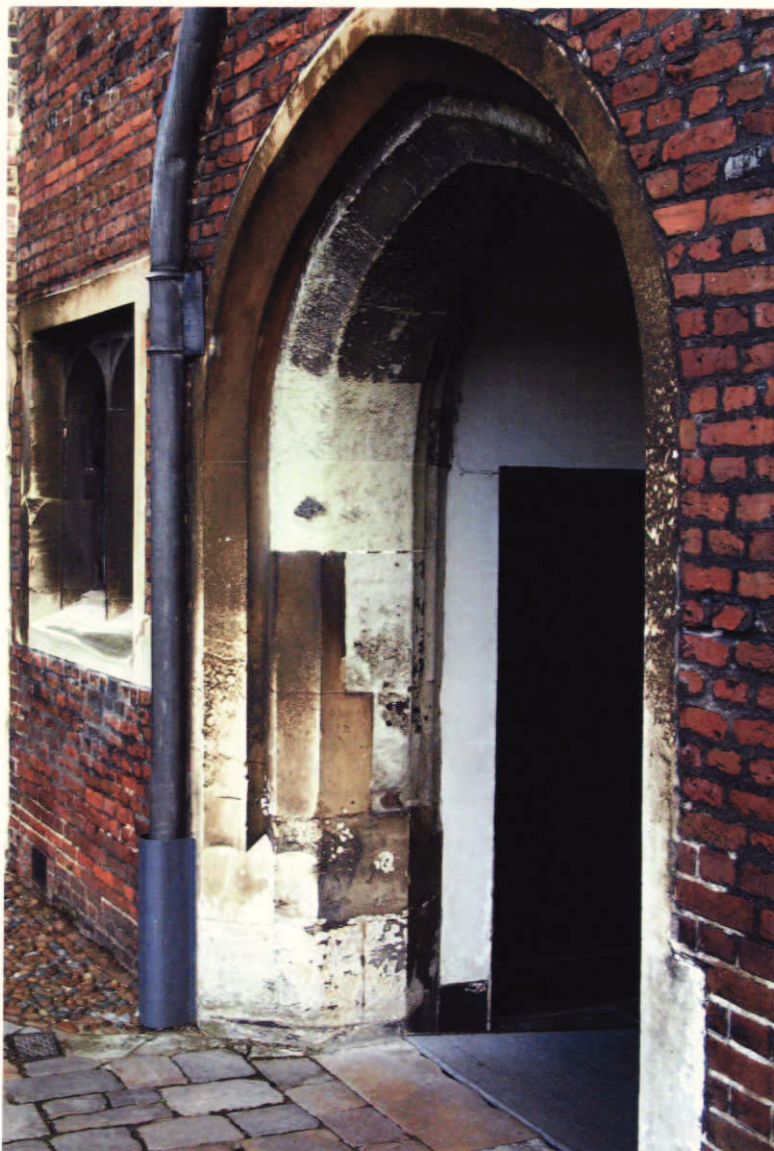
Plate 11. Base Court. Buttery door. Reigate stone survival in inner arch.

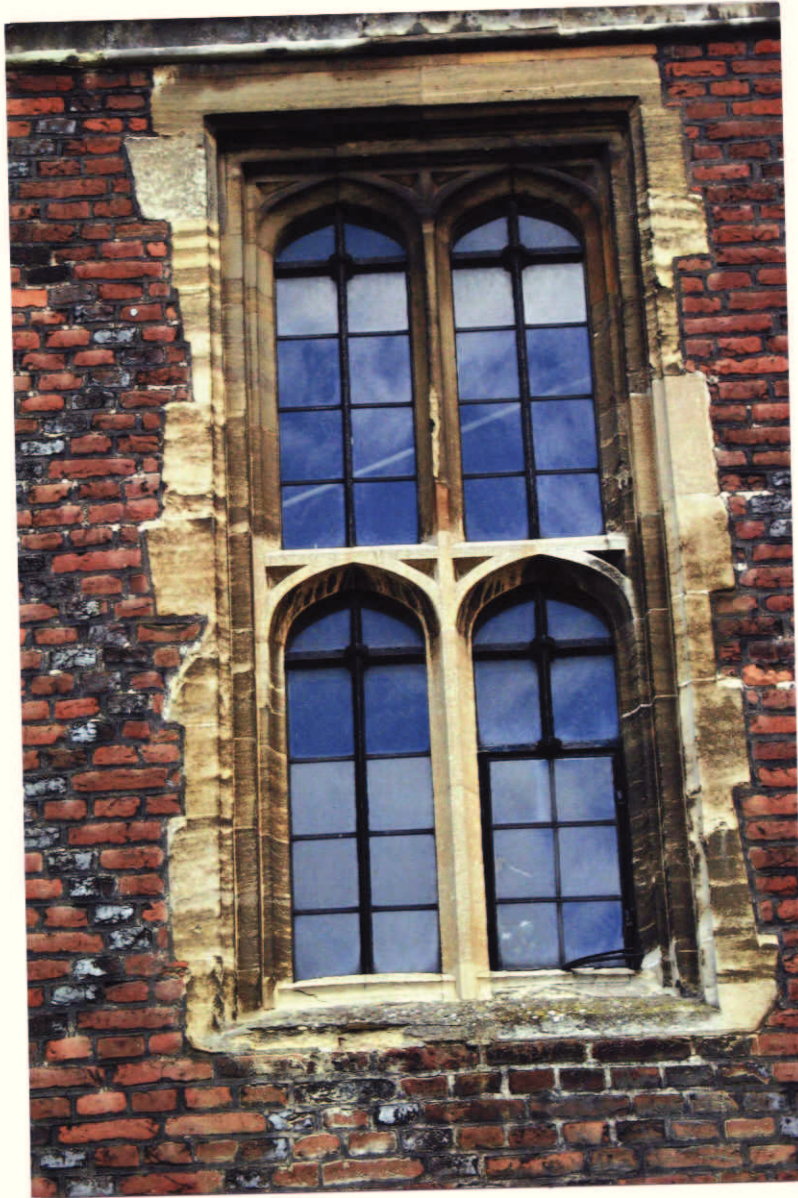
Plate 12. Base Court, south range.
1st floor window of Wheatley
Limestone.

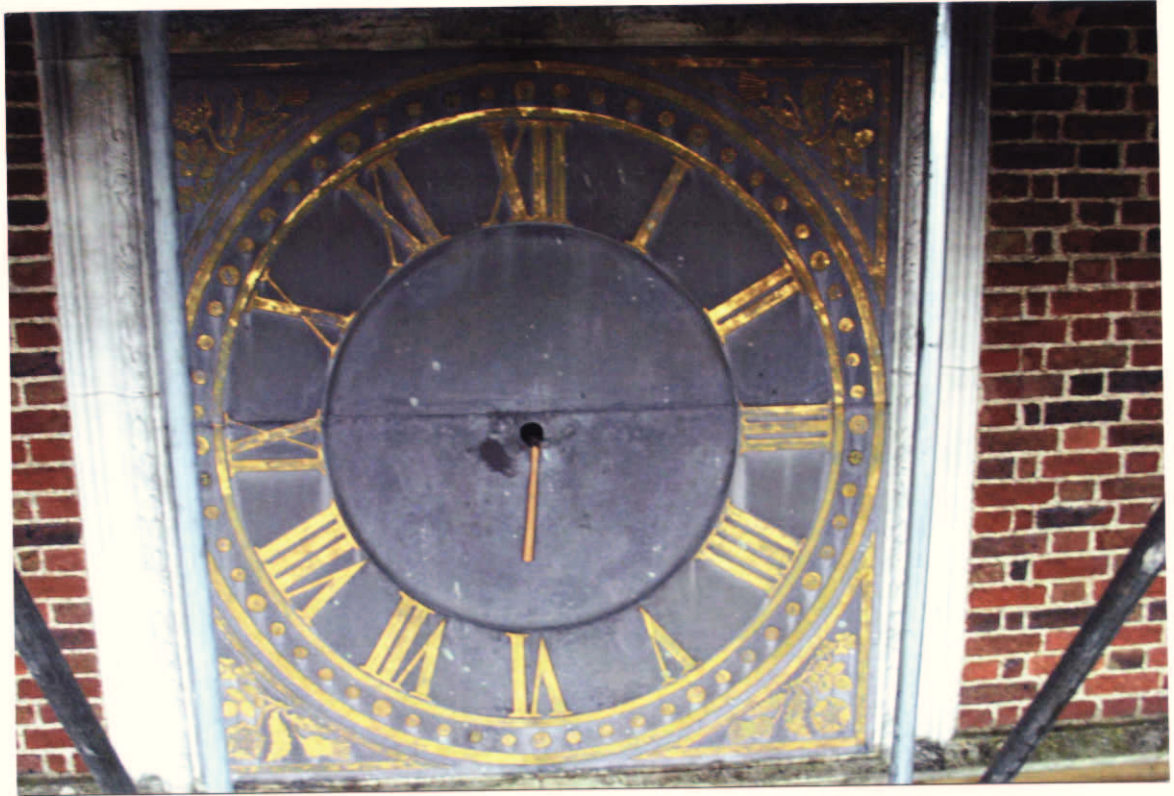
Plate 14. Base Court clock dial. Welsh Cambrian slate.

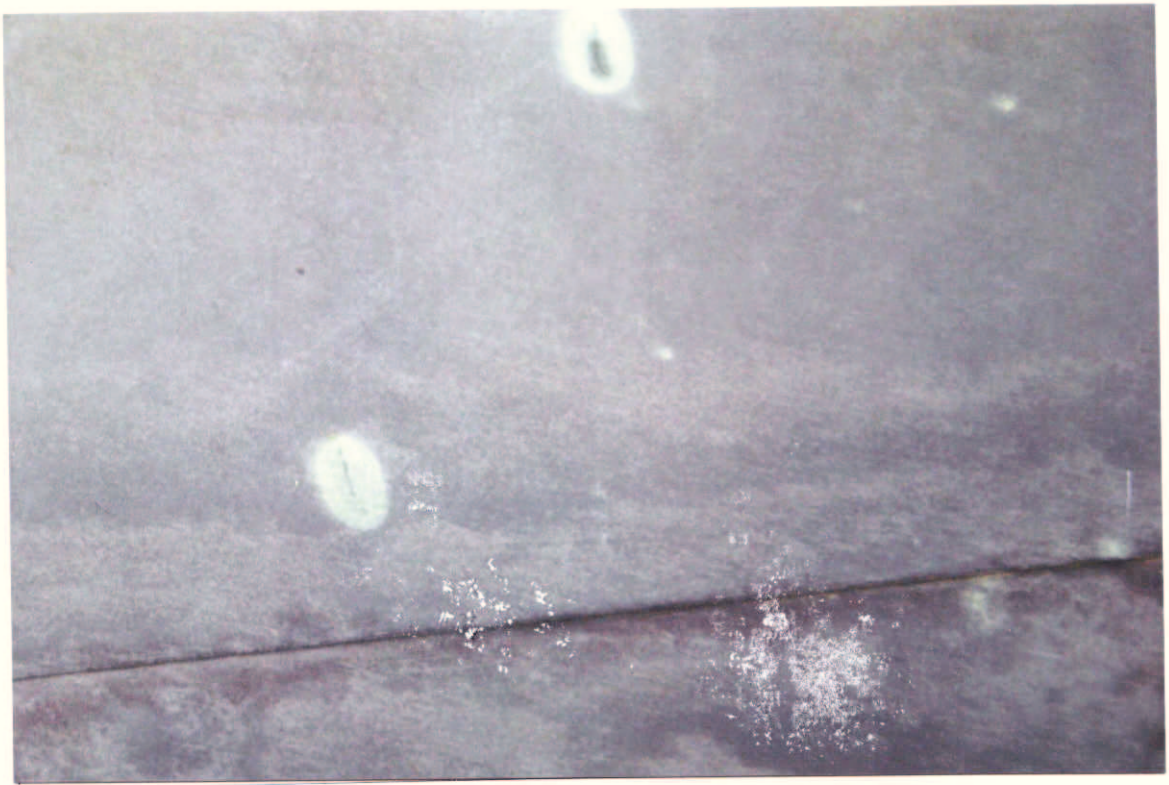
Plate 15. Reduction spots in slate. Detail of Plate 14.
