Hampton Court Palace Vrow Walk Test pits

Archaeological Watching Brief Report

February 2011

Client: Historic Royal Palaces

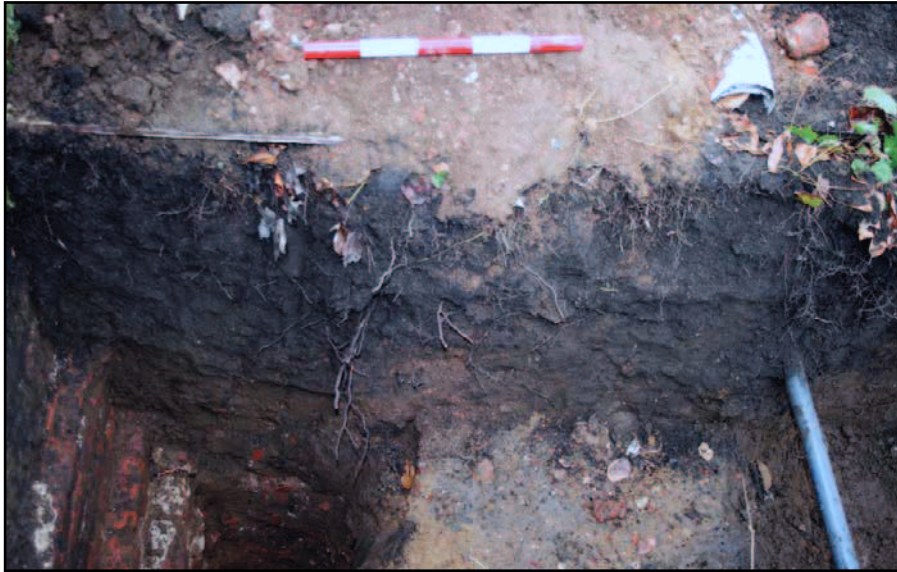
Plate 1: Trench 1

- 3.1.1 This test pit (Fig. 2 and 3, Plate 1) was excavated to the north of the main car parks north wall in what was first the Tiltyard, and subsequently became the Kitchen Gardens and was excavated to identify both archaeological remains that may be associated with the tiltyard or kitchen gardens and also the presence of any service pipes in the vicinity.

- 3.1.4 The remaining 2.35 m length of the test pit was separated from the flower beds by wooden boards and was only excavated to a depth of 0.75 m; it was made up of mid brown/grey silty subsoil (102) with <1% small stone inclusions, overlain by 0.67 m thick silty brown/grey garden soil, (101), which is seen in the entire length of the test pit. Brick and tile fragments were recovered from this deposit. The garden soil in this part of the trench was overlain by a 0.1 m thick turf line which bordered both the flower beds and the path.

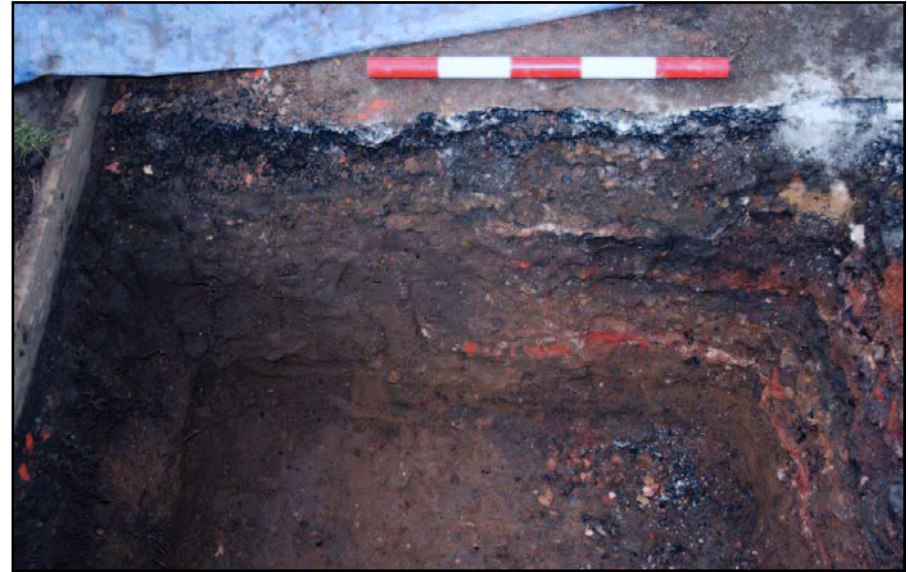
Plate 2: Trench 1a

- 3.1.5 Test Pit 1a (Fig. 2 and 3, Plate 2) was excavated to the immediate north of Test Pit 1 and was excavated into the path way adjacent to the grass. The test pit was 1.25 m x 0.80 m and was excavated to a depth of 0.75 m.

- 3.1.6 The test pit was made up of a 0.4 m wide and 0.53 m thick silty brown/grey garden soil deposit (114), overlain by a compact 0.15 m thick brown rubble levelling deposit (107). This deposit most likely served as a base for the overlying tarmac path surface (106). Deposit (114) was identified at the southern end of Test Pit 1a and was abutted to the north by a series of layers that appear to make up different surface layers. Deposit 113 is the lowest layer and is a compact 0.09 m thick rubble deposit consisting of brick fragments and stone. This deposit most likely formed a solid base for the overlying 0.07 m thick brick rubble layer 112, which may be the remains of an old surface/path. Deposit 112 is overlain by layer 111, a compact brick and stone base for the overlying tarmac path layer (110). Deposit 110 represents an old path surface and is 0.06m thick that was subsequently buried by a later path. Layer 109 is the brick rubble base of a later tarmac path, (108). Path 108 is overlain by deposit 107, seen in the southern part of the test pit which was overlain by current tarmac path surface, (106).

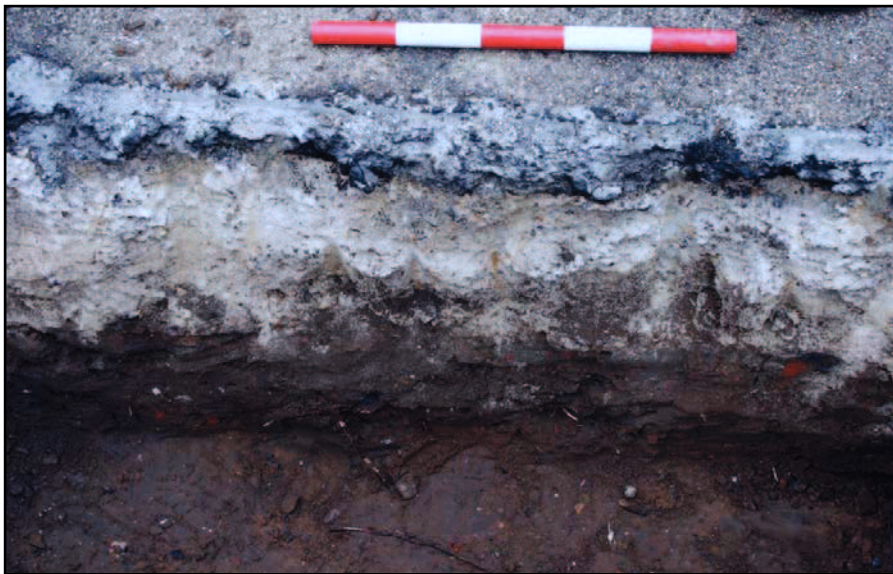
Plate 3: Trench 2, through footpath

- 3.1.11 The central part of the test pit (Plate 3) was excavated through the public foot path that ran down Hampton Court Road and was 3.5 m long and 0.80 m wide. The compact

backfill deposit (209) was overlain with a 0.31 m thick pale yellow concrete layer (208), which would have been laid down to provide a stable base for the overlying tarmac and gravel path (207).

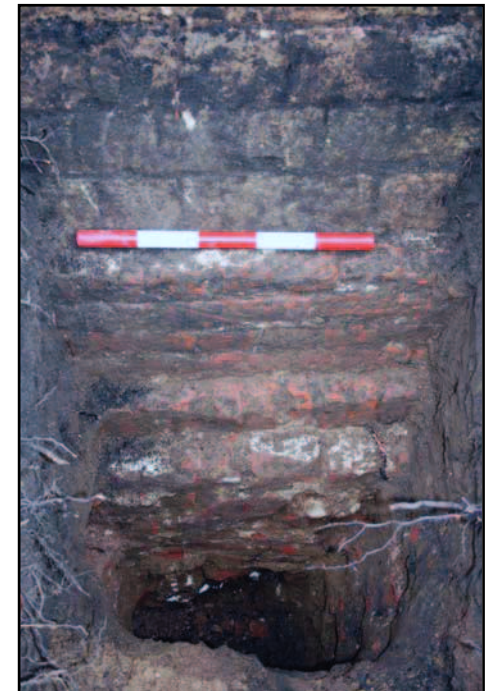
Plate 4: Footings
of Hitchen garden wall

- 3.1.2 The trench was excavated to a depth of 1.5 m up against the Kitchen garden wall which exposed the footings (Plate 4), which were made up of 0.6 m of rough stone, brick and chalk foundations overlain by 0.4 m thick red clay brick footings of a regular course with a concrete bond. The faced stone block wall was built onto the footings in a regular course with no discernible pattern.
