Toy Green Hampton Court Palace

Archaeological Evaluation and Watching Brief Report

July 2013

Client: Historic Royal Palaces

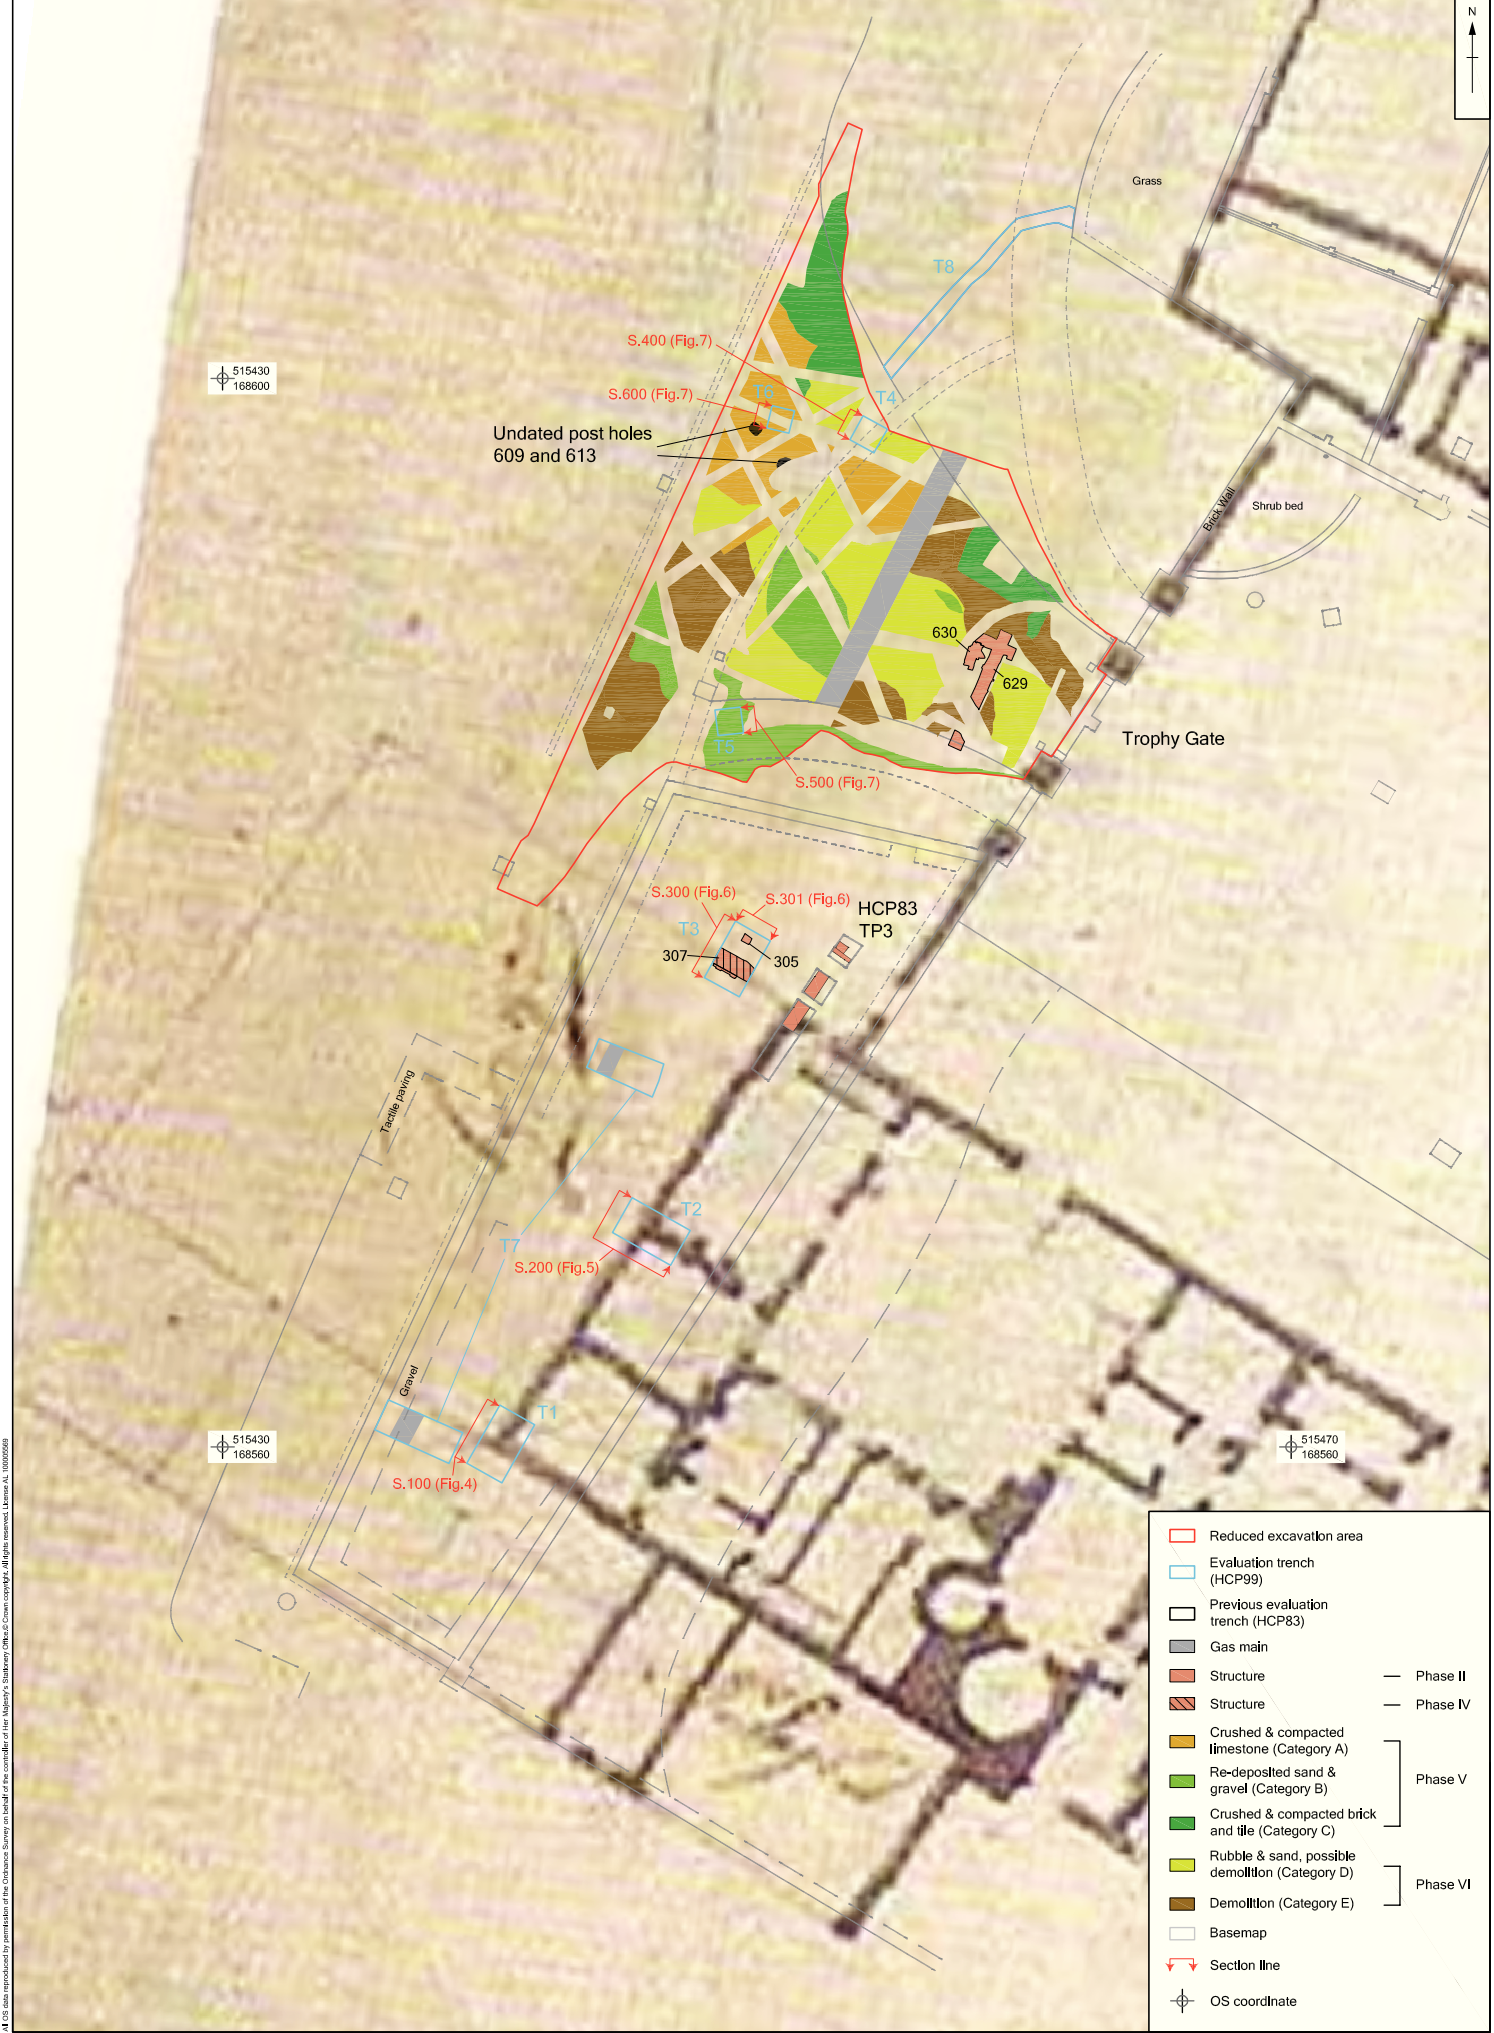
Figure 3: HCP99 - Trenches in relation to Thomas Fort Map

- 3.2.6 The reduced dig was generally to 8.40m aOD and the area reduced is indicated on Figure 3.
- 3.2.7 Characterisation of the deposits revealed following the general ground reduction was problematic given the archaeologically arbitrary elevation of the formation level for the re-surfacing and landscaping works. Consequently, the deposits recorded have been divided into 5 broad categories based primarily on their composition (see table below).

Trench 3 (Figs 3 and 6, Plate xx)

- 3.2.5 Trench 3 measured 2.5m x 1.5m and was excavated to a maximum depth of 1.15m below ground level (7.80m aOD). The earliest deposit encountered was a 0.15m+ thick dark greyish brown sandy silt layer (305) with charcoal and oyster shell throughout. This had been cut by the construction trench [312] for a NW-SE aligned stepped brick wall footing 307 which had the remnant of a brick floor surface on its southern side 309 which overlay a mortar bedding deposit (310), in which could be seen the impressions of the removed brick surface. The highest surviving element of the wall was at c 0.75m below ground level (8.20m aOD). Also overlying deposit (305) was a NE-SW aligned brick built structure 308, which may have represented an outbuilding to the north of structure 307. Both structures 307 and 308 had been truncated and were overlain by demolition deposits (304 and 306), the top of which were 0.6m below ground level (8.35m aOD). These levels had been cut by pit [303], which were in turn overlain by 0.6m of modern topsoil/landscaping and turf (301 and 300 respectively).

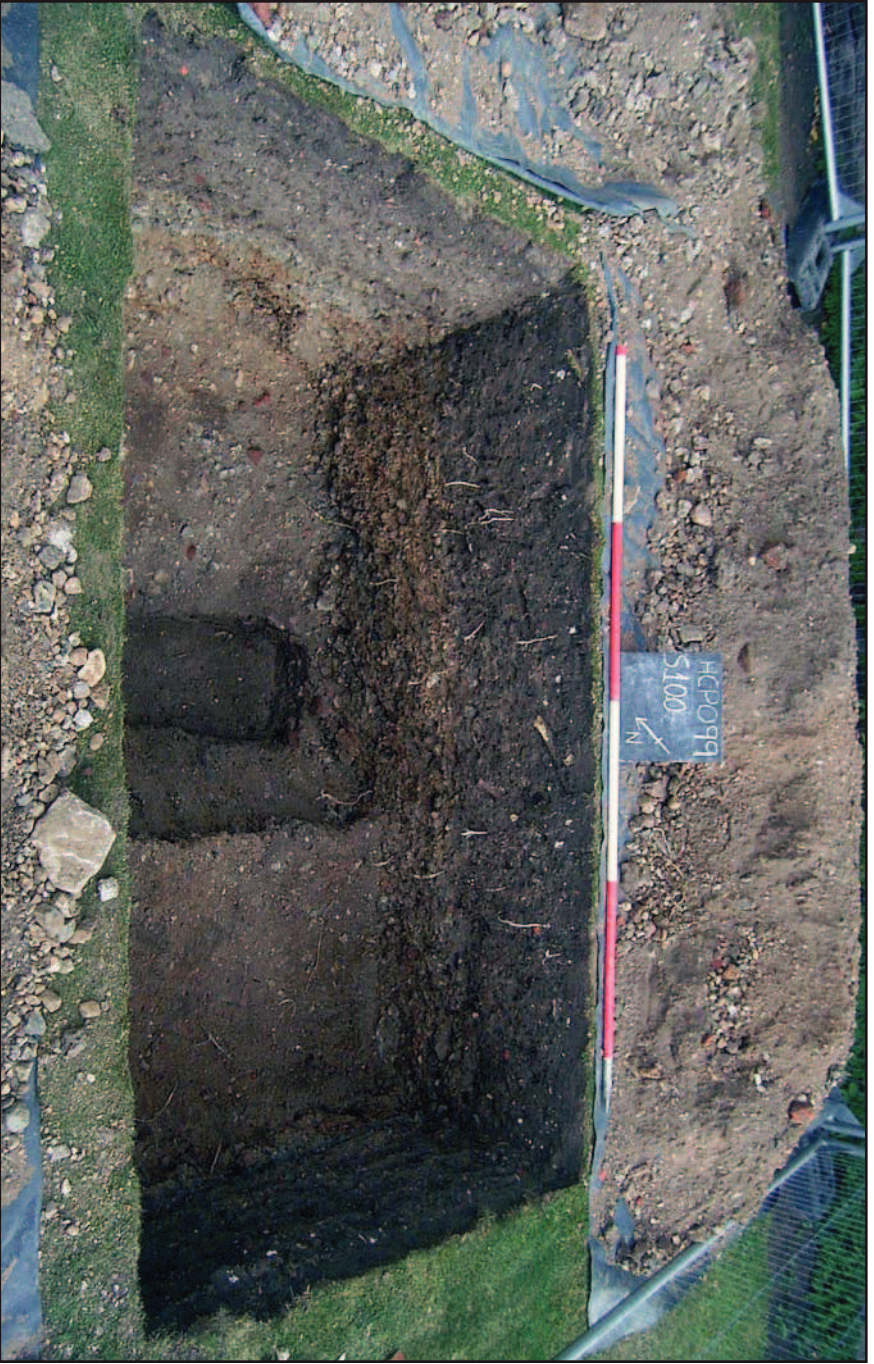
Plate 1: Trench 1 - looking SE

3.2.1 The trench measured 2.5m x 1.5m and was excavated to a maximum depth of 1.34m below ground level (8.02m aOD). The earliest deposit encountered was a mid greyish brown sandy silt (104), at least 0.17m thick. This was overlain by a series of gravel rich deposits (amalgamated as contexts 102 and 103) which were approximately 0.65m thick and contained tarmac and concrete.

- 3.2.2 The gravel rich layers were overlain by modern topsoil/landscaping (101) and the existing turf (100) which together measured 0.5m thick.

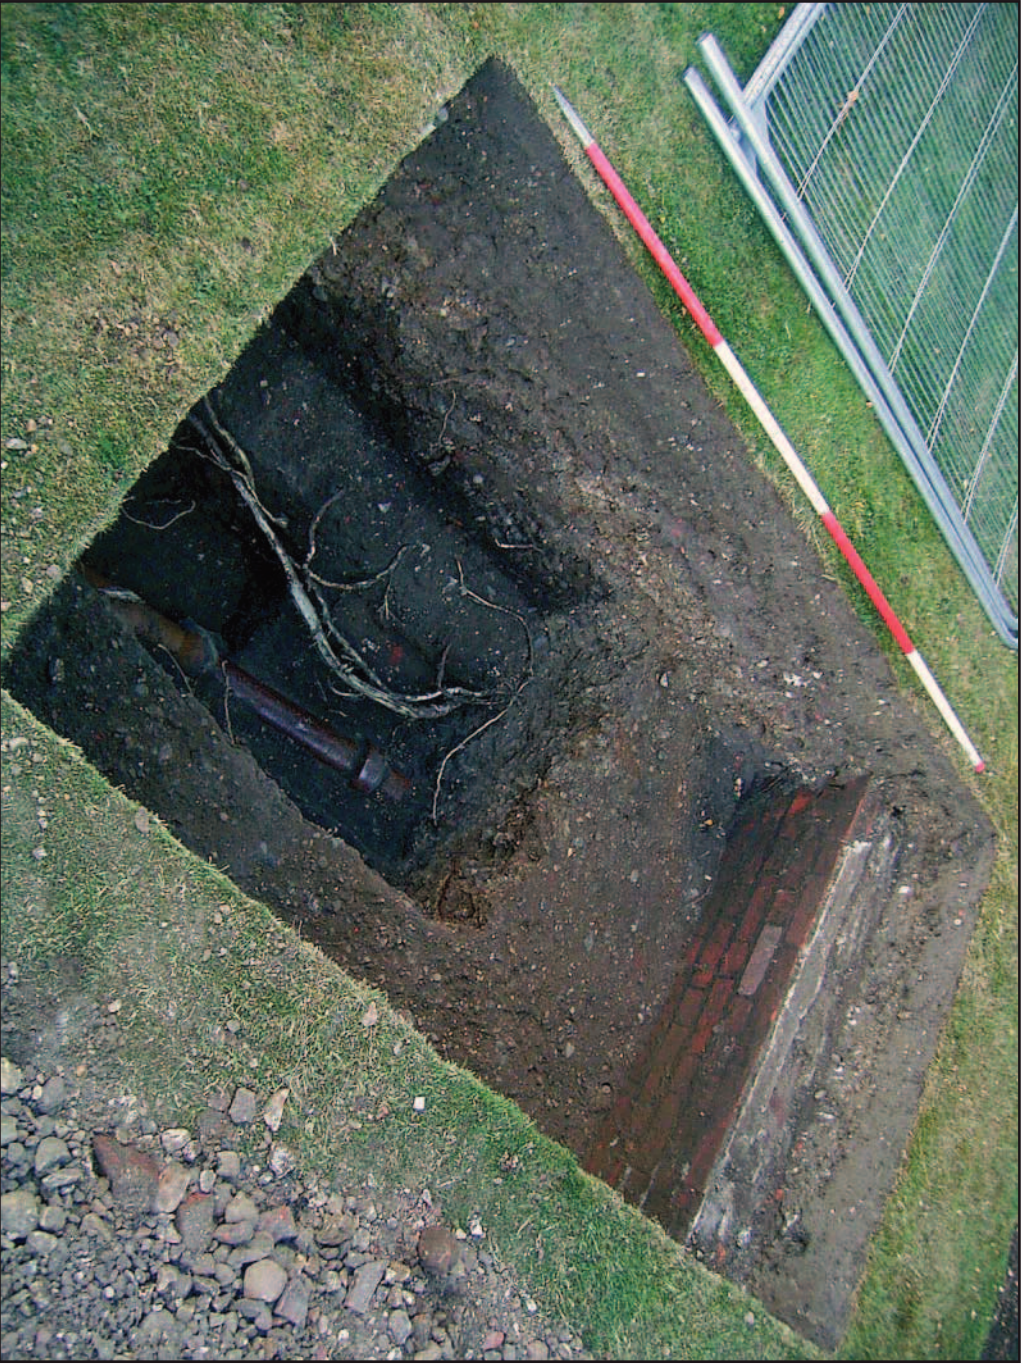
Plate 2: Trench 2 - looking SE

- 3.2.3 Trench 2 also measured 2.5m x 1.5m and was excavated to a maximum of 1.7m (7.46m aOD) below ground level (this in a shovel-width sondage in the base of the trench). The earliest deposit reached in the base of the sondage appeared to be a fairly compacted mortar deposit (211) which may have represented a floor layer, or a bedding deposit similar to that seen in Trench 3 (see below) - although this is very circumspect given the limited extent of the sondage. This was overlain by two deposits (200, 210 - 0.32m and 0.25m thick respectively) which contained relatively high concentrations of building material (this was particularly true of 210).

- 3.2.4 Deposit (200) was overlain by a 0.22m thick deposit (201) which was similar in composition to deposit (104) in Trench 1. This was in turn overlain by a 0.4m thick layer which was of more mixed composition (202), but may have been part of the same phase of deposition. Deposit (201) had been cut by a trench for a ceramic service pipe [203] which appeared to feed from a square-built brick structure/manhole 209 located at the eastern end of the trench (there was some evidence that this pipe had been broken and repaired). Both deposits had been cut by a feature(s) [205] marking the northern extent of the gravel rich deposits seen in Trench 1 (102, 103) and again in Trench 2 (206). If this was a single feature, then the northern edge was very irregular in plan. The gravel rich deposit was overlain by modern landscaping/topsoil (207) and turf (208) which together were 0.45m thick.

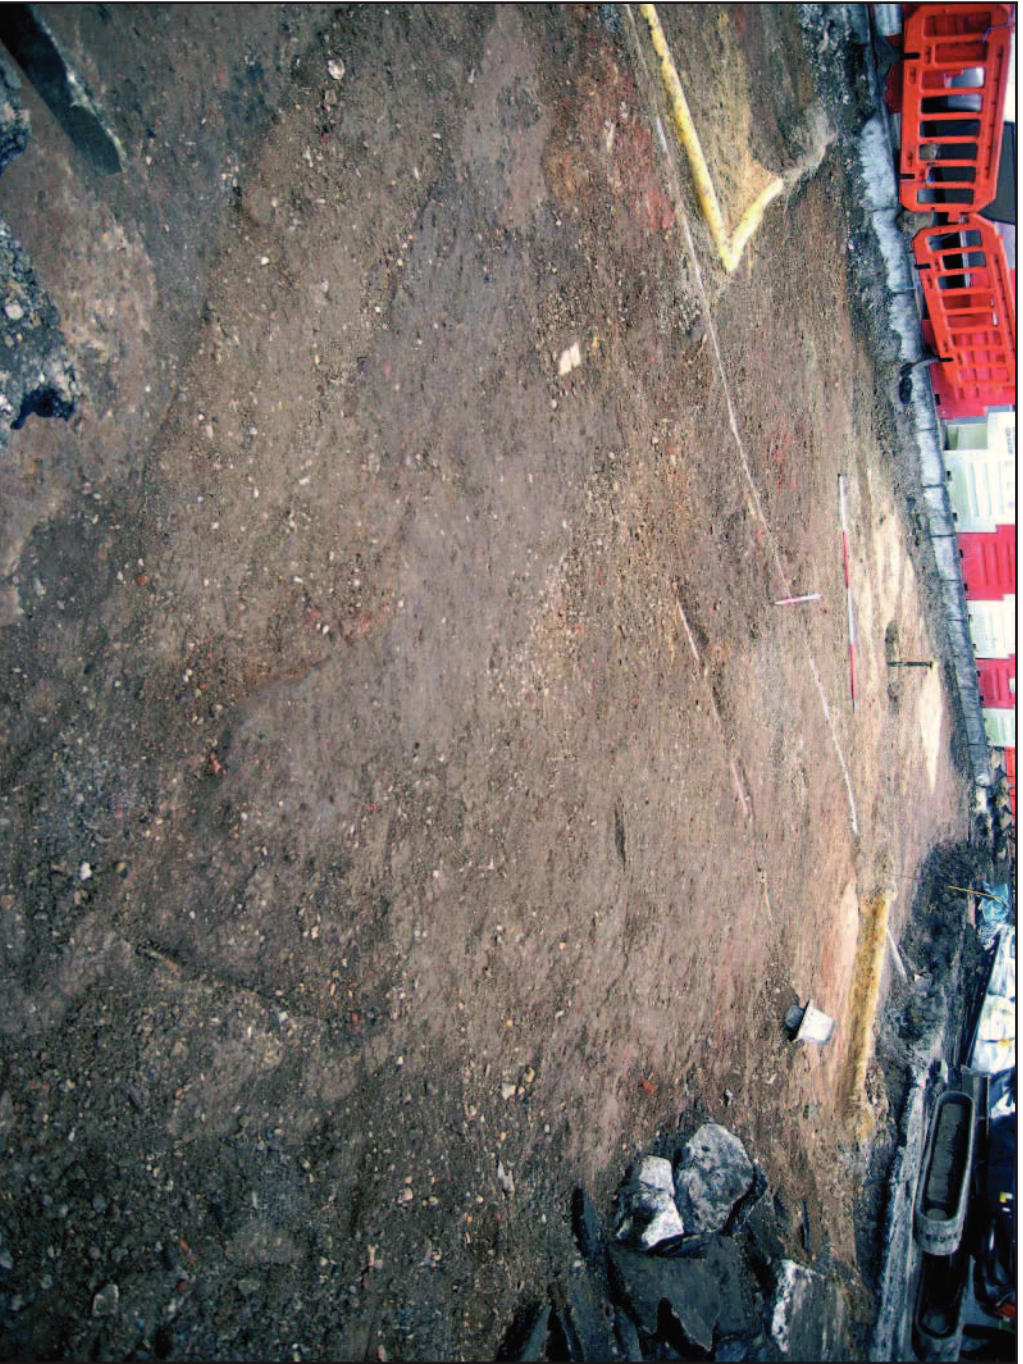
Plate 4: Reduced dig - looking NW

3.2.8 As these deposits were only revealed in plan, the stratigraphic relationships between them was difficult to establish with any degree of certainty, the exception being where service inspection test pits were excavated (see Trenches 4-6 below).

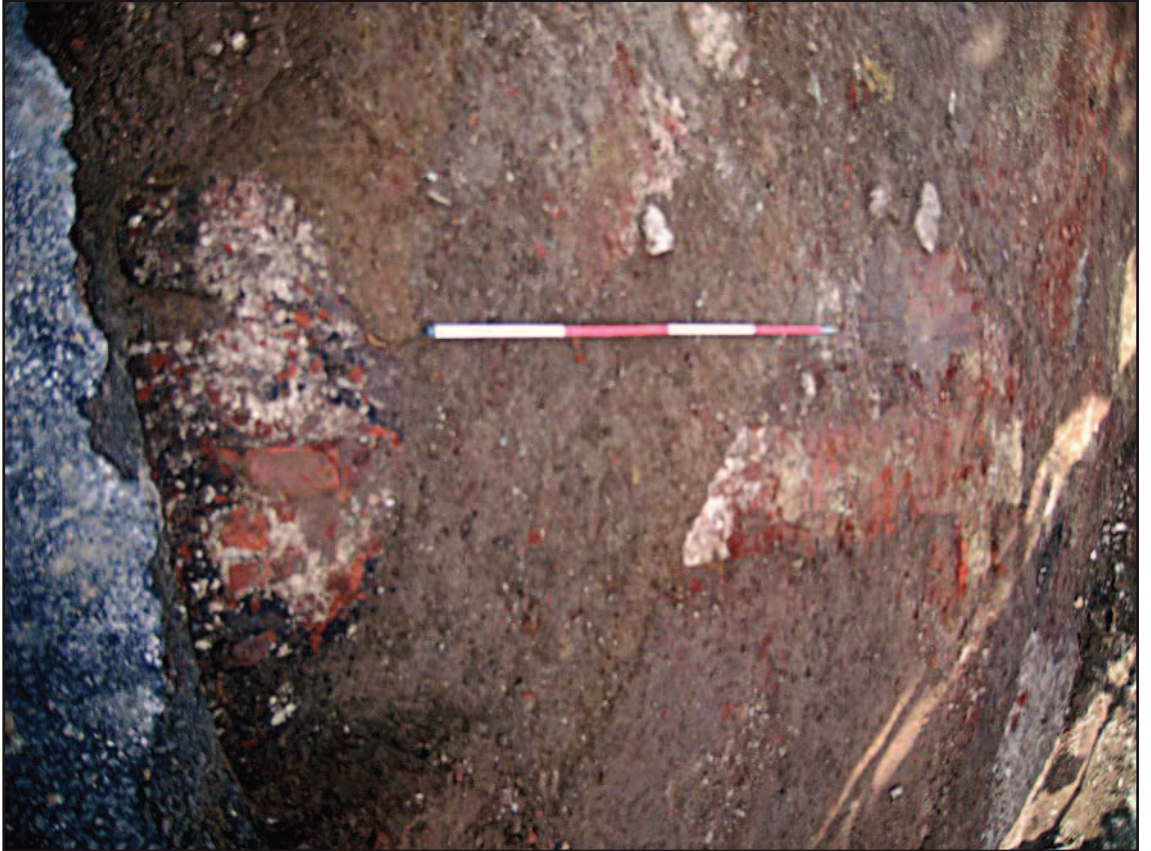
Plate 5: Wall 629 - looking N

3.2.9 Also revealed during the general reduction was a 4.5m long brick wall footing on a roughly NE-SW alignment (Plate 5), with a cruciform configuration at its northern end (629). The structure was of unfrogged bricks bonded with a yellow sandy lime mortar. Immediately to the west was a single course of brick 630 covering an area approximately 3m x 1.9m and heavily truncated by modern services. This was initially thought to potentially represent a brick drain as the base was slightly concave, although it is possible that it is the remnant of a surface. The relationship between this structure and the deposits listed above was unclear.
