Stage 1 Trial Trenching

# North East Embankment

Former Henley Cable Works  
Northfleet  
Kent

## Archaeological Evaluation Report

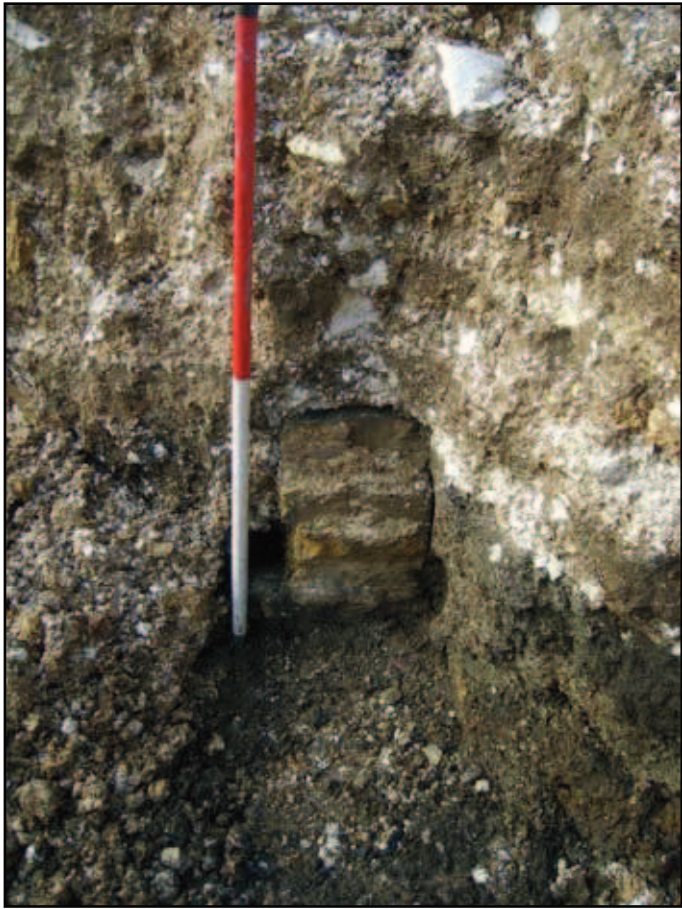
Plate 4: Brick wall, looking south-west

3.4.4 At the north-west end of the trench was the remains of a narrow wall (115), constructed from red clay brick and yellow stock brick (Fig. 5, Section 100; Plate 4). The wall was

only one brick length wide and was observed in both the SW and NE facing sections, suggesting a NNE to SSW orientation. The wall appeared to have been truncated within the trench during excavation most likely due to its insubstantial construction. The thin width of the wall suggested it was more likely to be ornamental than structural, perhaps being associated with garden landscaping.

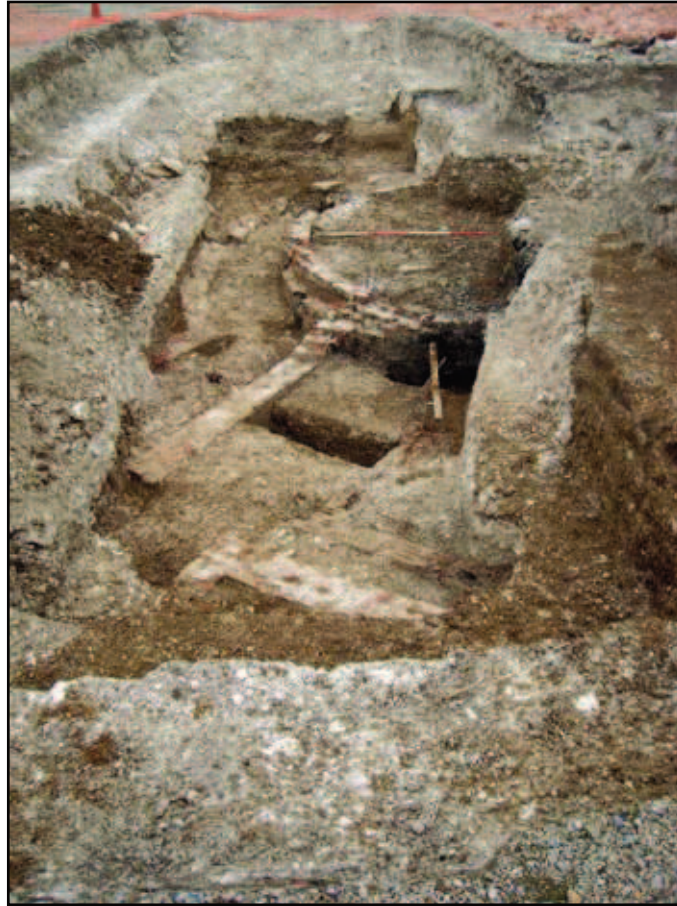
Plate 5: Trench 2. Bear pit, looking south-west

- 3.5.2 Trench 2 came down onto a curved brick wall (3001) at a depth of 2m from the present upper ground surface. This wall extended approximately 2.40m into the trench and appeared to be the remains of the Bear Pit (Plate 5). A machine excavated sondage was excavated through the inner backfill of this structure and determined that the walls survived to a depth of at least 1.95m. At this depth the remains of a grey slate floor was encountered and excavation ceased (Plate 6). It appears that only the bottom 2m of the Bear Pit survives and that the upper half has been truncated by the site clearance prior to the construction of the Henley Cable Works with additional disturbance during the recent remediation of the site. An extant example of a similarly dated circular Bear Pit in Sheffield Zoological Gardens is 4m deep and it is entirely likely that the Rosherville Bear Pit was of a similar depth.

- 3.5.5 A curved chalk wall, 3003, was observed approximately 1m to the SE of the brick wall of the Bear Pit (Plate 5). It predominantly mirrored the curve of the Bear Pit until it butted against a brick wall to the NE (296). The brick wall ran under the eastern trench baulk. The chalk wall continued to mirror the brick wall to the SW. The function of this wall remains uncertain, but may be associated with the landscaping of the raised Broad Walk, perhaps acting as a retaining wall.

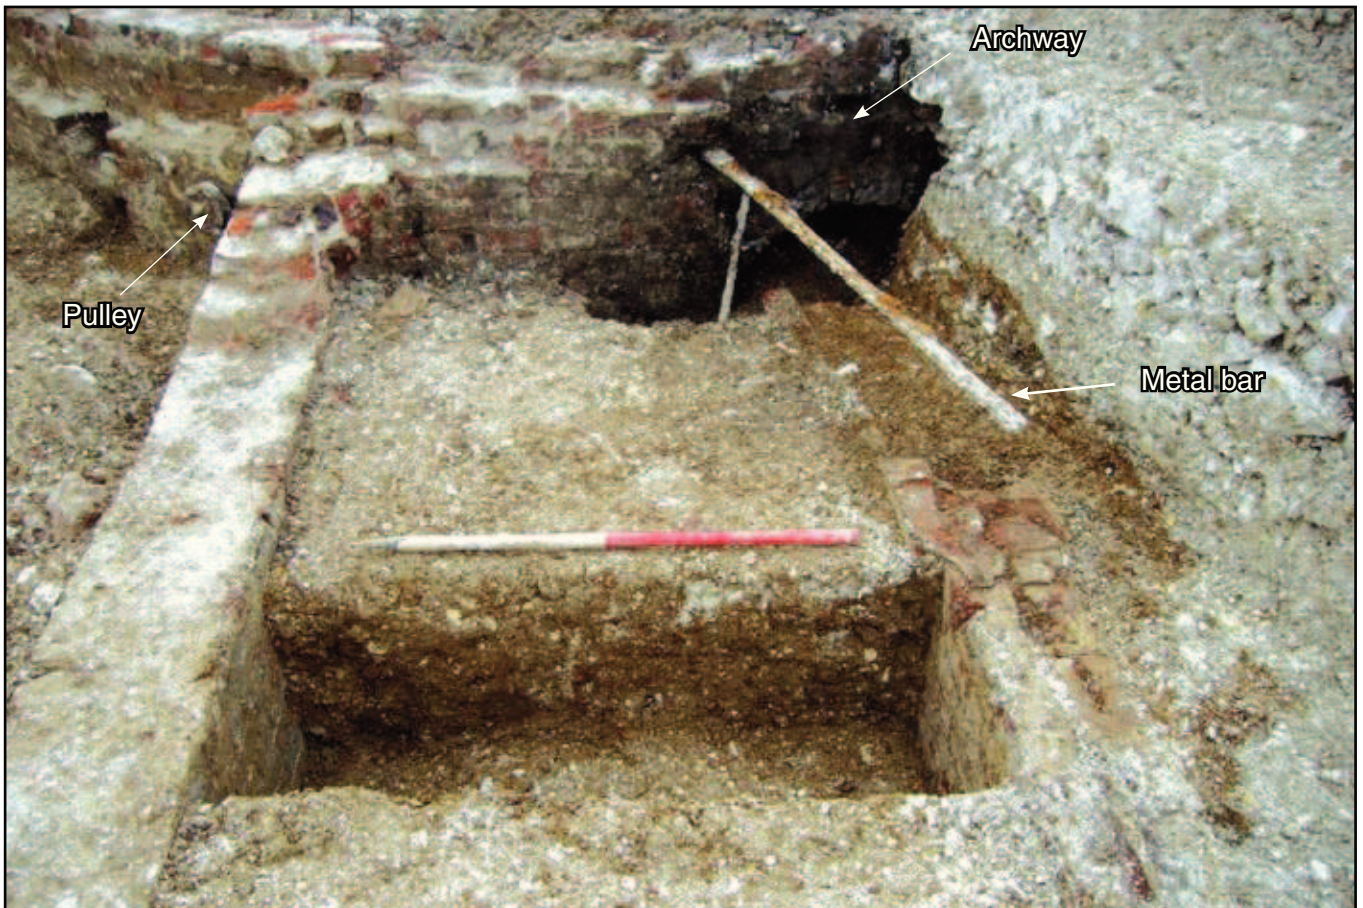
Plate 7: Metal pulley, bar and archway, looking south-west

- 3.5.3 During hand cleaning of the exterior curved wall of the Bear Pit, a metal pulley wheel was observed attached to the brick work. Additional metal fittings were also observed in what appear to be associated rooms, probably subterranean cages, exterior to the circular structure (see 3.5.6) (Plate 7).

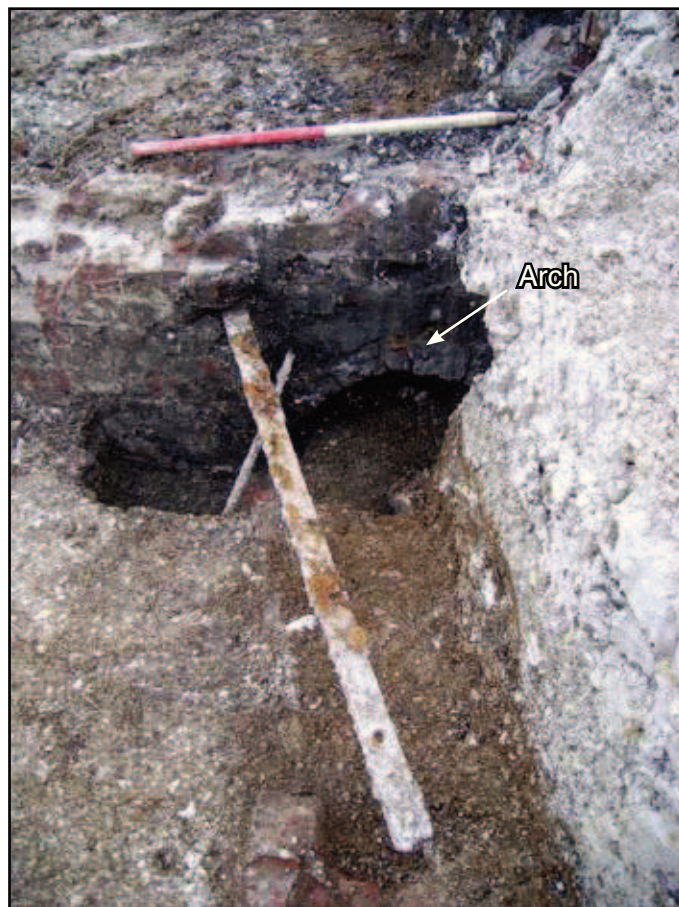
Plate 10: Iron bar and arch, looking south-west

- 3.5.7 Wall 288 appears to terminate 1m short of the Bear Pit in a brick pier centred roughly on the middle of the arched doorway, perhaps suggesting the subterranean pen had several rooms. An iron bar extended from the Bear Pit towards the pier. The bar had a number of holes through it and may be associated with a gateway separating the rooms (Plate 10).

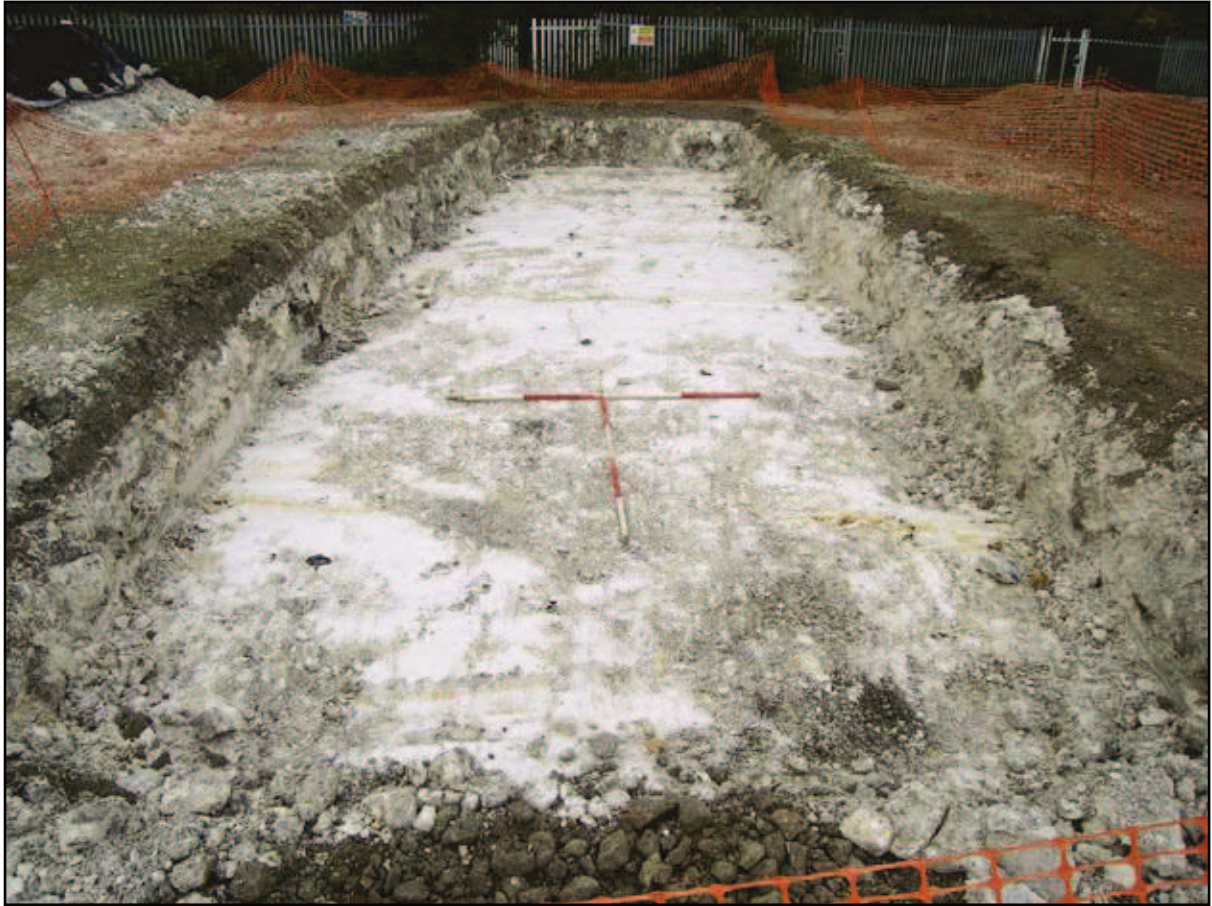
Plate 11: Trench 3, looking south

- 3.6.1 Trench 3 was excavated to the south of Trench 2 and was aligned roughly N-S (Plate 11). The trench measured 20m x 4m, and was excavated to a depth of 0.85m.
- 3.6.2 The trench was excavated to the natural chalk which was overlain by 0.55m deep deposit of redeposited chalk, which in turn was overlain by a 0.30m layer of crushed concrete and stone.
- 3.6.3 No archaeological features were observed in this trench.
