Stage 2 Trial Trenching

North East Embankment

Former Henley Cable Works
Northfleet
Kent

**Archaeological
Evaluation Report**

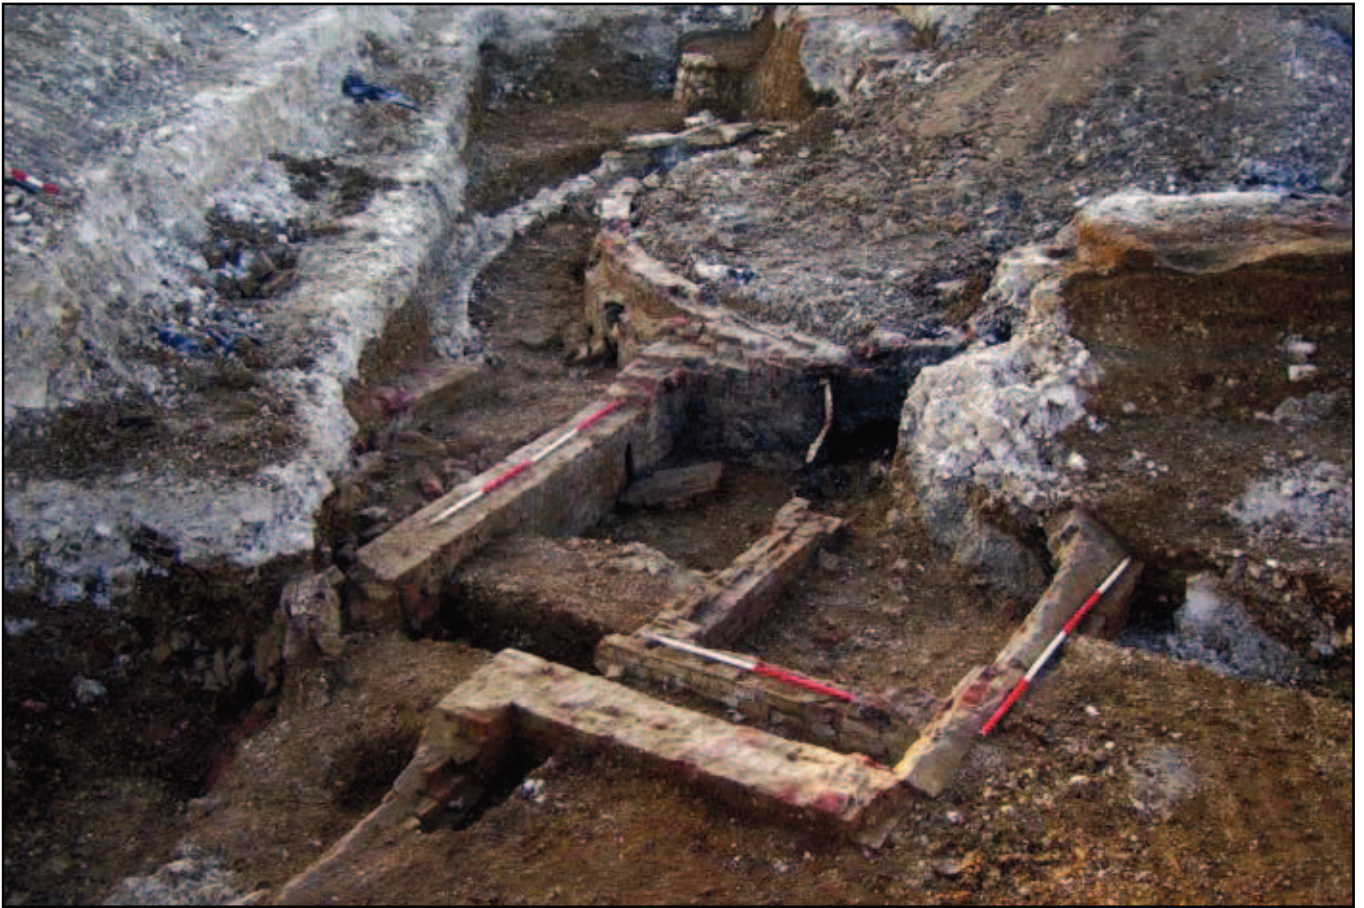
Plate 1: Trench 2. Bear Pit, looking south-west

- 3.4.5 The main circular wall (3001) for the Bear pit measured around 6.45m in diameter with an internal diameter of 6m. The pit was not intact, having sustained damage from the demolition and site clearance in the late 1930s. The south-eastern side identified during the Stage 1 works was encountered at around 1.8m bgl (3.77m OD) and survived to a depth of around 2.3m. However, the Stage 2 works quickly established that the north-western arc of the wall survived to a much greater height (3m), and was encountered at a depth of around 1m bgl (4.45m OD) and appeared to have suffered very little truncation.

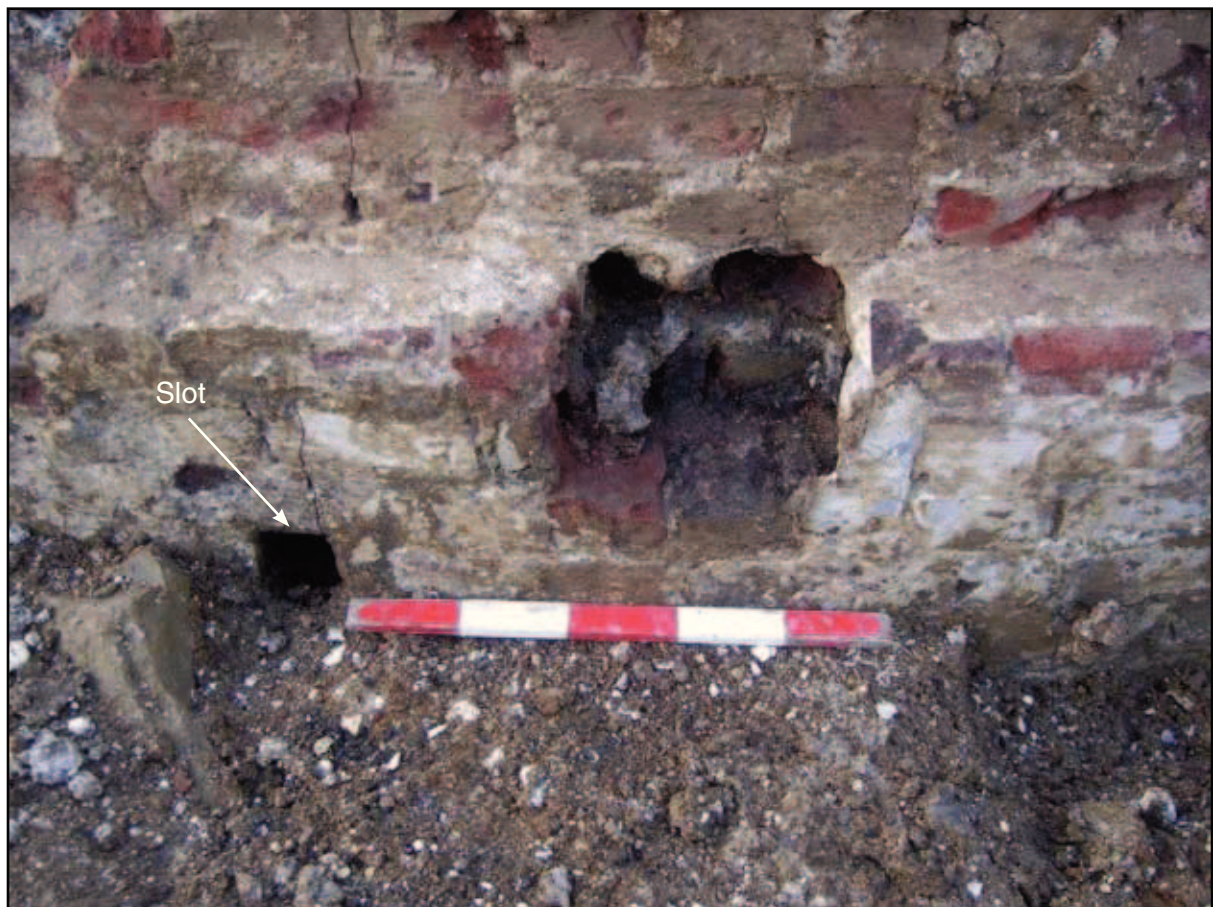
- 3.4.10 There was also evidence of two small vertical slots through wall 3001. These were wider on the outside than the inside and very similar to arrow slots (Plate 4). These may have been used by the keepers to observe the bear or possibly to safely goad them to entertain the viewing public. A similar slots was observed in an external room (Room 4) to the north-east of the pit (illustrated in Plate 13).

Plate 4: Trench 2. Elevation view of recess for horizontal support in wall 3001, and window slot visible, looking north-west

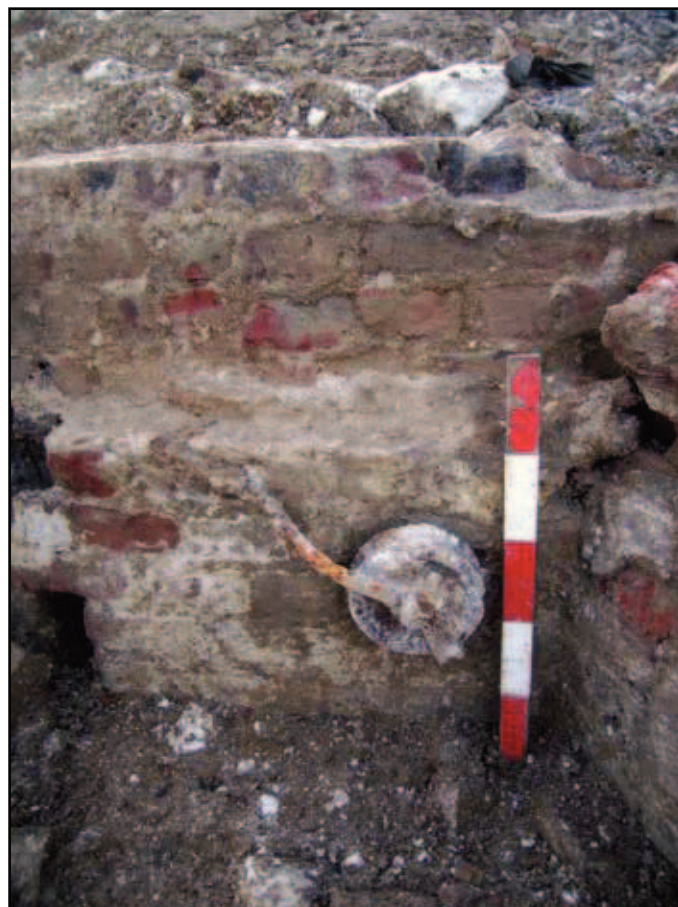
- 3.4.11 A metal pulley wheel was attached to the brick work (Plate 6) and additional metal fittings were also observed in the associated rooms. These were probably part of the operating system for subterranean cages and gates used to manage the animals.

Plate 6: Trench 2. Elevation view of iron pulley and window slot in wall 3001, looking north-west

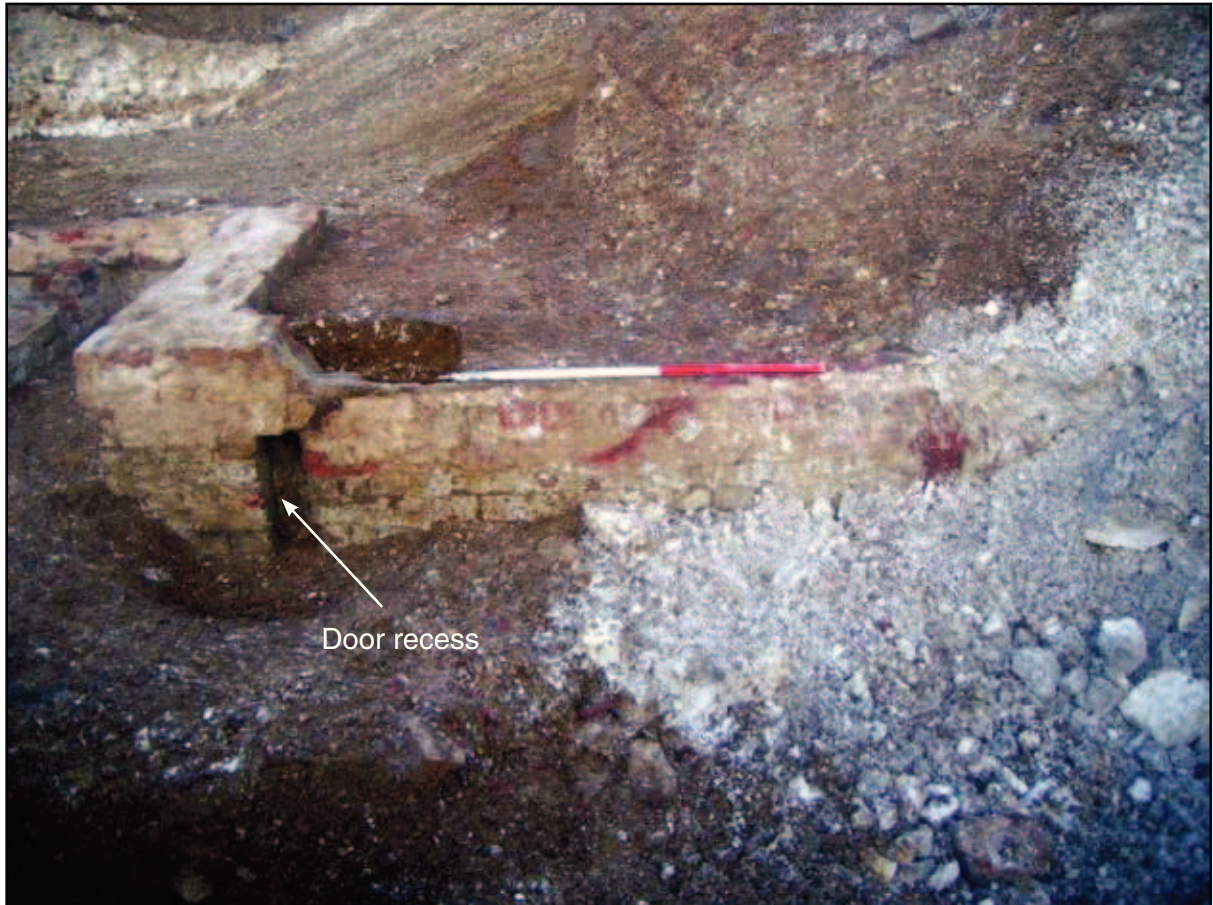
- 3.4.14 Room 1 consisted of walls 3030, 286, 3031, 288, 3029 and part of 294 (damaged during demolition). It was a small area measuring approximately 3m x 0.6m, with a doorway to the south-west. It was presumably accessed via an entrance in the Italian Gardens to the north-east. The room shared an arched roof (287) with Room 2 to the south-west (Plate 7). The small size of Room 1 suggests it may have been used for storage and gaining a view into Room 2. Excavation in Room 1, as with all the rooms, ceased before the floor was reached (primarily for health and safety reasons). Although no evidence of a viewing slot was discovered, it seems logical that a window, like the one between Rooms 3 and 4 (Plate 13) would have been present along the north-west south-east orientated wall. Room 3 could be accessed along the south-western wall of Room 1, through a narrow entrance. The head jam for this doorway had been truncated away (Plate 8). A small recess to the north-west in wall 3030 may represent another doorway separating Room 1 from the entrance corridor (Plate 9).

Plate 9: Trench 2. Elevation of wall 3030, door recess, looking north-west

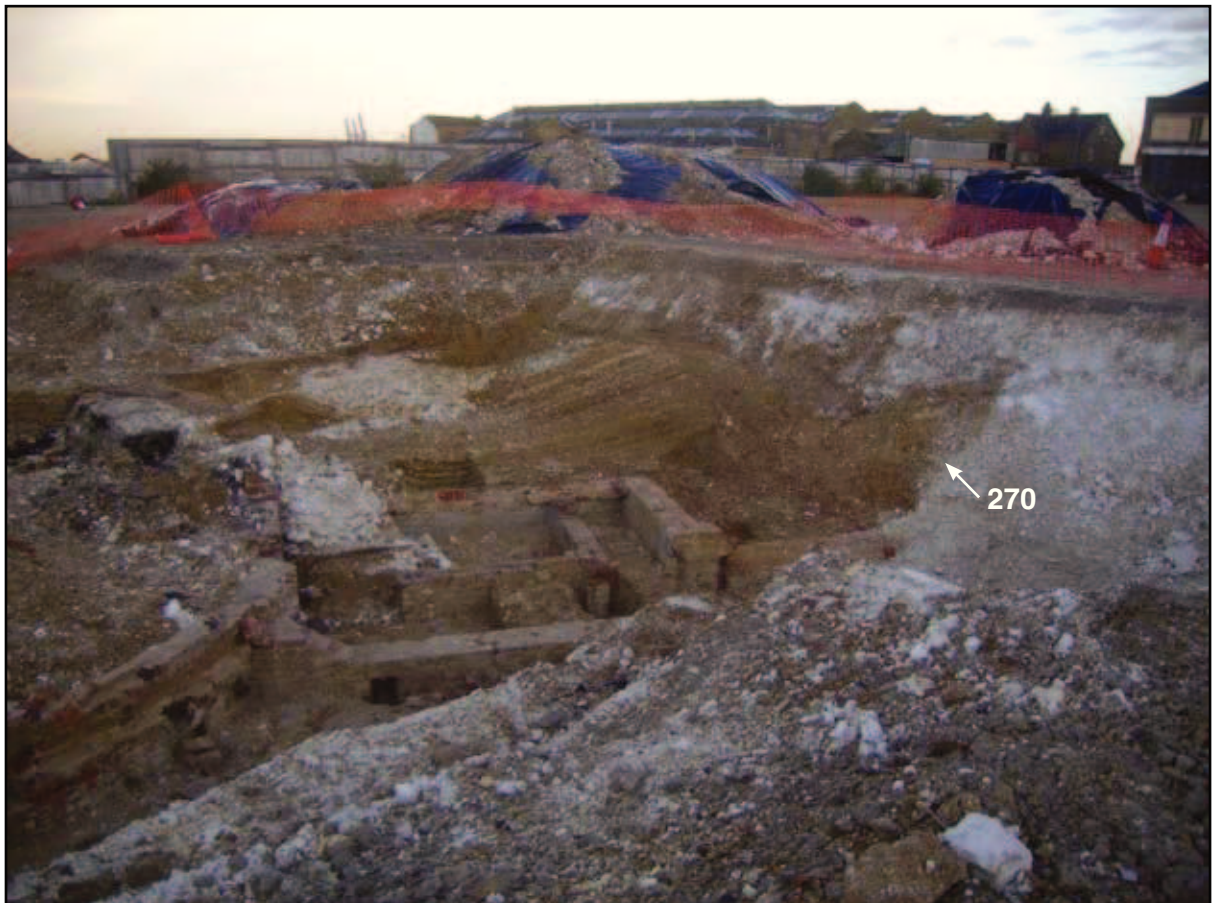
- 3.4.25 Cut 270 (Plate 20) is filled with a loose disturbed chalk deposit. This, along with cut 266, visible only in the Stage 1 trenching (see Fig. 4, Stage 1 report), appears to be associated with the demolition of the Bear Pit structure and adjacent rooms shortly after Rosherville Gardens closed, probably to ensure not voids were present within the area prior to the construction of the Cable Works. This may also account for the varying degrees of preservation of the Bear Pit. The better preservation of the north-western

Plate 20: Trench 2. General view showing mounded deposits, looking north

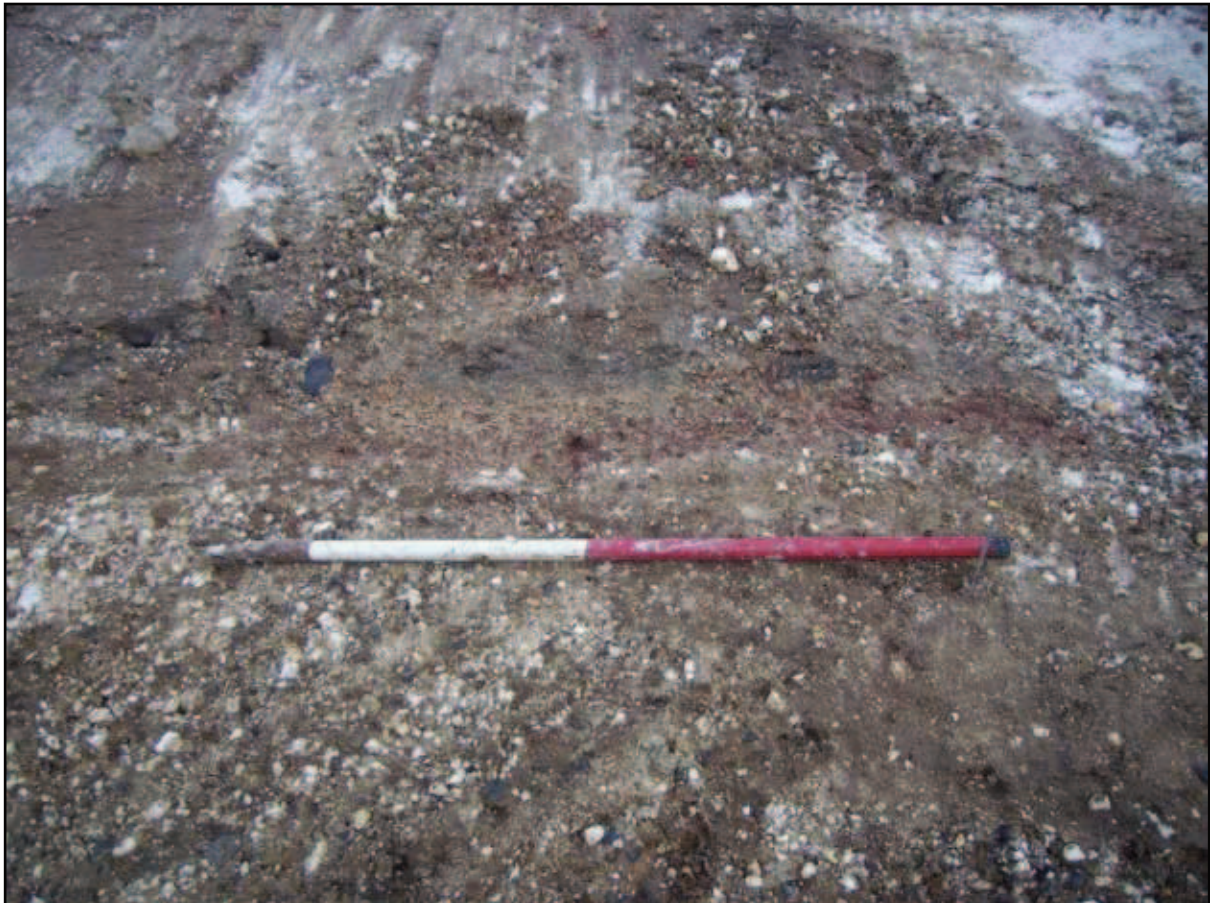
- 3.4.23 At the top of the backfill sequence was the material associated with the path on the walkway. There was a dramatic change from the tipped deposits of the mound to the horizontally laid deposits. These deposits consisted of 229, 245 247-248 and 264. Overlying these was a layer of finely crushed ceramic building material (CBM) (228/263) which was probably the bedding layer for the path. This distinctive layer was also seen in Trench 7 as 737. The path material itself (262) would appear to have been shell rich and was observed intermittently (Plate 22).

Plate 22: Trench 2. Walkway layers 263 and 262, overlying mounded deposits, looking north

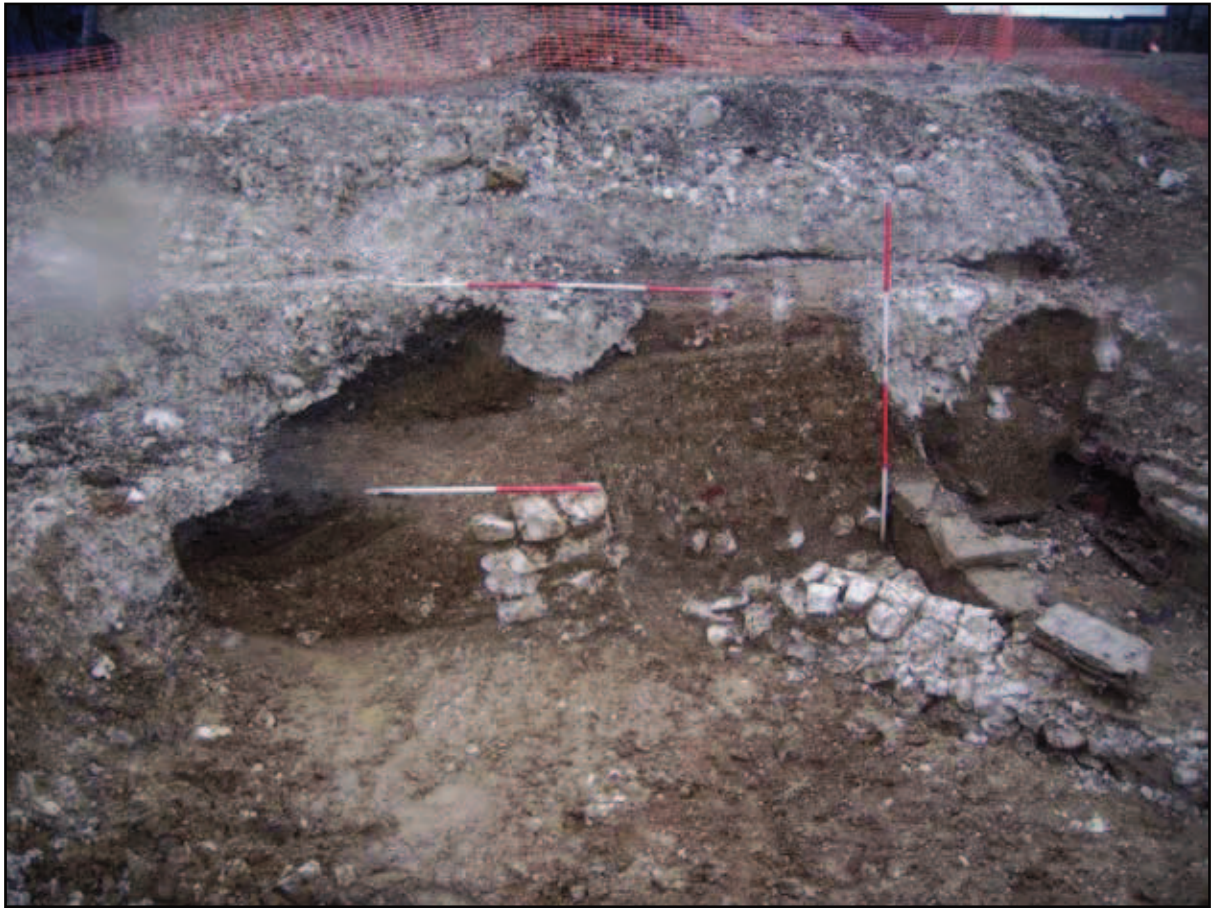
- 3.4.26 On the south-west side of the trench more sloping construction layers were observed (208, 209 and 3018). These were seen to tip downwards forming the south-western terminal of the mound and the rounded end of the Broad Walk; with the shell rich deposit (3017) visible at the top of the sequence (Plate 23).

Plate 23: Trench 2. Section to the south-west of the Bear Pit, looking north-west

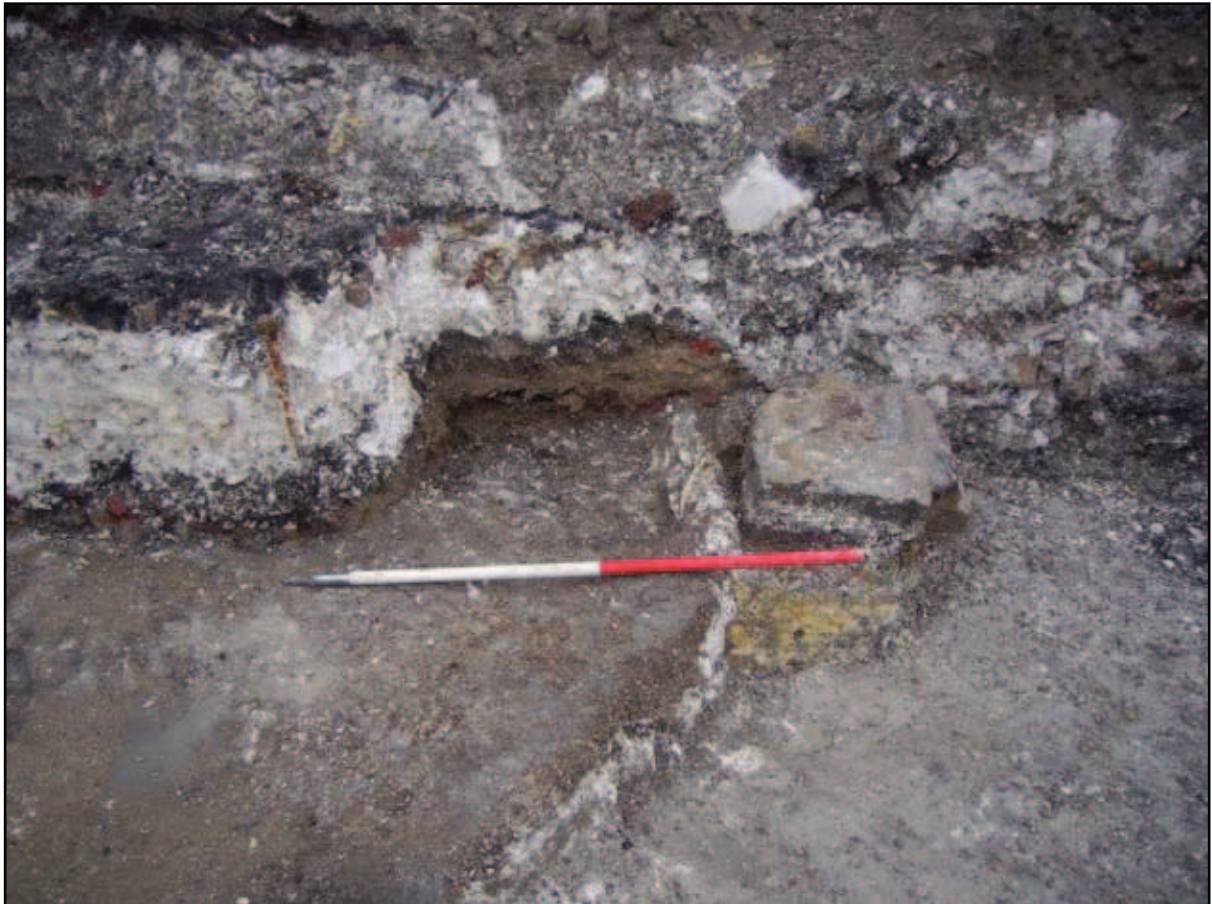
- 3.7.5 The small squared brick structure 6012 was the probable foundation for an upright structural element seen on the northern side of the trench (Plate 28). It was unclear whether it was related to any other features or a discrete structure such as a pillar. In any case, it appeared to have been displaced from its original location.

Plate 28: Trench 6. Plan view of 6012, looking south

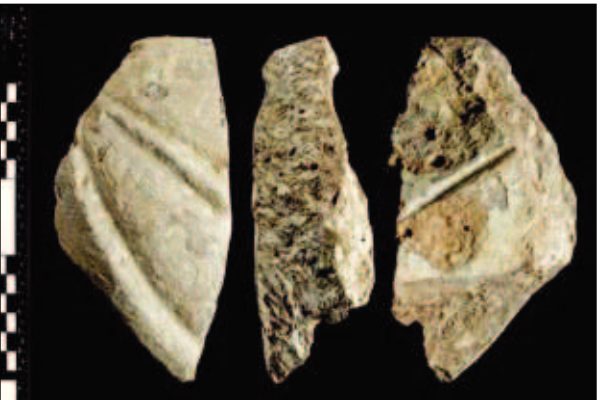
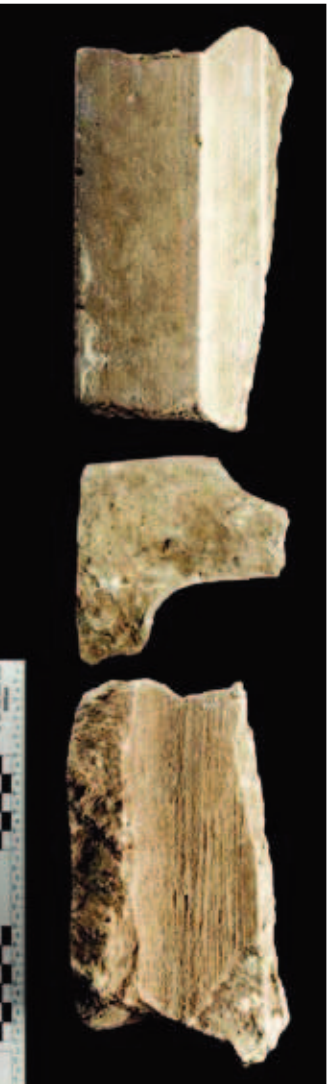
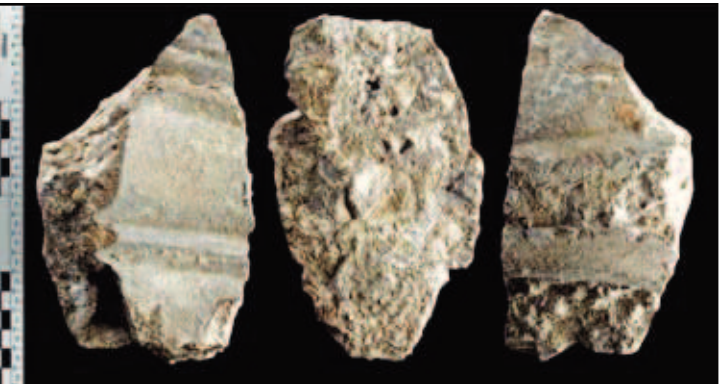
- B.3.11 No further work is recommended, although several of the moulded pieces are worth illustrating (Plate 35).

Plate 35: A selection of moulded pieces from the fountain (706)
