Tithe Barn  
Church Lane (South)  
Sydling St Nicolas  
Dorset  
DT2 9PA  
Scheduled Monument No. SM  
DO 105; HA 1003209

**Archaeological  
Evaluation Report**

**Tithe Barn, Curch Lane (South),  
Sydling St Nicholas,  
Dorset, DT2 9PA:  
Scheduled Monument No. SM DO 105; HA 1003209.**

**An Archaeological Evaluation Report**

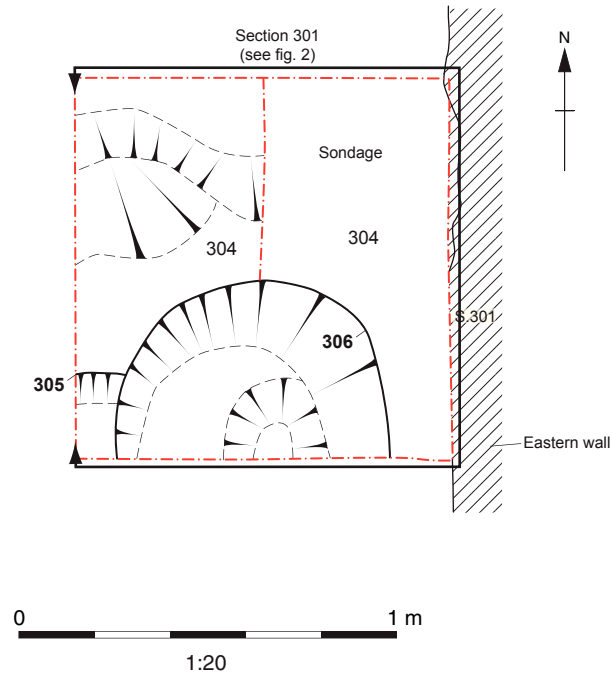
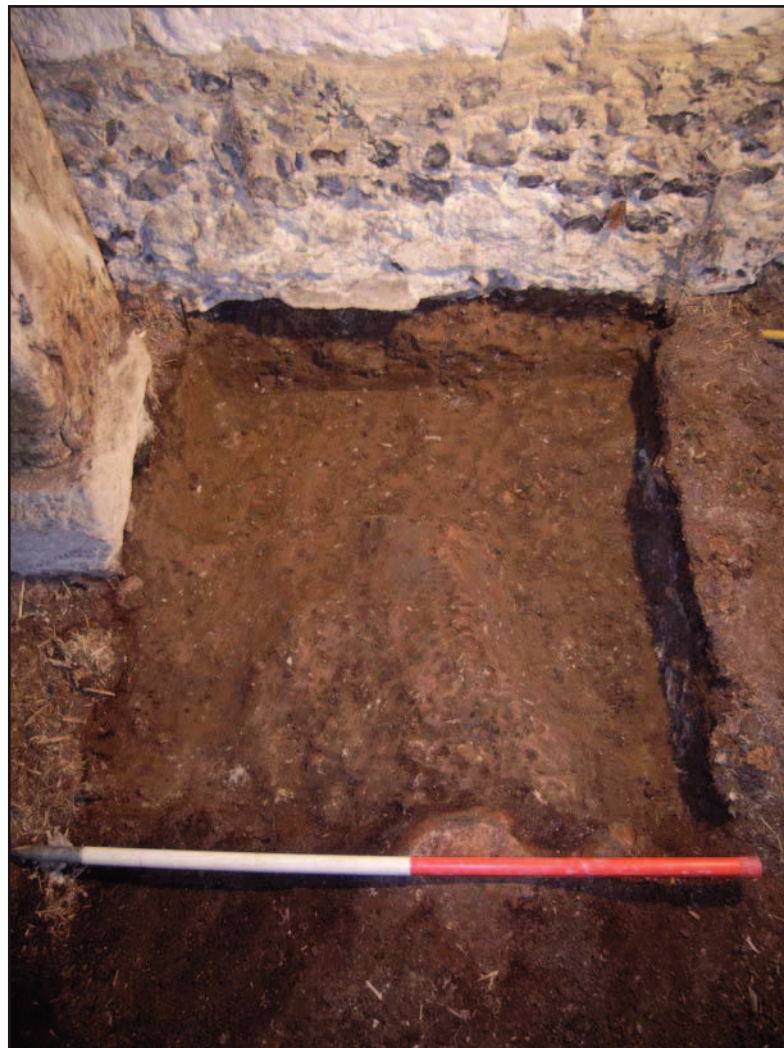
Figure 4: Test Pit 3 - Plan and photograph after excavation completed

Test Pit 3 - View to the east

- 5.2.5 Test Pit 3 was located against the eastern gable end wall of the barn and the north-easternmost aisle post and measured 1 m x 1 m (Fig 2), a sondage measuring 0.5 m x 1.0 m was located in its western half .

- 5.2.6 An uneven mid brown clay deposit (304) was encountered at 116.66 m OD, between 0.1 m – 0.15 m below current ground level, the sondage confirmed that it was sterile and probably of geological origin. At the southern edge of the test pit a shallow feature (306) was partially revealed, it measured 0.60 m E-W by 0.5 m N-S but extended beyond the southern baulk, and was 0.10 m deep. This was filled with a grey brown silt clay with chalk inclusions (305). This feature had been truncated by an east-west aligned shallow linear (303 filled by 302) whose eastern terminus respected the extant barn wall and then extended 0.96 m westwards to continue beyond the limits of the trench.

- 5.2.7 Both the extant eastern wall to the barn and the extant post pad sat directly on the clay natural with no construction cuts observable or any discernible foundations, and with no relationship to the features 303 and 306 described above.

- 5.2.8 The overburden consisted of a mid-dark brown, humic-rich silt deposit (301), this overlay the entire test pit and abutted both the wall and post-pad. No *in situ* stone floor surface was present, and in places the overburden immediately overlay the natural geology.

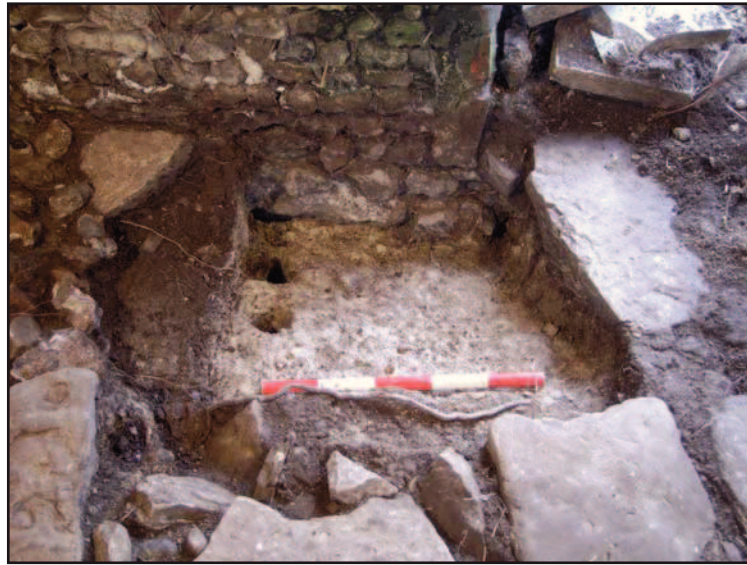
Figure 5: Test Pit 4 - Plan and photograph after excavation completed

Test Pit 4 - View to the south

- 5.2.10 The natural chalk horizon (401) was only exposed within the sondage, at 0.15 m below current ground level at 116.48 m OD. This had been truncated by an east-west aligned construction cut (409) for the existing vertical mortared flint foundation (408) to the southern wall of the barn. The foundation appeared to utilise larger less tightly packed flint than the wall above.

- 5.2.11 A pair of stake/post-holes (404) and (406) cut the chalk and were aligned perpendicular to the foundation/wall. Sealing the chalk natural and the features, was a friable dark grey brown clay silt (402) which was overlain by a surface comprising limestone flags and flint cobbles (401) at 116.70 m OD. This surface abutted the extant barn wall but extended beyond the limits of the test pit (its observable extent was planned and is shown on Figure 3, it does however extend beyond its' observable limits but was covered by overburden).

- 5.2.12 The corner to the entrance to the barn had been modified/repaired with brick.

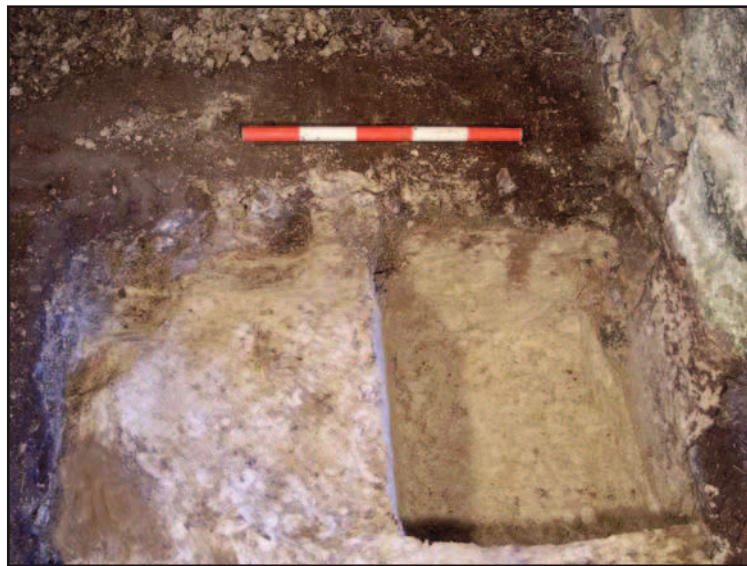
Figure 6: Test Pit 5 - Plan and photograph after excavation completed

Test Pit 5 - View to the west

- 5.2.14 Natural degraded chalk and clay (517) was recorded at 116.60 m OD, some 0.10 m below current ground level. At this horizon three postholes (503), (507) and (513) as well as four closely positioned stake holes (505), (509), (511) and (519) were revealed. No dating evidence was found in the similar brown silt fills of these features. A pair of north-south aligned wheel ruts were recorded at this level at the eastern extremity of the test pit aligned with the edge of the entrance way into the barn.

- 7.4.8 There is a similar case to be made for the post/stake holes in Test Pit 5. Several of the post holes and stake holes revealed in Test Pit 5 apparently cut the backfilled construction cut of the original northern wall and are also partially sealed beneath a layer of chalk and flint rubble (502) which contained the 19<sup>th</sup> century pottery. It is possible that this rubble derives from stone dressing for on site wall repairs, in the 19<sup>th</sup> century, carried out from scaffolding that was set into these post and stake holes. A number of these could also form an internal division of bay.

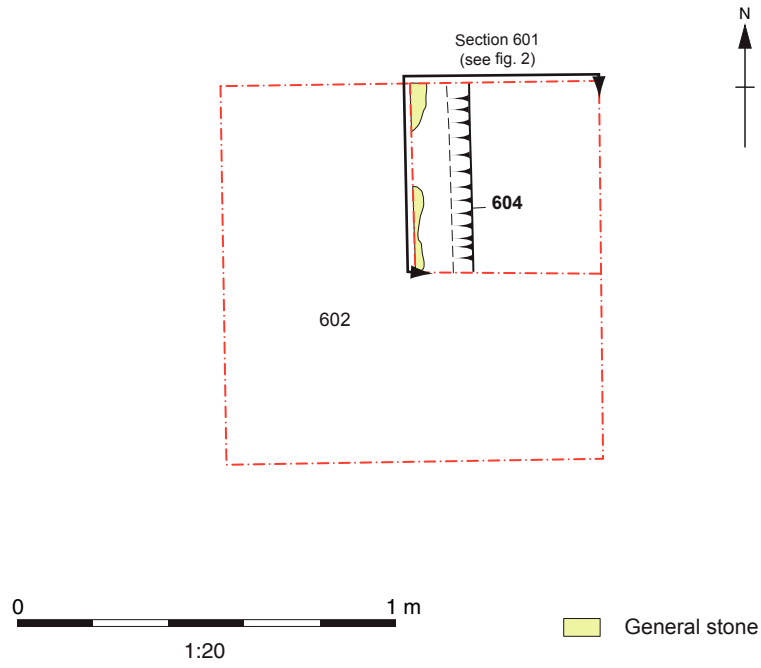
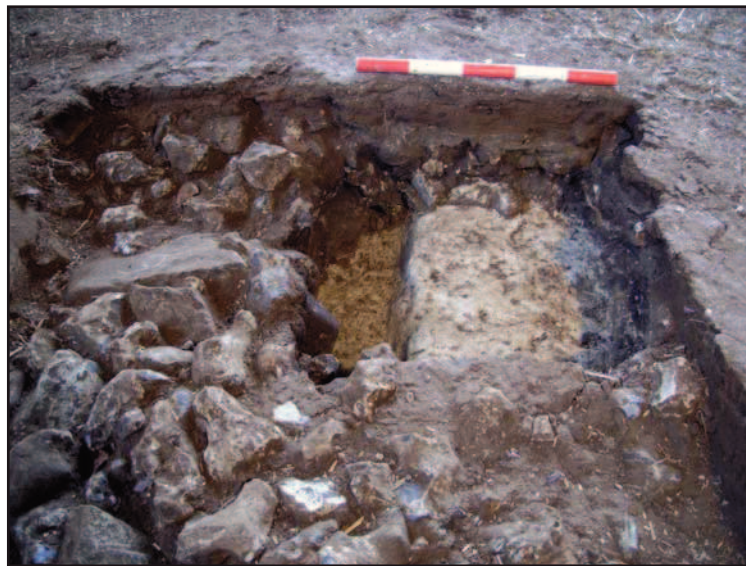
Figure 7: Test Pit 6 - Plan and photograph after excavation completed

Test Pit 6 - View to the north

- 5.2.18 Natural chalk bedrock had been cut at the western side of the sondage by a north-south aligned linear feature (604) which was 0.10m in depth. A lime mortared brick structure was constructed on the base of the cut, it was 3 courses high and one brick header wide (top level at 116.56 m OD) it was aligned perpendicular to the cut on an E-W axis. The flat base of the feature was lined with pottery sherds, all dating from the 19<sup>th</sup> century which lay at the base of a thick deposit of loosely packed dressed flint nodules within a compact dark brown calcareous silt matrix (603). This deposit filled the cut, abutted the brick structure on both its sides and sealed the natural chalk horizon to its east. The feature probably acted as some form of drain. Overlying (603) lay a rough flint cobbled surface (602) at approximately 116.60 m OD. This was overlain by (601), a similar dark brown humic-rich deposit as seen elsewhere within the barn.

- 7.4.11 The linear cut in Test Pit 6, aligns well with the eastern sides of the westernmost entrance. The brick divide[?] and the loose flint nodule fill suggests a drainage function below a resurfaced flint floor. The loose flint nodule fill of linear (102) in Test Pit 1 is similar and may share a similar function. This could suggest a difference in use of the western end of the barn.
