Vrow Walk Hampton Court Palace

Archaeological Watching Brief Report

July 2013

Client: Historic Royal Palaces

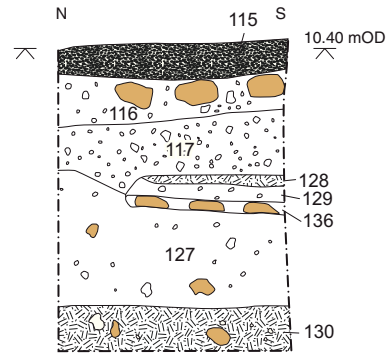
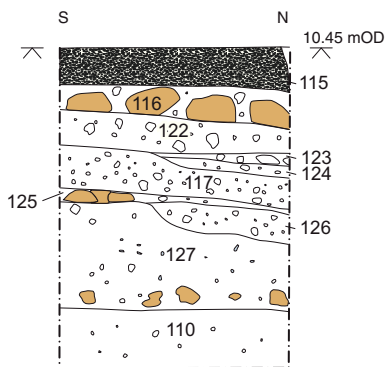
Figure 4: Sections 104, 106, 105 and 103

- 3.1.10 Deeper stratigraphic sequences were recorded in the service trenches and associated trenches. Trenches 1-8 were situated close together in the western part of the area, immediately within the Vrow Walk Gate, and revealed similar sequences of deposits (Fig. 4 sections 105 and 106, Plate 6). The earliest deposits were demolition layers, represented by deposit 110 in Trenches 3, 4, 7 and 8 and by deposit 130 in Trenches 1, 2 and 5. Deposit 110 was a 0.54m thick orange-grey, clay silt with frequent pebble and charcoal inclusions. Layer 130 was exposed in the bases of the trenches closest to the gateway and was formed mainly of crushed lime mortar with small pieces of broken brick and tile. It was at least 0.2m thick. The deposit was exposed at c 9.56m aOD and was similar in appearance and level to layer 109 in Trench 13 in Area G. The depth of neither deposit was established as they extended below the lower limit of the excavation. Layers 110 and 130 were both overlain by layer 127, a mixed, homogeneous sand-silt deposit that contained sparse CBM and charcoal inclusions and measured up to 0.51m thick. It probably represented a former garden soil. It was on this layer that Structure 136 had been constructed. Structure 136 was overlain by a mixed, silty deposit (126, 129). It contained frequent gravel inclusions and measured 0.06m in thickness, and probably represented levelling. It was overlain by a thin layer of crushed lime mortar and very fragmented brick (125, 128). These deposits were sealed by a large deposit of golden sandy gravel (117), 0.2m thick, that was probably part of a path or surface and extended across the entire length of Area E, some 12m N-S x 4.5m E-W. This was in turn overlain by layer 122, a dark grey-brown silt-sand with frequent stone inclusions. Layer (122) was 0.12 thick. It contained abraded sherds from red terracotta flowerpots of 19th century date. Levelling deposit 116 overlay layer 122 and was 0.1m thick. It contained a high quantity of broken brick and CBM as well as gravel, the extent of which continued beyond the limit of excavation in all directions. This was overlain by the modern tarmac surface.

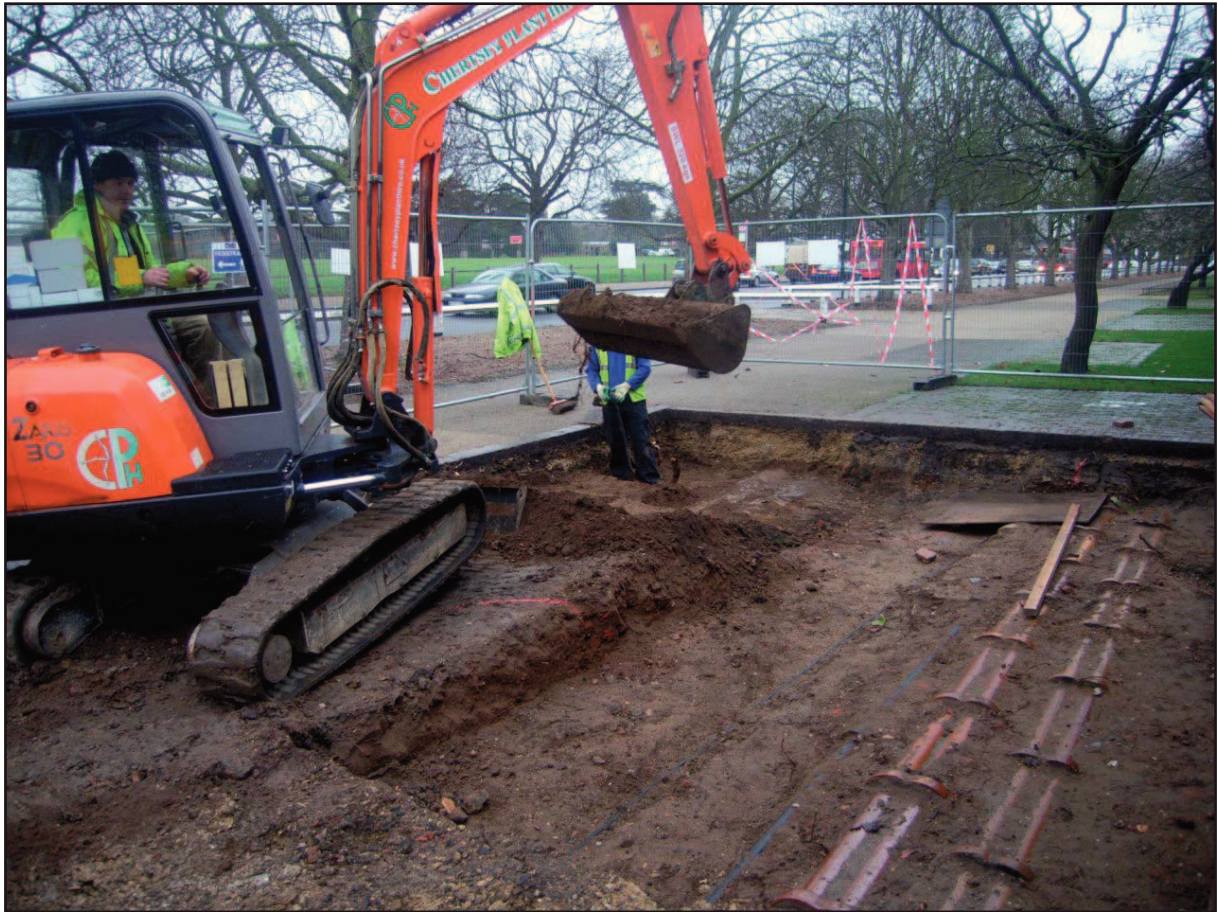
- 3.1.3 Area C was reduced by 0.6m to a depth of 9.81m aOD. Running N-S across the area were two service trenches, which effectively divided the area into three long thin strips. Deposit (101), as seen in Area B, was recorded throughout Area C, again extending deeper than the base of the excavation.

Plate 1 - Machine excavation in Area C exposing modern services .
The roadside verge (Area A) and Vrow Walk (Area B) can be seen in the background

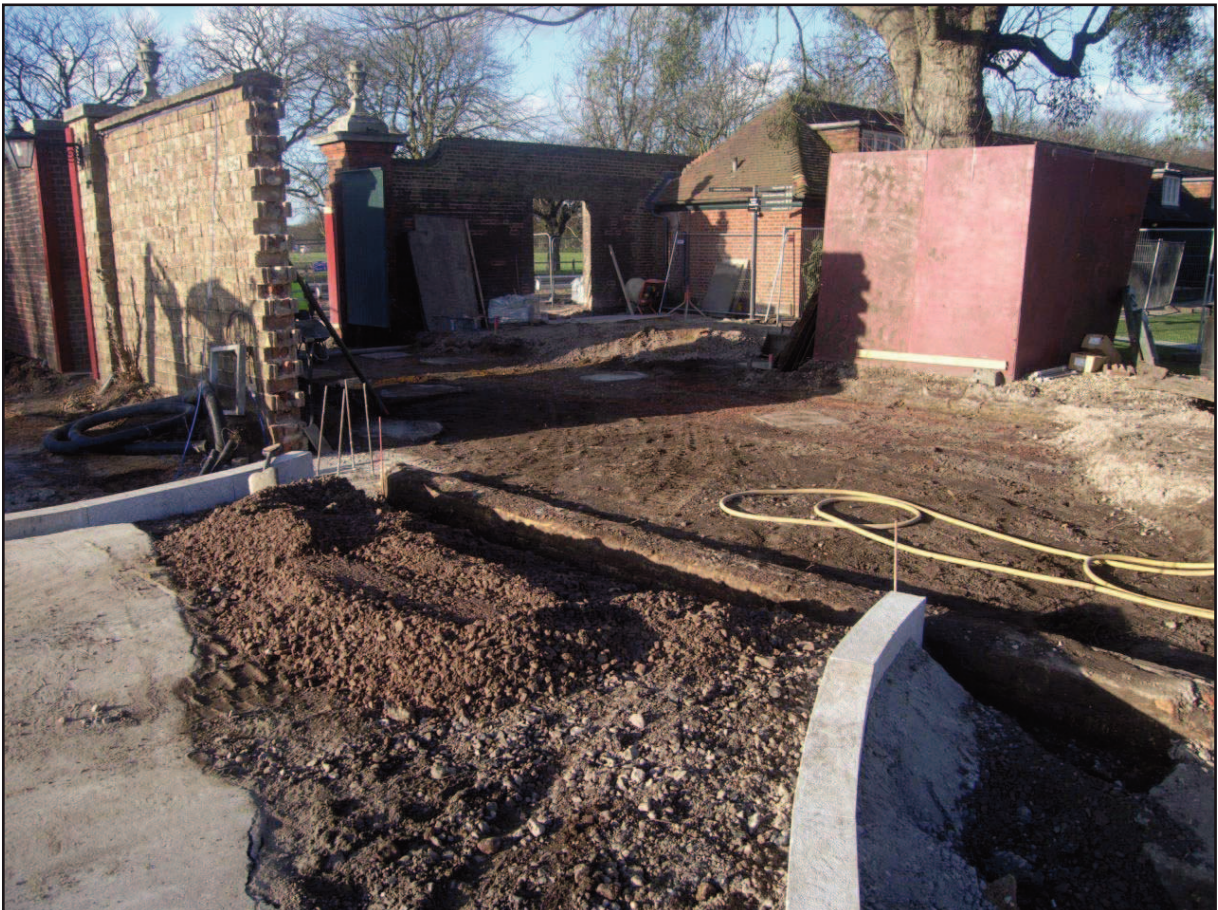
Plate 2 - View through the break in the 19th century garden wall toward Vrow Walk Gate during the groundwork. Upper Car Park (Area H) is the left and the walkway

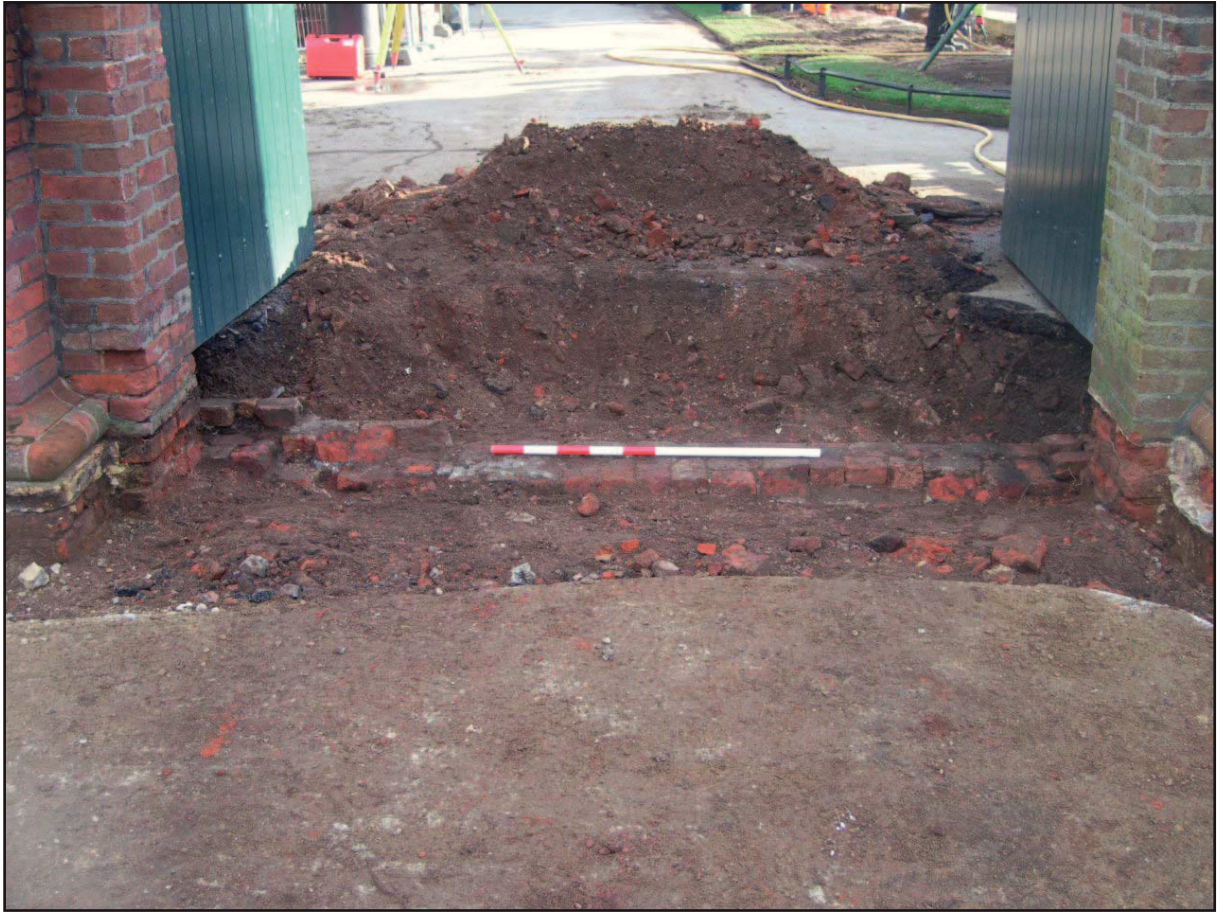
- 3.1.6 Area D, the area within Vrow Walk Gateway, contained the remains of several brick structures (102, 103, 104 and 132; Fig. 3 and Plate 3). Structures 102 and 103 were positioned to the north and south of the gateway respectively and both butted up to the inside corners of the existing brick plinths forming the gateway. Each measured 0.4m N-S x 0.32m E-W and survived to a height of three courses, totalling 0.2m. The bricks measured 220 x 110 x 60mm and were of a soft, mid-red material, bonded with a creamy, soft mortar. The bricks were laid in an irregular coursing and had been previously cut back, leaving an irregular upper surface. A brick sample taken from structure 103 suggests that it dated from no earlier than the 18th century (see below).

- 3.1.7 Running between and abutting structures 102 and 103 was wall 104, which measured 2.25m in length, 0.3m in width, and also had three courses surviving. The bricks measured 220 x 100 x 50mm and were hard and brown-red with a dark grey gritty mortar with lime flecks. The bricks were laid in an irregular stretcher bond with poor quality pointing. The upper courses of all three structures had to be removed and a 0.5m wide slot was cut through wall 104 for construction purposes; otherwise these structures were retained *in situ*. Overlying all three brick structures was a modern levelling deposit of sand and gravel, capped by the stone threshold beneath the gate.

Plate 3 - Structures 102, 103 and 104 exposed within Vrow Walk Gate , Area D

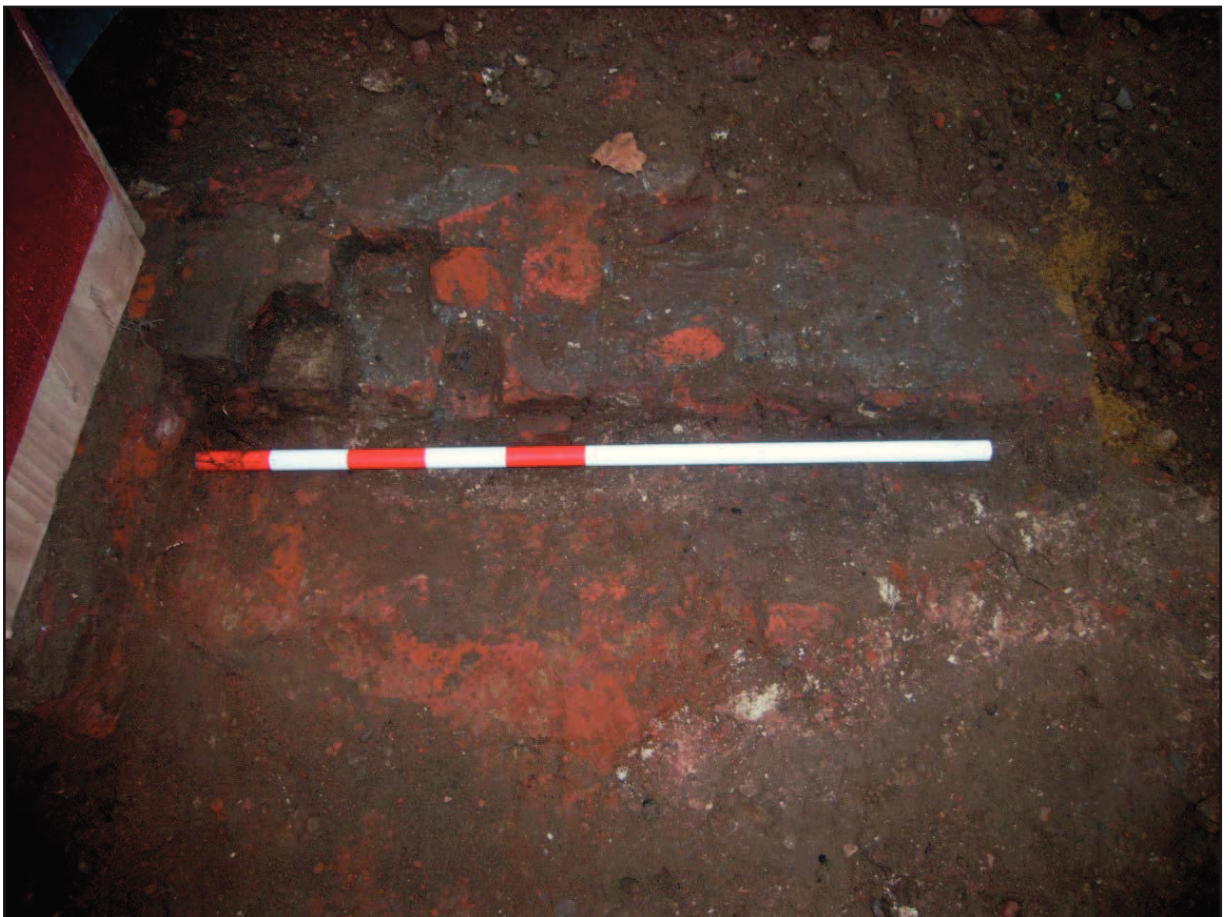
- 3.1.8 Abutting the west sides of structures 102, 103 and 104 were the remains of structure 132 (Fig. 3, Plate 4) which probably represented a continuation of the possible brick surface (131) that was revealed in Area C. Constructed of similar bricks, it measured at least 2.6m N-S by 0.4m E-W and comprised a single course, measuring 0.075m thick. The structure had been heavily truncated to the north, possibly by the same service trenches that had truncated structure 131.

Plate 4 - Brick surface 132 exposed within Vrow Walk Gate, Area D

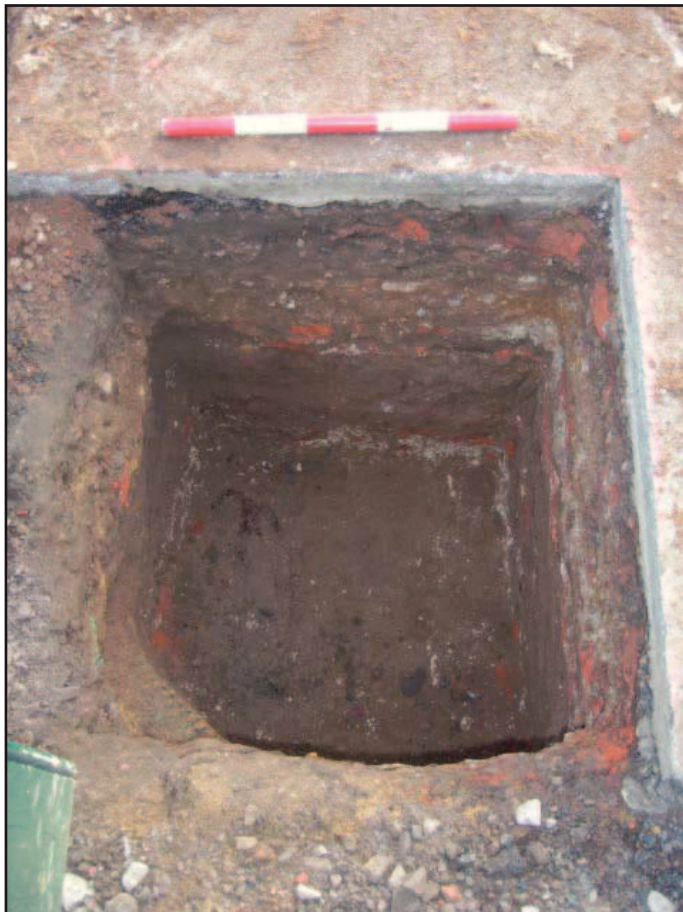
Plate 6 - Trench 5, Area E

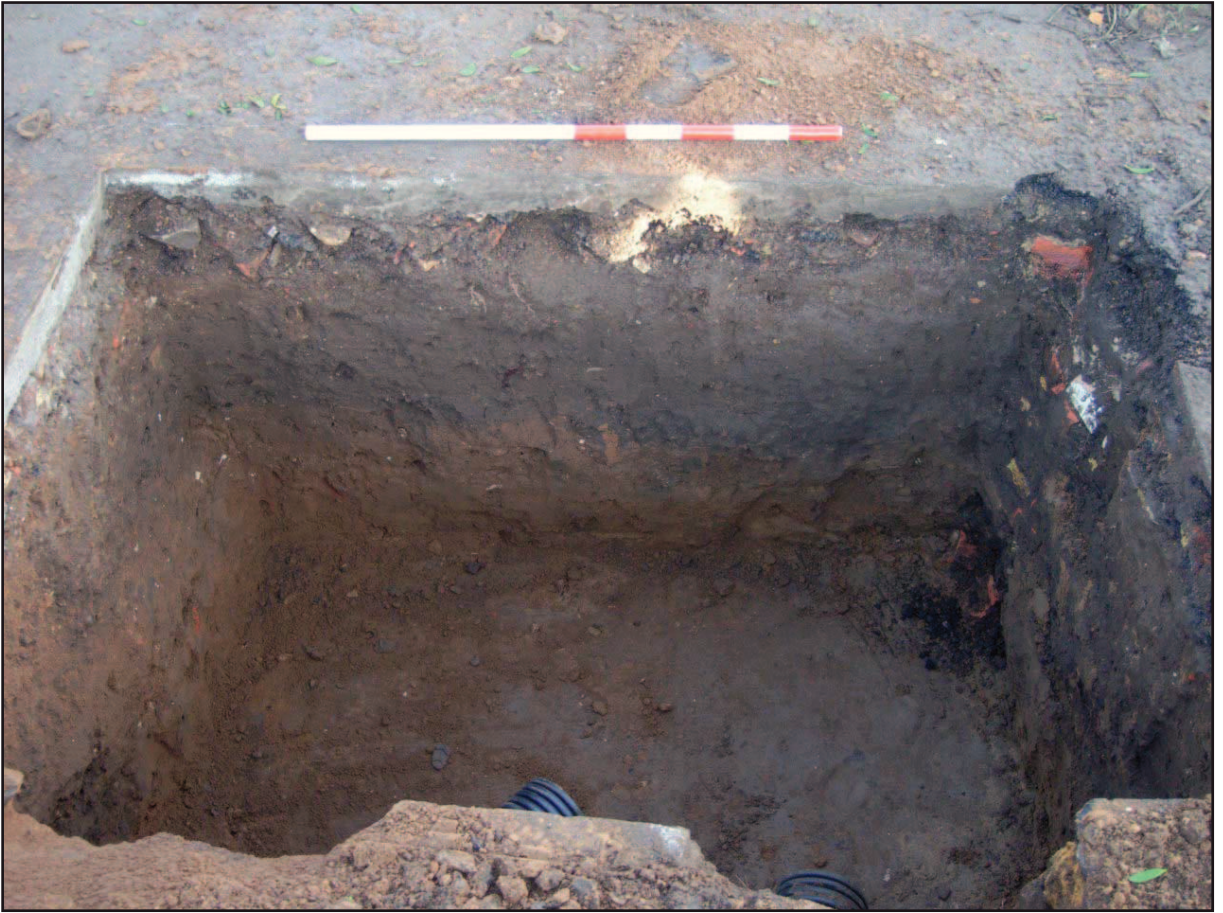
- 3.1.11 Trench 10 was situated at the northern edge of the area and exposed a slightly different sequence (Fig. 4 section 103, Plate 7). The earliest level revealed was a sandy brickearth deposit (121) that was exposed at 8.98m aOD, 1.29m below ground level. This was overlain by demolition deposit 110, which had also been recorded in trenches in the central part of the area. It was overlain by a buried topsoil layer (111) that was sealed beneath modern make-up (114) and tarmac (115).

Plate 7 - Trench 10, Area E

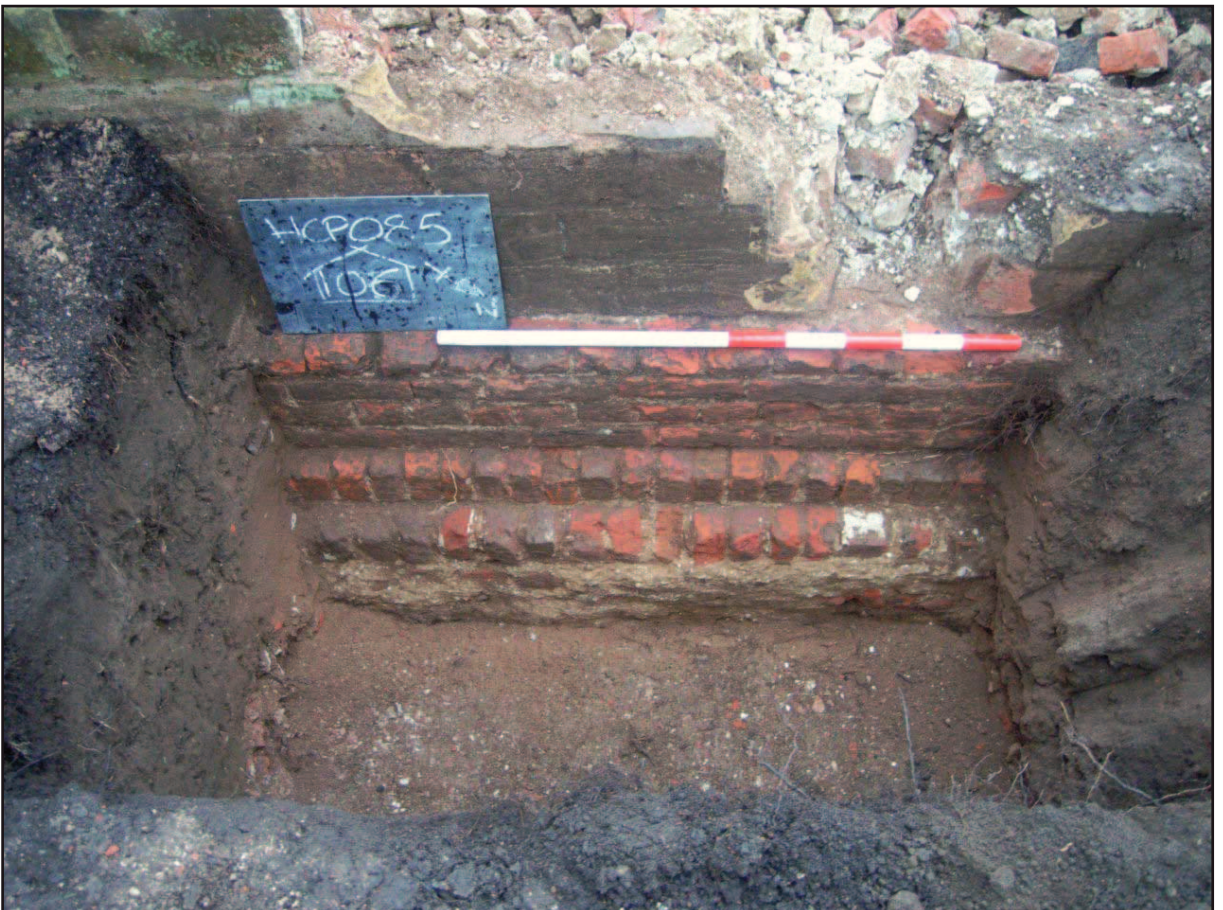
- 3.1.15 Layer 127 was cut by the construction cut (112) for a substantial brick wall (105/106) that was revealed beneath the existing garden wall (108) along the southern boundary of the car park (Figs 3 and 5; Plate 8). It was exposed for a length of 8.8m and measured 0.45m wide and 0.5m high, surviving to four courses in height above a stepped foundation. The wall stepped out twice such that it measured at least 0.8m in width at its base. The bricks were handmade, orange/rose or rose coloured, measuring 220-228 x 100-105 x 58-64mm and were bonded by dark cream mortar with lime inclusions. The bricks were of late 17th or 18th century type. The wall was supported upon a foundation of compacted mortar, broken brick, tile, at least 0.3m thick that continued below the base of the trench. The backfill of the foundation trench comprised a mixed, silty deposit (137) derived from the material through which it was cut, as a consequence of which the edge definition was unclear.

Plate 8 - Wall 106 exposed beneath the existing 19th century garden wall in Trench 11, Area E
