# Water Inlet Home Park Hampton Court Palace

**Historic Structure Recording  
and Investigation**

March 2014

**Client: Historic Royal Palaces**

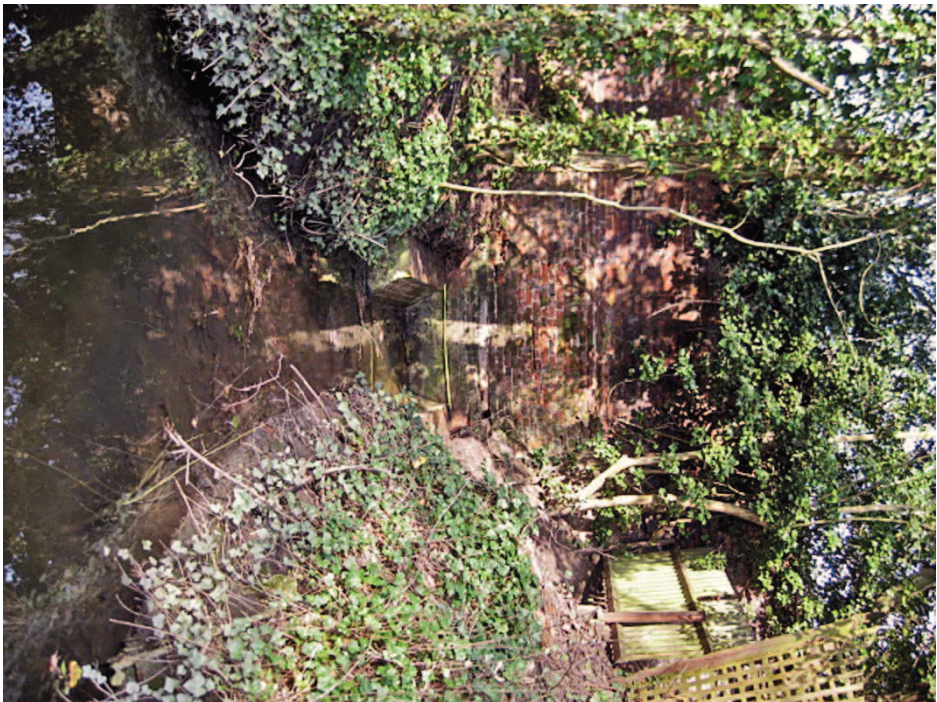
Plate 1: Water inlet, looking north

3.1.1 The structure under investigation is located on the eastern side of the boundary wall just south of the north eastern most corner of the park. The structure comprises two short opposing stretches of yellow brick embankments, which abut the eastern face of the wall to their west, and flank a terracotta pipe protruding from the walls base. These brick embankments act as revetments to the higher ground on either side of the channel (Plate 1). At the time of survey the pipe and the inlet appeared active, with water present.

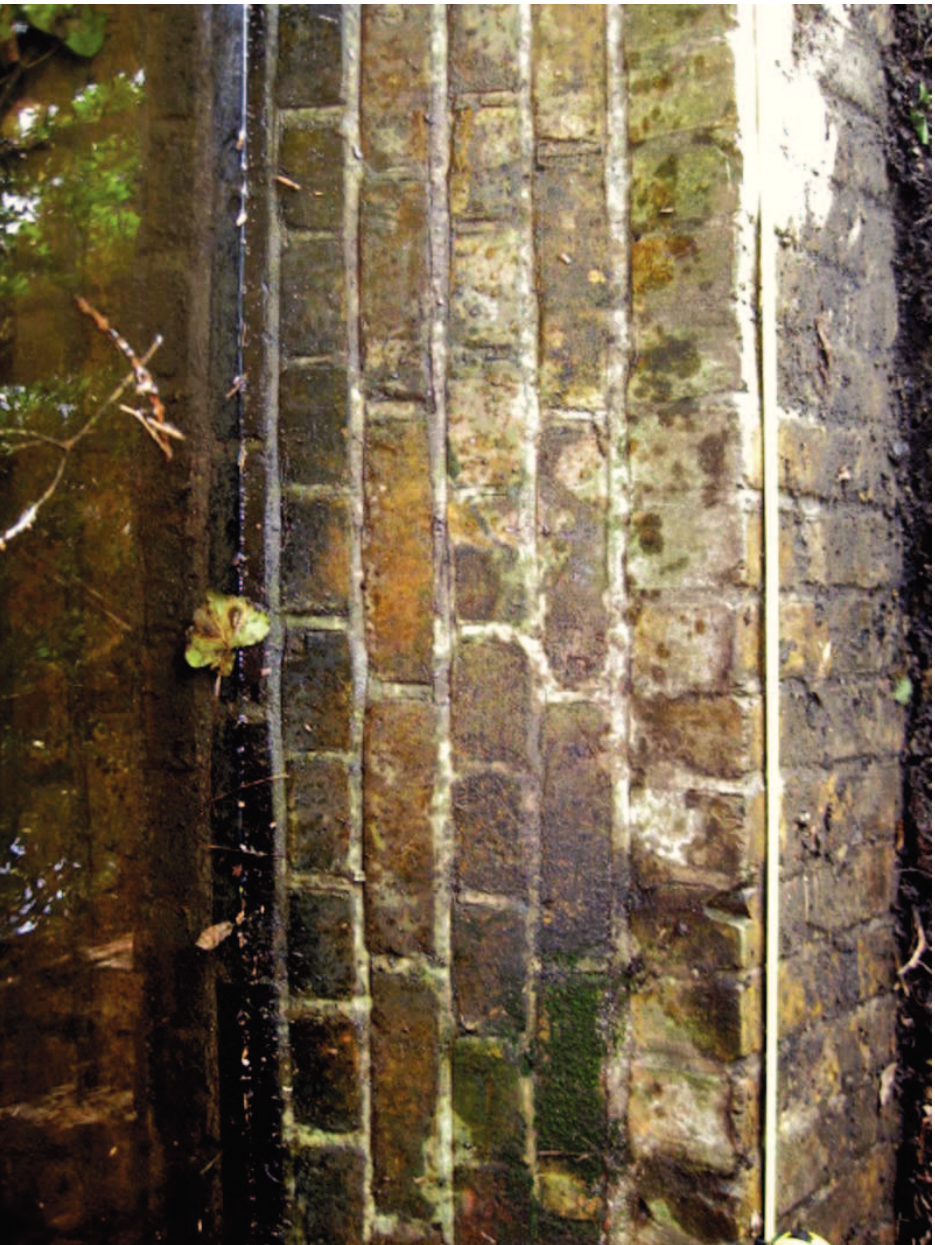
Plate 4: Detail of water inlet, looking west

- 3.2.2 The embankments are constructed with a yellow Gault brick and a hard grey cementitious mortar in an English bond (Plate 4). This is a similar brick used elsewhere in the locality e.g. at Southwark & Vauxhall Water Company buildings on Thames Street, Hampton. The embankments are in good condition with little sign of weathering and appear fit for purpose as revetments to the channel banks.

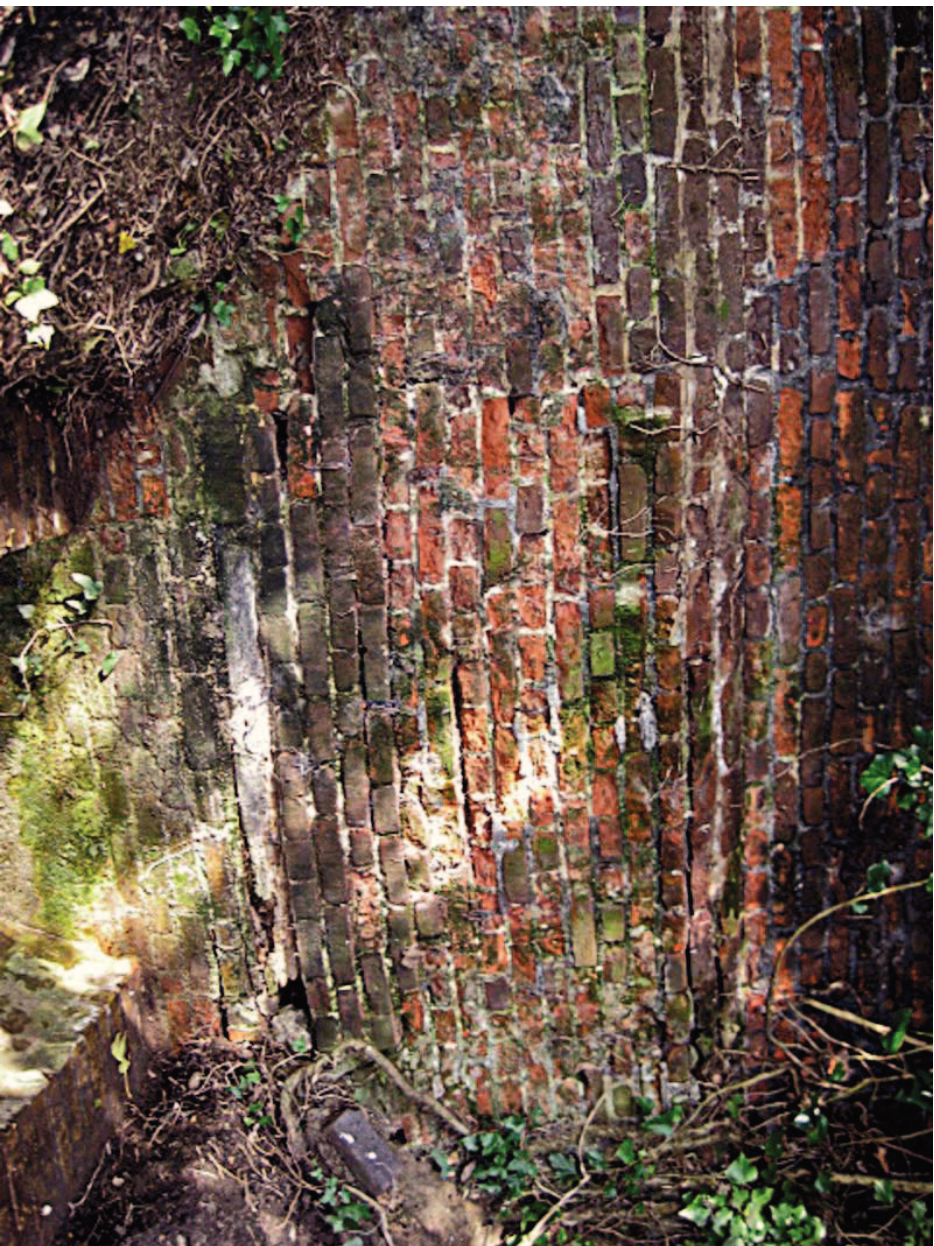
Plate 5: Historic boundary wall above water inlet, looking north

- 3.2.3 The embankments abut the boundary wall of Home Park wall, which is earlier in date (Plate 5). The bricks are rough in texture and a rich orange colour, with irregular coursing that appears to be English bond in some courses. The mortar is a yellowish white friable lime mortar. Above the channel is a much weathered wooden lintel (partly missing at its northern end), this is surrounded by crumbling white lime mortar, the coursing of the wall above the lintel sags somewhat. Straight joints appear in the wall below the lintel (Figure 12), which may represent repair of infill of the area surrounding the modern terracotta pipe. The section of wall immediately surrounding the pipe is plastered with cement. Above this, there is a rough straight joint or a repaired crack.

- 4.1.1 The bricks of the boundary wall are in poor condition, many having lost their faces due to weathering and clear signs of patching repair work, making it difficult to date them. However, they do not appear to be later than 18th century and may in fact belong to the start of this century, such as a Wren stock brick dating to the turn of the 18th century. This is probably therefore the wall shown in Talman's Plan dating to 1698. These bricks are similar in colour and dimensions to those found in the William and Mary compartment walls from the Kitchen Gardens in the former Tiltyard dating which date to the turn of the 18th century (OA, 2013; Trenches 12 & 17).

- 4.1.2 The lintel, which is likely to be contemporary with the brickwork, and the later brick blocking below, may indicate that there was once an opening in the wall through which the open channel originally passed, and before the channel to the west was covered over. The embankments under investigation may have been built at the time that the easternmost ponds of the Hampton Wick Pond group were filled in, and the stream was narrowed i.e. some time between 1865 and 1898. As stated above, they appear to be built from the same Gault brick as the nearby Southwark & Vauxhall Water Company buildings, which were built between 1867 and 1886. It is likely that they date to this period of construction and were built from surplus bricks or were a part of a programme to update the drainage in the area. The terracotta pipe and the cement work around it are likely to be later in date than the embankments.
