# Chamberlain Hall University of Southampton

## Archaeological Evaluation Report

June 2012

**Chamberlain Hall**  
**University of Southampton**  
**Hampshire**  
***ARCHAEOLOGICAL EVALUATION REPORT***

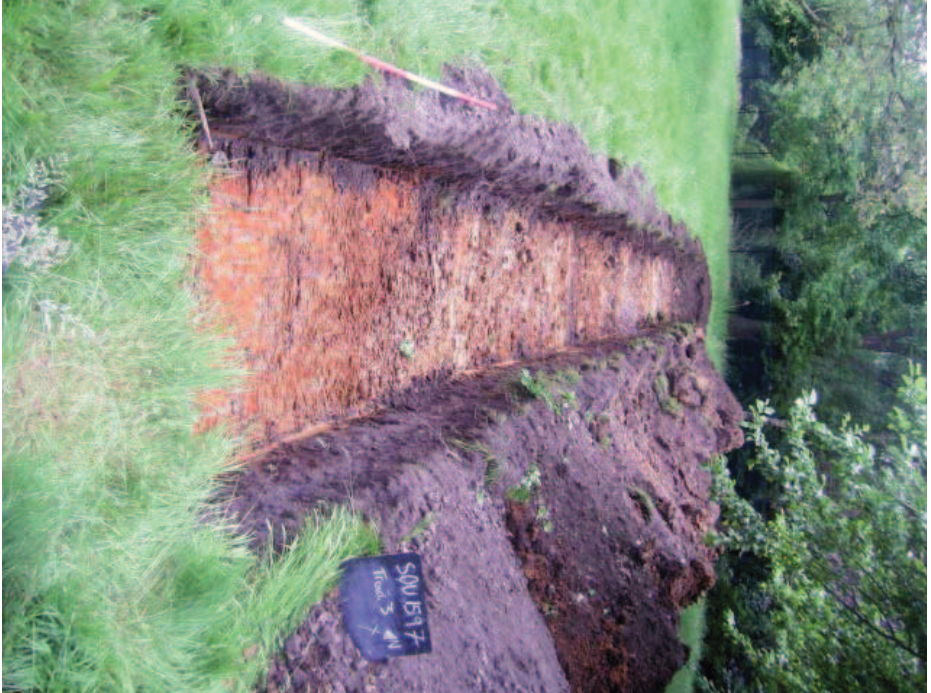
Plate 1: Trench 1

Trench 1						
<b>General description</b>					<b>Orientation</b>	NE-SW
Consists of a buried subsoil and topsoil overlain by a modern landscaping deposit and present topsoil.					<b>Avg. depth (m)</b>	0.9
					<b>Width (m)</b>	1.6
					<b>Length (m)</b>	13
Contexts						
Context No	Type	Width (m)	Depth (m)	Comment	Finds	Date
100	Layer	-	0.3	Topsoil	-	-
101	Layer	-	0.25	Redeposited orange brown natural clay – landscaping deposit	Pottery	19th-20th C
102	Layer	-	0.26	Buried topsoil. Friable dark brown sandy clay with gravels	-	-
103	Layer	-	0.1	Subsoil / dirty natural – a disturbed interface between natural and old plough soil	-	-
104	Layer	-	-	Natural – orange brown clay with patches of gravel	-	-

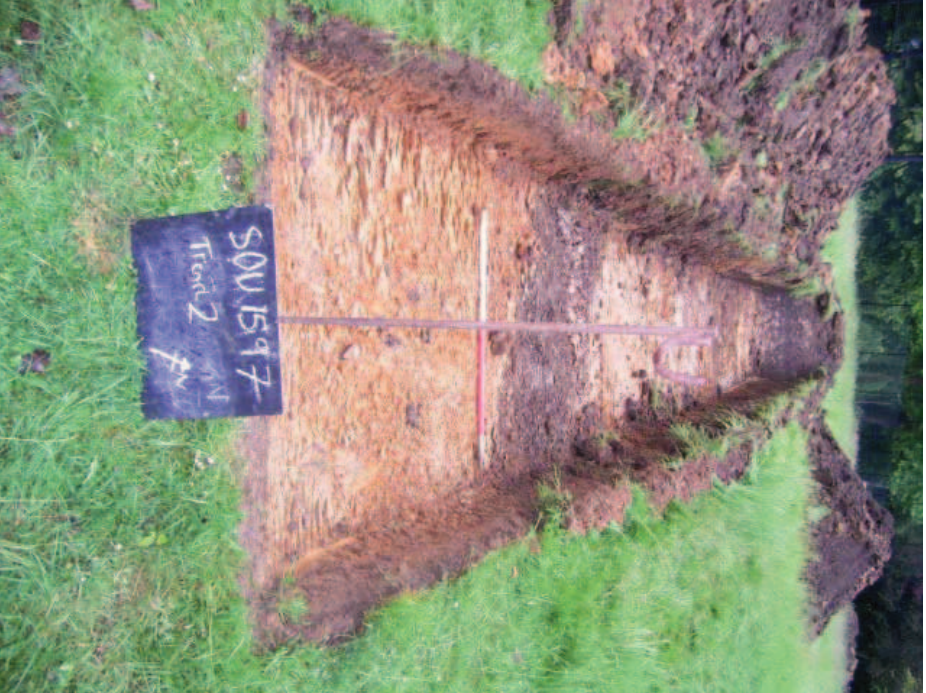
Plate 2: Trench 2

4.2.1 No archaeological remains were encountered in any of the trenches. Five out of the six trenches excavated (Trenches 1-4 and 6) exhibited evidence of modern landscaping relating to the extant structures and modern landscaping. Trench 2 also contained a modern service, which was left *in situ*.

Trench 2						
<b>General description</b>					<b>Orientation</b>	NW-SE
Trench devoid of archaeological remains. Consists of soil and subsoil overlying a natural deposit of silty sand.					<b>Depth (m)</b>	0.5-1.0
					<b>Width (m)</b>	1.6
					<b>Length (m)</b>	15
Contexts						
Context No	Type	Width (m)	Depth (m)	Comment	Finds	Date
200	Layer	-	0.2	Topsoil	-	-
201	Layer	-	0.36	Redeposited yellow orange natural clay – landscaping deposit	-	-

202	Layer	-	0.36	Buried topsoil. Tenacious dark brown silty clay with gravels	-	-
203	Layer	-	-	Natural - yellow orange clay	-	-

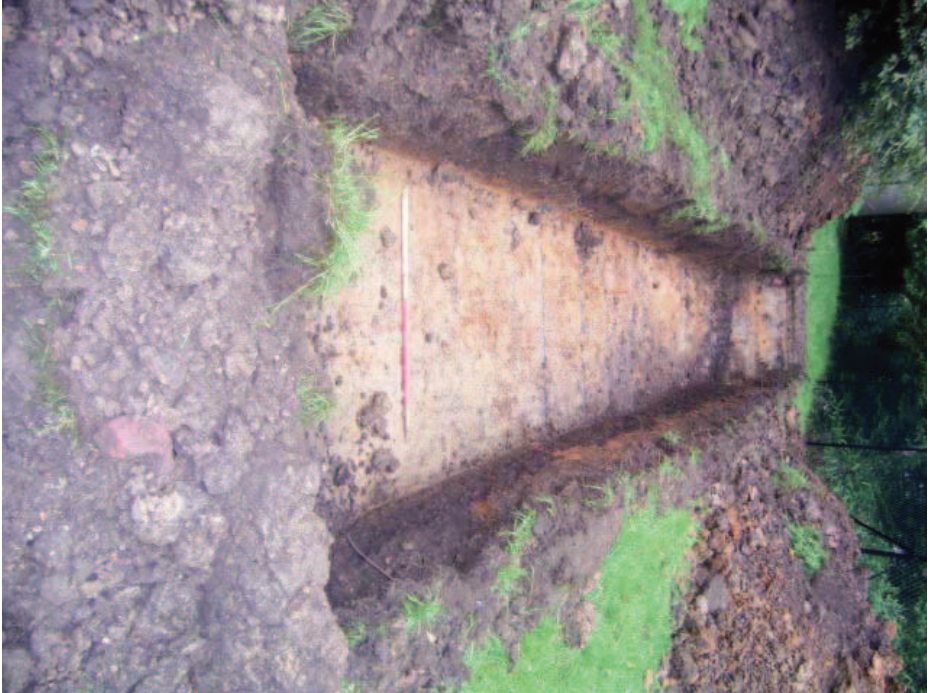
Plate 3: Trench 3

Trench 3						
<b>General description</b>					<b>Orientation</b>	NE-SW
Consists of topsoil and a landscaping deposit overlying the natural clay.					<b>Avg. depth (m)</b>	0.6
					<b>Width (m)</b>	1.6
					<b>Length (m)</b>	22
Contexts						
Context No	Type	Width (m)	Depth (m)	Comment	Finds	Date
300	Layer	-	0.25	Topsoil	-	-
301	Layer	-	0.45	Mixed grey sand and ash-rich gravel with orange clay – landscaping deposit	-	-
302	Layer	-	-	Natural	-	-

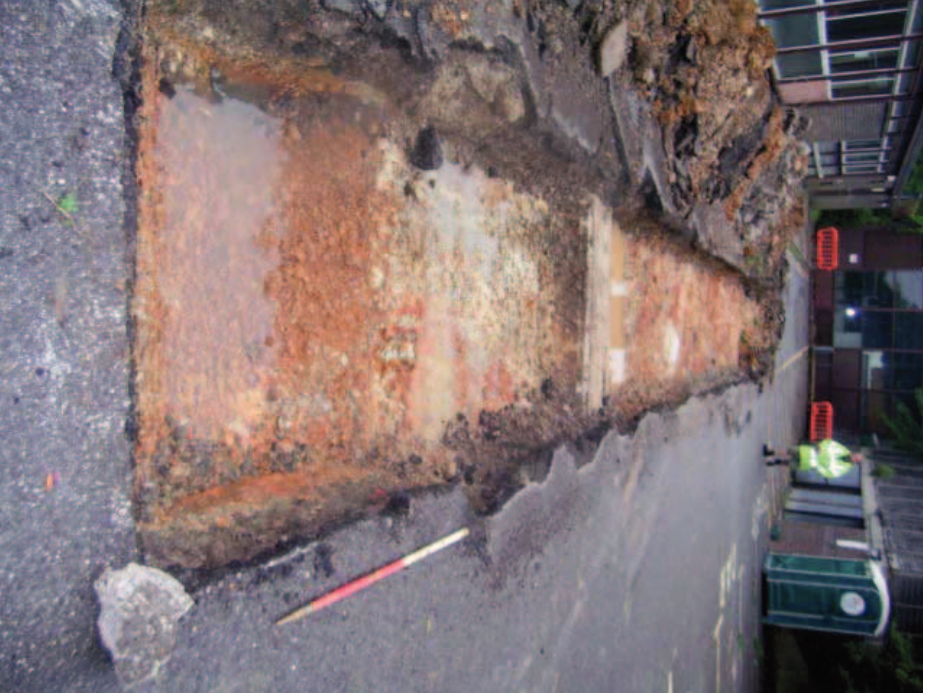
Plate 4: Trench 4

3.2.2 Trench 4 was dug through a tarmac surface that had been laid over a combination of concrete slab and made ground overlying the natural clay.

4.2.2 In Trench 4, the modern carpark surface sits directly on the natural geology and has completely truncated away any previous land surface.

Trench 4						
<b>General description</b>					<b>Orientation</b>	E-W
Trench devoid of archaeological remains. Consists of modern tarmac and concrete overlying a natural orange clay with gravel patches. Concrete beam present within the trench. This beam is likely to be associated with the foundations of Chamberlain Hall.					<b>Avg. depth (m)</b>	0.35
					<b>Width (m)</b>	1.6
					<b>Length (m)</b>	17
Contexts						
Context No	Type	Width (m)	Depth (m)	Comment	Finds	Date
400	Layer	-	0.1	Tarmac	-	-
401	Layer	-	0.25	Made ground	-	-
402	Layer	-	0.22	Reinforced concrete	-	-
403	Layer	-	-	Natural	-	-

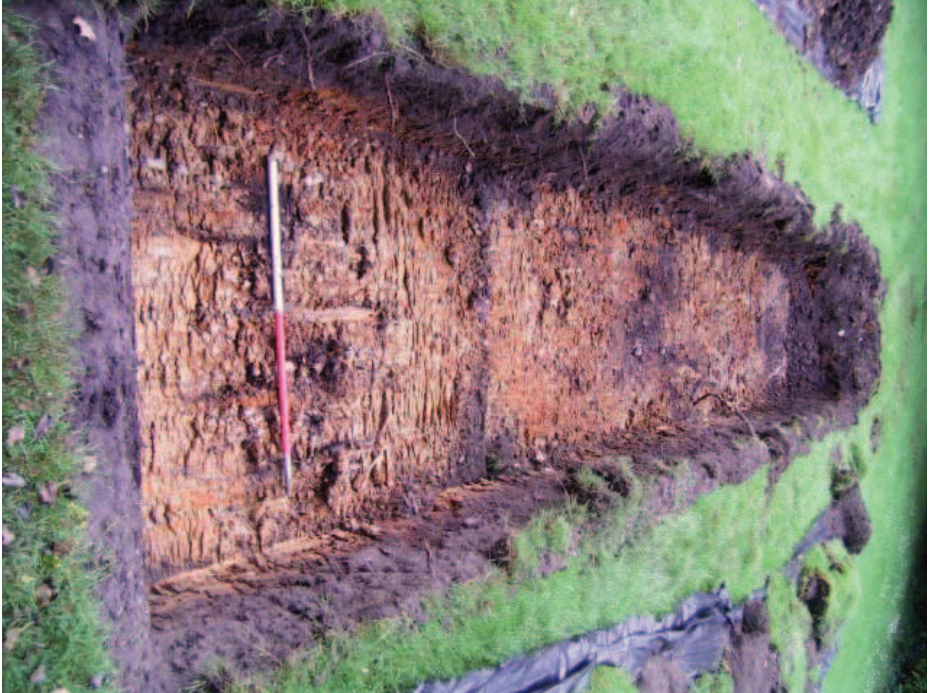
Plate 5: Trench 5

<b>Trench 5</b>						
<b>General description</b>					<b>Orientation</b>	NNW-SSE
No archaeological remains present.					<b>Avg. depth (m)</b>	0.6
					<b>Width (m)</b>	1.6
					<b>Length (m)</b>	9
<b>Contexts</b>						
<b>Context No</b>	<b>Type</b>	<b>Width (m)</b>	<b>Depth (m)</b>	<b>Comment</b>	<b> Finds</b>	<b>Date</b>
500	Layer	-	0.35	Topsoil - mid grey brown silty clay	Pottery	19th century
501	Layer	-	0.26	Subsoil - tenacious mixed yellow brown clay with mixed mid grey brown clay. Heavily root disturbed.	-	-
502	Layer	-	-	Natural – tenacious orange brown with grey mottles and clayey outcrops of poorly sorted gravel	-	-

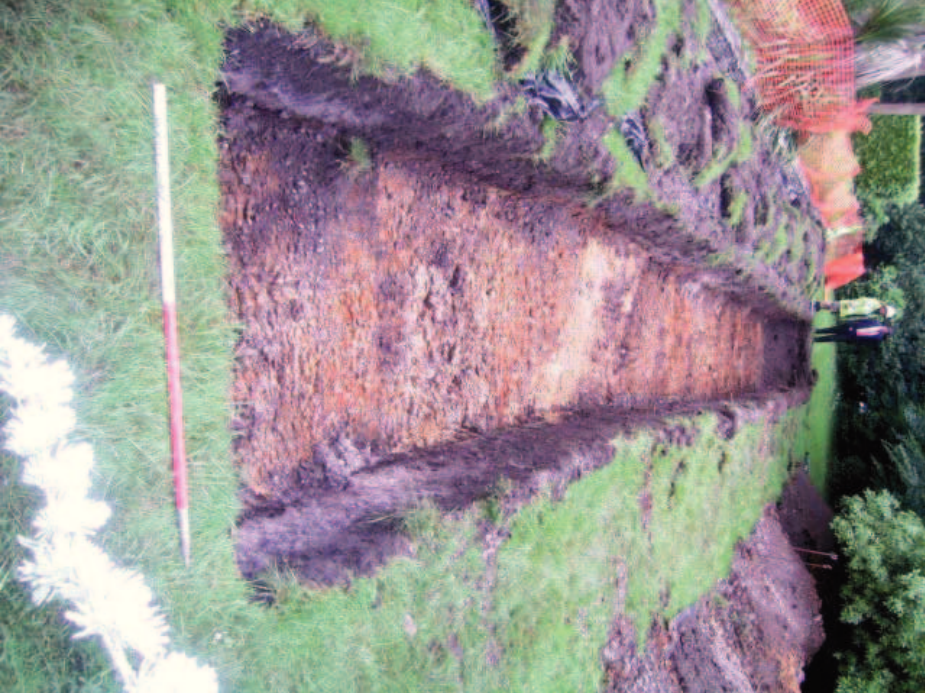
Plate 6: Trench 6

<b>Trench 6</b>						
<b>General description</b>					<b>Orientation</b>	ENE-WSW
No archaeological remains. Some evidence of made ground likely associated with 19th-century landscaping associated with Bassett House.					<b>Avg. depth (m)</b>	0.6
					<b>Width (m)</b>	1.6
					<b>Length (m)</b>	18
<b>Contexts</b>						
<b>Context No</b>	<b>Type</b>	<b>Width (m)</b>	<b>Depth (m)</b>	<b>Comment</b>	<b> Finds</b>	<b>Date</b>
600	Layer	-	0.28	Topsoil – friable mid brown sandy clay	-	-
601	Layer	-	0.5	Made ground – friable light grey silty sand with poorly sorted gravel and lenses of grey ashy gravel	-	-
602	Layer	-	-	Natural – orange /light grey sandy gravel.	-	-

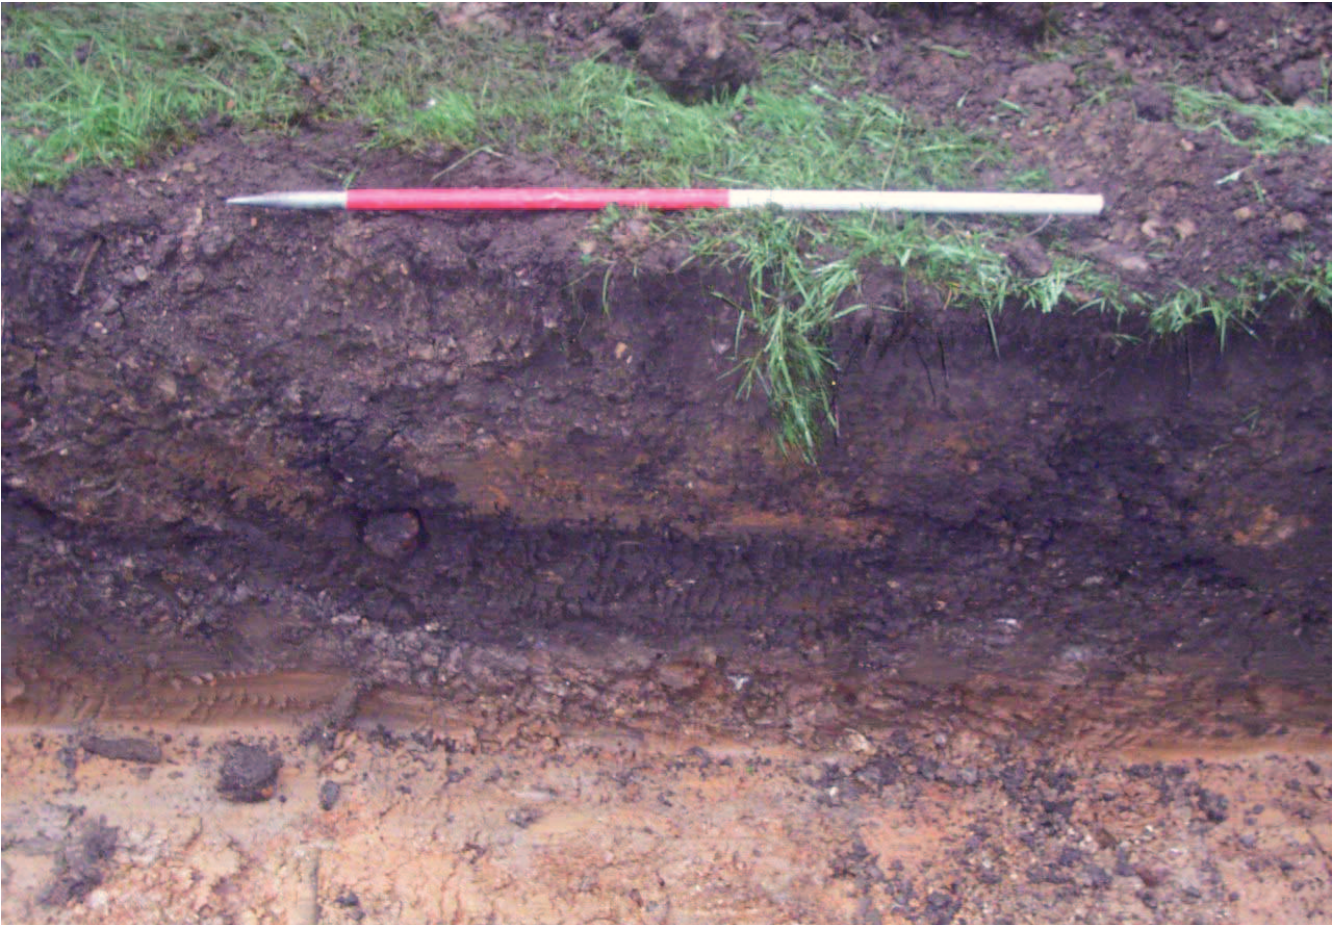
- 4.2.3 The presence of a buried soil in Trenches 1 and 2 and the absence of any landscaping deposit in Trench 5 suggest that there has been little truncation of the earlier soil sequence in the west of the site.

Plate 7: Trench 1 showing modern landscaping deposit overlying buried topsoil

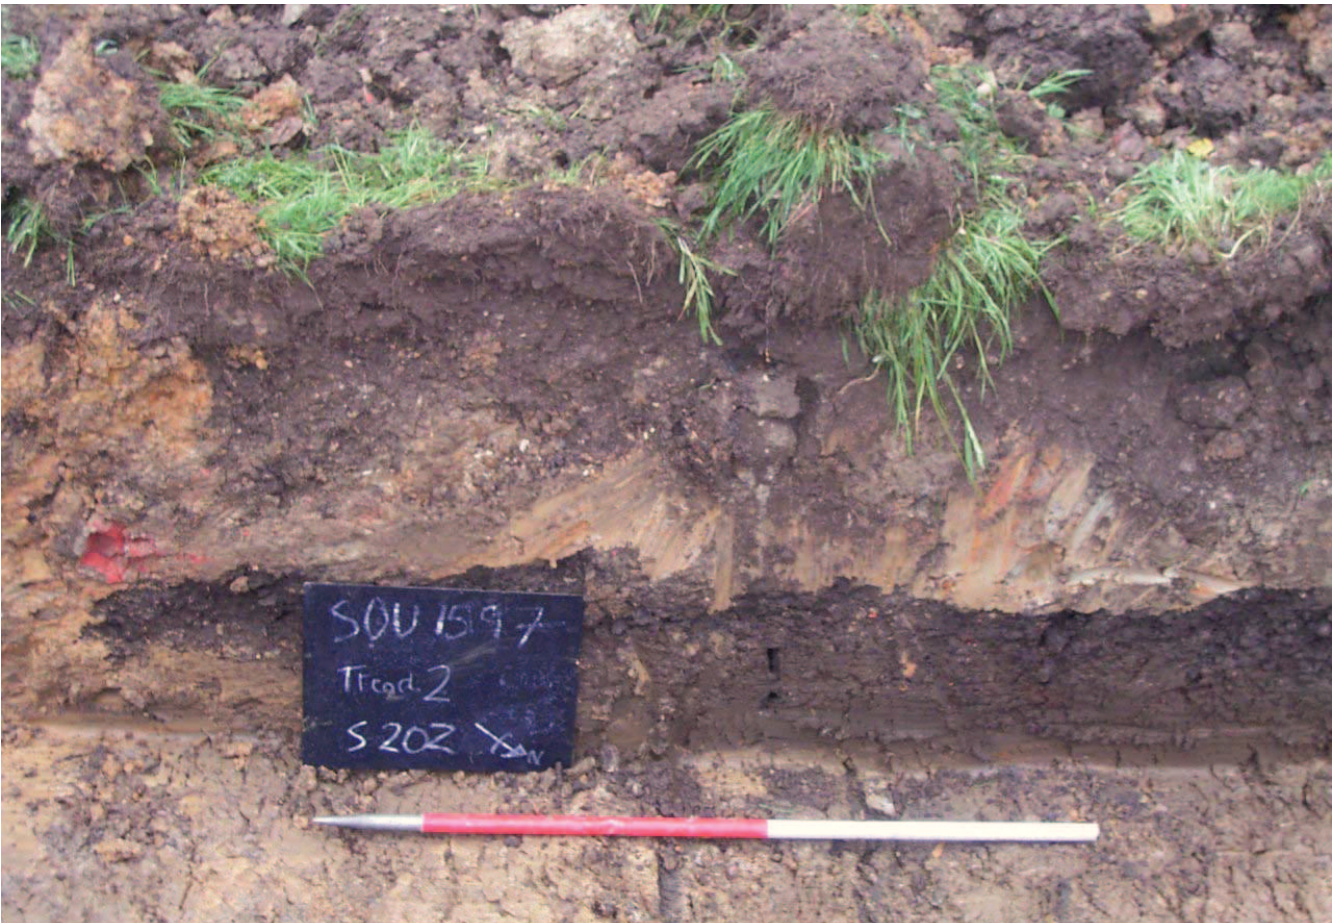
Plate 8: Trench 2 showing modern landscaping deposit overlying buried topsoil

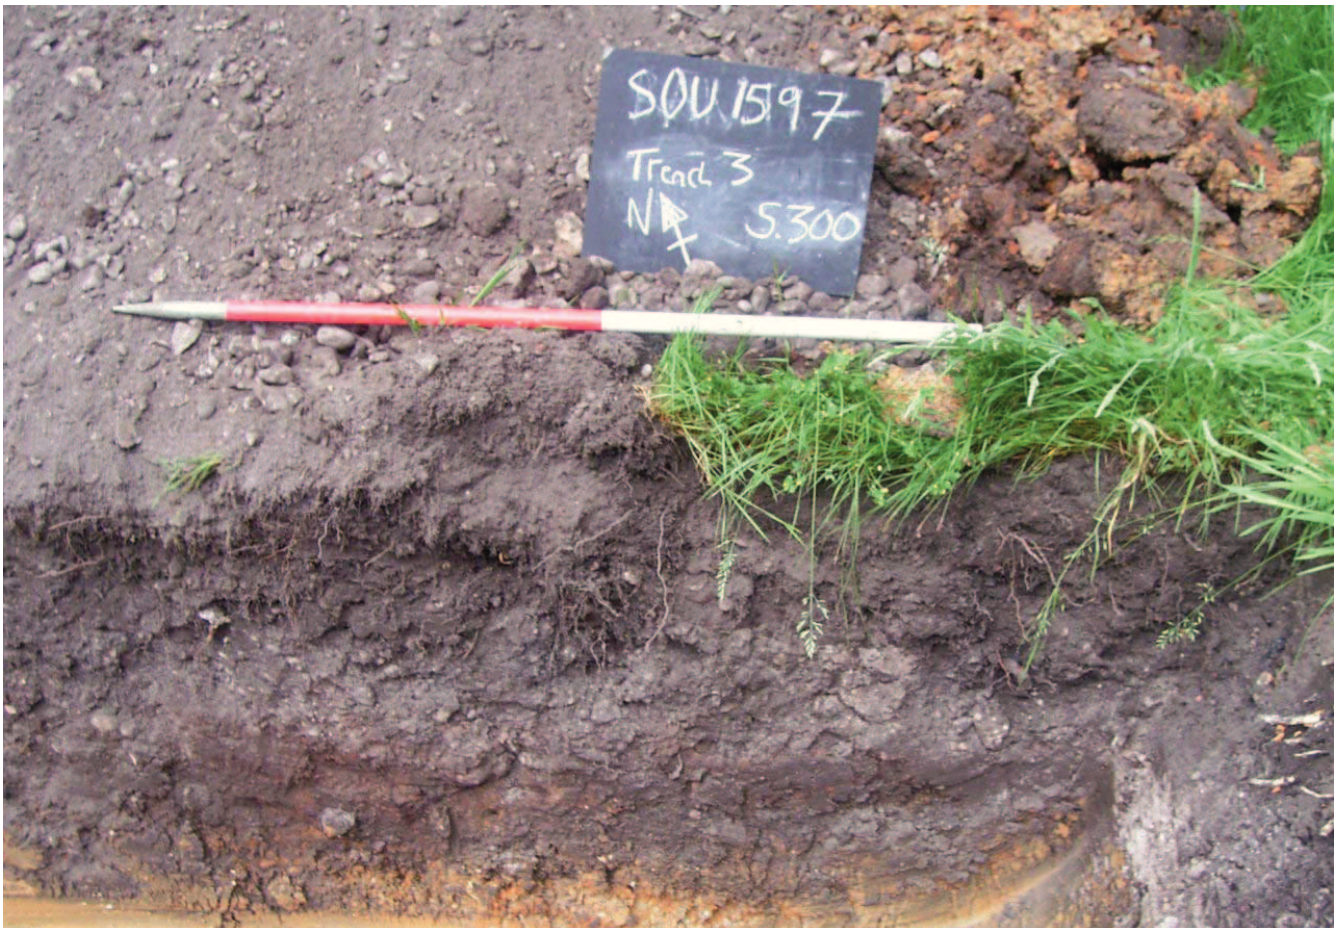
Plate 9: Trench 3 showing landscaping deposit

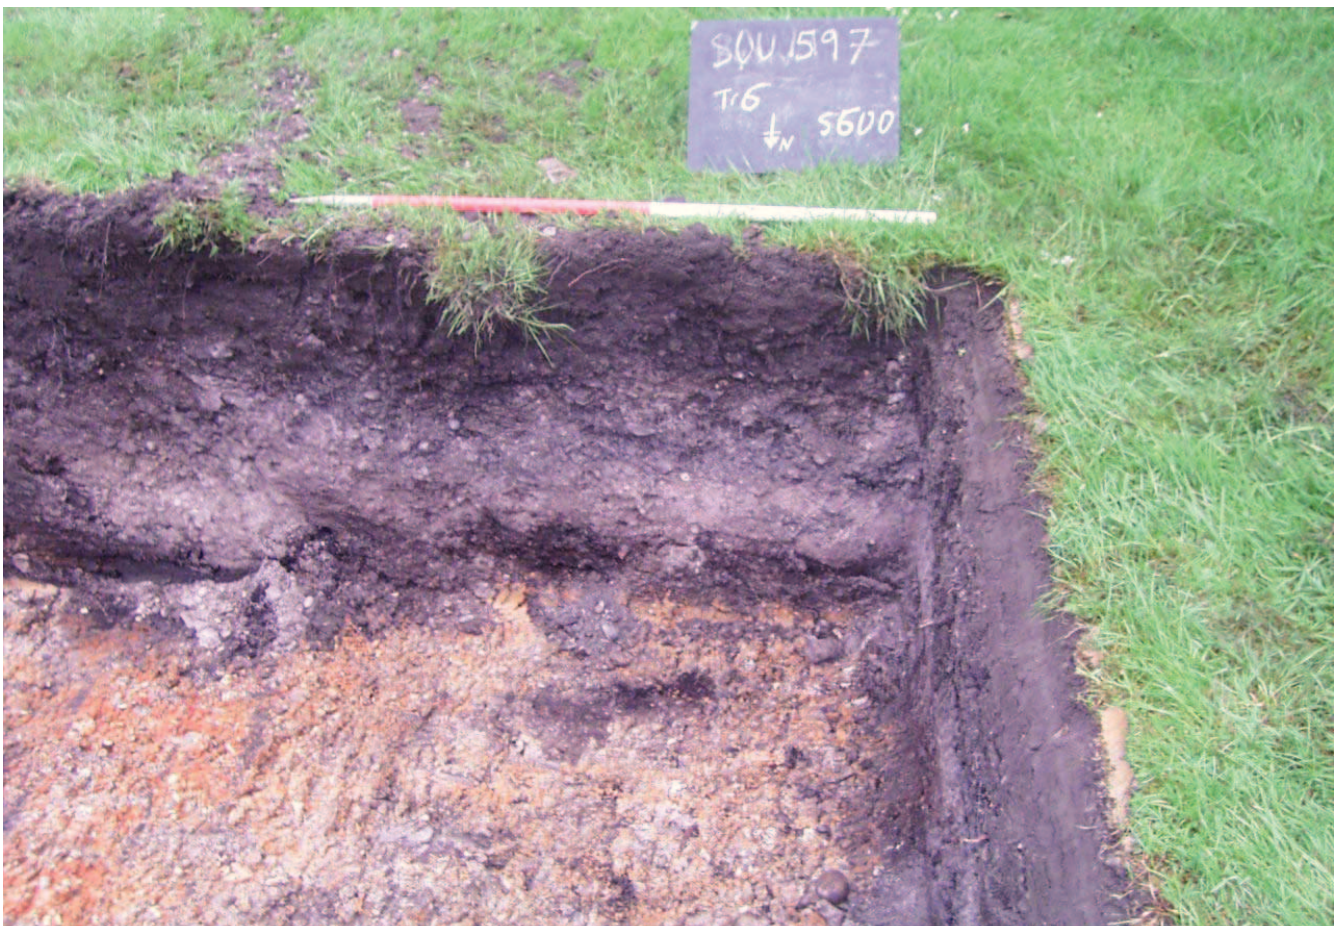
Plate 10: Trench 6 showing landscaping deposit
