# Power Line Pole Refurbishment Trowbridge to Hawkeridge Wiltshire

## Archaeological Watching Brief Report

May 2014

Client: SSE

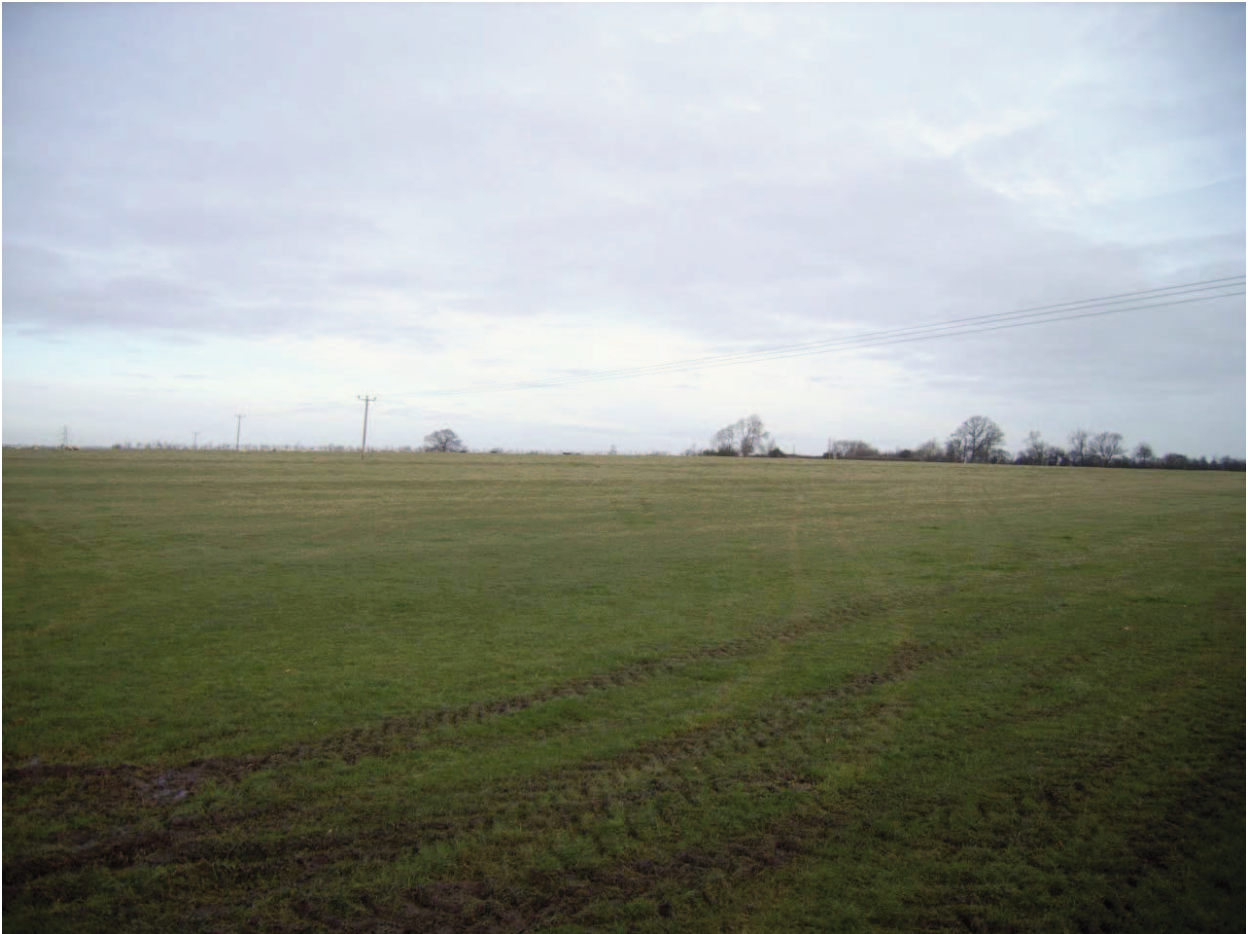
Plate 1: View NE across the DMV at Arnold's Hill

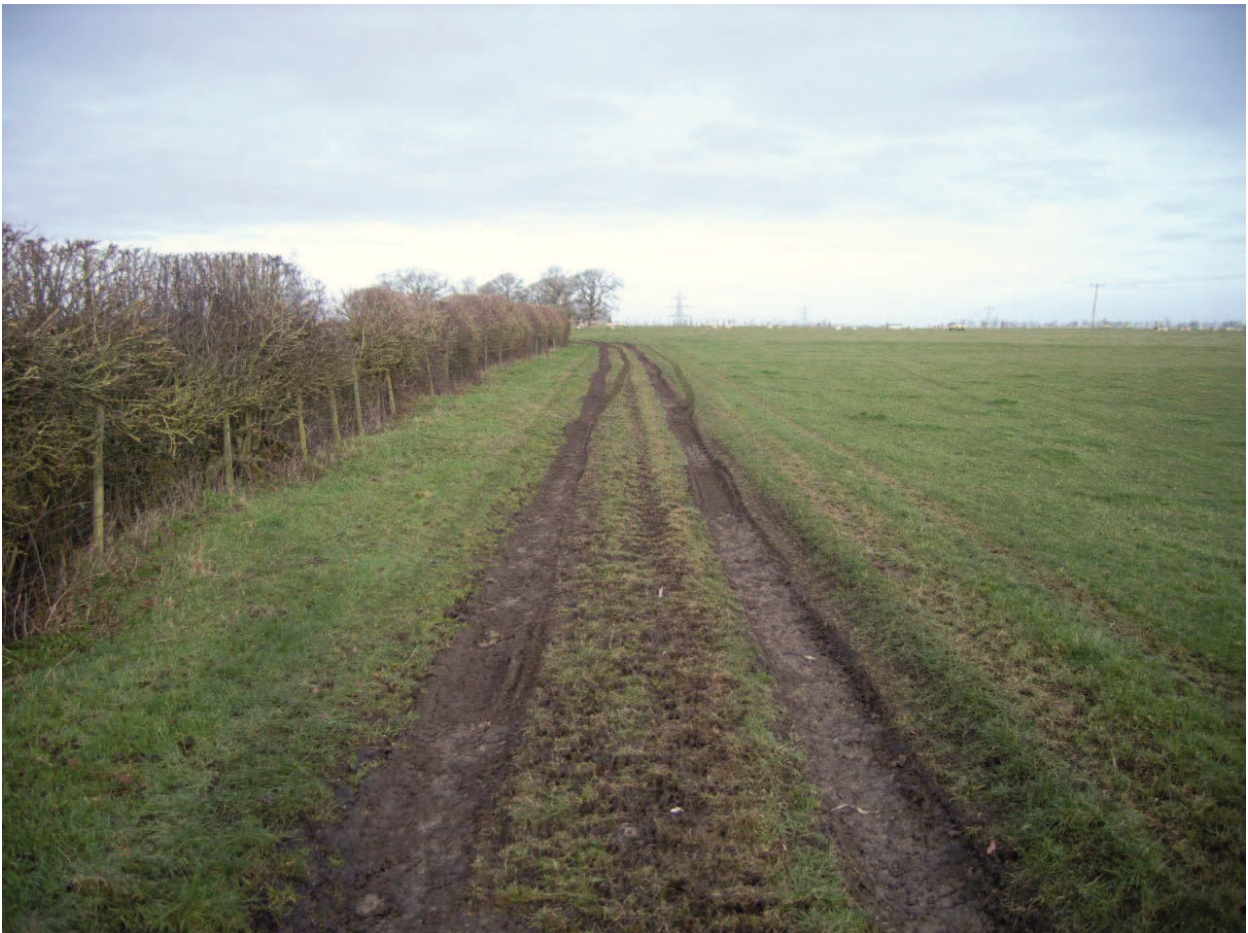
- 3.1.3 By utilising the existing farm tracks vehicle movement over areas of archaeological interest was limited to a minimum (Plate 2). The ground conditions during the work were firm which, combined with the use of low pressure within the tyres and restricting the number of vehicles that needed to access the site, resulted in minimal rutting and compression of the soil (Plate 3). Where noted this was generally confined to the upper 25 mm of the turf and topsoil caused by the tyre tread of the excavator (Plate 4).

Plate 2: View NW along the existing farm track west of poles 10 and 11

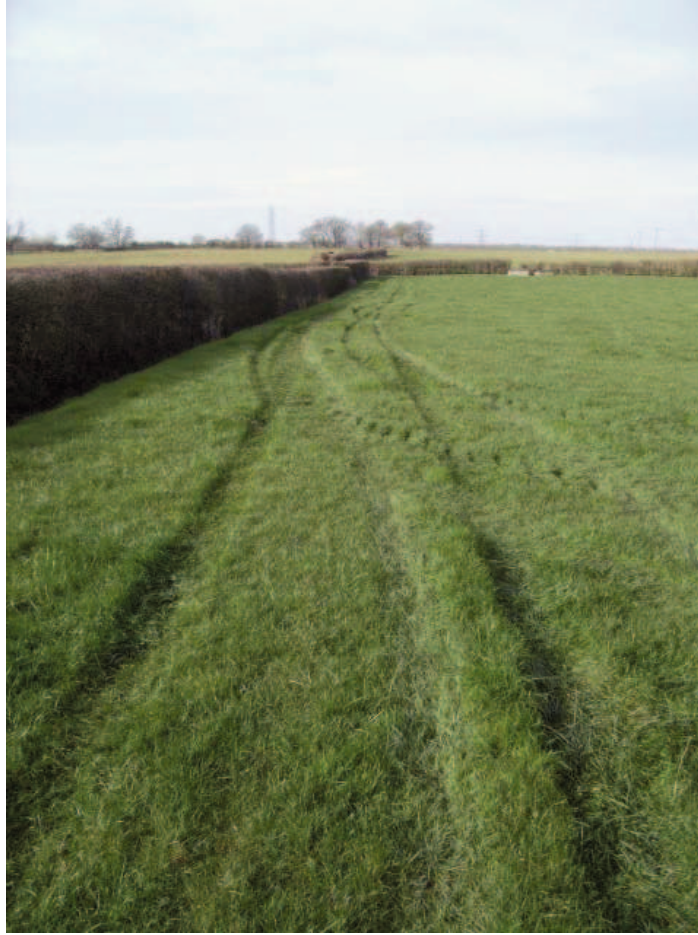
Plate 3: View NW illustrating the limited surface compaction caused by the works

- 4.1.2 The impact of the plant upon the upstanding earthworks was very limited with no permanent affect to these. Restrictions to plant movements and careful consideration of access routes following advice from the OA staff proved very effective.

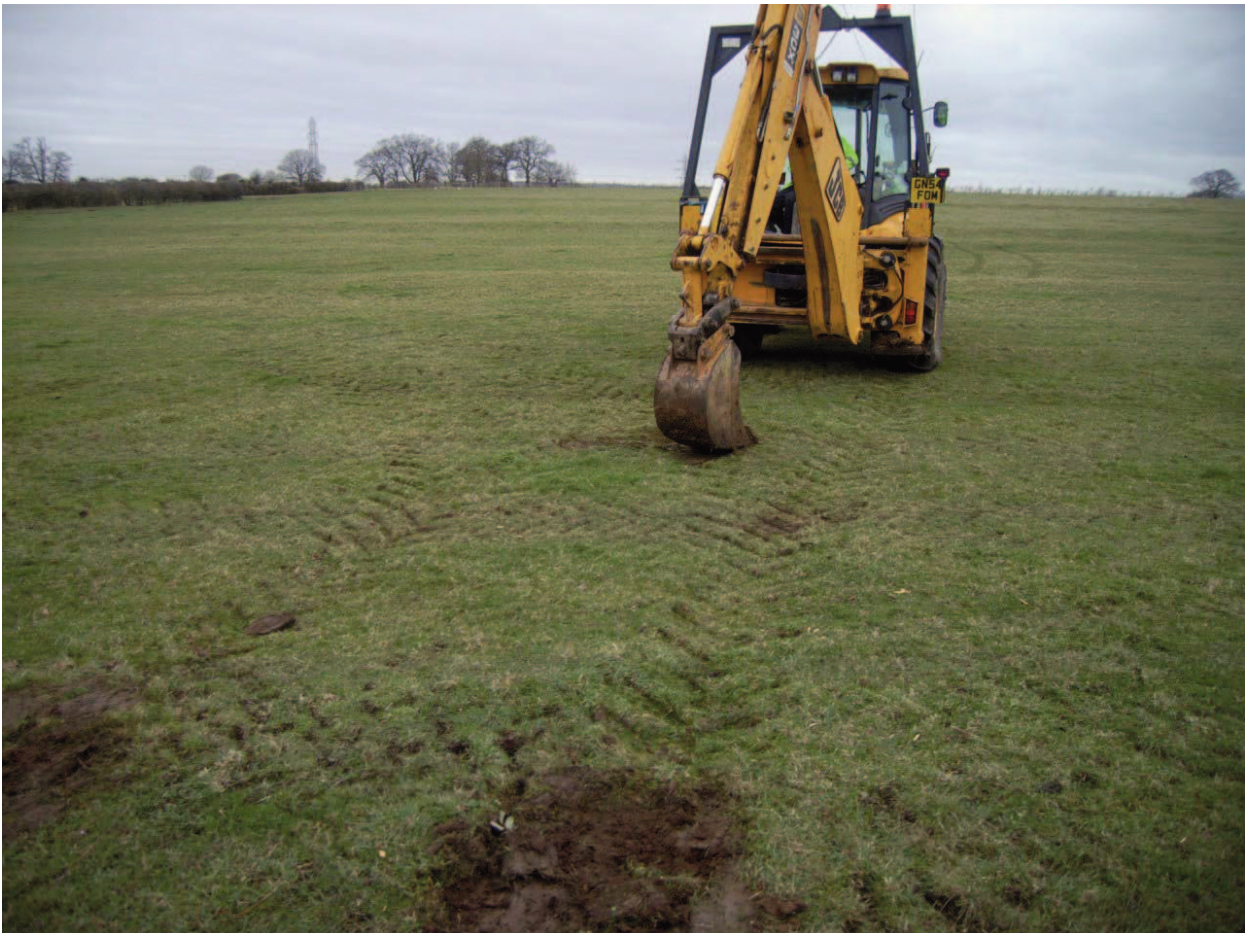
Plate 4: View N illustrating the limited surface disturbance adjacent to pole 11

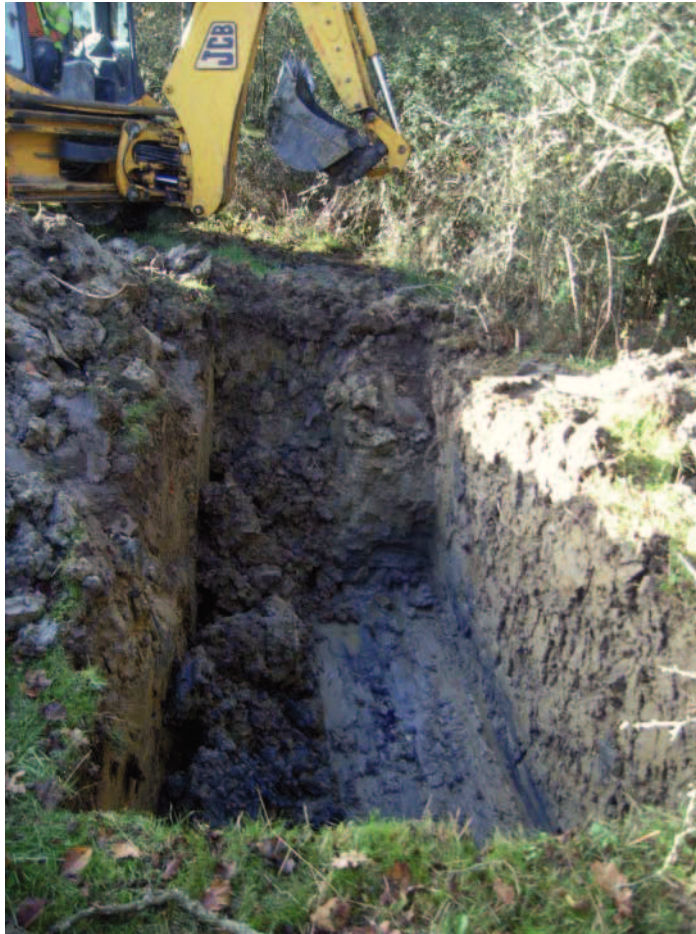
- 3.1.10 Prior to the replacement of pole 48 two temporary poles (jockey poles) were installed to support the overhead wires before pole 48 could be removed. One of these poles was installed 25m south of pole 48 and the second 25m to the north-west, inside the deer park boundary. The installation of the temporary poles required the excavation of trenches to similar proportions for those of the single pole replacements. The new double pole location (P48) required the excavation of a trench measuring approximately 3m long, 1m wide and 1.75m deep (Plate 5).

Plate 5: Replacement pole 48 excavated trench

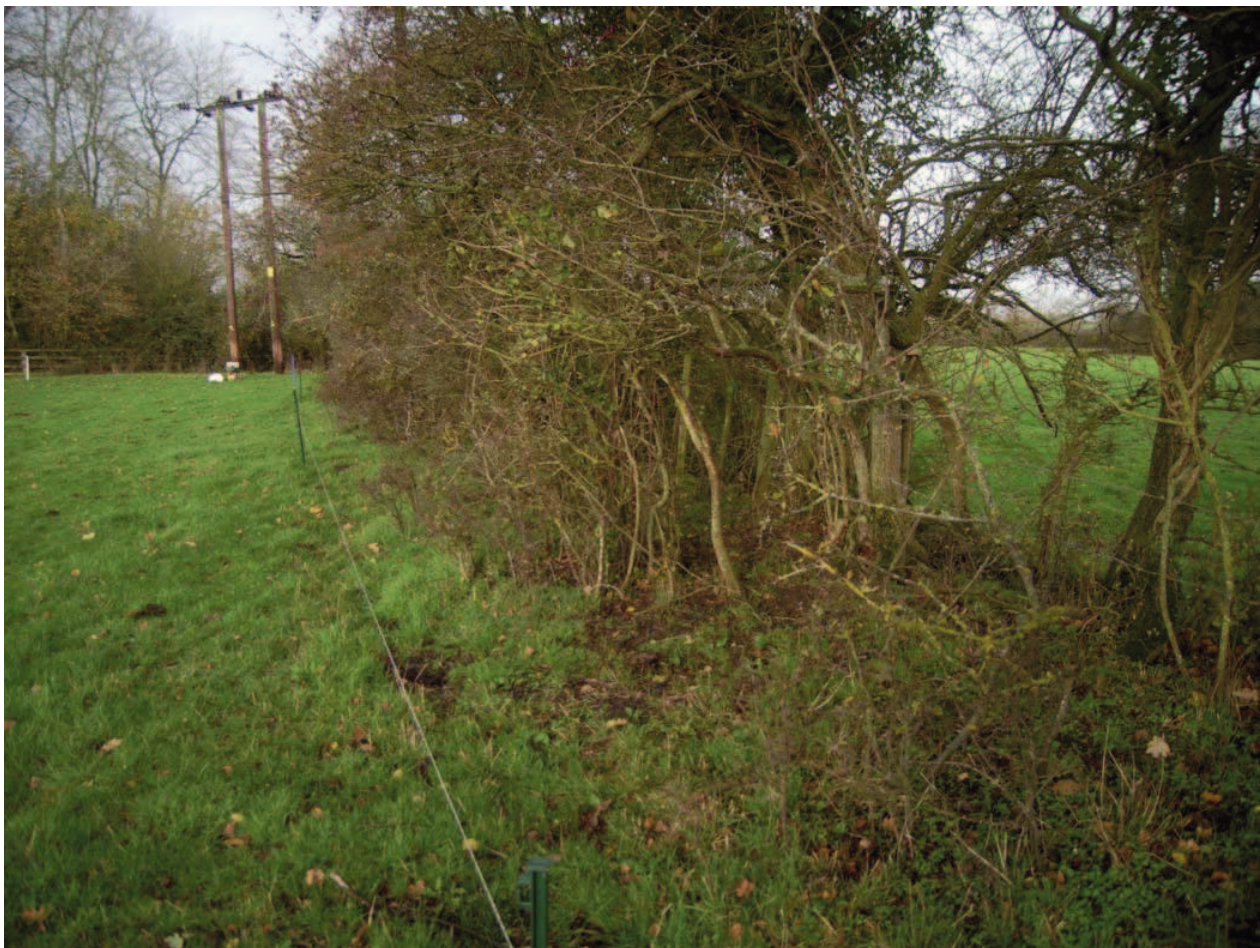
- 3.1.12 A profile of the extant ditch and bank boundary to the immediately east of pole 48 was also recorded as part of the field investigation (Fig. 6, section 4 and Plate 6). The remaining bank measured approximately 0.4m high and 2.4m wide and the ditch was approximately 0.5m deep and 1.5m wide. Both the ditch and the bank had been subject to erosion and animal disturbance leading to silting up of the ditch and a spread of the bank. The surface of the field on the north side of the bank was roughly 0.15m lower than that of the field on the southern side.

Plate 6: View NW along the existing hedge boundary with the ditch and bank earthwork adjacent to pole 48

- 4.3.1 The eroded bank and infilled ditch associated with the deer park were clearly visible adjacent to the existing pole and formed part of the current field boundaries. Pole 48 was sited within 3m of the feature although this was sufficient for it not to encounter any part of the boundary within the replacement pole trench excavation. Vehicle movement within this area was confined to existing farm tracks including where it was necessary to cross the ditch and bank.
