# Dove House, Cassington, Oxfordshire

## Archaeological Watching Brief Report

September 2014

**Client: PCA Architects**

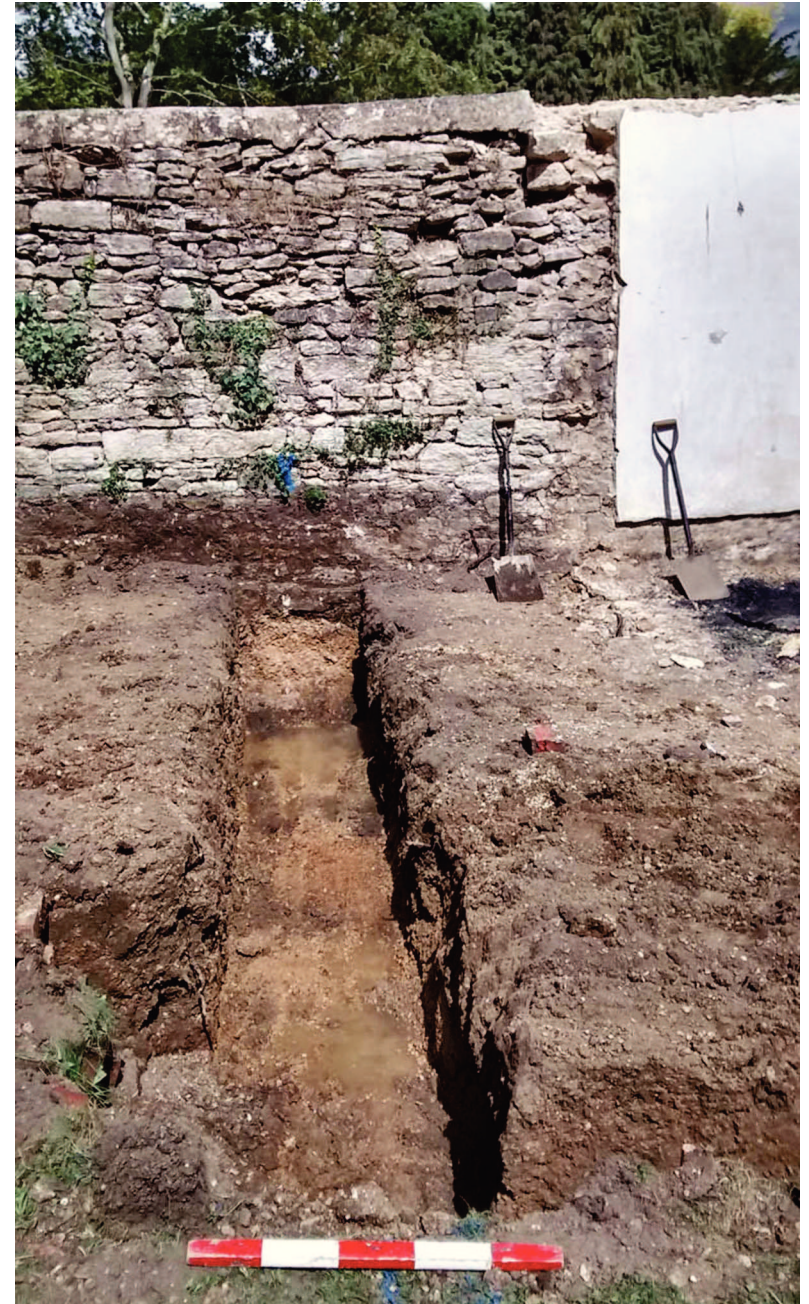
Plate 2: Foundation trench, northern end showing wall 117, looking west

- 3.1.6 The foundation of the NE-SW aligned boundary wall 117 (Plate 2) was less substantial than that of wall 100 as it was not a load bearing wall.
- 3.1.7 There were a number of modern 20th-century disturbances to the deposits. At the southern end of the trenches deposits 106 and 105 were bedding material for a shallow concrete footing that ran northwards beyond the confines of the trench (Fig. 3, Section 1). A pipe trench (109) was seen throughout the central part of the works, and further pipe (124) was present towards the northern side. A brick-built manhole (116) was seen in the extreme northern section (Fig. 3, Section 1). The square manhole, 115, was constructed of red 'London Brick Company' bricks, and served the drainage system, now defunct.

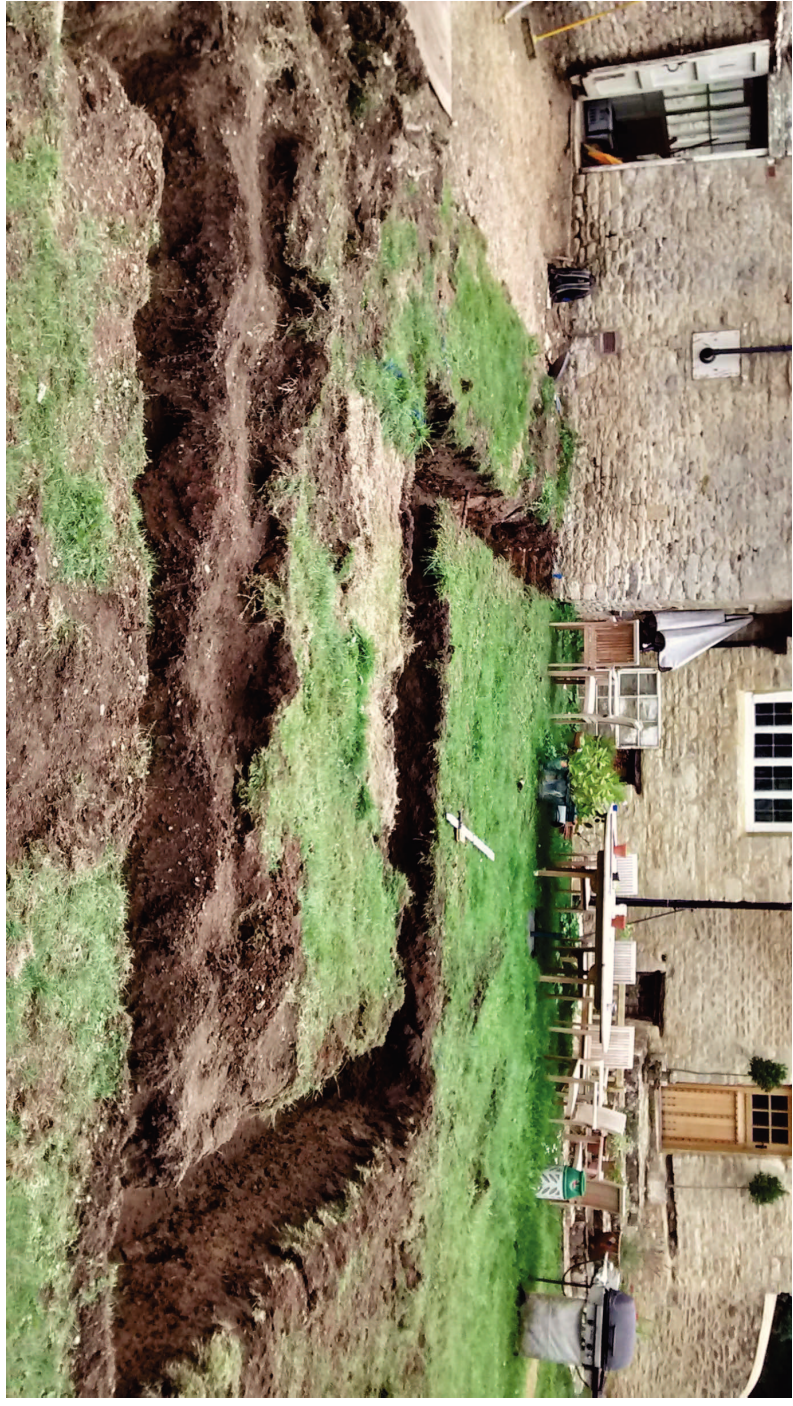
Plate 3: Foundation trenches, looking east

- 3.1.8 The most recent deposits (101 and 104) were the overlying garden soils (Plate 3). At the northern end, adjacent to the boundary wall 117, where there was no existing garden soil there was a layer of mixed soils and gravel (122). This layer may have been reinstated after the store and/or the boundary wall were constructed.
