# Engineering Test Pits The Buttery and Kitchen University College High Street, Oxford

## Archaeological Evaluation Report

## Engineering Test Pits, The Buttery and Kitchen University College, High Street, Oxford

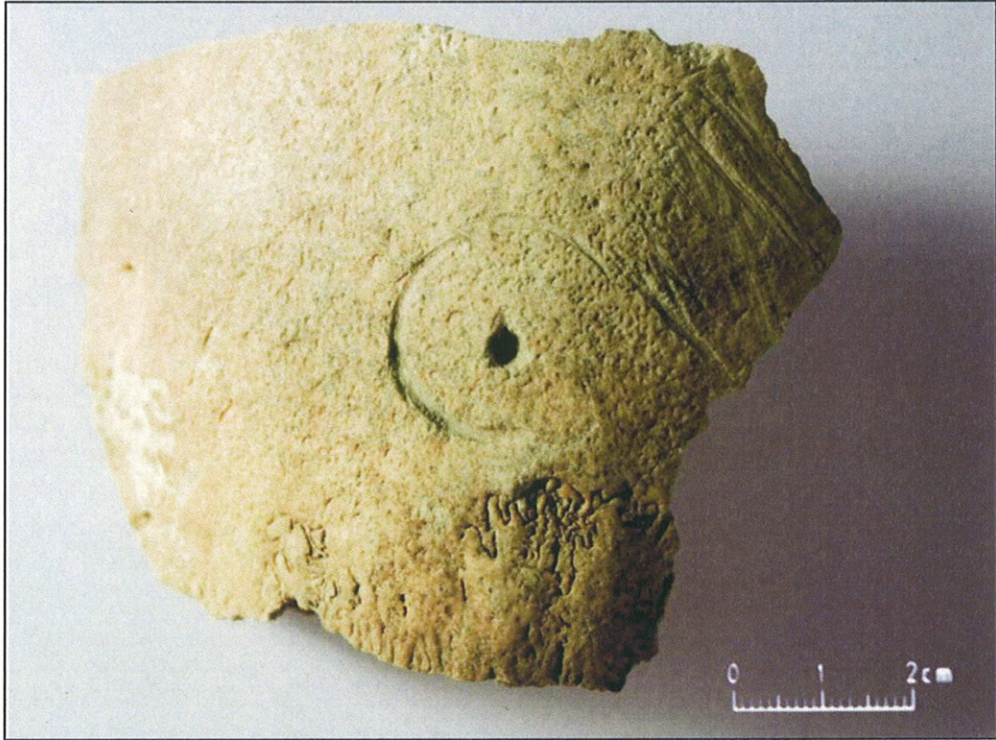
Plate 5 Trepanned skull fragment

The 86mm by 63mm fragment comprised the posterior portion of the right parietal bone. The posterior margin of the fragment incorporated part of the lambdoid suture and the medial margin, part of the groove for the sagittal sinus. The anterior margin of the fragment had broken just posterior to the parietal eminence.

A dense patch of oblique striations was located adjacent to the circular groove, on the latero-anterior aspect of the skull fragment. These had 'v'-shaped profiles, were of uneven thicknesses and depths and had a polished appearance. They broadly observed the same direction and some partially criss-crossed one another.
