Burford Road, Cirencester, Gloucestershire

Archaeological Watching Brief Report

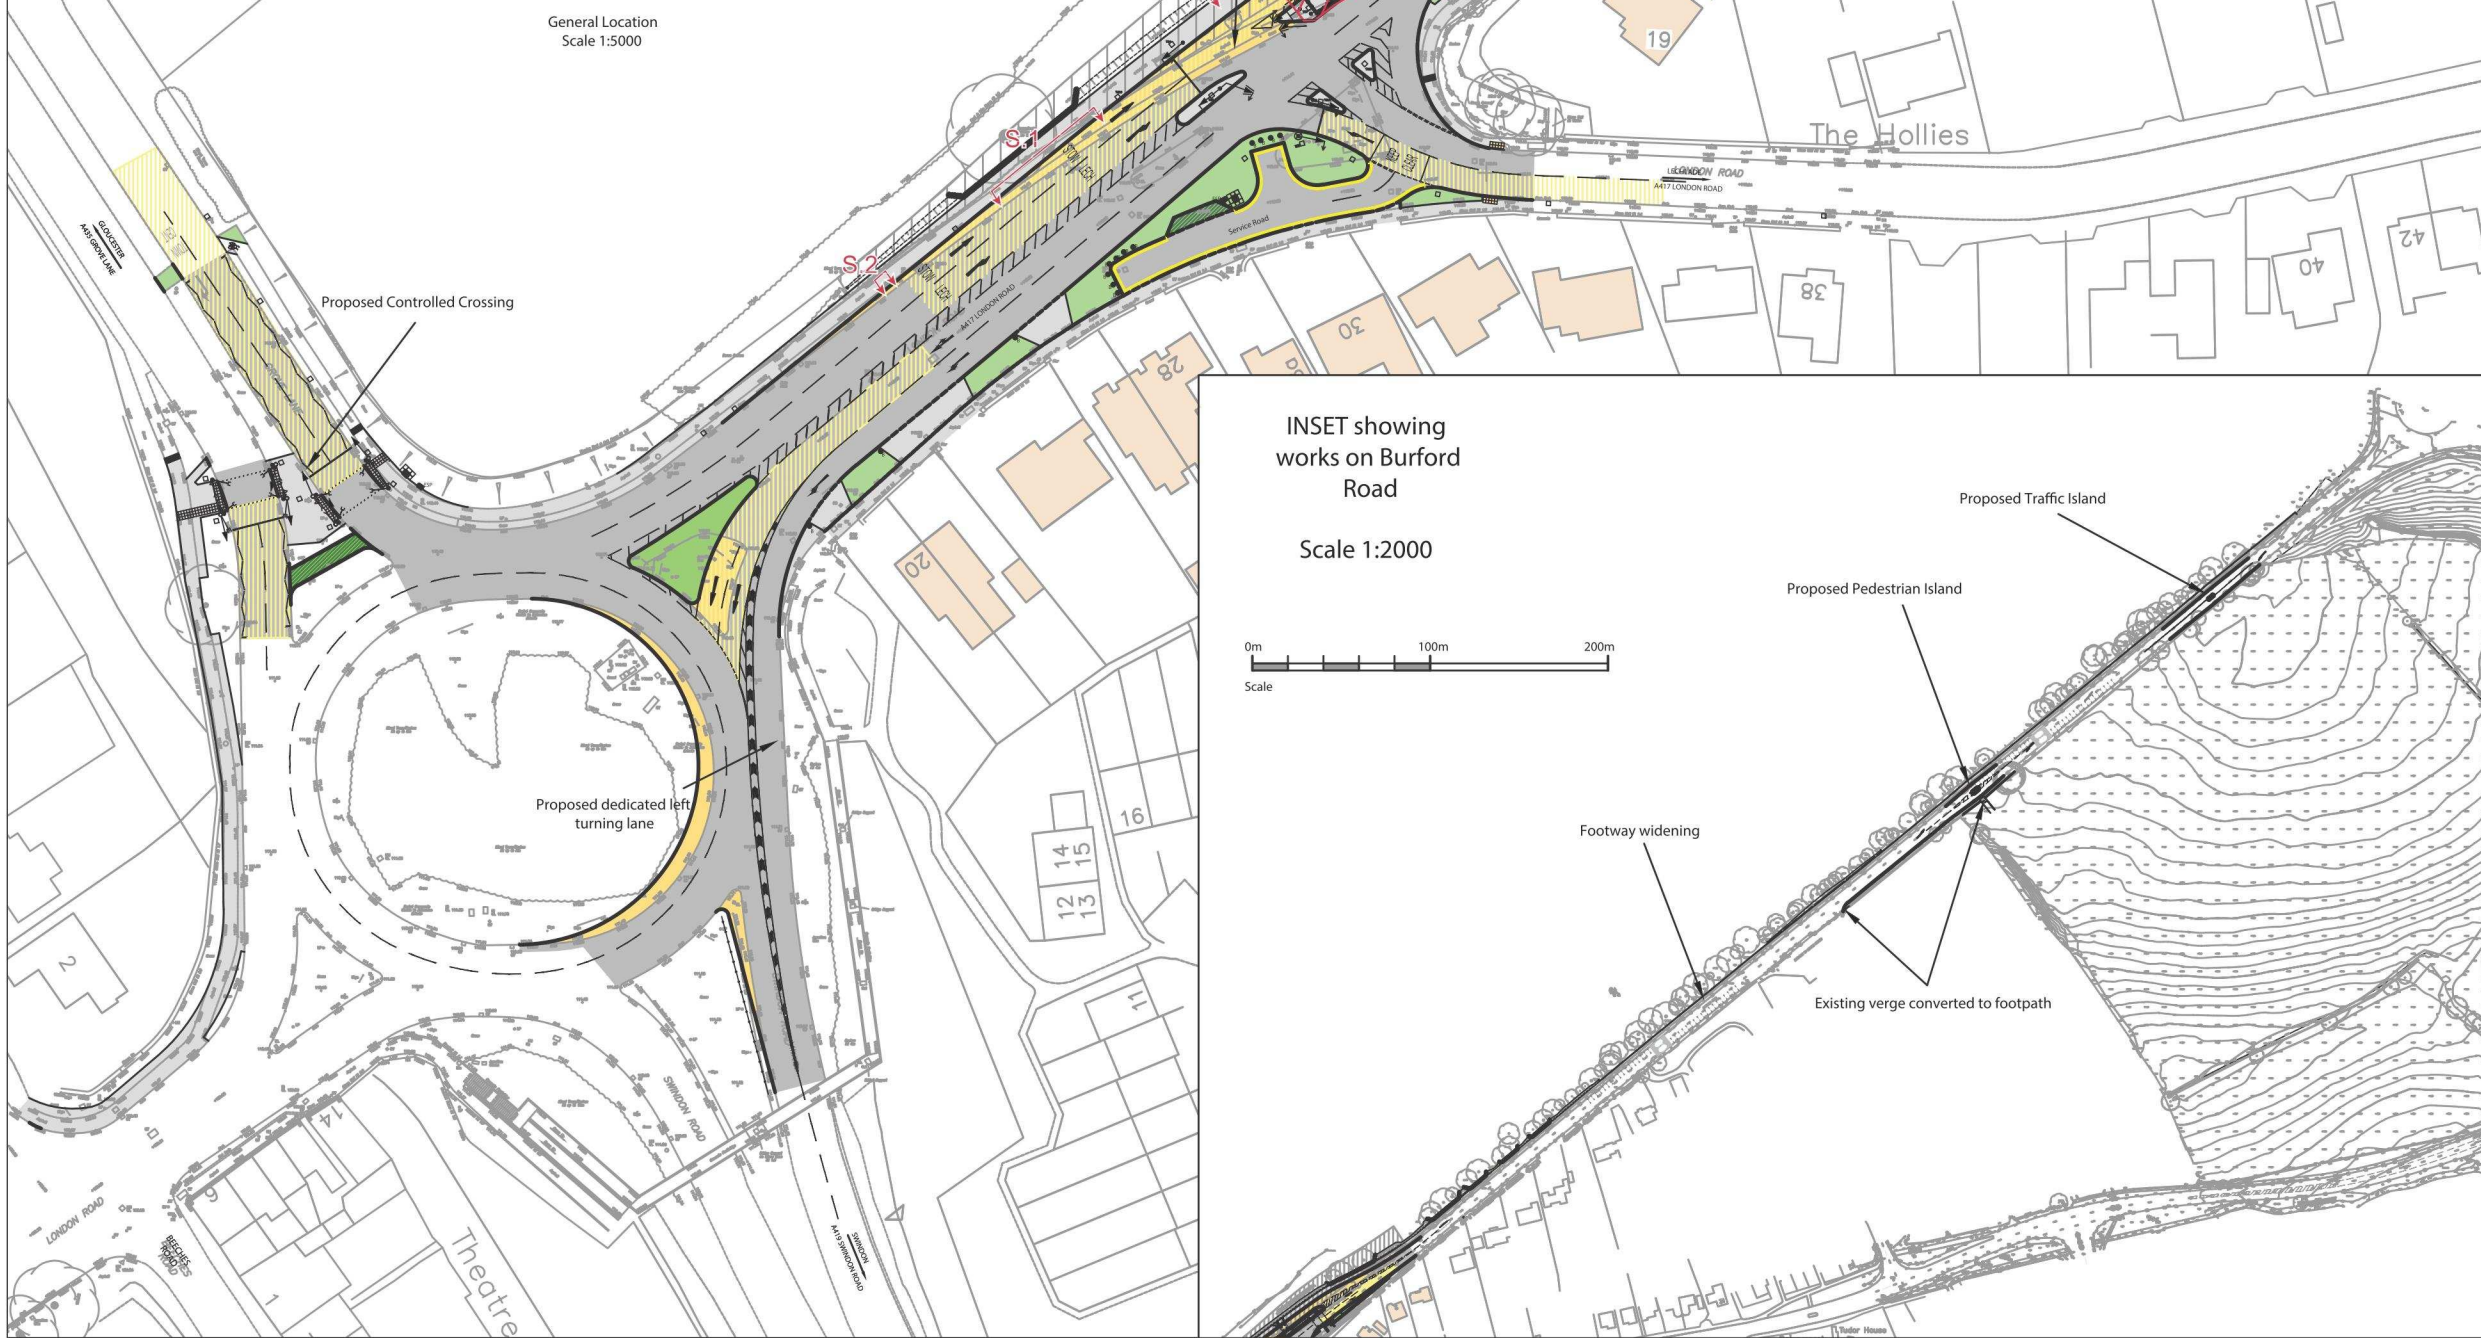
Figure 2: Site plan

- 1.1.1 Oxford Archaeology (OA) was commissioned by CgMs Consulting to undertake a watching brief during highway improvement works on the A429 Burford Road to the east of Cirencester town centre (Fig. 1). The works included the upgrading of the approach to the Grove Lane roundabout and the widening of the footpath along Burford Road to provide a new cycleway (Fig. 2).

- 3.1.1 The watching brief was undertaken in three distinct phases:
- Recording previously exposed soil profiles and the mound section (Fig. 2);
 - Monitoring of remaining ground works at the approach to the Grove Lane roundabout (Fig. 2);
 - Intermittent site visits during the construction of a new cycleway (Fig. 2, inset).
- 3.1.2 The observations made during the various phases of monitoring are described separately below, followed by an overall discussion and conclusion.

- 3.3.1 The remaining excavations in the main ground works area were monitored (Fig. 2).

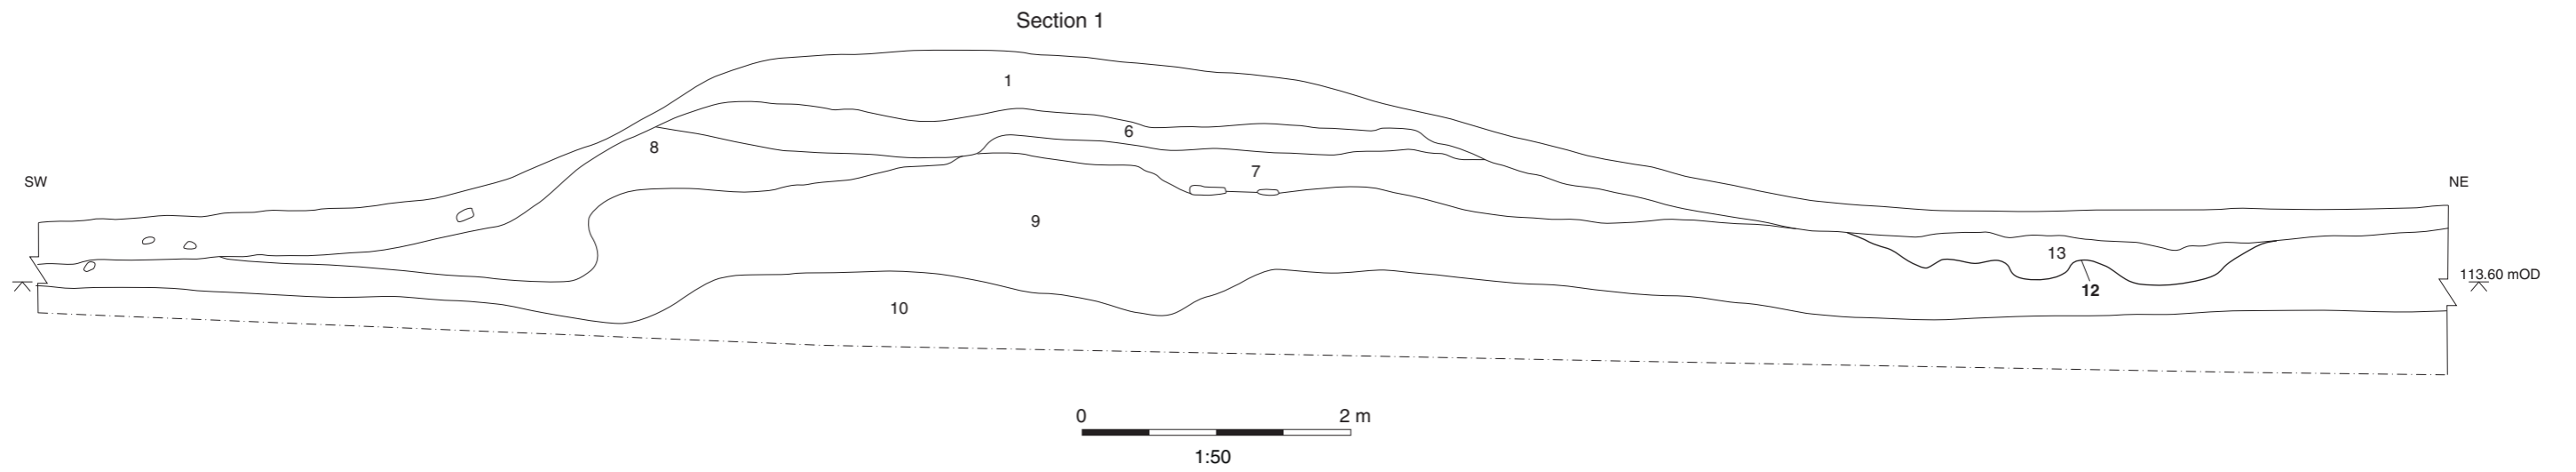
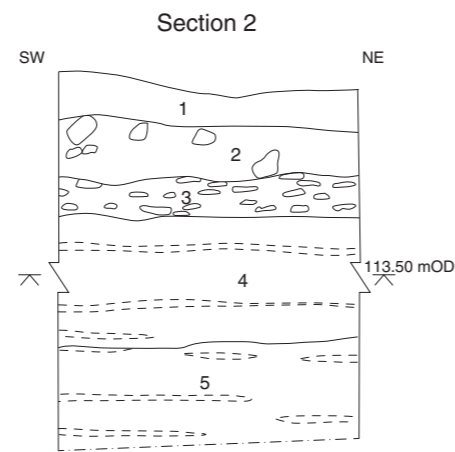
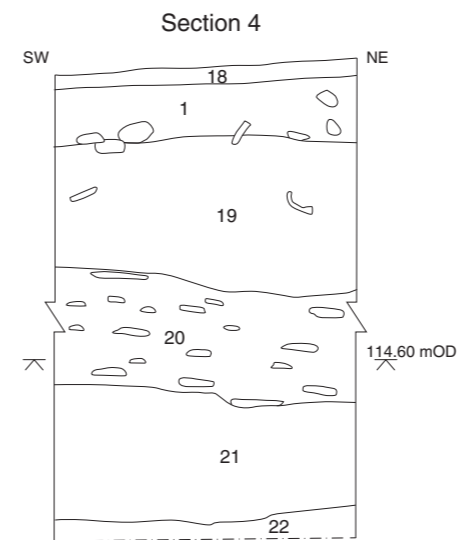
Figure 3: Sections

- 3.2.1 The soil profiles exposed in the south-east facing section of the excavations displayed a sequence of bedrock units of the Forest Marble Formation dating to the Upper Jurassic (Fig. 3, sections 2 and 3. Plates 1 and 2). The bedrock units (contexts 3, 4 and 5 in section 2 and contexts 20, 21 and 22 in section 4) varied slightly in colour and stoniness, but generally displayed a horizontal structure. The weathered upper bedrock horizons were overlain by a subsoil (contexts 2 and 19) composed of brown or olive sandy silt. which in turn was overlain by the modern topsoil (context 1). The topsoil was in places overlain by an organic leaf litter layer (context 18)

- 3.2.2 The exposed section through the mound (Fig. 3, section 1, Plate 3) consisted, at its base, of 1.35 to 1.55m of Upper Jurassic bedrock in several superimposed beds (contexts 7, 8, 9 and 10). The geological beds had slightly wavy contacts. At the south-west side of the mound, the geological beds formed a small local fold. The top bed of the fold (context 8) consisted of light grey angular mudstone clasts which clearly displayed the bend in the fold.

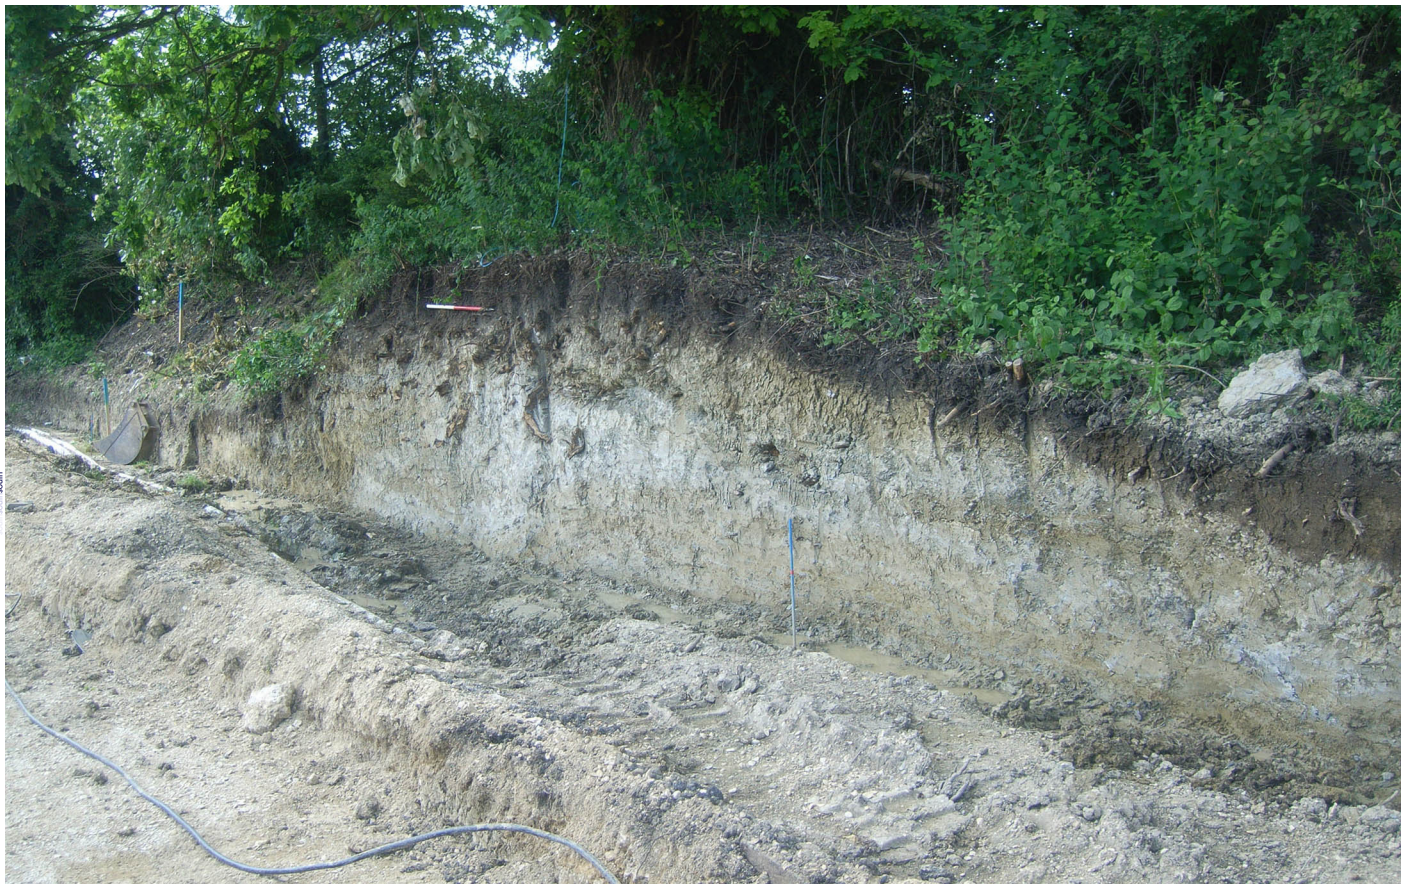
Plate 3: Section through mound

- 3.2.3 Overlying the weathered bedrock was the subsoil (context 6), 0.2 to 0.35m thick. This layer produced a sherd of pottery of post-medieval date and a small brick fragment.

- 3.2.4 The top of the mound sequence was formed by a dark brown topsoil (context 1), 0.5m thick.
- 3.2.5 Particular care was taken to establish whether any evidence of ditches flanking the mound was present. No such evidence was present to the south-west of the mound. To the north-east, an irregularly shaped depression (context 12), up to 0.35m deep and 3.05m wide, was present, cut from immediately beneath the topsoil. It was filled with a mixed deposit, largely comprised of topsoil (13).

- 4.1.3 The mound at the north-west side of the road is built up from this local geological stratigraphy. The steeper south-west side of the mound section is caused by the firm brittle bedrock unit which forms part of a small local tectonic fold. The irregularly shaped feature at the north-east side of the mound section was filled by a mixed sediment, partially derived from topsoil and likely to be of recent origin. The presence of the mature tree on top of the mound has undoubtedly protected the mound from truncation during more recent road construction works.

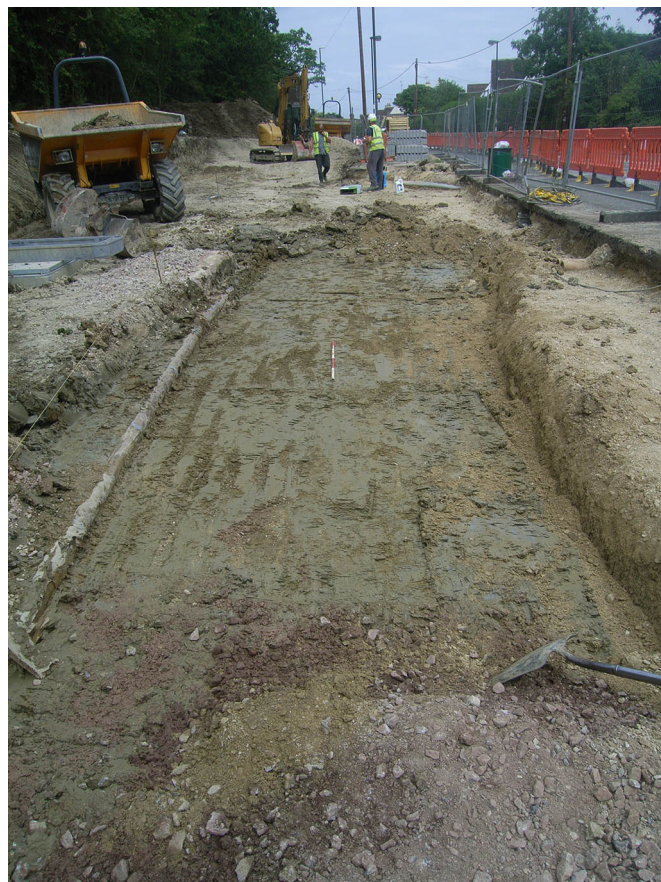
Plate 6: General view of ground reduction

- 3.3.2 The ground reduction exposed a number of service trenches cut into geological deposits. The geological sequence had been truncated across much of the width of the new works, presumably by earlier road construction.
- 3.3.3 The soil profiles exposed in the area were recorded in several sample sections. These displayed a similar stratigraphy as recorded further to the south-west (see above).
- 3.3.4 No archaeological features or deposits were present.

- 4.1.4 The area of earthworks which were monitored revealed a number of service trenches cut into weathered and truncated Upper Jurassic bedrock.
- 4.1.5 No archaeological features were present in the area of footpath widening other than the footing of a dry stone wall which had flanked the existing road.
