# Eton College Courtyard Resurfacing Work, Windsor, Berkshire Archaeological Watching Brief Report

March 2017

**Client: Eton College**

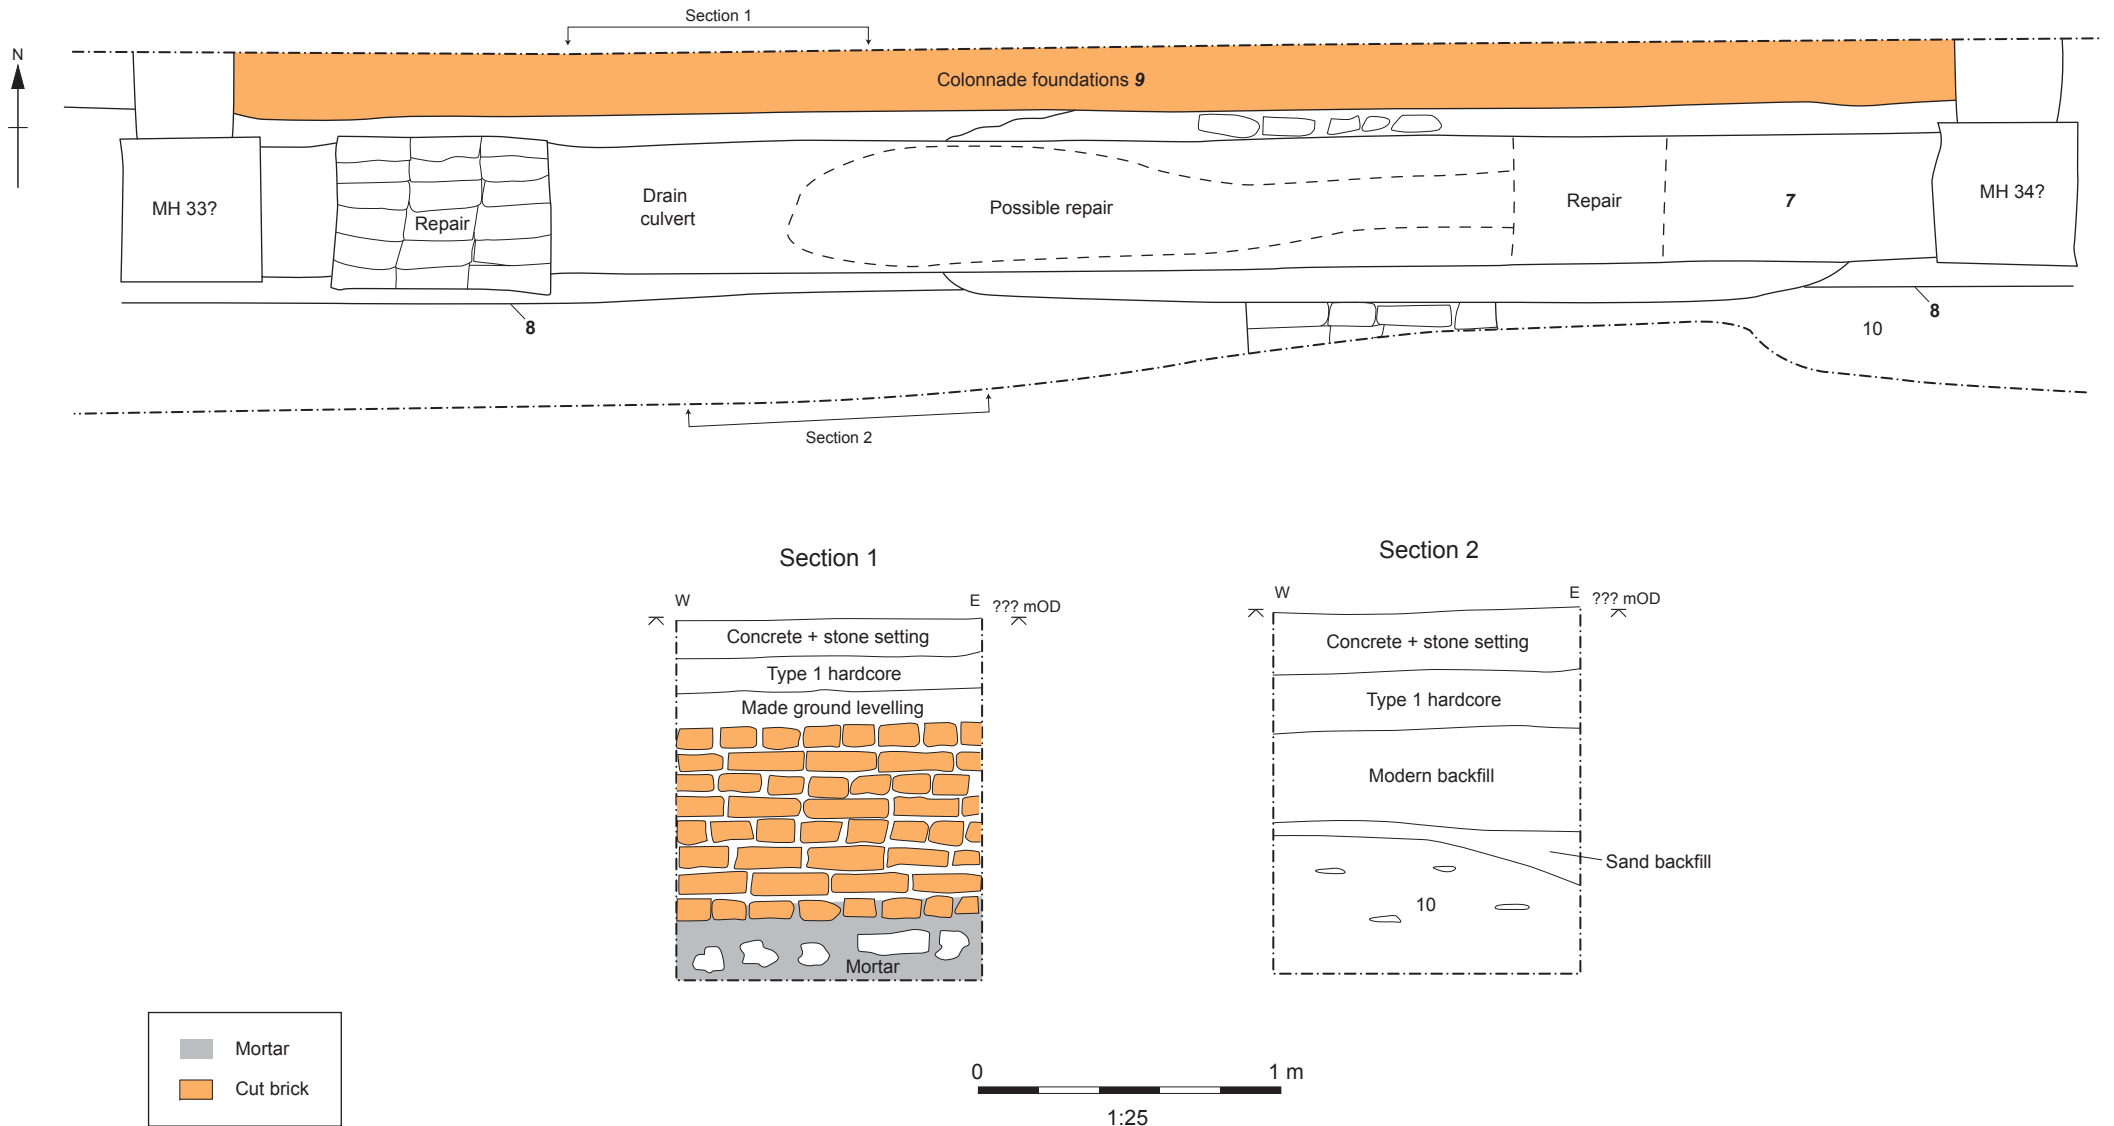
Figure 3: Sections and plan of the colonnade section

- 3.3.2 An arched brick culvert system was observed during the new drainage repair excavations (Figure 3; Plate 5). The lower courses of the culvert drainage system appeared to be largely red brick work although their bonding appeared to be weak. The brick work consisted of three courses thought to be from the original construction phase with further courses forming an arched roof. The arched roof was found to be in a poor state of repair.

3.3.13 The trenching along the route of the culvert on the northern side of the courtyard was also of a depth which enabled the presence of the brick foundations of a potential colonnade or loggia to be observed (Figure 3). However, due to the trench only being opened to allow access to the drain system the foundations were not fully exposed. Further work which took place to remove the cobbled surface was not of sufficient depth to allow observation of any other colonnade remains at ground level.

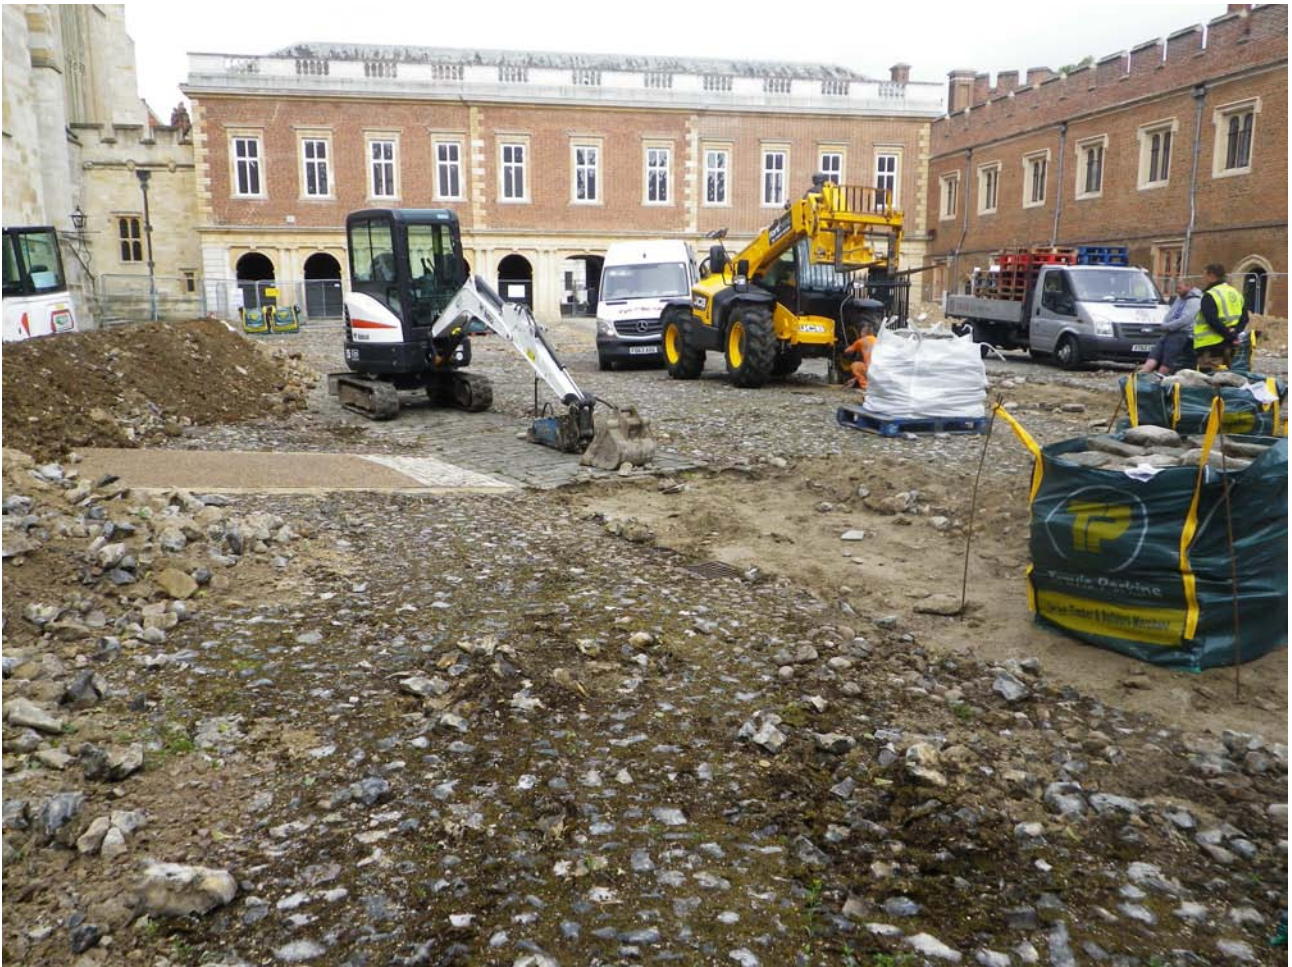
Plate 3: Monitoring of the removal of the existing cobbled surfaces (looking northwest)

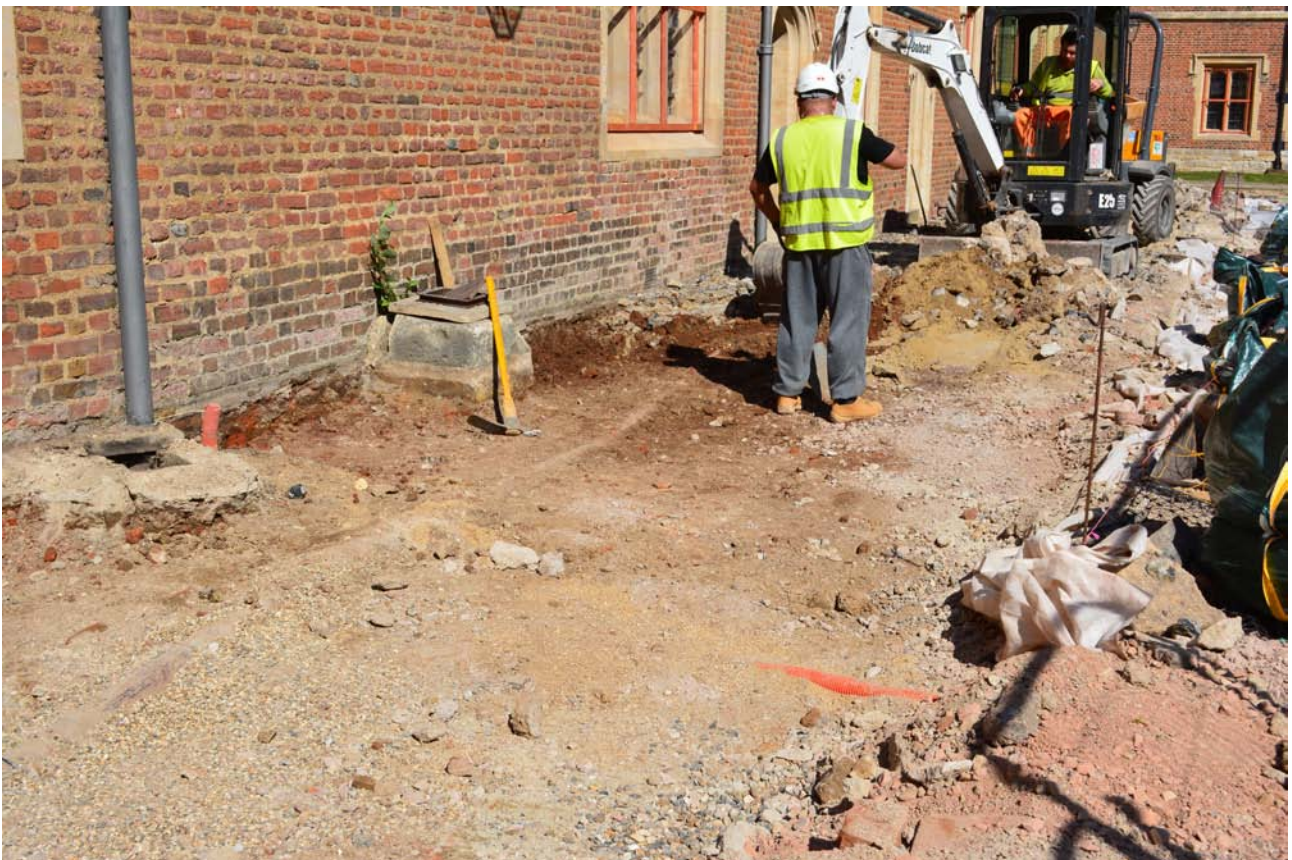
Plate 4: Sandy base of the cobbled surface (looking east)

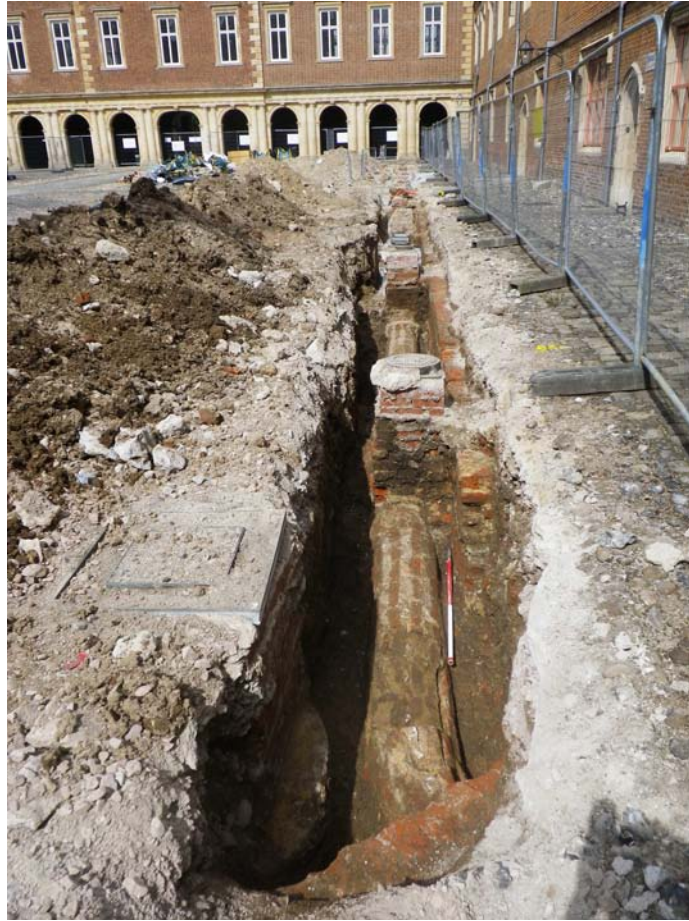
Plate 5: Excavations of the main drainage culvert (looking west)

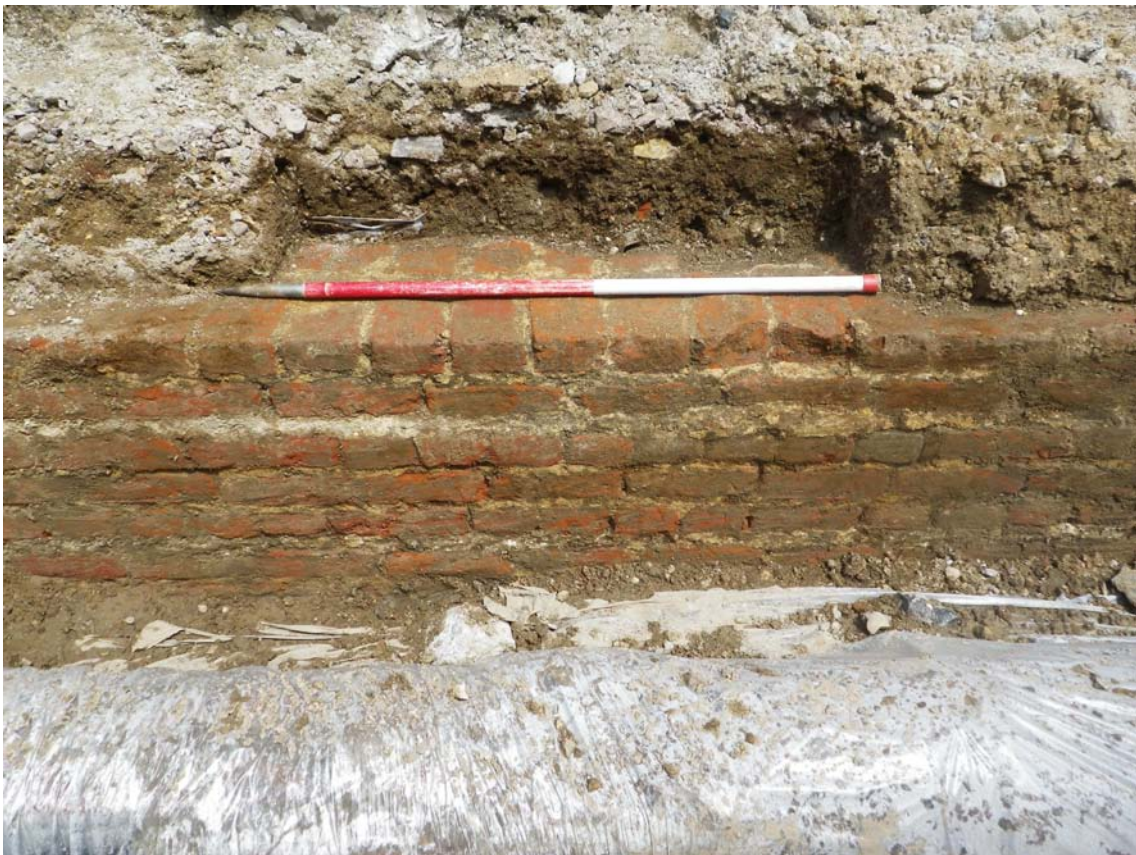
3.3.14 The red brick foundations were identified along the length of the courtyard running east-west and aligned with the first arch of the western colonnade. The position of the foundations and potential date of the bricks are consistent with a postulated 17th-century colonnade or loggia associated with the Lower School in the Historical Heritage Statement (Martin Ashley Architects 2015).

3.3.15 The foundations were constructed of handmade bricks with a loose lime mortar. The bricks were of a soft orange-red sandy fabric with rare coarse flint inclusions (length: 250mm, width: 110mm, thickness: 65mm). They had crinkled/creased sides and remnants of a mould impression. Dating of handmade brick is not precise but a broad 17th-century date may be assumed.

Plate 6: Red brick foundations of a possible 17<sup>th</sup>- century colonnade or loggia (looking north)

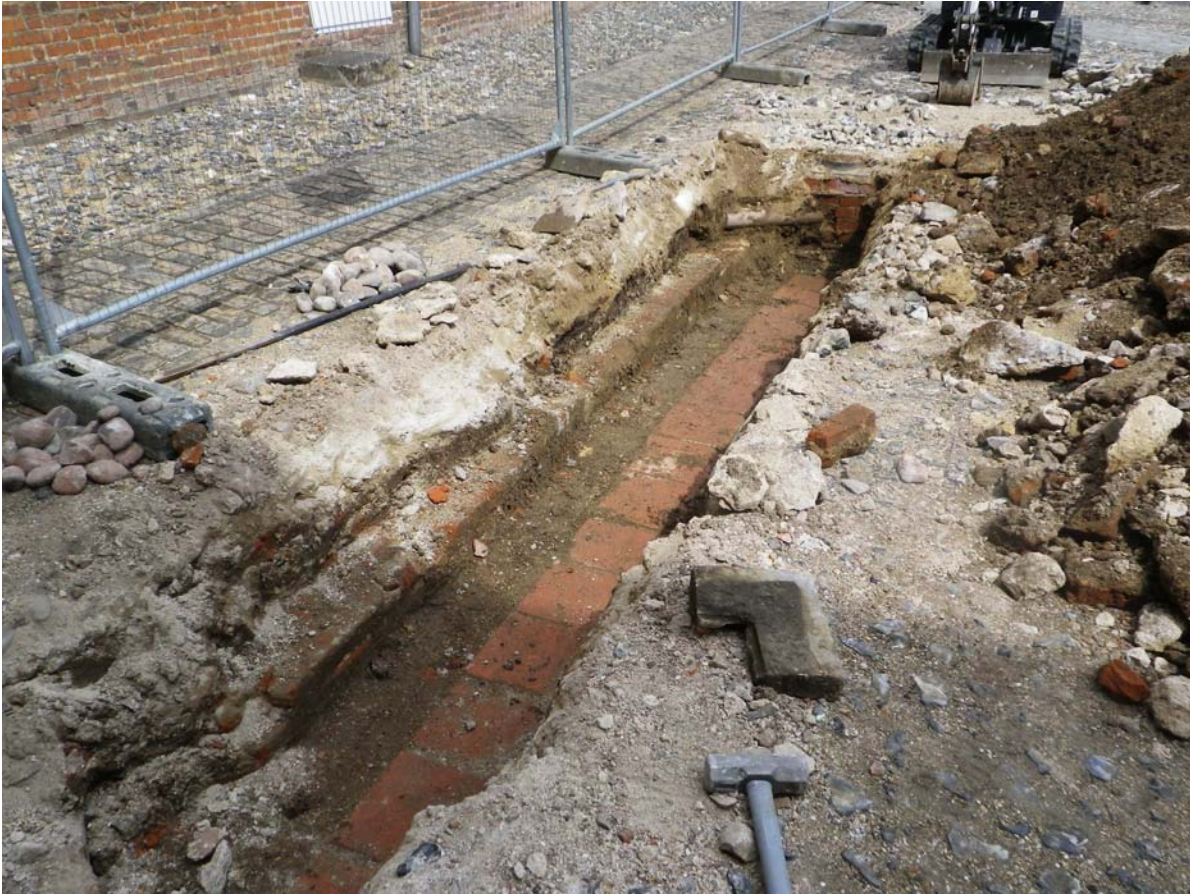
Plate 7: Brick drain located on the southern eastern corner of the courtyard (looking south)

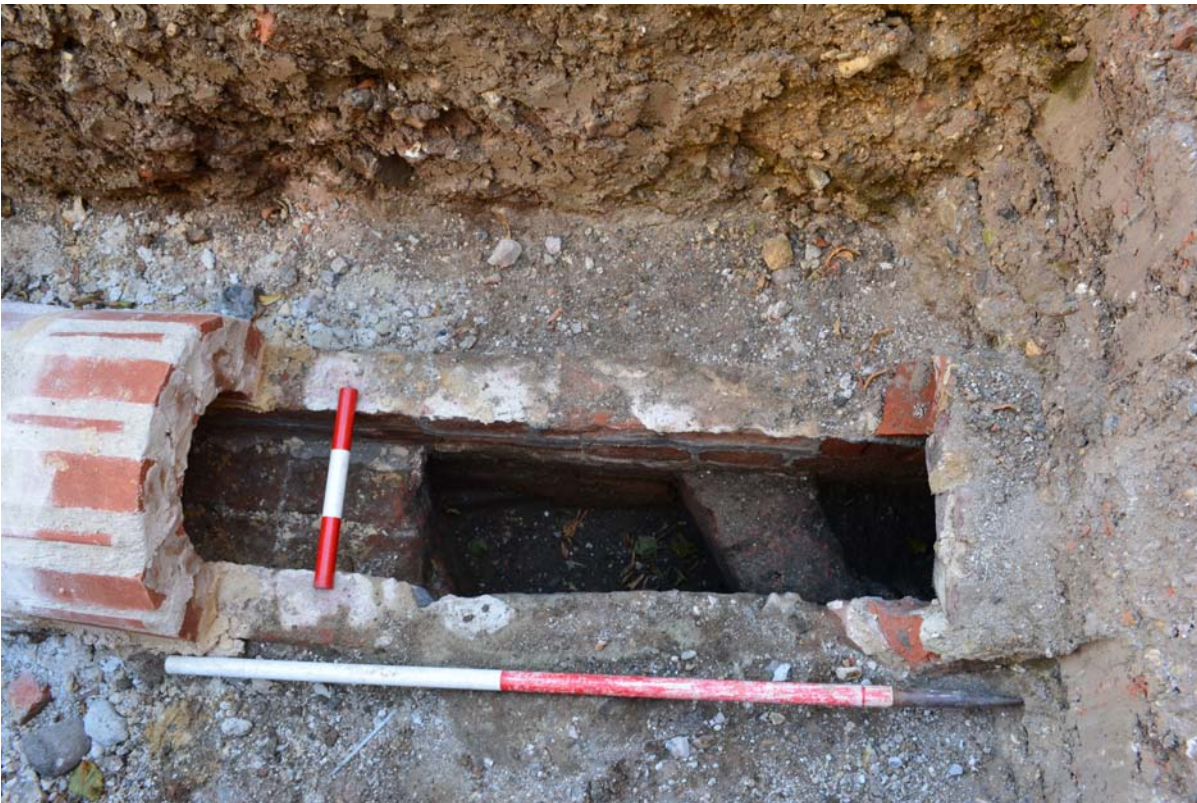
- 3.3.11 In two locations structures were found to indicate that an earlier culvert/drainage system had been replaced by the one currently in use (Plate 8). Both were observed on the eastern side of the school yard. The first constituted an overflow tank blocked with brickwork observed elsewhere, possibly when a sewage pipe was put through the top of the structure. In the south-eastern area a narrow red brick channel (Plate 7) was observed to run on a different alignment to the system in current use. This appears to have been subject to some form of repair before being built through by the current system.

Plate 8: Repaired culvert sections with signs of early drainage at the base

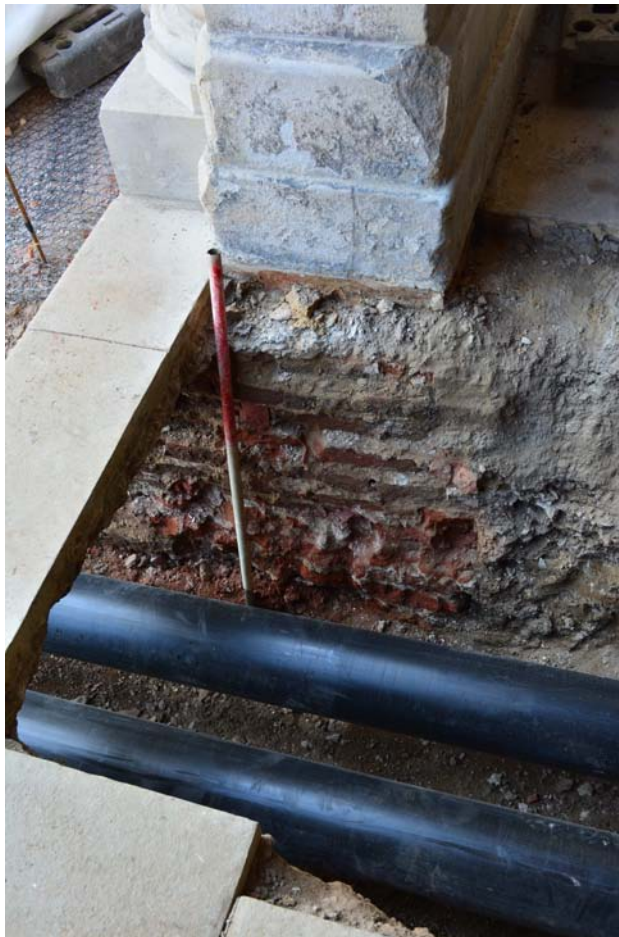
Plate 9: Excavations of a pit under the colonnade southwest corner

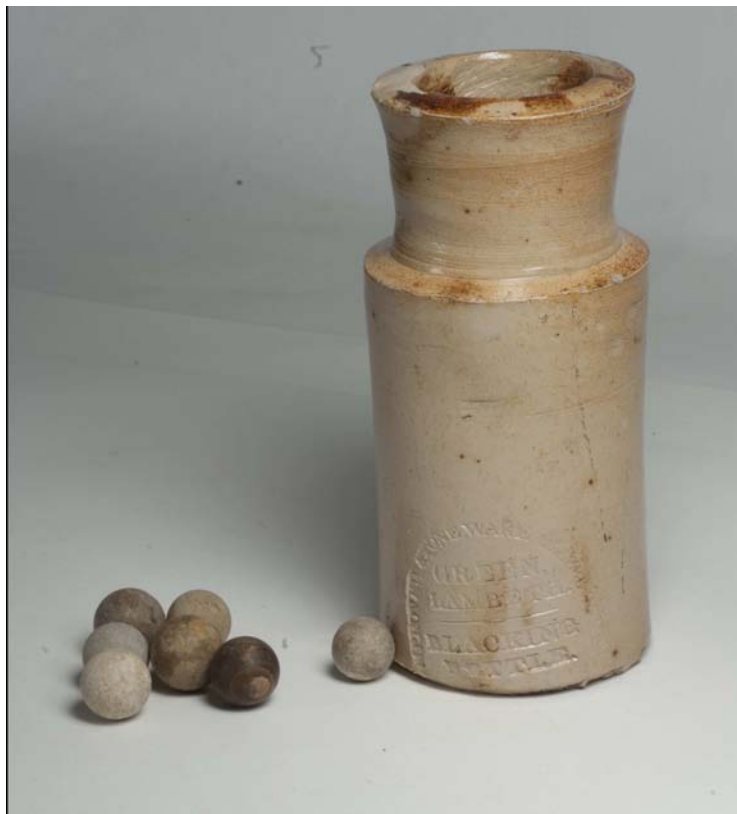
3.4.3 A stoneware bottle was found just inside the colonnade in the south-west corner of the courtyard. The colonnade forms the western side of the courtyard and the Henry VI chapel forms the southern side. More precisely, the find spot lay between the two southernmost stone piers of the classical colonnade (Plate 9), and closer to the northern one. The bottle and its contents were exposed when workmen lifted a flagstone here. It seems to have been found in a small pit dug into the rubble underlying the flagstone paving. When examined, the otherwise empty bottle was found to contain a group of seven early stone gaming marbles (Plate 10).

- A.1.4 Light brown salt-glazed stoneware blacking bottle (London Fabric code: ENGS). Typical cylindrical body with a sharply angled (carinated) shoulder. Above this a steep flaring neck and a plain thickened flat-topped rim with a slight external bevel and a sharp angular lip. Clearly wheel-thrown. Quite heavy in the hand, and thickly potted (10mm thick at the rim). Flat base with a slightly bevelled basal angle. The cylindrical body is very slightly waisted (concave) in the middle. In perfect condition apart from a slight modern chip on the surface of the rim at one point revealing a fine, dense, light grey, stoneware fabric beneath. It has an even covering of salt glaze all over externally with a blank circular area (diam. 45mm) on the underside of the base – probably a stacking mark from the rim of a smaller bottle. External salt glaze mainly light grey and transparent but with subtle light brown tones here and there, particularly on the neck, shoulder and near the base. The inside of the vessel has a much darker brown (possibly feldspathic?) glaze covering, probably applied in liquid form as an iron-rich glaze slip (liquid clay). Some of this has dribbled out onto the top of the rim (probably when the maker was swilling it around in liquid form to obtain an even coverage). A few small grazes or facets occur here and there on the outside of the vessel, possibly made with a bladed tool while the vessel was still leather-hard and unfired, and before glazing.

Plate 10: Early 19<sup>th</sup> century stone blacking bottle and marble set
