Ambrosden Court, Merton Road, Ambrosden, Oxfordshire

Archaeological Evaluation Report

Client: Croudace Homes

Issue No: 1
OA Job No: 6170
NGR: SP 6018 1911

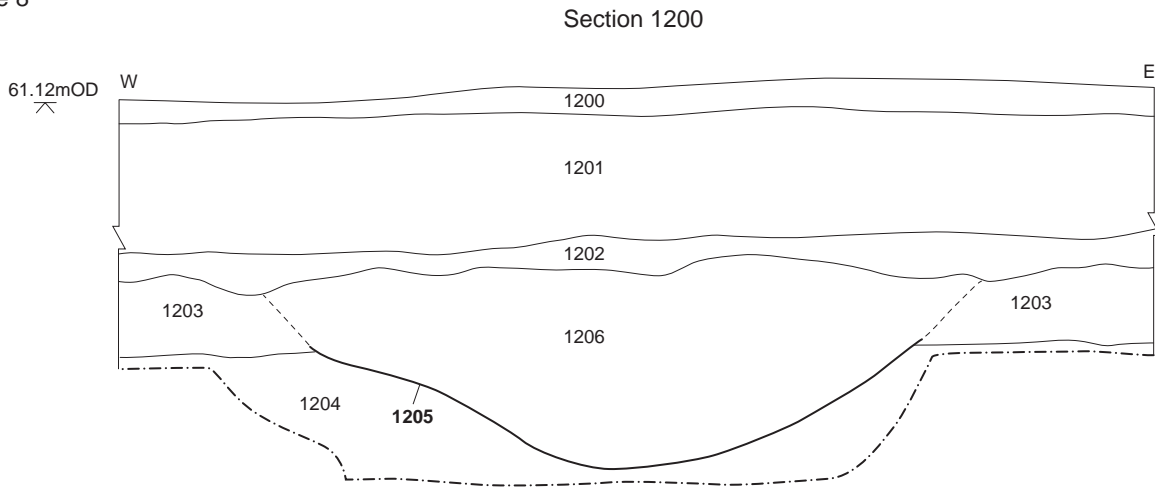
Figure 8

Figure 8, 9 and 10: Trench 12: Section of ditch. Trench 13: Section of ditch and Trench 14: Section of pit

- 3.4.2 A single linear feature was visible towards the western end. The feature, 1205, was aligned NE-SW with a 'U'-shaped profile and a single fill 1206, which contained no artefactual material. The feature was interpreted as a ditch 1205 (Figure 8).

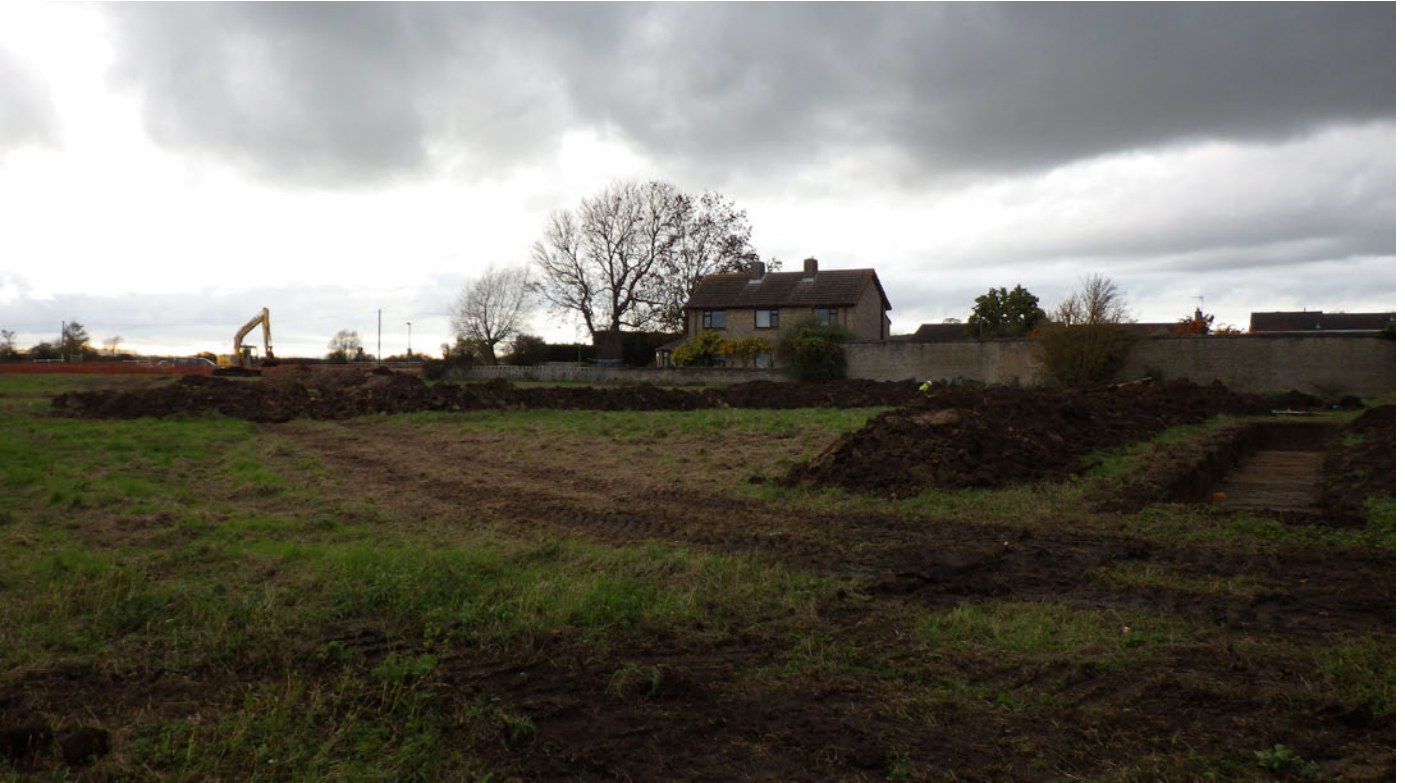
Plate 1: Area A: general view, looking north

- 3.3.1 Of the ten trenches within this western field (Figures 2 and 3; Plate 1), five (Trenches 6-10) contained features of archaeological origin.
- 3.3.2 Trenches 1-5 all demonstrated a compatible sequence of modern imported soil and subsoil, which overlay a rubble-rich extensive layer. This then overlay a humic/peaty silt which had uneven boundaries (Plate 2) and the sampled peat was found to be rich in fibrous material and root fragments. The peaty deposit overlay a more oxidised brown-orange alluvium, which overlay a blue-grey alluvial clay. Only within Trench 1 and the sondage within Trench 4 was a more solid geological deposit seen at a depth of 1.9m. These five trenches contained no discernible features of significant archaeology.

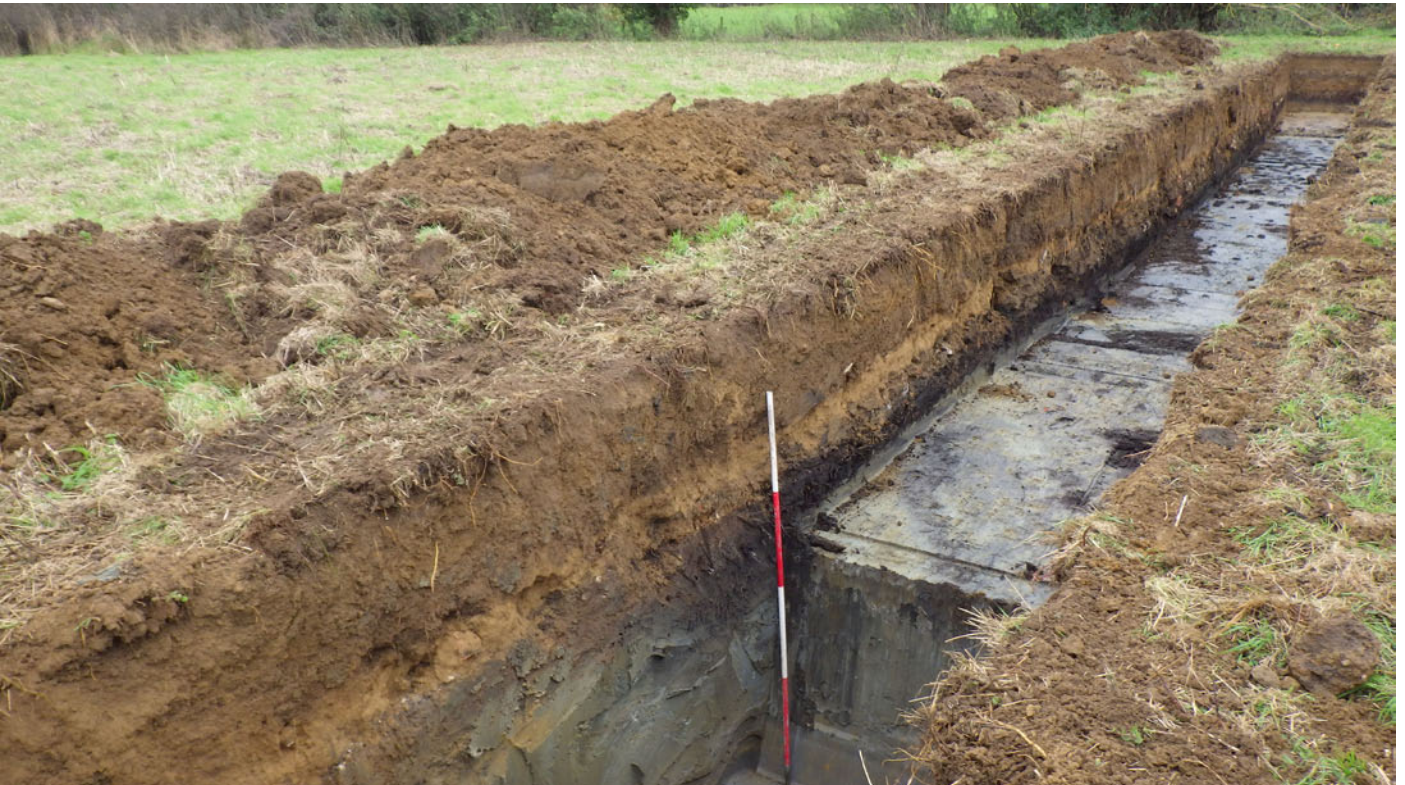
Plate 2: Trench 5: general section view, looking south-east

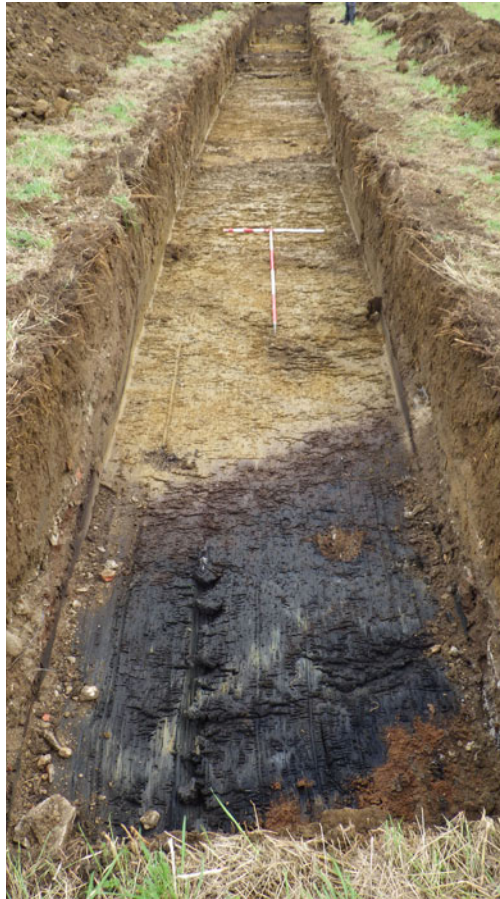
Plate 3: Trench 6: general plan view, looking east

- 3.3.4 The trench contained two linear features 607 and 609 (Plate 3). Feature 607 (Plate 4) was a NW-SE aligned stone drain. It was constructed from two parallel alignments of rough-hewn stones, with the faced stones on internal sides, which formed a channel. The drain survived to two courses in height. There was evidence of disturbance along the eastern side, with either deliberate or accidental damage and a later deposit layer including 612 which contained four fragments of 17th-18th century pottery and two pieces of ceramic building material (CBM) of the same date.

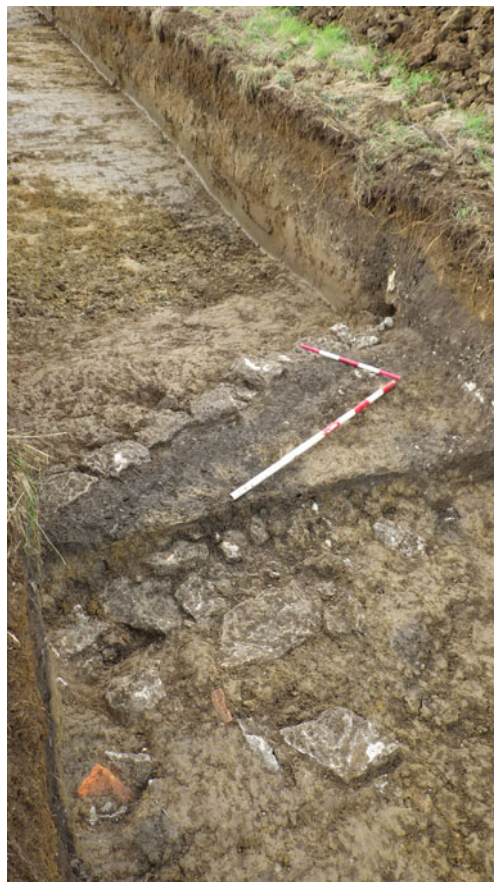
Plate 4: Trench 6: plan view of drain 607, looking north-west

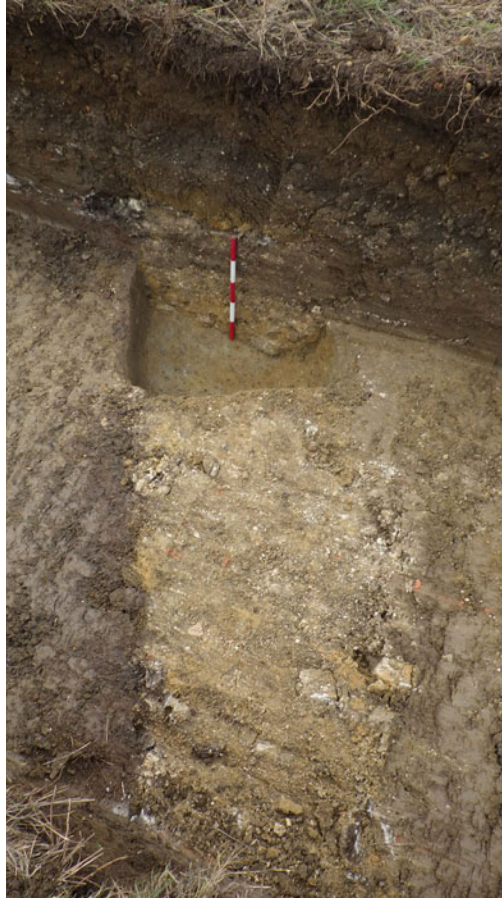
Plate 5: Trench 6: feature 609, looking north-west

- 3.3.5 Towards the western end there was feature 609, which had three fills, 608, 614 and 615 (Plate 5). All three showed mixed sources of material and were consistent with deliberate, rapid backfilling. The feature is likely to be of modern date, but is of uncertain function. Fill 608 contained a single iron nail and eight pieces of 18th-early 19th century CBM.

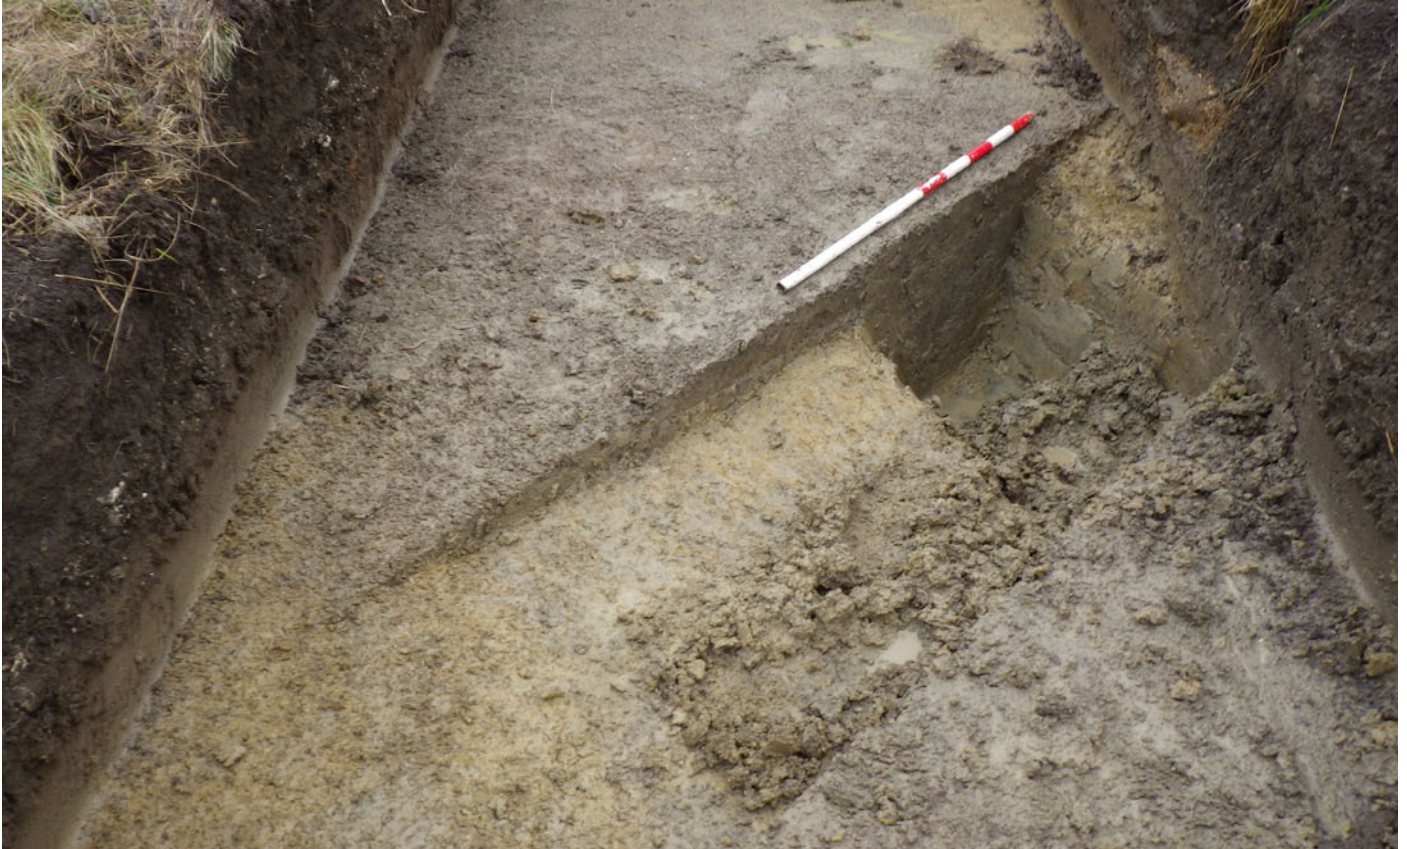
Plate 6: Trench 7: furrow 706, overlying ditch 704, looking north

- 3.3.8 The trench contained three linear features: a furrow 706 overlying a ditch 704 at the northern end, and a stone drain 709 further south. In addition there were two other NW-SE stone-packed drains (different construction), an E-W segmented ceramic drain and a NW-SE modern ceramic drain.
- 3.3.9 The NW-SE aligned furrow 706 was a shallow broad 'U'-shaped feature 2.5m wide, with a single fill 707 (Plate 6). It overlay the similarly NW-SE aligned ditch 704. The ditch was 0.73m wide, with a vertical-sided, flat-based profile. It had a single fill, 705 which yielded no artefactual material.
- 3.3.10 A single sherd from the neck of an 18th- or 19th-century wine bottle was recovered from the subsoil layer 701.

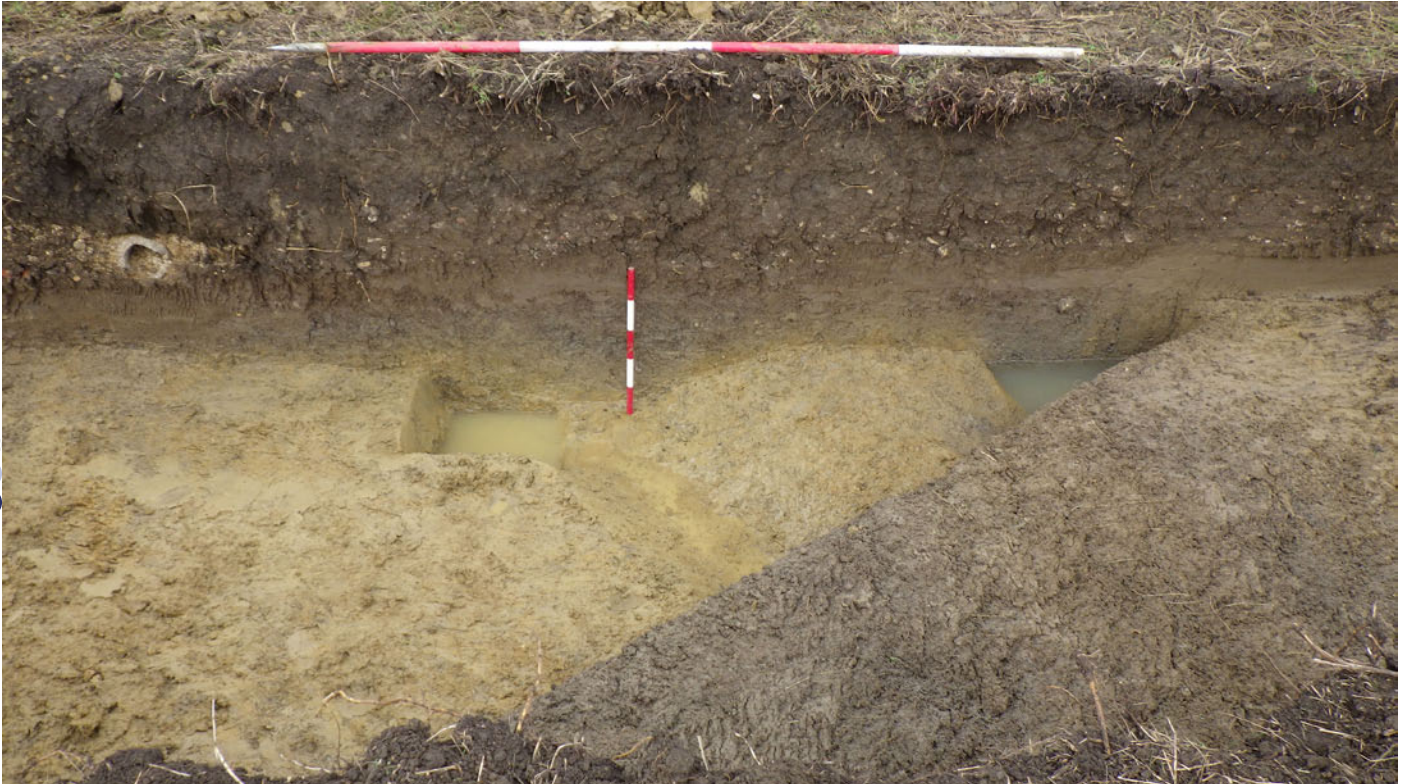
Plate 7: Trench 8: furrow 807, overlying ditch 810, looking north

- 3.3.11 Four linear features were visible within the trench comprising three furrows and a ditch. The furrows were all of a similar orientation, and width and were recorded at regularly spaced intervals throughout the trench.
- 3.3.12 The furrow 807 and underlying ditch 810 at the western end of the trench were excavated (Figures 3 and 4; Plate 7). The furrow and ditch were on the same NW-SE alignment as those seen in Trench 7 and were a continuation of those features. Furrow 807 was 2.5m wide with a slightly asymmetrical broad 'U'-shaped profile. It had a two fills (808 and 809), neither of which contained any artefacts.
- 3.3.13 The ditch 810 to the east was 0.67m wide and had the same vertical sided profile as Ditch 704 to the south. The single fill 811, contained no artefactual remains.

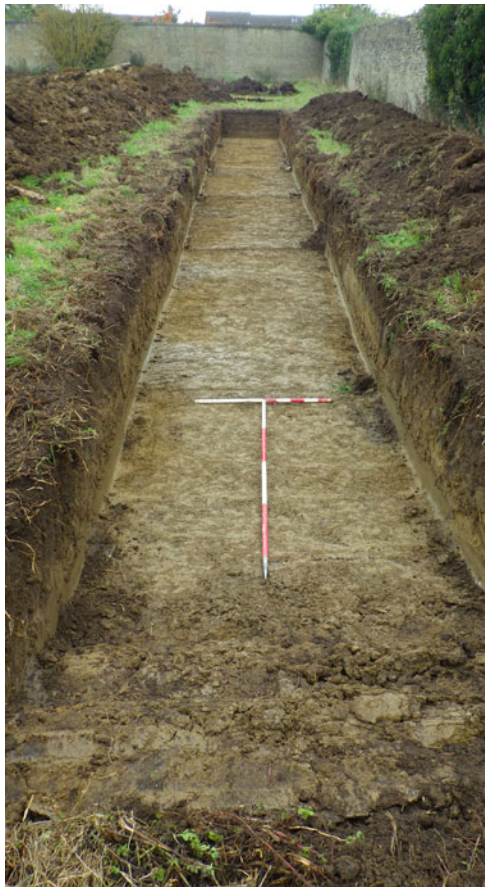
Plate 8: Trench 9: plan view, looking north-west

- 3.3.14 The trench contained two identified linear features; a furrow (905) aligned NW-SE that extended along the length of the trench (Plate 8). The furrow overlay a ditch 907 towards the northern end.
- 3.3.15 Ditch 907 was 0.94m wide and had steeply sloped sides with a flat base. The single fill, 906, contained no artefactual material (Figures 3 and 5; Plates 9 and 10).
- 3.3.16 Two possible features were seen to the west of the furrow, but these were more amorphous and probably resulted from tree rooting.

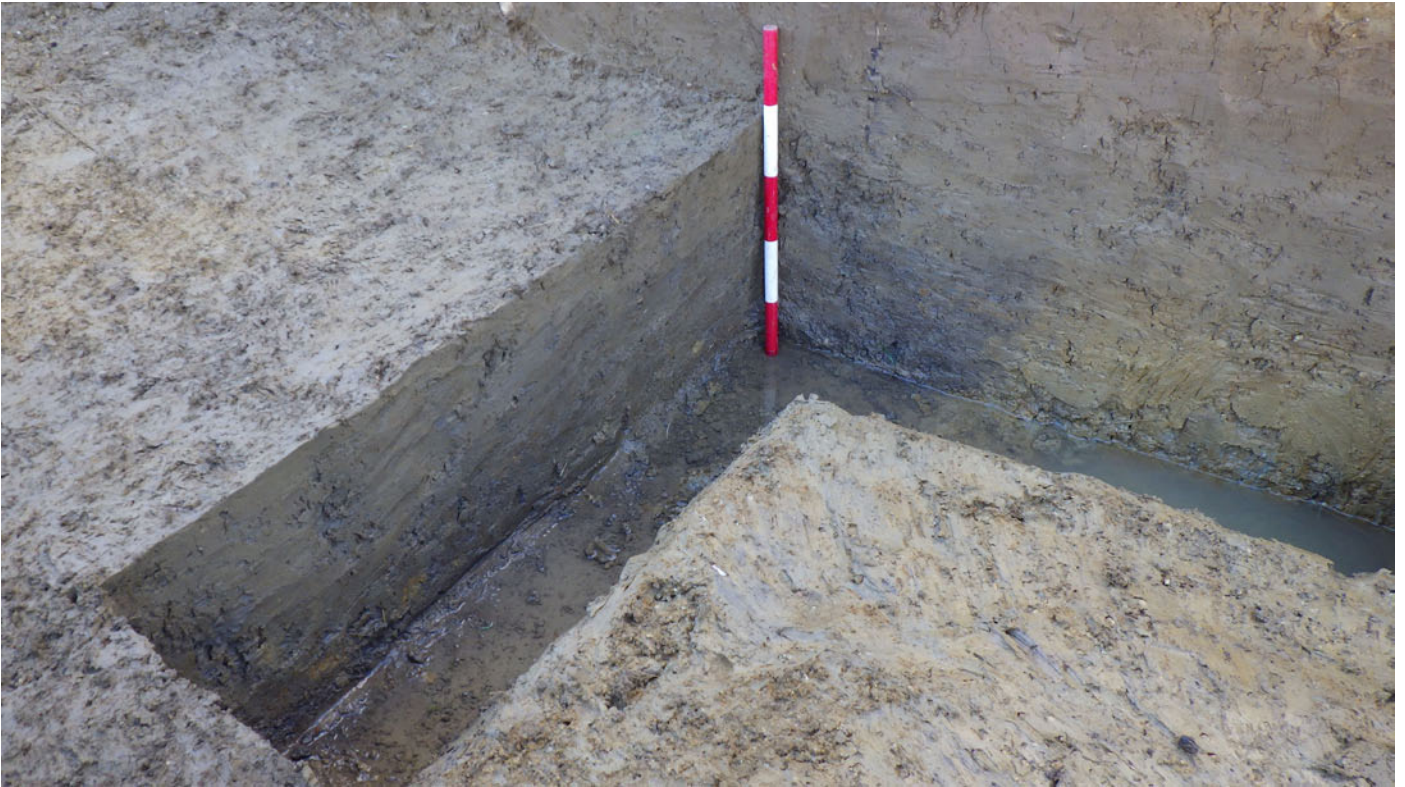
Plate 9: Trench 9: furrow 905, overlying ditch 907, looking north-east

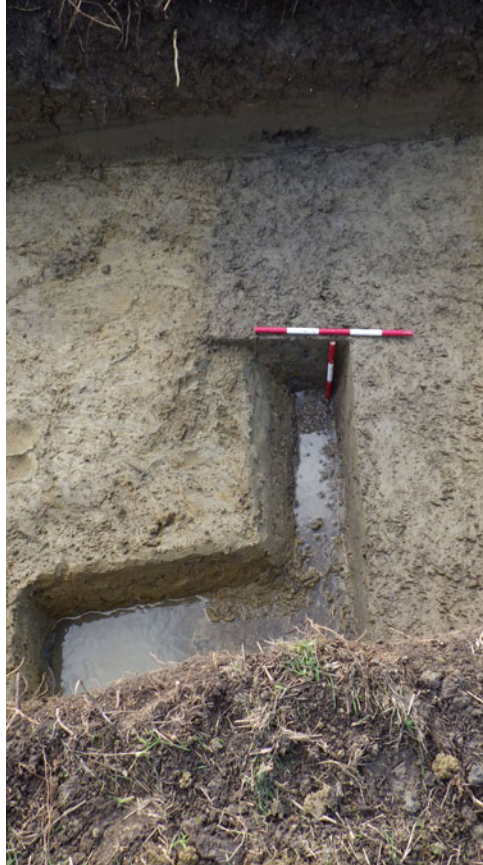
Plate 10: Trench 9: ditch 907, looking west

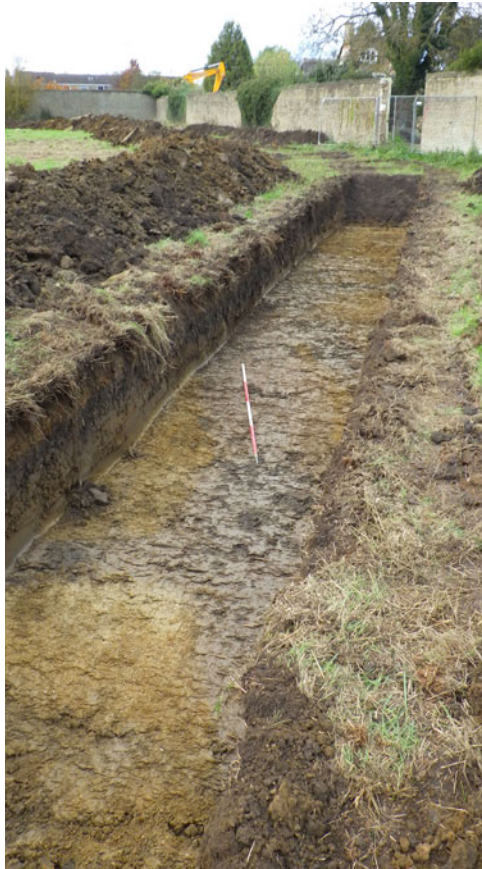
Plate 11: Trench 10: plan view, looking north

- 3.3.17 Three linear features were seen within this trench: ditches 1005, 1008 and 1010 (Plate 11). In addition there were three segmented ceramic drains seen on varying alignments.
- 3.3.18 Ditch 1005 was aligned E-W, with a right-angled return to the south at the western side of the trench (Figure 6; Plate 12). It was 0.7m wide and had two fills, the lower (1006) being overlain by (1007). The upper fill 1007 contained two abraded fragments of CBM and one small worn fragment of grey ware dated to the Roman period.
- 3.3.19 Ditch 1008 was aligned ENE-WSW and was 0.5m wide (Figure 7; Plate 13). It had a single fill, 1009 that contained no artefactual material. Fill 1009 was truncated by Ditch 1010.
- 3.3.20 Ditch 1010 was aligned NW-SE, parallel to the return of Ditch 1005. It was 1m wide and had a single fill which contained no artefactual material.

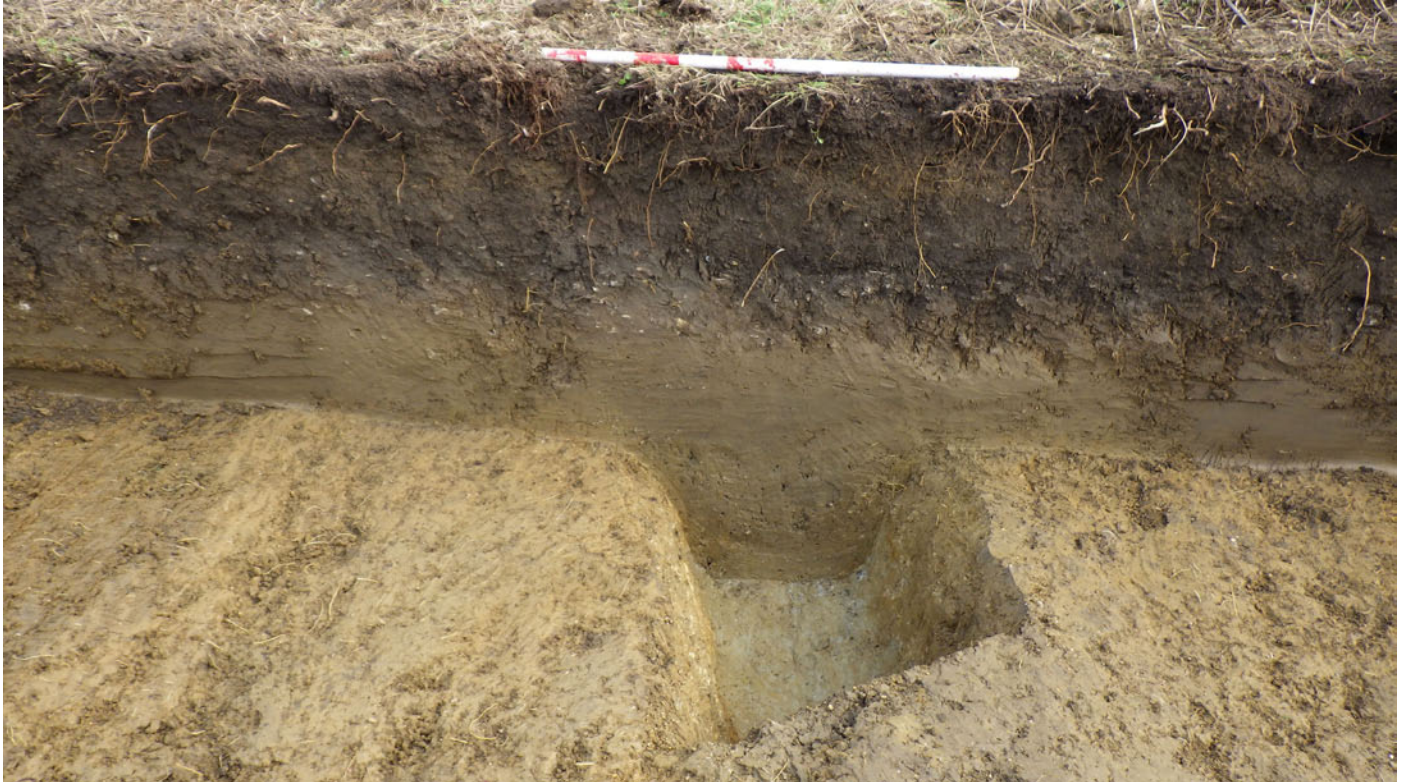
Plate 12: Trench 10: ditch 1005, looking west

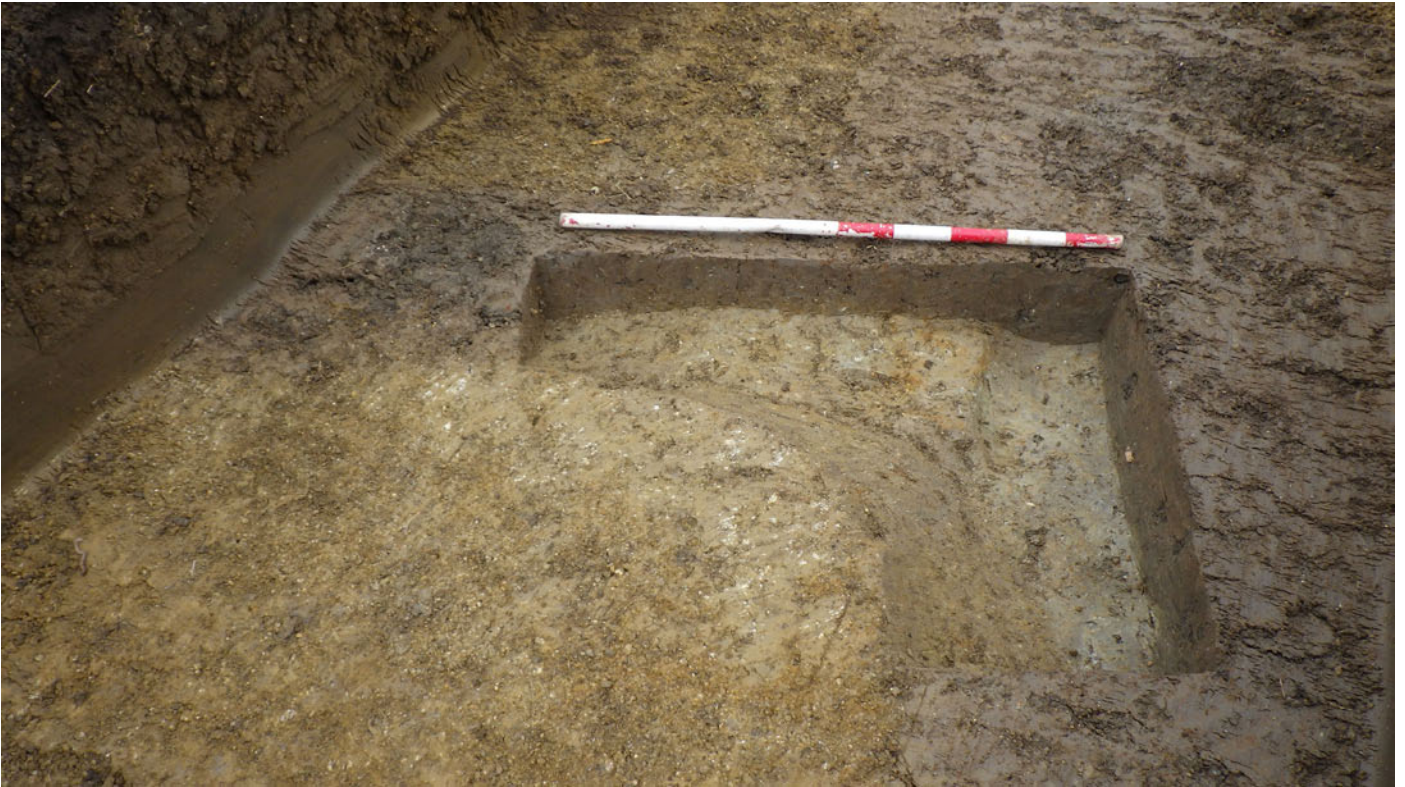
Plate 13: Trench 10: ditch 1010 overlying ditch 1008, looking north-east

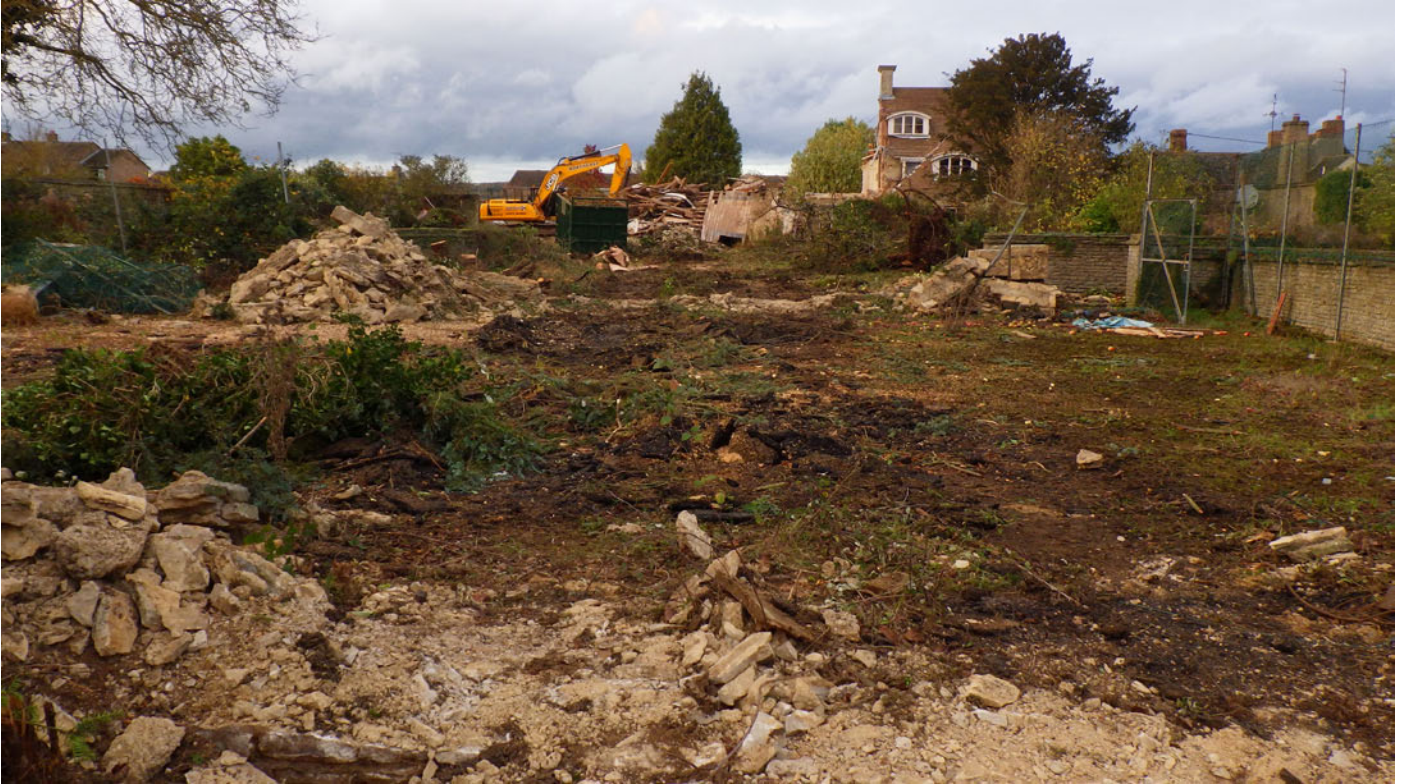
Plate 14: Area B: general view, looking north

- 3.4.1 All of the three trenches within this eastern area contained features of archaeological origin. This area had been subject to more intensive domestic, structural and garden occupation in the modern era, than had the western field (Plate 14).

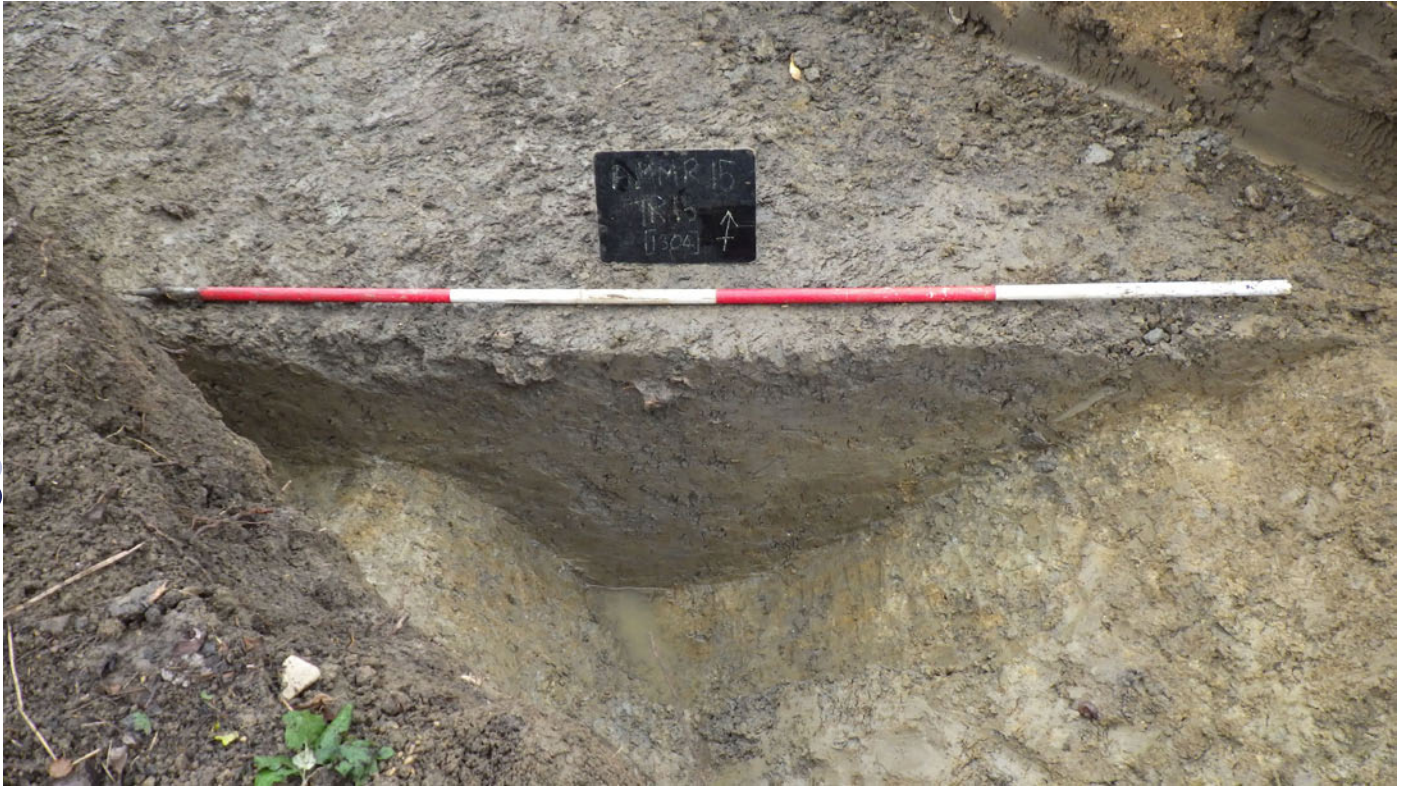
Plate 15: Trench 13: ditch 1304 overlying ditch 1305, looking north-east

- 3.4.3 The trench contained two inter-cutting linear features, Ditches 1304 and 1305, and a third linear feature, Drain 1303. The drain and ditches had no stratigraphical relationship within the confines of the trench.
- 3.4.4 Ditch 1304 was on a N-S alignment, was 2.2m wide and had sloping side with a concave base (Figure 9; Plate 15). There were two fills, lower fill 1306 and upper fill 1307. Fill 1307 contained a small amount of undated animal bone. The bones included one cattle astragalus, one horse scapula, humerus and skull, as well as some indeterminate fragments. The scapula and the humerus are fused, indicating an age-at-death of at least 10-12 months and 3.5 years respectively.
- 3.4.5 The ditch cut an earlier ditch, Ditch 1305, which was on the same alignment, to the immediate west. It only partially lay within the trench but was seen to extend over 0.6m

- B.1.3 The two fills of undated ditch 1304 contained one cattle astragalus, one horse scapula, horse humerus and horse skull, as well as some indeterminate fragments. Humeri and skull fragments were found in both fills, but element fragmentation, bone colour and bone condition suggest that they are in fact from single bones that may have erroneously been assigned different contexts during excavation. The scapula and the humerus are fused, indicating an age-at-death of at least 10-12 months and 3.5 years respectively (Habermehl 1975, 48).

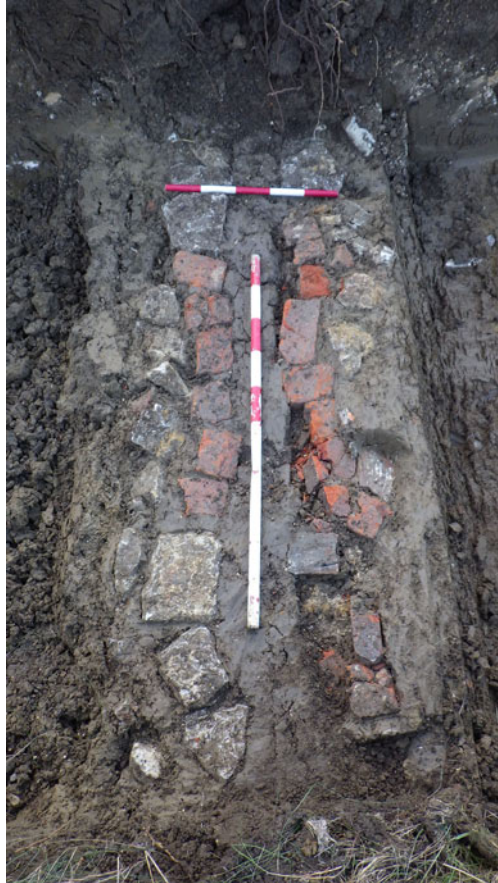
Plate 16: Trench 13: drain 1303, looking west

- 3.4.6 Drain 1303 was aligned E-W was 0.63m wide and constructed of 50% rough-hewn stones and 50% unfrogged brick fragments (Plate 16). The structural elements formed two parallel alignments with a central channel, infilled with clay which had been waterlain. The CBM sampled from the drain dated to the 16th-early 17th century but it was probably reused rather than original.

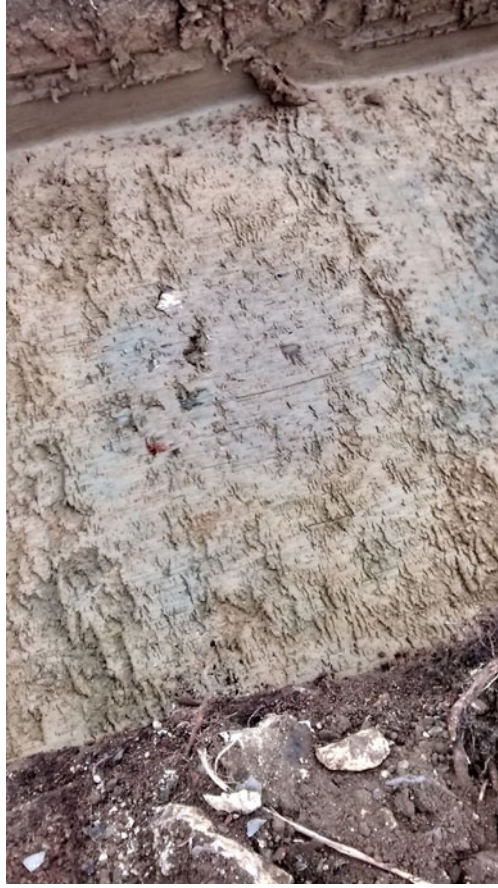
Plate 17: Trench 14: pit 1403 pre ex, looking east

- 3.4.7 There was a single round feature, (1403) within the trench. In addition there was evidence of modern truncation from the pre-existing greenhouses at the south-western end of the trench.
- 3.4.8 Feature 1403 was interpreted as a small pit, 0.8m in diameter with a single 0.15m deep fill 1404 that contained two fragments of undated animal bone (Figure 10; Plates 17 and 18).

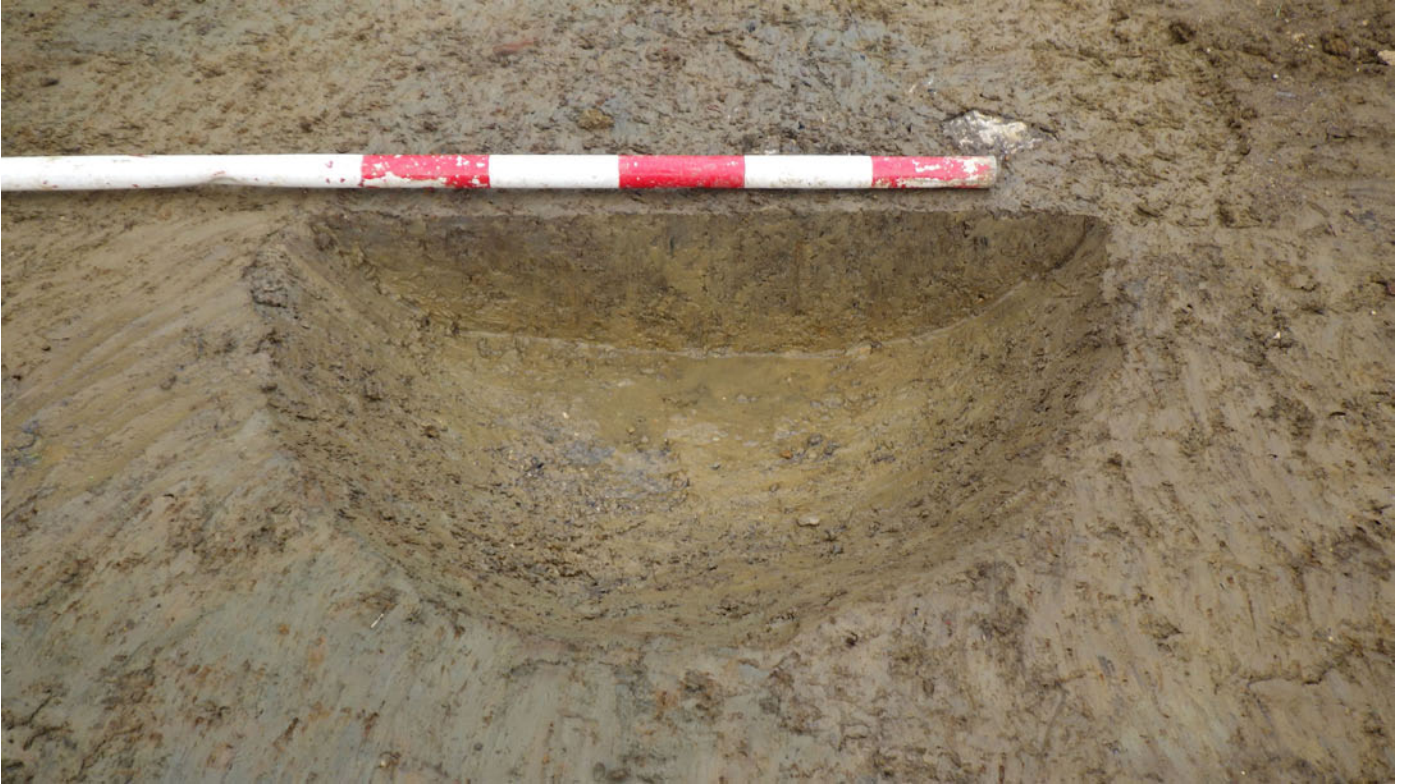
Plate 18: Trench 14: pit 1403, looking north
