New School Buildings  
Wraysbury Primary School  
Wraysbury  
Royal Borough of Windsor  
and Maidenhead

**Archaeological  
Watching Brief Report**

November 2011

**Client: Royal Borough of  
Windsor and Maidenhead**

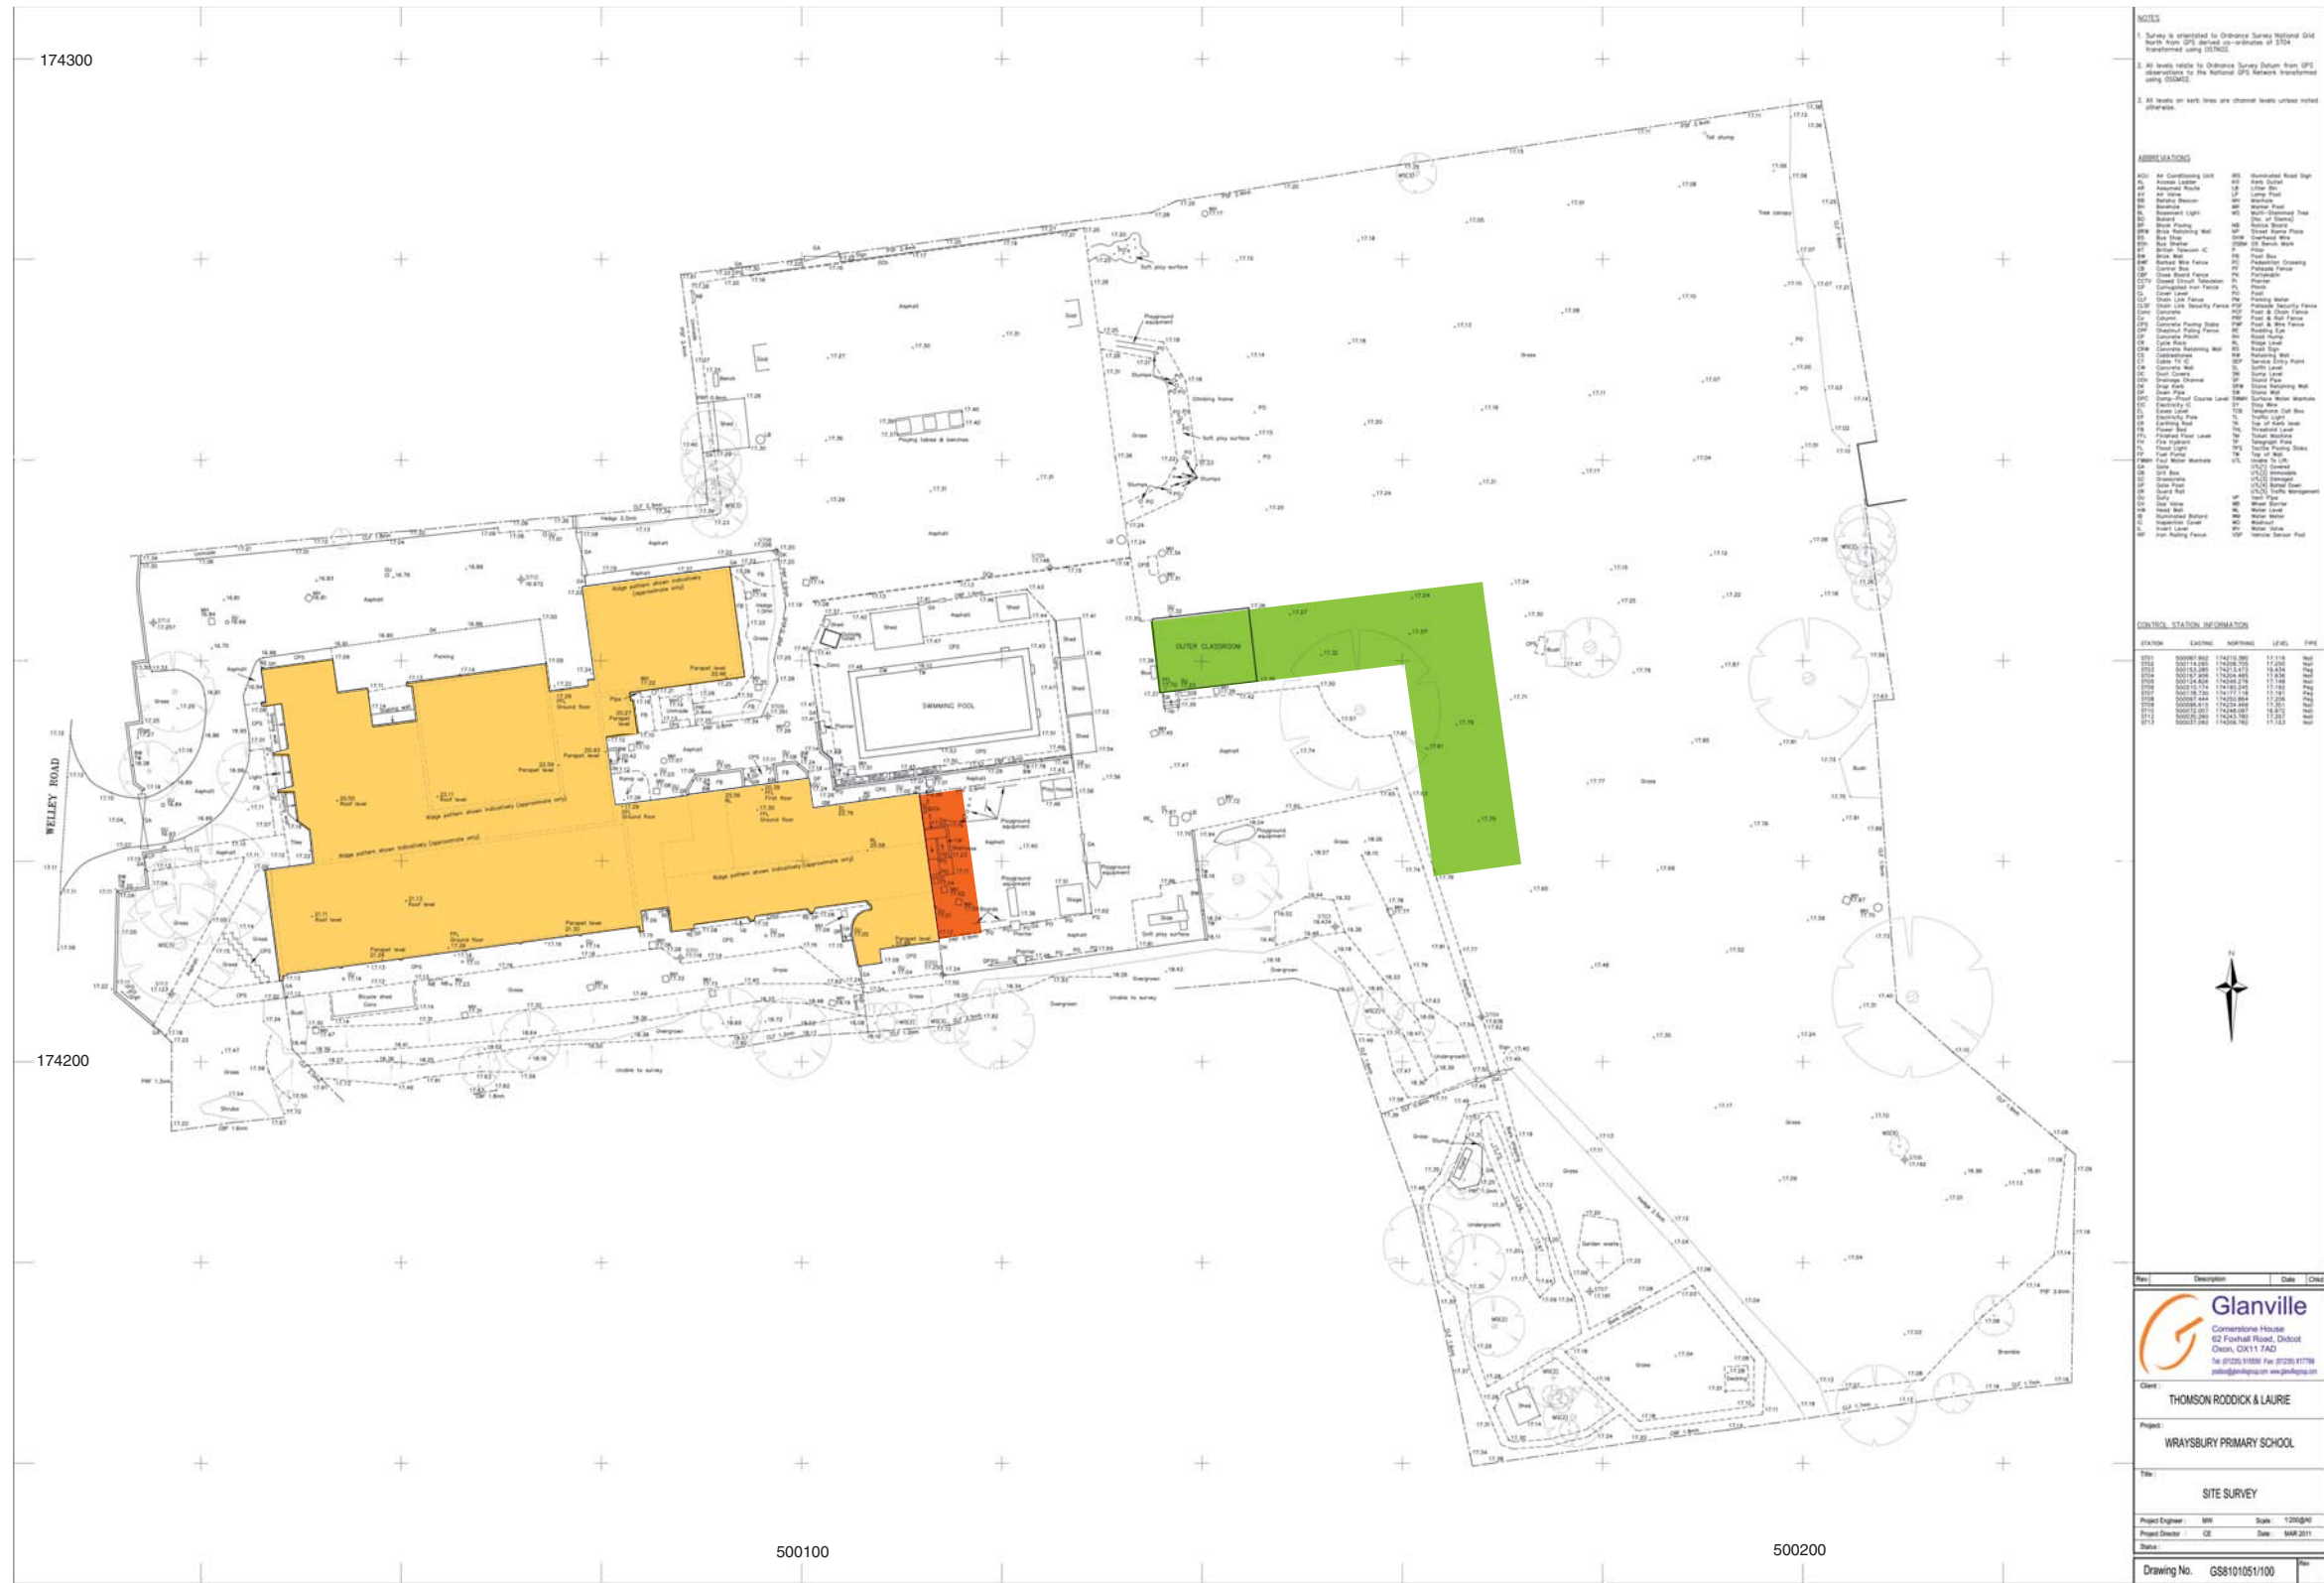
Figure 2: Site plan

Traditional build  
 "Rollalong" building  
 Existing school building

- 2.2.1 The archaeological work on the site was undertaken in two phases (Fig. 2). In June 2011 OA undertook a watching brief during the groundworks conducted prior to the installation of the "Rollalong" prefabricated buildings. These works included the excavation of foundation trenches, foundation pads, soakaway pits and associated service trenching.
- 2.2.2 The second phase was undertaken during the construction of a traditionally built extension on the south side of the main school building during August 2011.
- 2.2.3 This watching brief was maintained as a continuous archaeological presence during all groundworks that had the potential to affect or reveal archaeological deposits.

- 3.4.1 The works included the topsoil strip and leveling within the footprint of the development, the excavation of foundation trenches for the brick skin (0.5 m wide and averaging between 1 m and 1.2 m in depth), the excavation of 73 pits for foundation pads (each nominally 1 m square and between 1m and 1.2 m in depth), 4 soakaway pits, each 2.6 m square by up to 3.1 m in depth and associated service trenching 0.5 m width and up to 0.6 m in depth (Fig. 2 and Fig. 3).

- 3.4.9 The works included the removal of the tarmac playground surface, ground reduction within the footprint of the development and the excavation of foundation trenches for the external and internal walls and measured approximately 2.2 m by 7.4 m (Fig. 2 and Fig. 4). The stratigraphy observed was similar throughout the site and a general description can be applied with local variations described as appropriate.

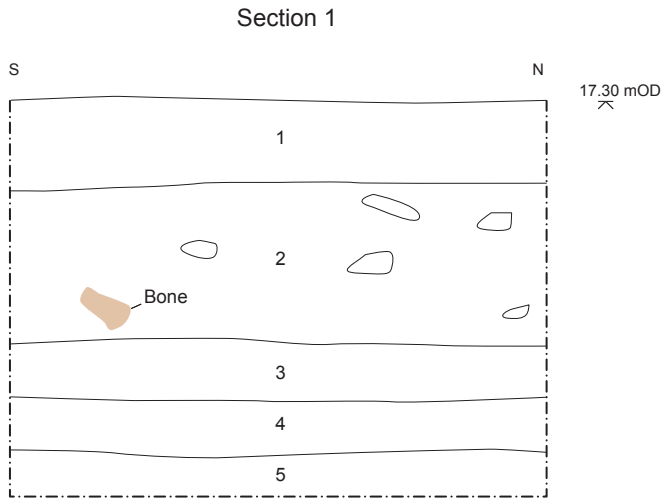
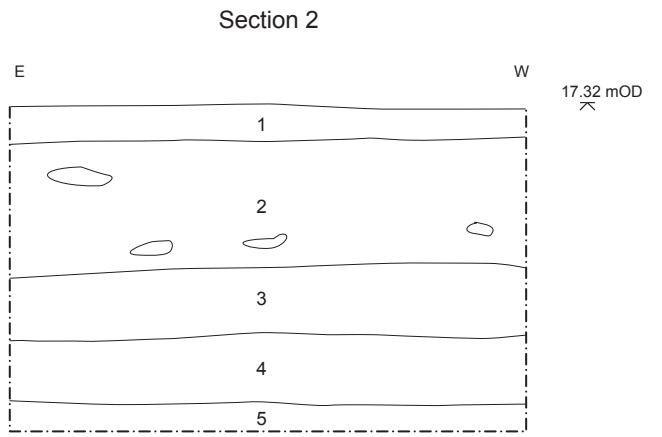
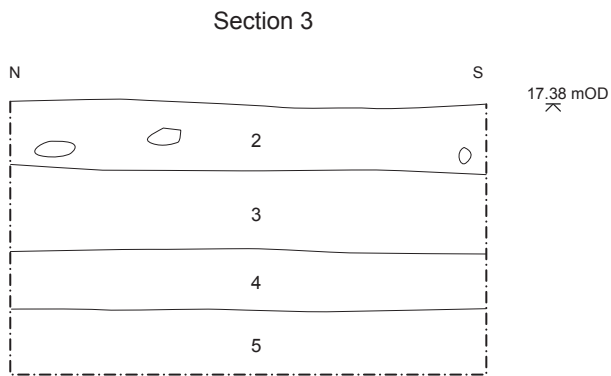
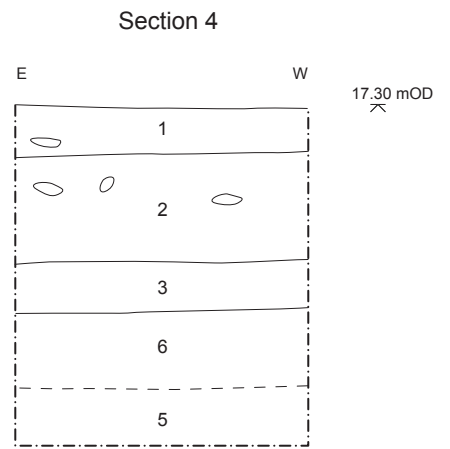
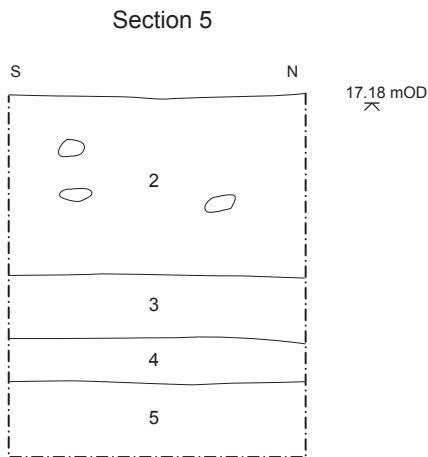
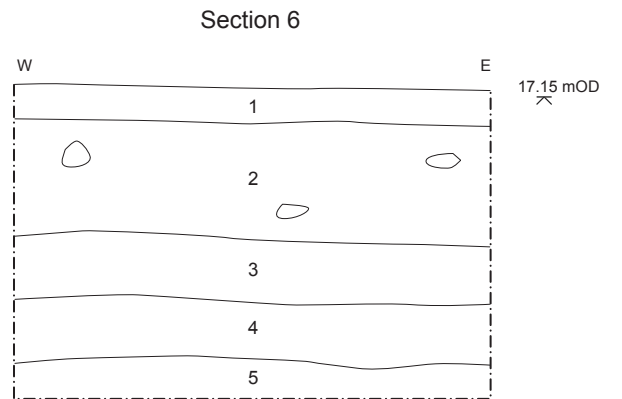
Figure 5: Sections 1-6

- 3.4.3 The underlying natural, a yellow-brown compacted terrace gravel (5), was encountered at a depth of between 0.9 m and 1.1 m below the current ground level (Figs. 5 and 6, Sections 1 to 8). Within the majority of the site the gravel was overlain by a layer of fine yellow-brown clay silt containing coarse sand and fine gravel (4), measuring between 0.2 m and 0.4 m in depth. Within the area around Section 4 the gravel was overlaid by a lens of orange-brown sandy silt clay (6) measuring 0.25 m deep and 3 m wide.

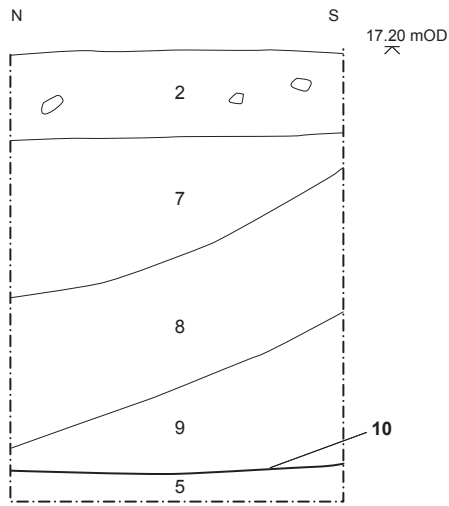
### Section 7

- 3.4.5 This layer had been cut by a roughly circular vertical sided pit (10) measuring approximately 1.2 m deep and 5.5 m in diameter (Section 7). This was filled by a sequence of redeposited material (7, 8 and 9) which produced modern finds such as lengths of pipe and angle iron.

- 4.1.4 This layer has been cut by a large pit (10), probably dug for small scale gravel extraction, backfilled with material containing 20<sup>th</sup> century artefacts. The absence of washed in soils or slumping would suggest that it had been backfilled soon after extraction finished giving a 20<sup>th</sup> century date for its excavation.

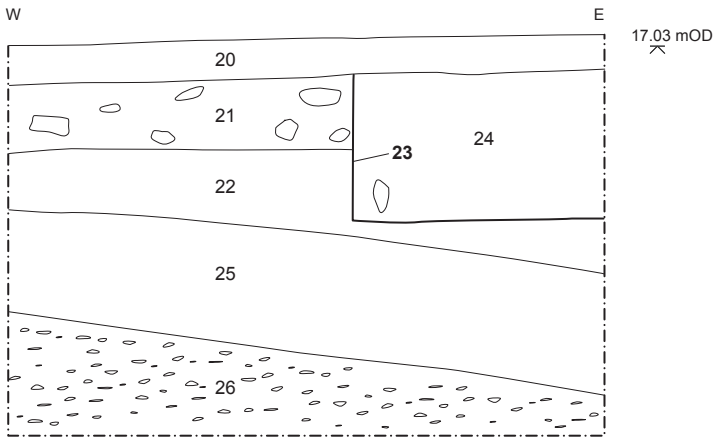
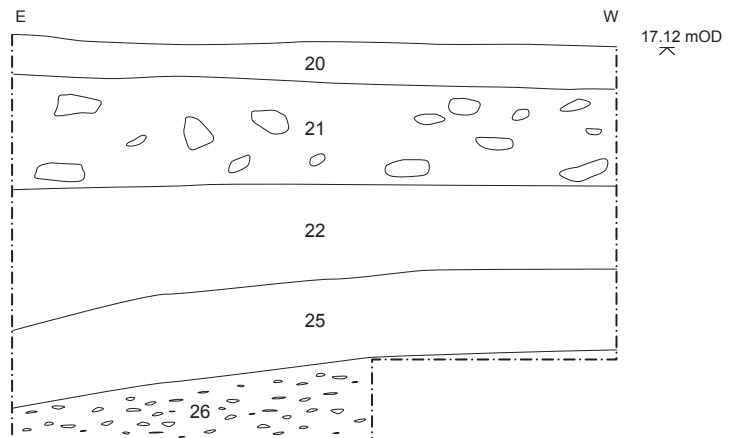
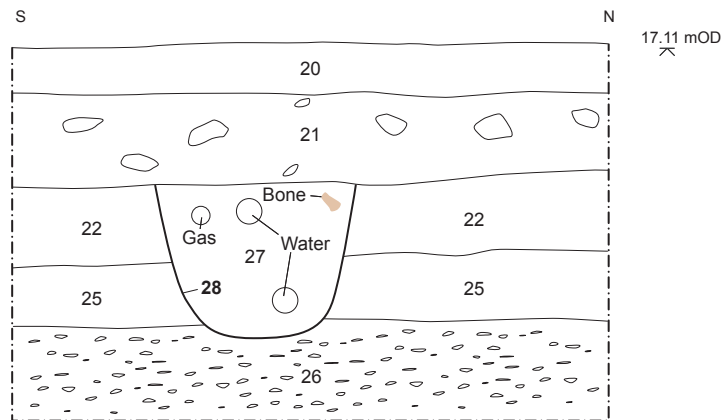
Figure 6: Sections 7, 8, 10-12

- 3.4.10 The underlying natural gravel (26), was encountered at a depth of between 0.9 m and 1.2 m below the level of the playground (Fig. 6, Sections 10-12). This was overlaid by a second undisturbed natural deposit of a coarse reddish orange sand and small gravel (25) measuring up to 0.35 m in depth.

- 3.4.11 Covering layer 25 was a layer of brownish yellow coarse sand (22) up to 0.28 m in depth. This was also a probable natural deposit. All these deposits tipped down towards the east (towards the Thames). Cutting this layer was a 0.7 m wide service trench (28). This trench contained 3 separate pipes and had been backfilled with redeposited material (27). This backfill produced a single fragment of human bone.

- 3.4.12 Sealing layer 22 and exposed throughout the footprint for the new build was a layer of light grey sandy silt (21), 0.2 m – 0.3 m in depth. This layer contained numerous fragments of modern building materials such as brick, concrete and plastic sheeting. Cutting this layer was a modern service trench (23) containing a cable duct. This had been backfilled with redeposited material (24).
