# Kiln Cottage Pottery Lane Inkpen Hungerford West Berkshire

Archaeological Watching Brief Report

November 2011

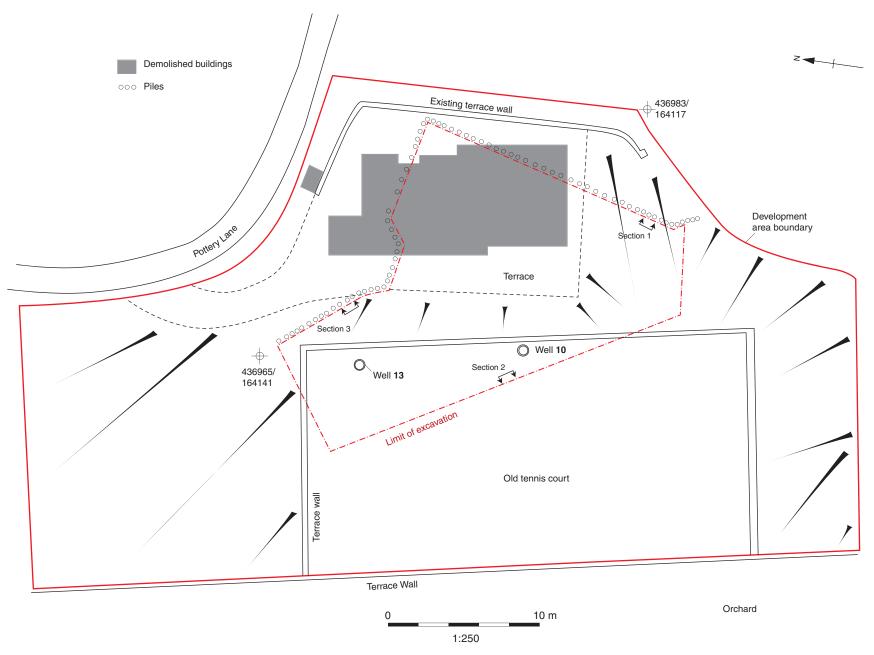
Figure 2: Site plan

- 2.2.1 An intermittent watching brief was undertaken during the below ground construction activities. The foundation for the lower ground floor was bounded by a piled retaining wall (a total of 79 piles) before the commencement of excavation (Fig. 2). The excess material was removed by machine. As part of the excavation several existing concrete terrace walls together with part of the existing tennis courts and an external staircase were also removed (Fig. 2).

- 3.1.3 Well 13 was located towards the north-western corner of the excavation (Fig. 2). The brick lining (13) had been constructed within a shaft (14) cut into the natural clay (Fig. 3 and Plate 2). It is probable that this was originally circular but ground pressure had deformed it into an eclipse measuring 1 m north-south and 0.82 m east-west. The method of construction of the brick lining was similar to that of well 10 with plain hand moulded unfrogged bricks measuring 0.228 m x 0.116 m x 0.065 m laid tangentially. As with well 10 the brick size suggests a late 18<sup>th</sup> or 19<sup>th</sup> century date. In places gaps between the brick lining and the well shaft were filled with a dark grey clay (16). The well had been backfilled by a mixture of whole and broken bricks mixed with a yellow-brown clay (15). This appears to have been the result of a deliberate collapse of the top of the well with many voids being left in the material.

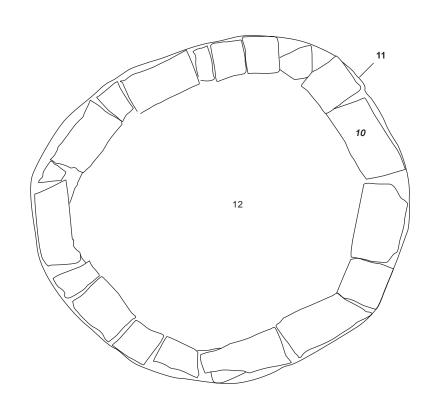
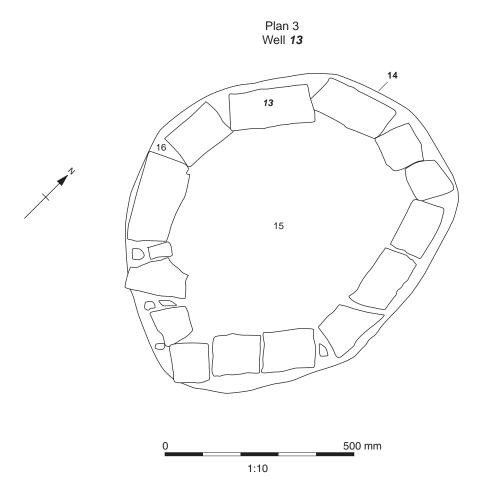
Figure 3: Plans of wells 10 and 13

- 3.1.2 In the base of the excavation two circular brick lined wells were exposed (Figs. 2 and 3) cut into layer 4. The southernmost of these, Well 10, had been built within a circular

- 0.87 m diameter shaft (11) with the brickwork butting tightly up against the cut with no evidence of backfilling between the brick lining and the shaft (Plate 1). The lining was constructed using plain unfrogged bricks measuring 0.228 m x 0.103 m x 0.067 m laid without mortar tangentially to the shaft. The upper two courses of the lining were tipped towards the centre of the well suggesting that the lining was originally topped with a hemi-spherical brick well cap. Both the brick size and the construction suggest that it dates to the late 18<sup>th</sup> or 19<sup>th</sup> century. The well was filled by a fine dark grey clay-silt (12) (possibly silting) with fragments of both brick and pottery in its surface. These fragments were also dated as being 18<sup>th</sup> to 19<sup>th</sup> century in origin.
