Land East of Newton Lane, Newton, Rugby

Archaeological Evaluation Report

June 2017

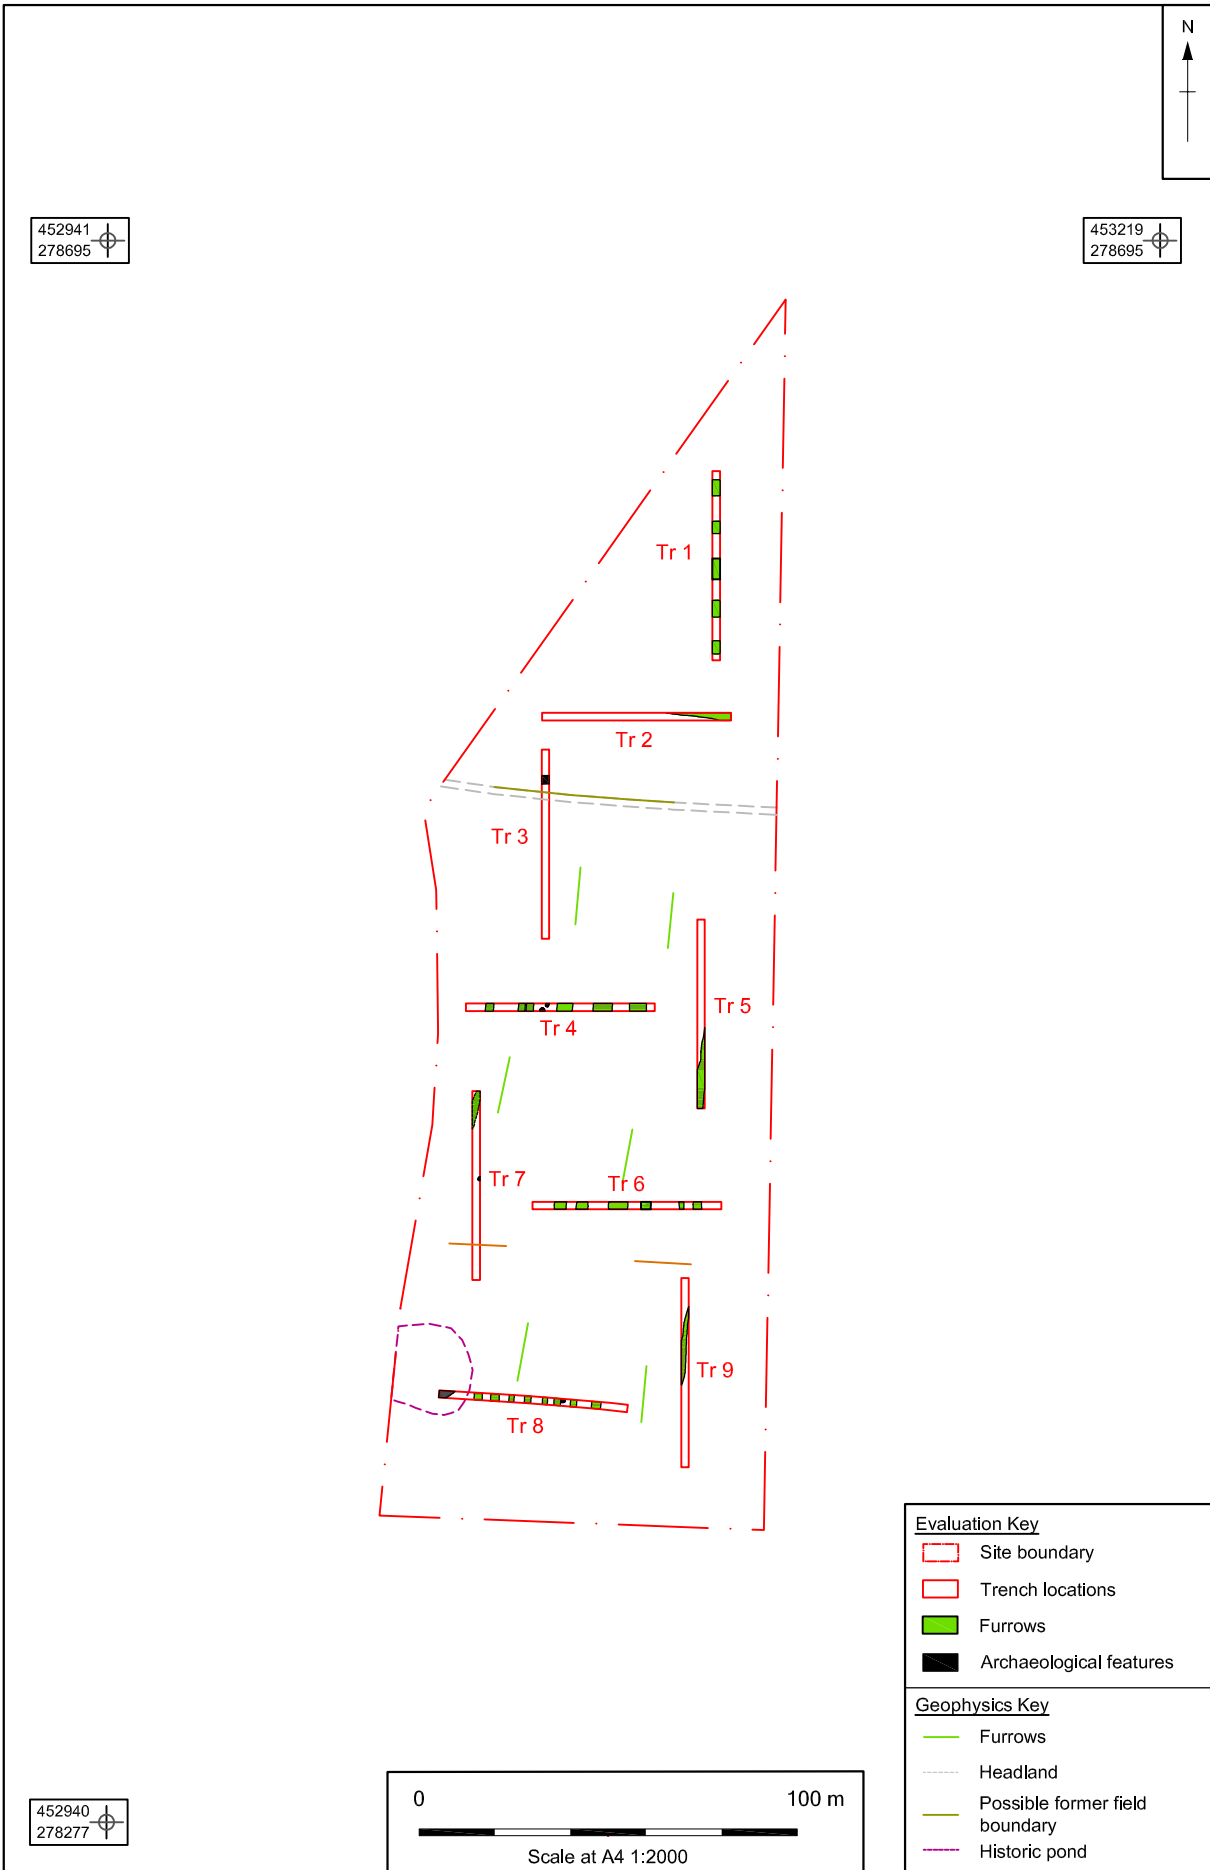
Figure 2: Trench layout with results of geophysical survey and archaeological evaluation

3.1.1 The results of the evaluation are presented below, and include a stratigraphic description of the trenches that contained archaeological remains with the exception of the furrows which are illustrated in Figure 2. The full details of all trenches with dimensions and depths of all deposits can be found in Appendix A. Finds data and spot dates are tabulated in Appendix B.

4.2.6 The location of the pond (Trench 8) is represented in the results of the survey as an area of strong magnetic debris which correctly reflects the nature of its backfill.

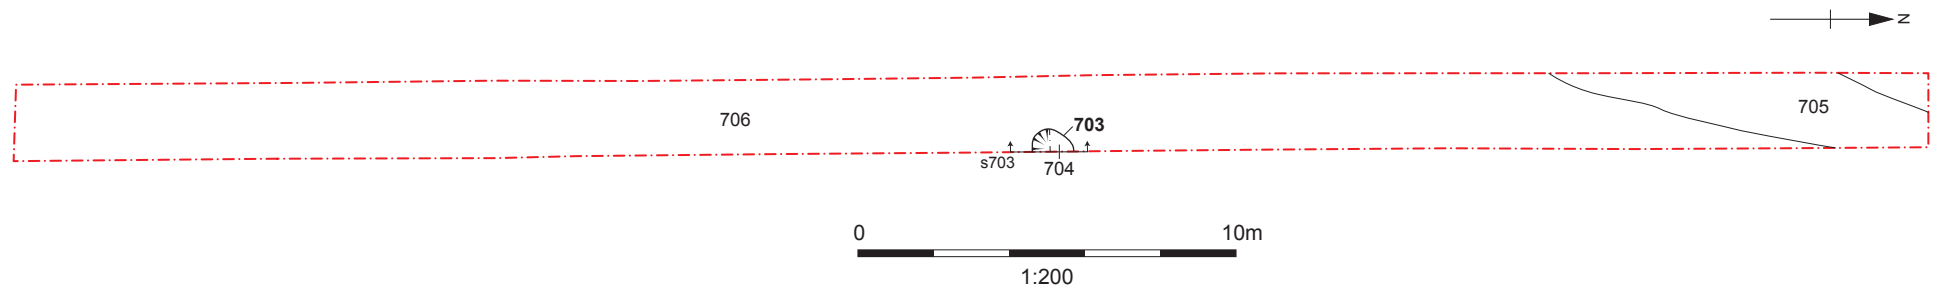
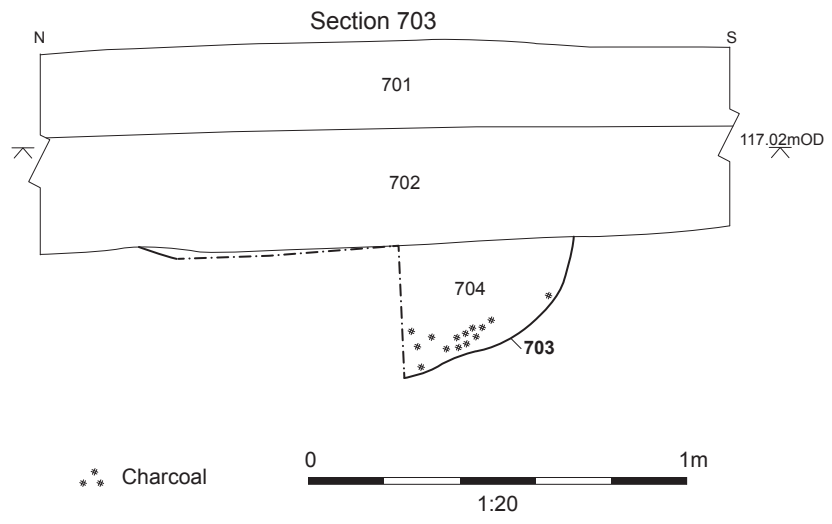
Figure 5 : Trench 7 plan and sections

3.10.1 The geological horizon (706) was established at a general depth of 0.4m (c 117.07m aOD). Trench 7 contained a single north-south furrow (705) and a small pit or ditch terminus (703) (Fig. 5).

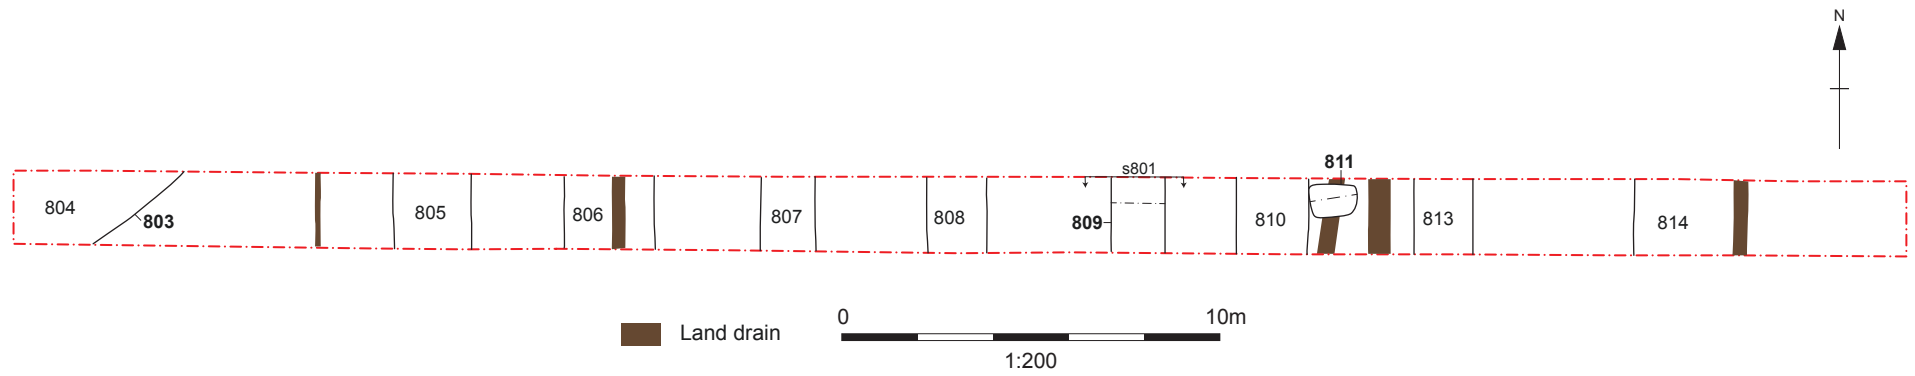
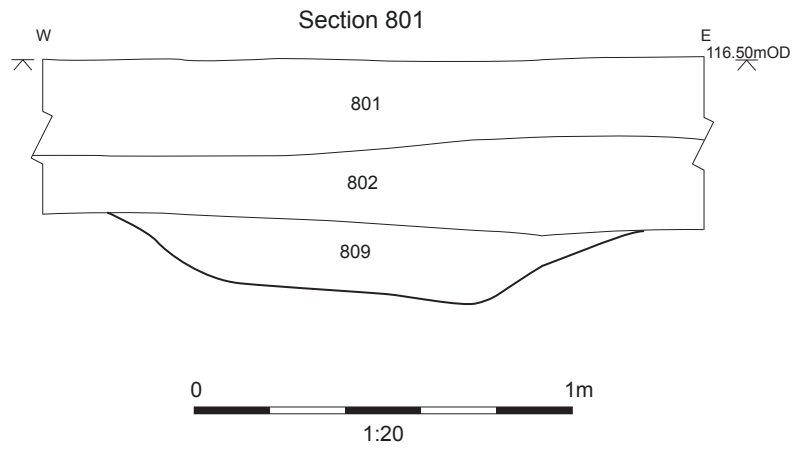
Figure 6: Trench 8 plan and section

3.11.1 The geological horizon (815) was established at a general depth of 0.5m (c 116.18m aOD). The eastern extent of a backfilled pond (803) and eight furrows (805, 806, 807, 808, 809, 810, 813 and 814) were identified within Trench 8. In addition, a subrectangular pit (811) was investigated (Fig. 6).

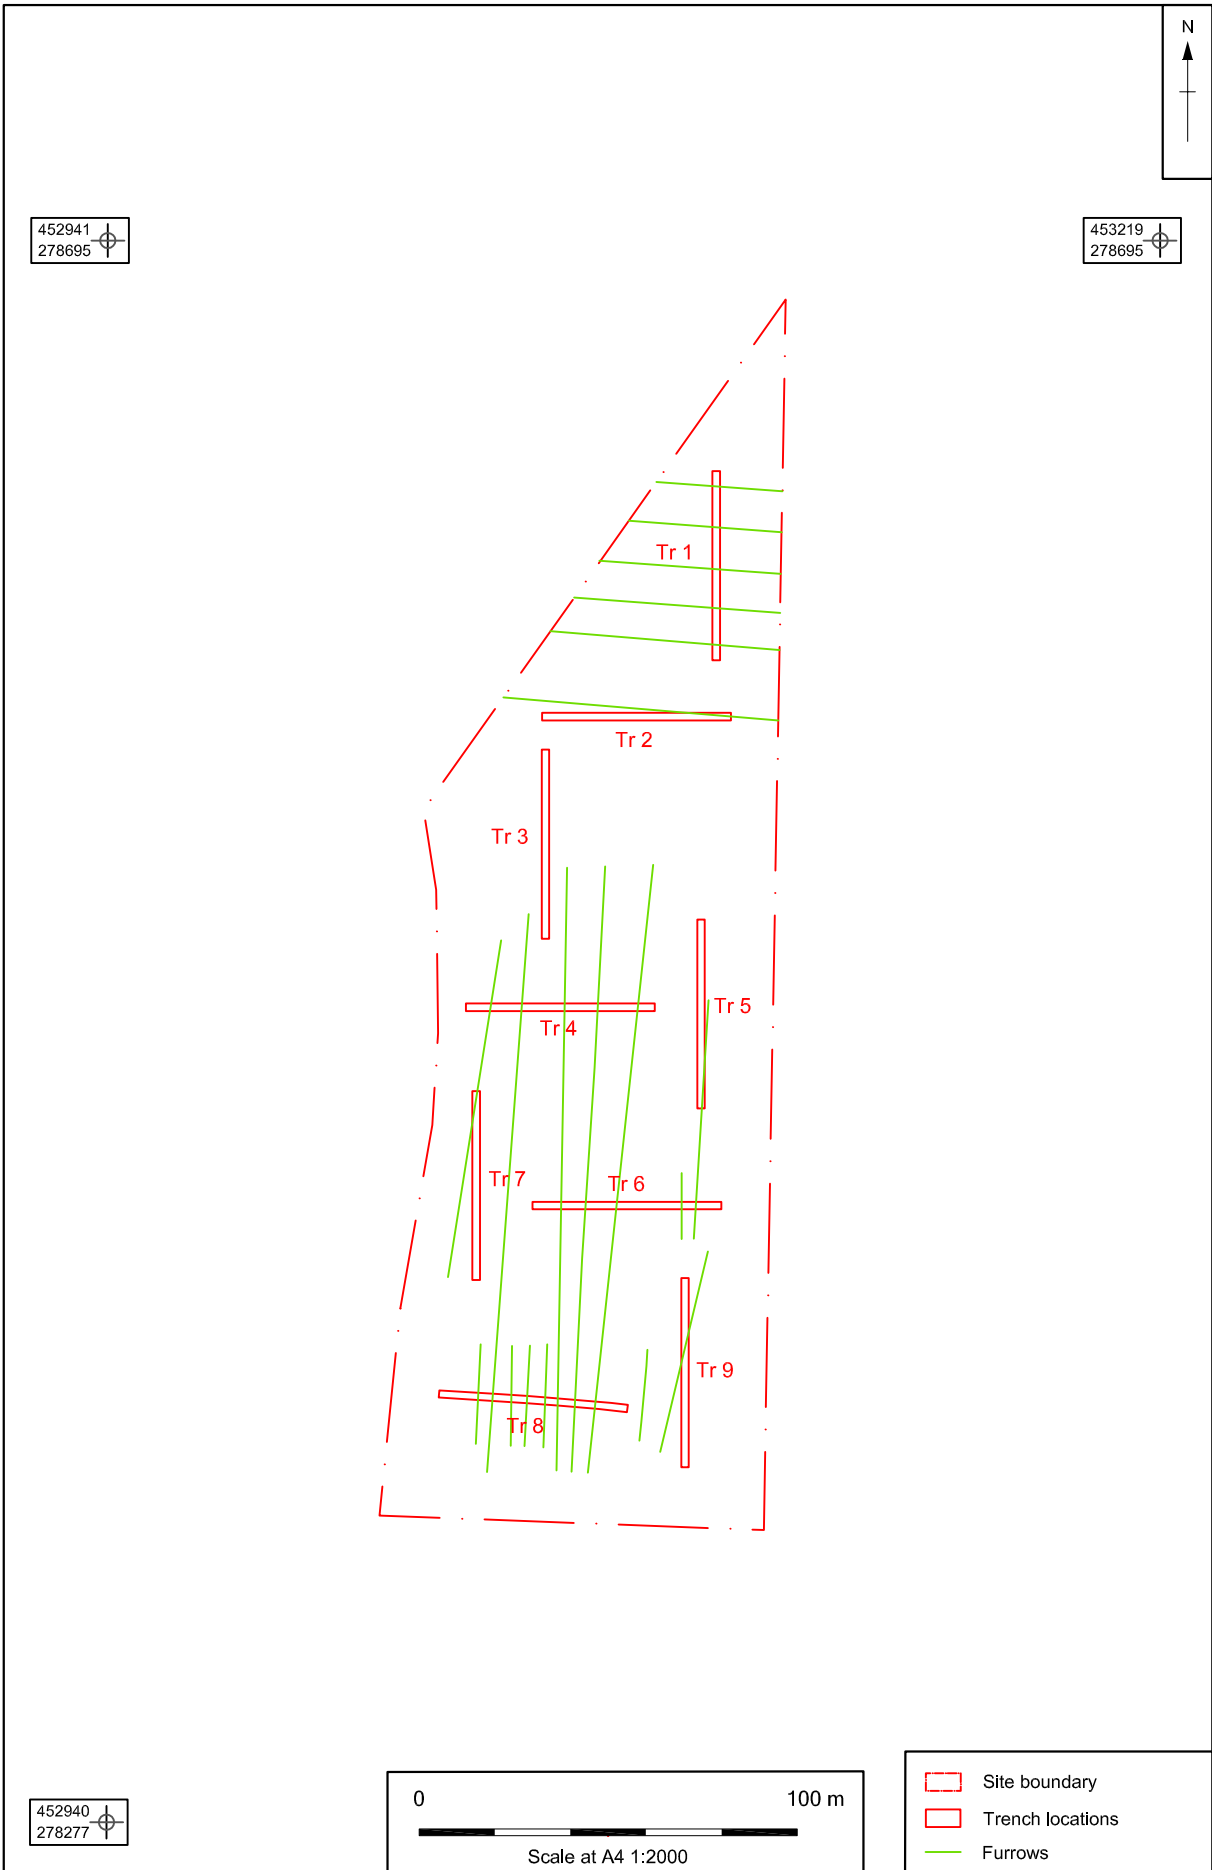
Figure 7: Extrapolated furrow alignment

4.3.3 The evaluation identified two distinct fields of probably medieval or post-medieval date, to the north and south of the site, divided by an extant headland which is parallel to and just to the south of a boundary ditch revealed in Trench 3. To the south of the headland and boundary ditch a system of furrows was identified aligned north-south. They were on average c 3m wide and 3.6m apart. To the north of the boundary ditch and headland a system of furrows aligned east-west was identified. In contrast to the furrows to the south these were 4m wide with spacings of c 6m (Fig. 7).

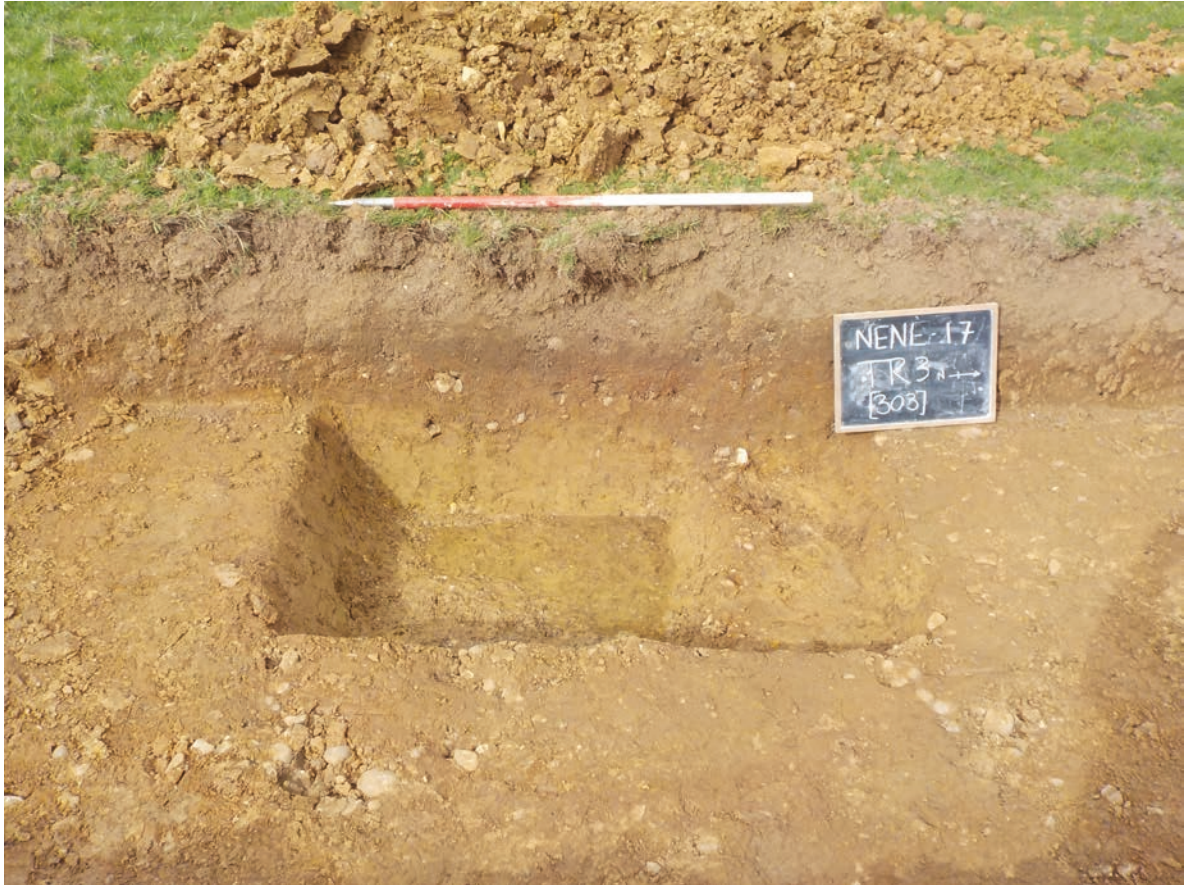
3.6.2 Ditch 303 (Plate 1) was situated immediately to the north of, and parallel to (E-W), the extant headland (Fig. 2). The ditch was 1.5m wide and 0.25m deep. The profile of the ditch was slightly irregular with the north side being 45° and smoothly breaking to a flat base. The south side of the ditch was somewhat irregular. This side was shallow for 1.2m before dropping sharply towards the base. It was filled with a homogenous deposit (304) of moderately compact, mid grey brown, slightly humic clay silt. The irregular character, diffused edges and humic fill suggest that this features represents a boundary ditch and associated hedge-line.

Plate 1: Boundary ditch (303) Trench 3

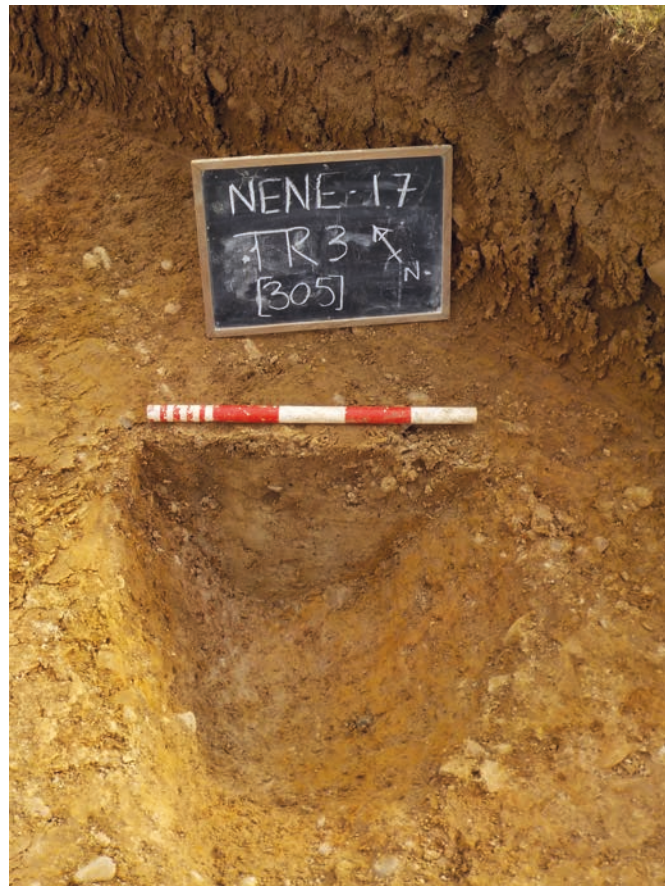
3.6.3 Gully 305 (Plate 2) was situated c 3.5m to the south of the boundary ditch. It was aligned northeast-southwest and terminated within the trench. The gully measured 0.5m in width and 0.3m in depth, with steep 40° sides and sharpish break to a U-shaped base. It was filled with a compact, pale brownish grey sandy clay (306) with 10% small rounded pebbles. It was noted that the south-eastern side of the gully was cut through the brown clay geology, as generally seen throughout the site, whilst the lower part of the gully's north-western side was cut through a geology of compact mid grey sandy clay, which was reflected in its backfill. This suggests the feature was filled relatively soon after excavation with its up-cast material.

Plate 2: Gully terminus (305) Trench 3

4.4.2 The alignment of the gully (305) terminating within Trench 3 is not in keeping with the alignment of the furrows or the field's boundaries and its function is unclear.

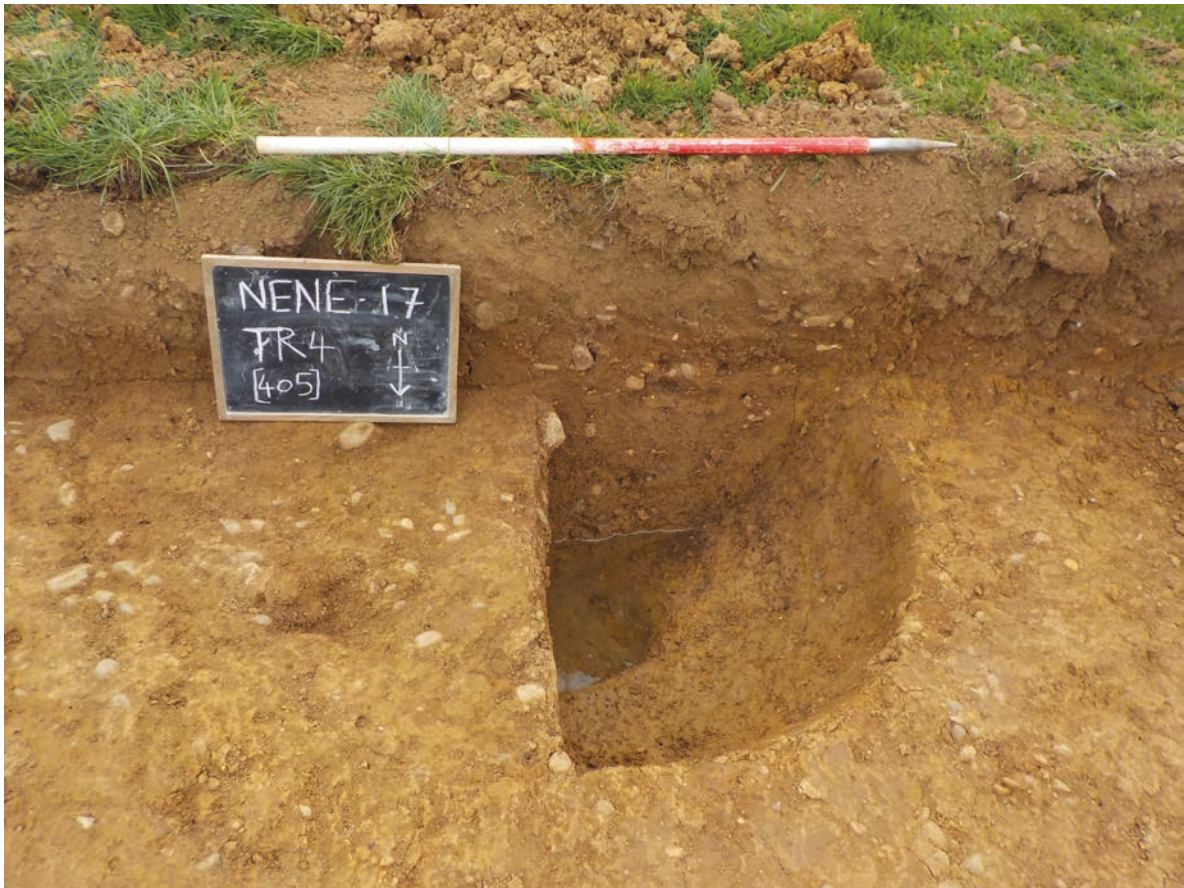
3.7.3 Between furrows 404 and 409, a small circular pit (405) was investigated (Plate 3). The pit had a diameter of 1.5m (E-W) and a depth of 0.52m, although its southern side extended beyond the limits of the investigation. It had regular 40° sides smoothly breaking to a flat base. It was filled with a moderately compact, mottled mid brownish grey sandy clay (406).

Plate 3: Post-hole (405) Trench 4

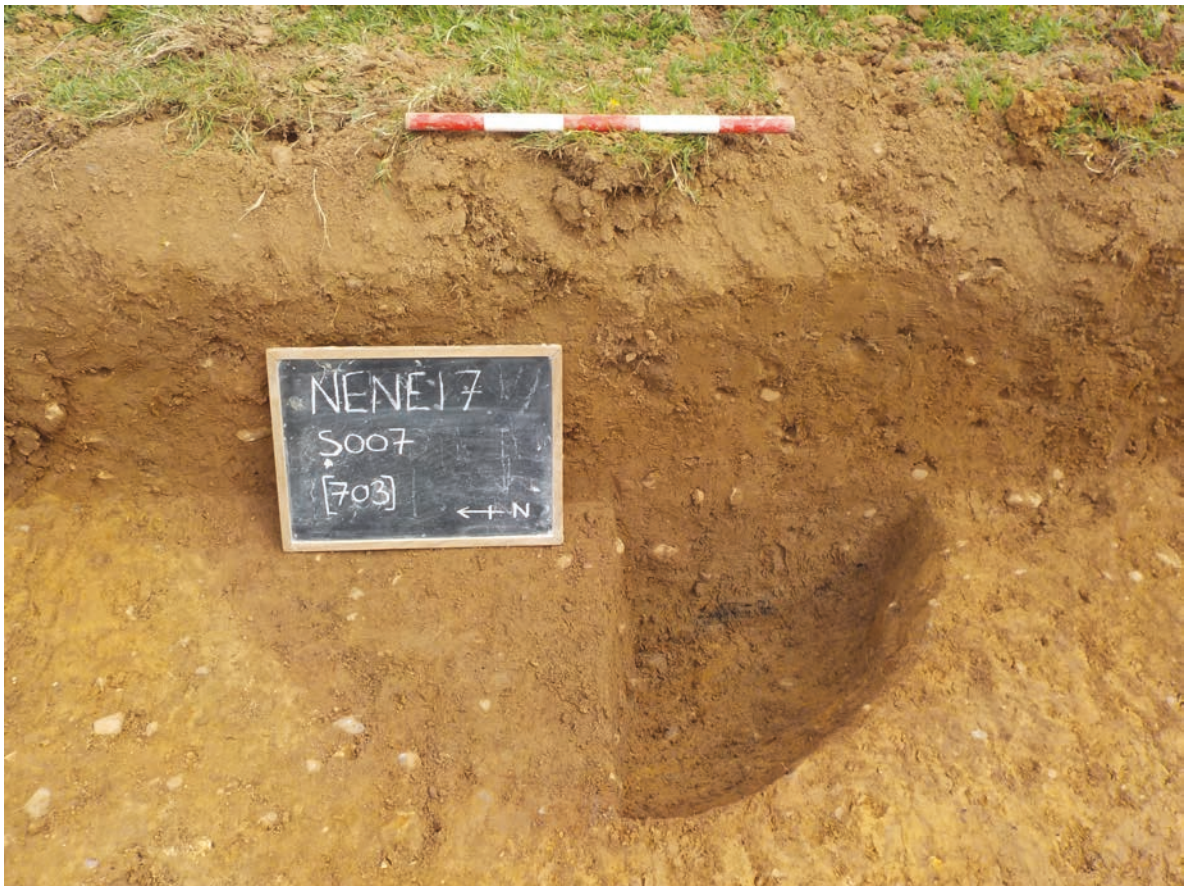
3.10.2 The pit or ditch terminus (703) (Plate 4) was 1.15m long (N-S), 0.6m wide (E-W, although it extended beyond the limits of the excavation) and 0.35m deep. It had steep 60° sides, smoothly becoming 20° towards its base. It contained a single fill comprising moderately compact, mid brownish grey sandy clay (704). The fill contained a small concentration of charcoal flecks. A single very worn fragment of ceramic building material, weighing 8g and of Roman date, was recovered from context 704.

Plate 4: Post-hole (703) Trench 7

4.4.1 The pit (703) in Trench 7 produced a fragment of ceramic building material (CBM) dated to the Roman period which is of some interest. The CBM is very abraded and almost certainly residual, and therefore can be considered of low significance. Pit 703 and the remaining undated features are likely to be related to the field's recent use to keep horses, perhaps representing post-holes for paddocks or enclosures.

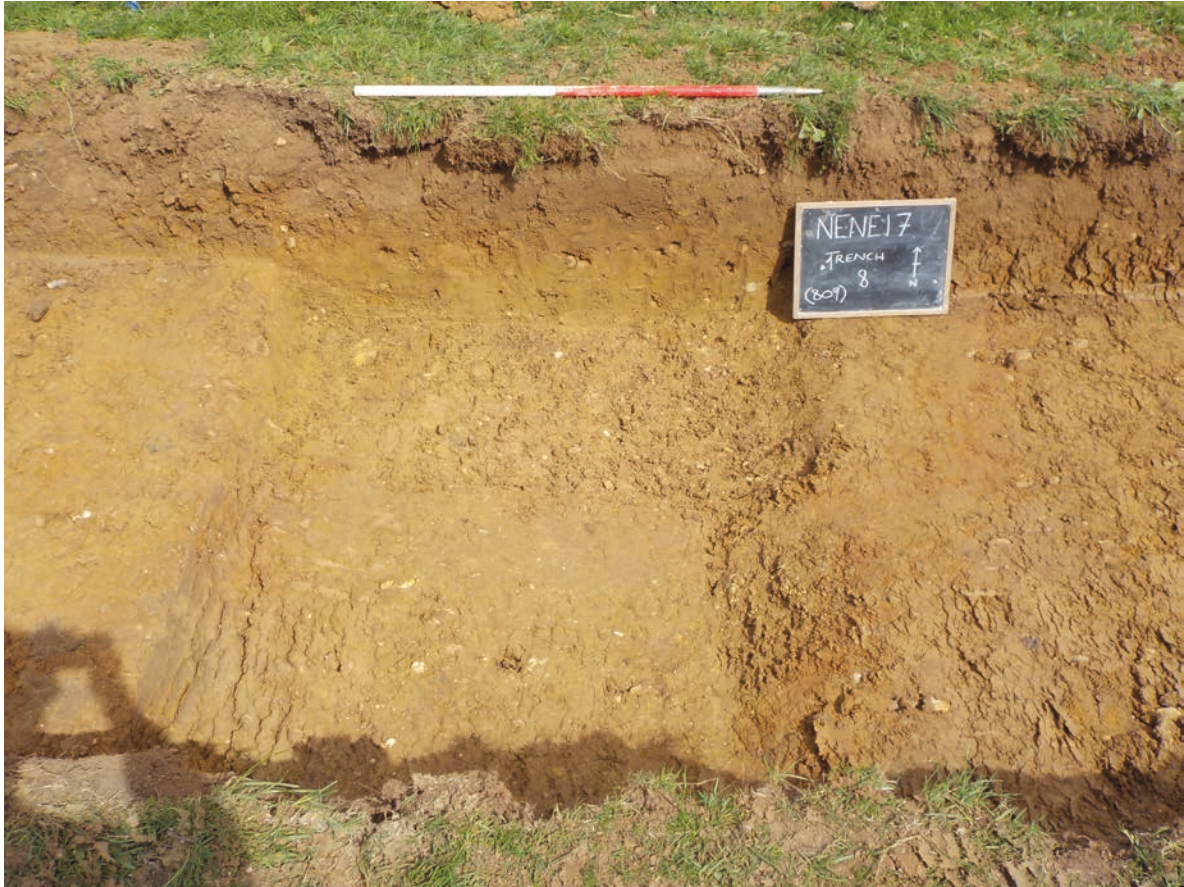
3.11.2 The furrows had an average width of c 2.2m and were spaced on average c 2m apart. Furrow 809 (Plate 5) was excavated by machine to establish its depth, which was 0.18m.

Plate 5: Furrow (803) Trench 8
