# St Clare's College Oxford

## Archaeological Evaluation Report

## **St Clare's College, 121 Banbury Road, Oxford**

### *Archaeological Evaluation Report*

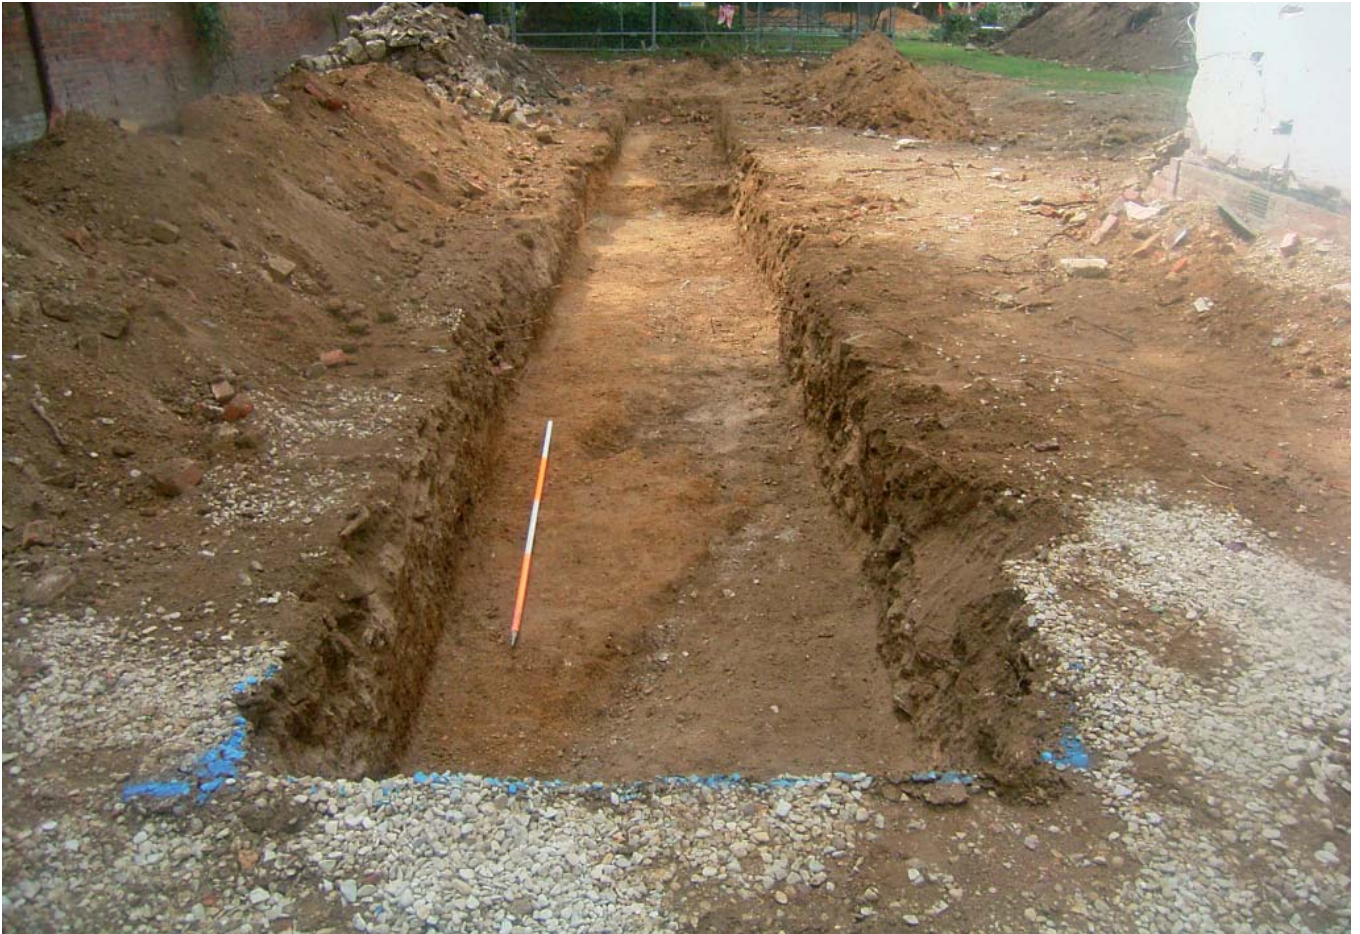
- 3.2.1 Trench 1 (Fig. 2) was excavated to the south of the retained element of 121 Banbury Road, within the footprint of the demolished southern wing. The trench measured 20m in length and was 1.8m wide. Natural geology was encountered at between 0.4m and 0.9m below ground level at an average of 62.79m OD, although this had been heavily truncated by the foundations of the recently demolished structure (Plate 1).
- 3.2.2 The gravel was overlain by a layer of mixed demolition material, which was the same in composition as the fill of the foundation trenches which truncated the gravel and both originate from the recent phase of demolition.

Plate 1: Trench 1: showing modern truncation of gravel by footings of demolished southern wing

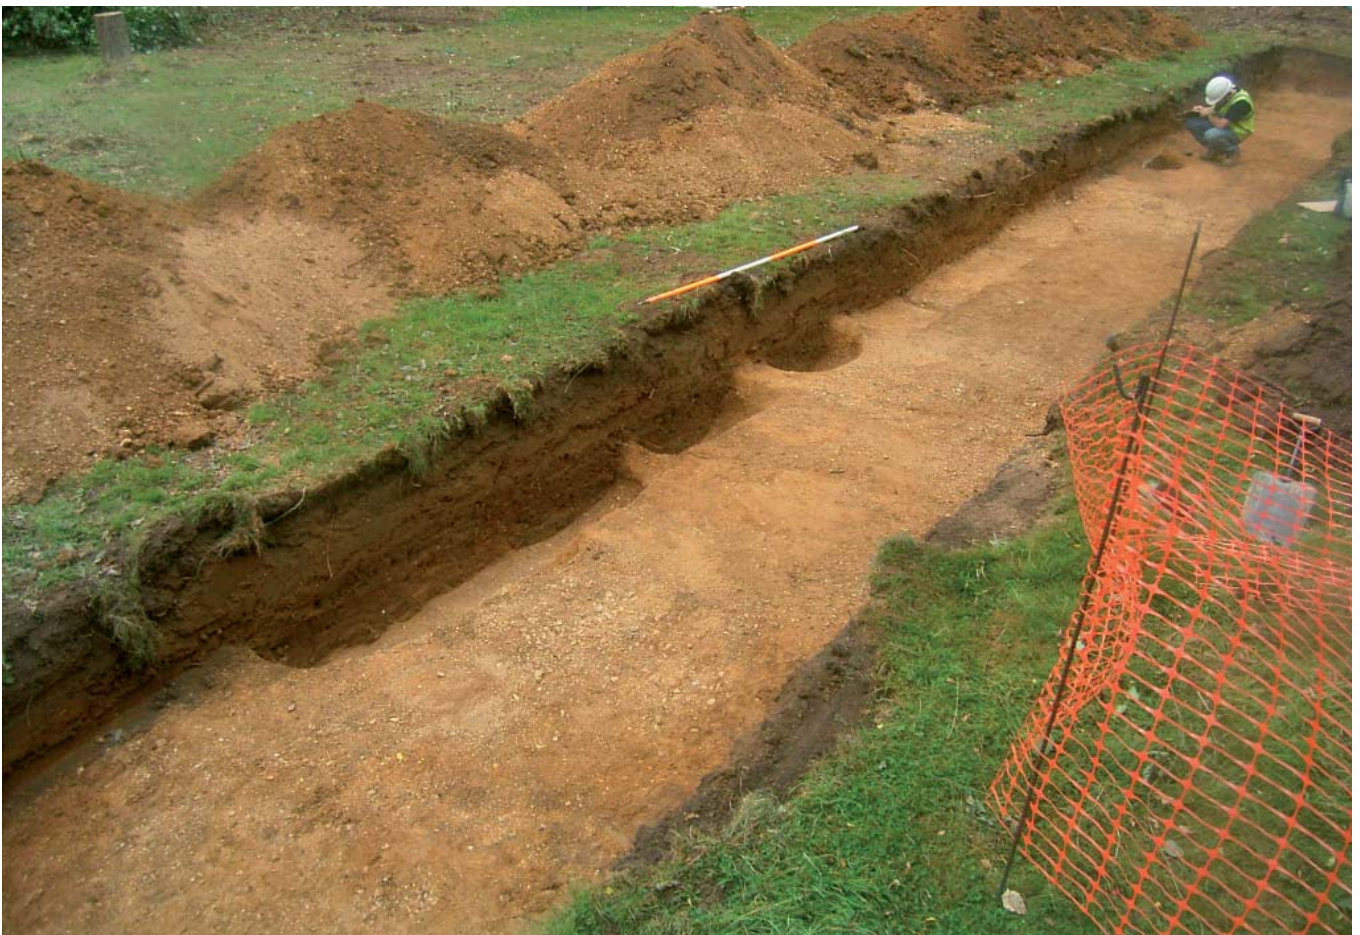
- 3.3.2 The fills of the furrows and the natural gravel were directly overlain by a buried soil (224) which was an average of 0.1m thick (Fig. 3, Sections 200 and 201). This also appeared to overlie the fills of two other possible features (200 and 220). Feature 200 had been heavily truncated by later pits (see below), although where visible, it was relatively regular in plan and profile and may have represented the remnant of a pit (Fig. 3, Section 200). No dating evidence was recovered from the single fill (201). Feature 220 was very irregular in plan and profile and was almost certainly the result of a geological variation or bioturbation (Fig. 3, Section 202).

Plate 2: Trench 2: Section 200
