Kings Square, Bitton, South Gloucestershire Archaeological Evaluation Report

June 2018

Client: JJH (Building Developments) Ltd

Archaeological Evaluation Report

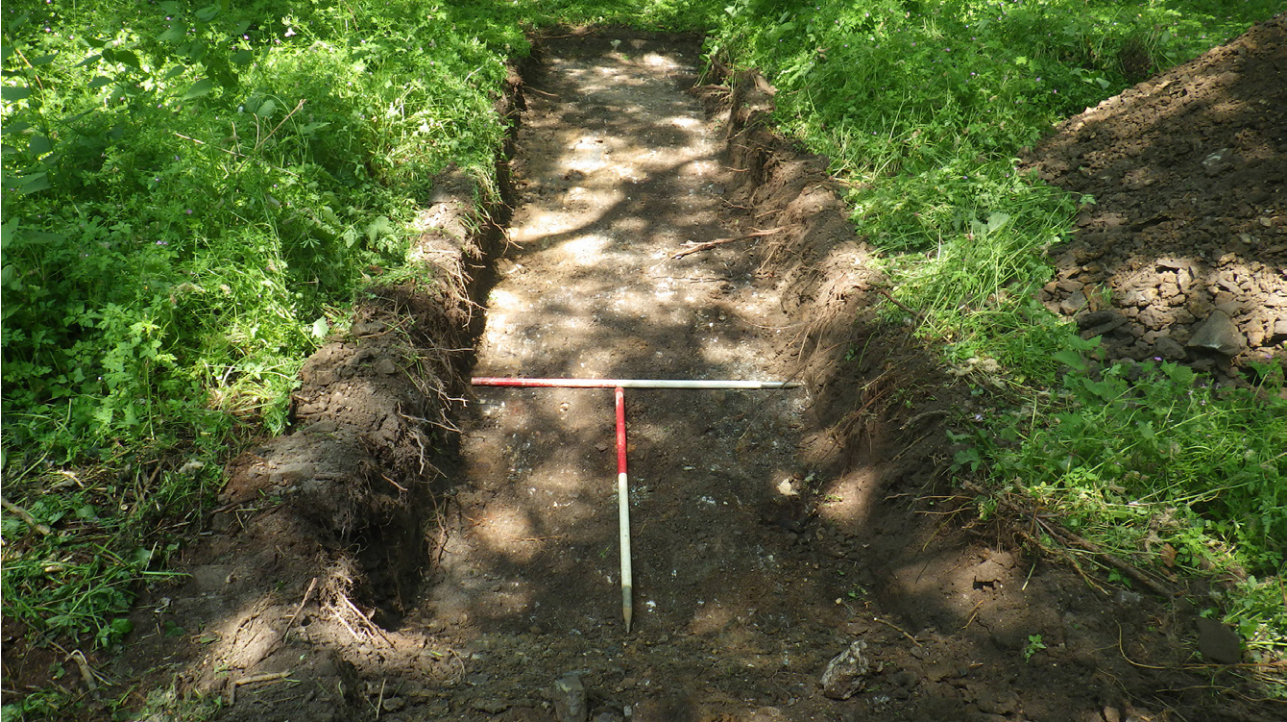
- 3.4.1 Trench 1 was positioned in a small clearing in the central southern part of the site. It was possible to excavate the trench to a total length of 6.5m. The natural geology was exposed within the northern end of the trench. This was the only location where undisturbed geological mudstone deposits were identified. The remainder and greater part of the trench was occupied by a large modern feature (102) with only its northern extent exposed within the trench. The fill (103) comprised an orange-brown clay containing quantities of modern refuse including bricks, concrete, metal objects and plastic. Limited machine excavation of this deposit and feature demonstrated that it had truncated and removed the potential archaeological horizon. The topsoil and leaf litter layer overlay the modern debris and mudstone.

Plate 1: Trench 1 looking North

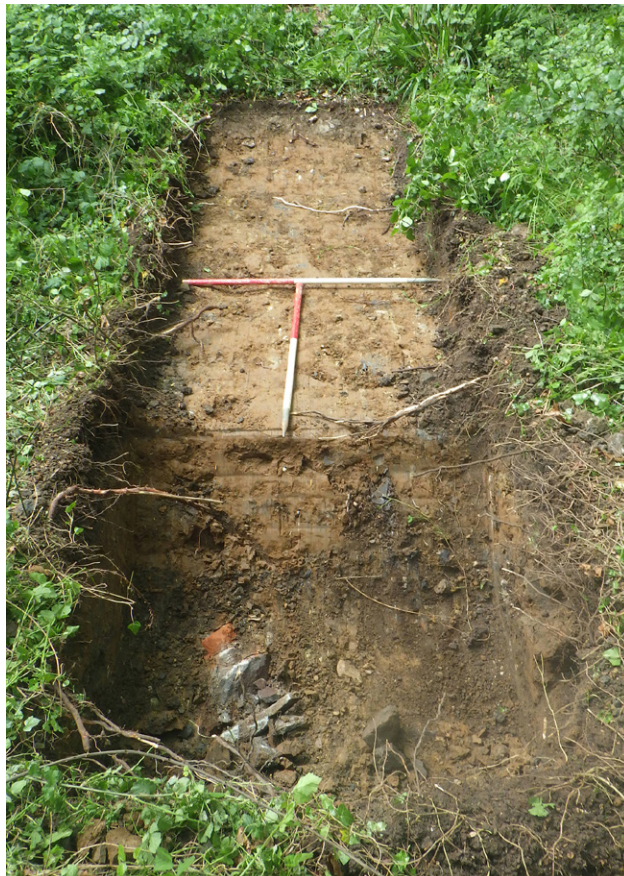
- 3.5.1 Trench 2 was located in the central northern part of the site. It was possible to excavate this to a total length of 5m. A machine-excavated sondage was excavated to 0.75m below the current ground level within the south-eastern end of the trench. This revealed a sequence of modern deposits (202 and 201) containing brick and concrete. The uppermost layer (201) was recorded throughout the trench. The silty topsoil and leaf litter layer overlay the modern debris.

Plate 2: Trench 2 looking North-West

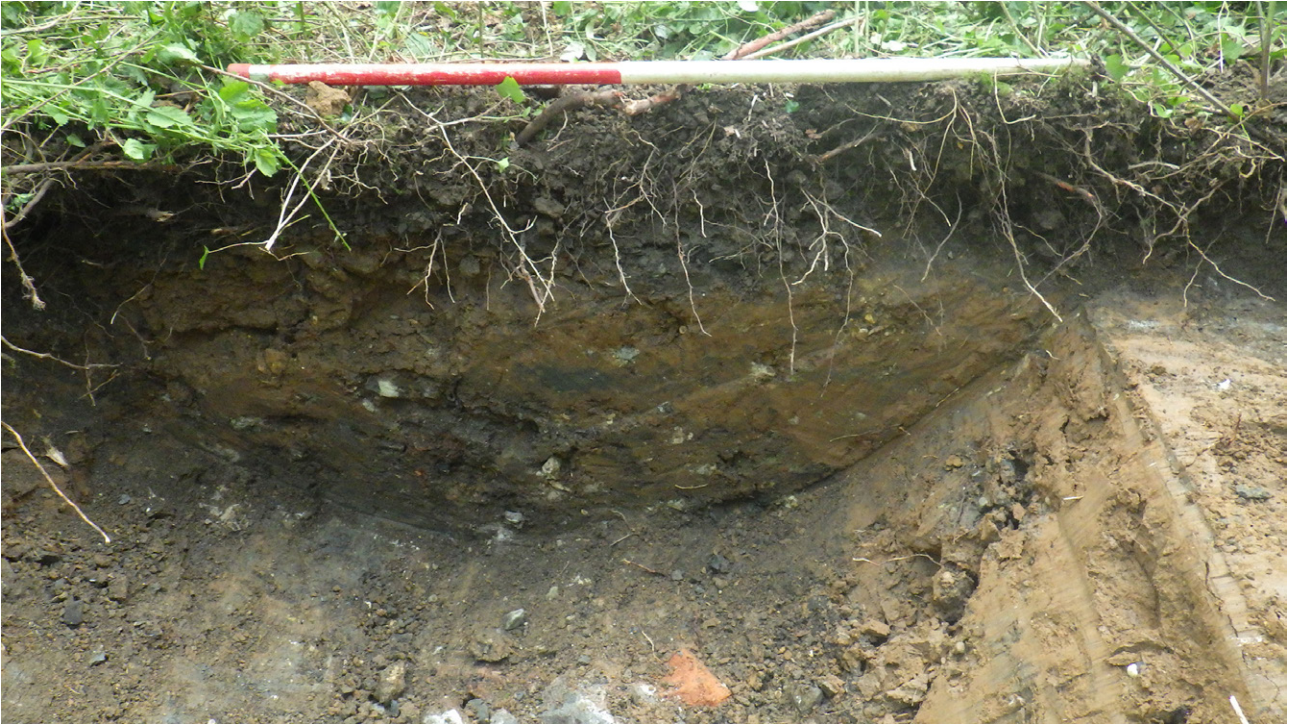
Plate 3: Trench 2 sondage looking South-West

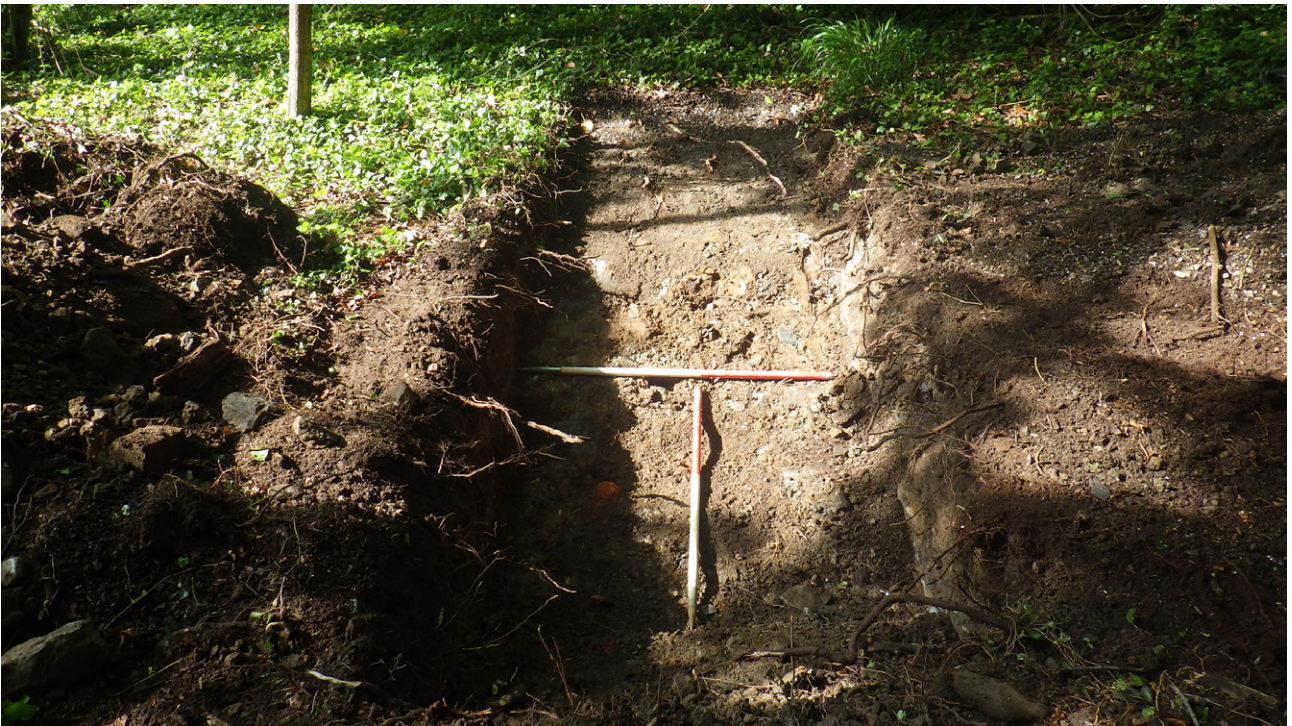
3.6.1 Trench 3 was located in the eastern part of the site partly within the former river channel. It was possible to excavate this to a total length of 3.9m. Increasing densities of tree roots greater than 20mm diameter were encountered within the south-western end of the trench within the topsoil horizon. As a consequence, this part of the trench was not excavated any deeper. A clayey layer with brick and concrete debris (301) almost identical to that found in Trench 2 (201) was revealed within the trench where it was possible to remove the topsoil. A machine-excavated sondage was excavated to maximum depth of 0.5m below the current ground level into this deposit in an attempt to examine the former channel. However, it was not possible to penetrate the concrete and brick rubble beyond this depth with the machine capabilities.

Plate 4: Trench 3 looking South-West

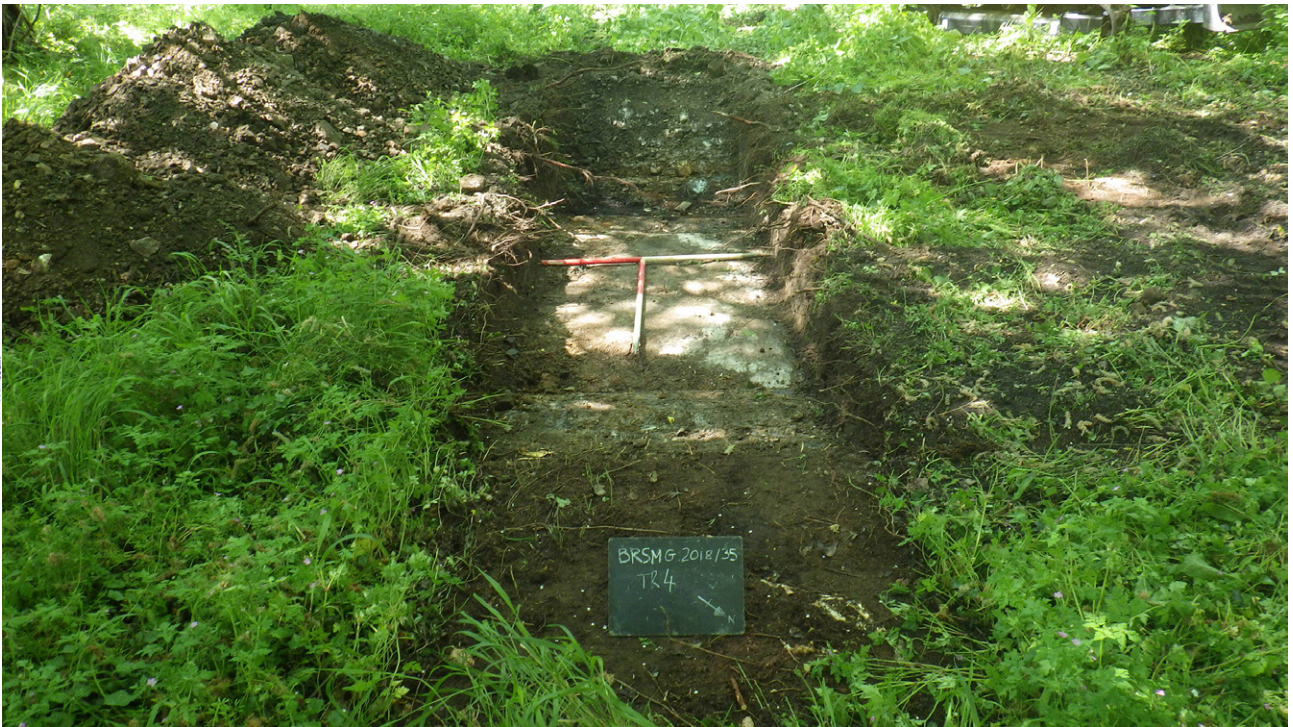
3.7.1 Trench 4 was located in the south-eastern part of the site. It was possible to excavate this to a total length of 5.5m. The presence of significant roots at both the north-east and south-west ends prevented the trench from being extended any further in either direction. Excavation of this trench revealed a similar compacted clay and debris layer (402) as that exposed in Trenches 2 and 3. A concrete probable foundation (403) was cut into and constructed at this horizon. This was sealed by a layer of mixed clay and modern debris (401) followed by the current topsoil and leaf litter horizon (400).

Plate 5: Trench 4 looking South-West

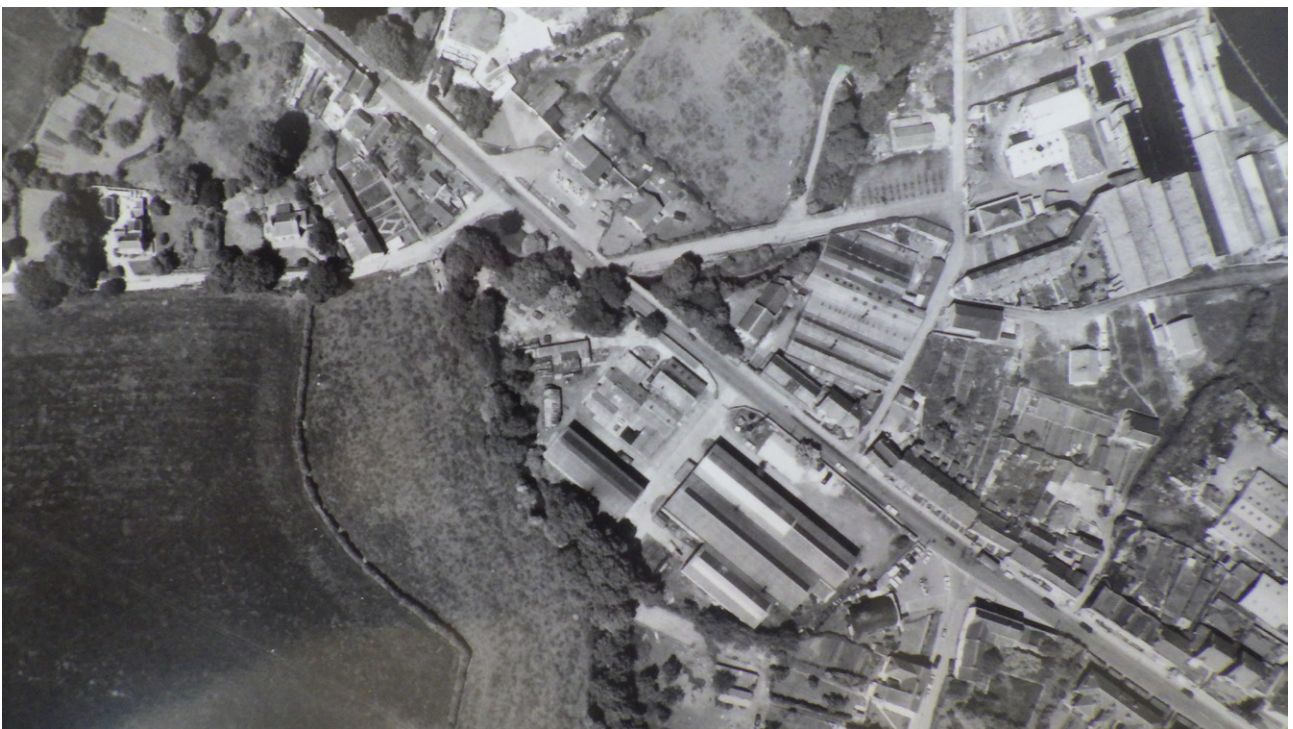
- 4.2.1 No archaeological deposits were encountered.
- 4.2.2 Considerable depths of modern debris were consistently present across the site. Within Trenches 1 and 4 these deposits appear most likely to have been related to the factory buildings visible in the 1969 aerial image (Plate 6). Both of these trenches were located beyond the former river channel, although undisturbed geological deposits were only encountered within a small part of Trench 1 at approximately 0.3m below the current ground level. Trench 4 was excavated to approximately 0.5m below the current ground level revealing only modern deposits suggesting that this area had been truncated and built up.

Plate 6: Factory activity 1969

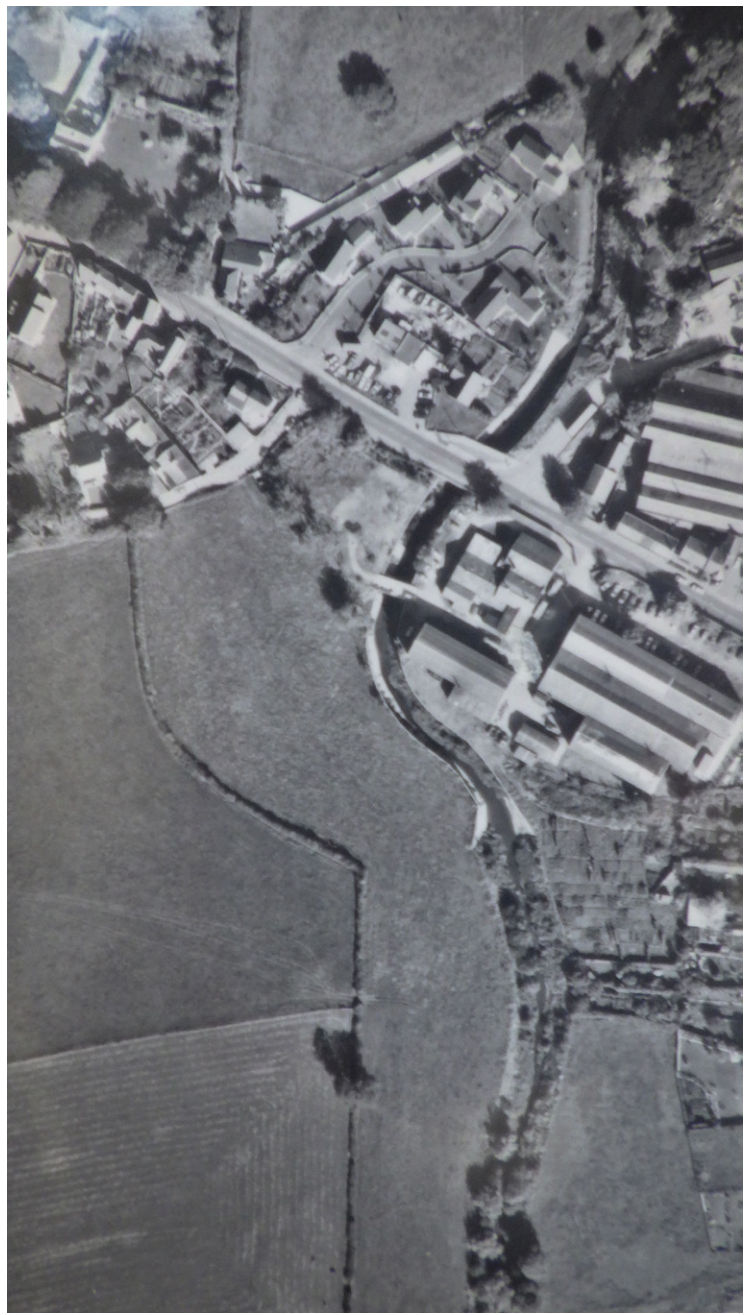
- 4.2.3 The majority of the other activity seen on the site appears to be associated with the 1970s construction of the culvert and the diversion of the River Boyd and the demolition and clearance of the former factory buildings. Aerial photographs from 1980 after the construction works on the river show that the factory buildings had been demolished and the area levelled (Plate 7).

Plate 7: After construction works of the River Boyd 1980
