Camden Crescent Viaduct

Bath

Historic Building Recording

December 2006

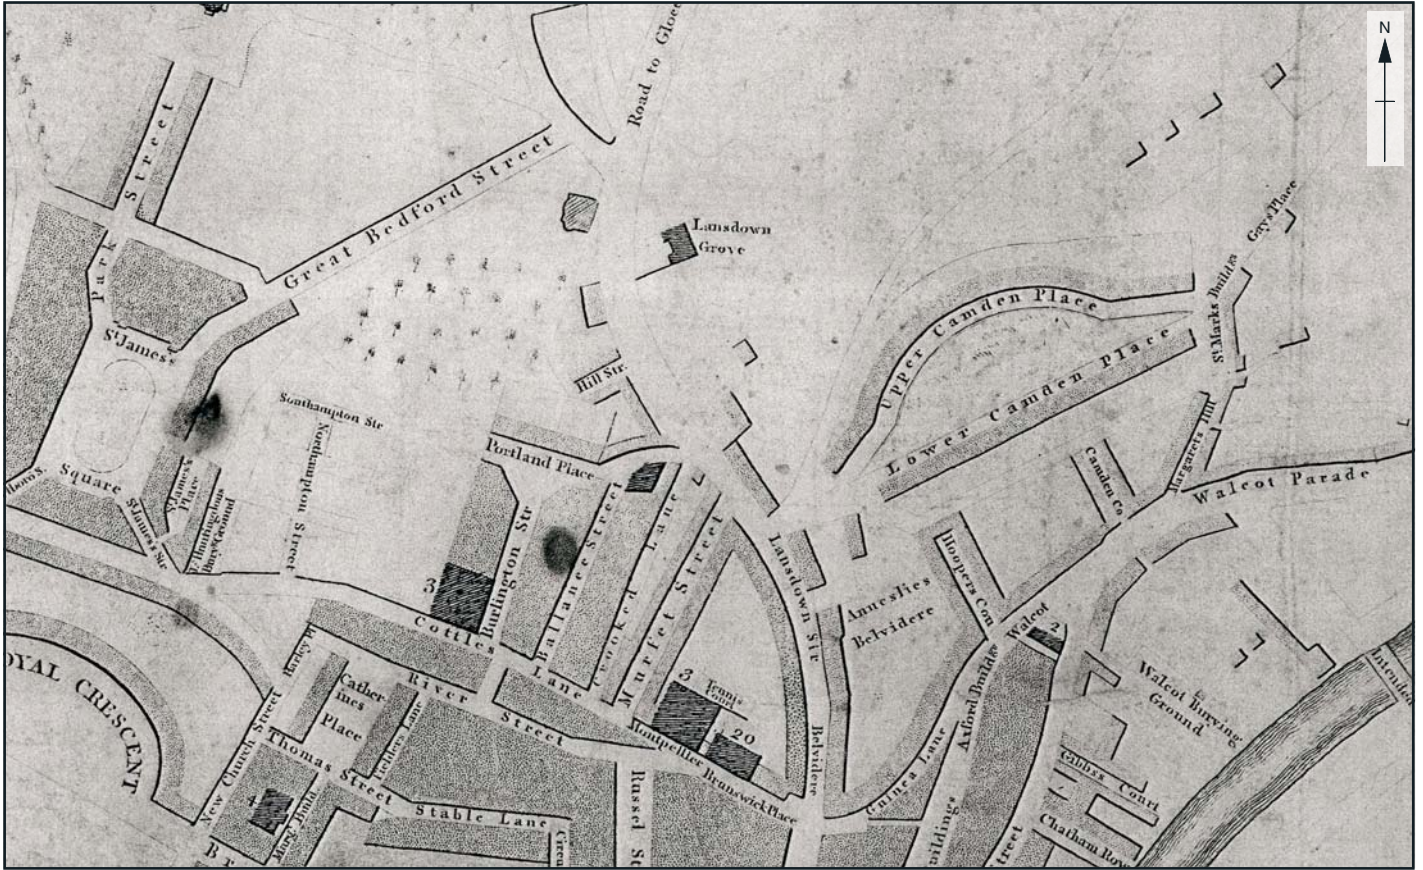
Figure 2: Plan of Bath in 1800 (published by Taylor and Meyler), showing Camden Crescent (then Camden Place)

- 2.4.3 The earliest map showing Camden Crescent dates to 1800 (Fig.2) and the main interest of this map is that despite the fact that it is known that Camden Crescent was never completed the map shows the entire composition of the crescent and wings (*Upper Camden Place*) and the lower, straight tangential terrace (*Lower Camden Place*). This might simply have been a cartographic simplification showing what was meant to have been constructed (and what they possibly still intended to construct) or it could be that they had not yet pulled down the half built north-eastern half and lower terrace.

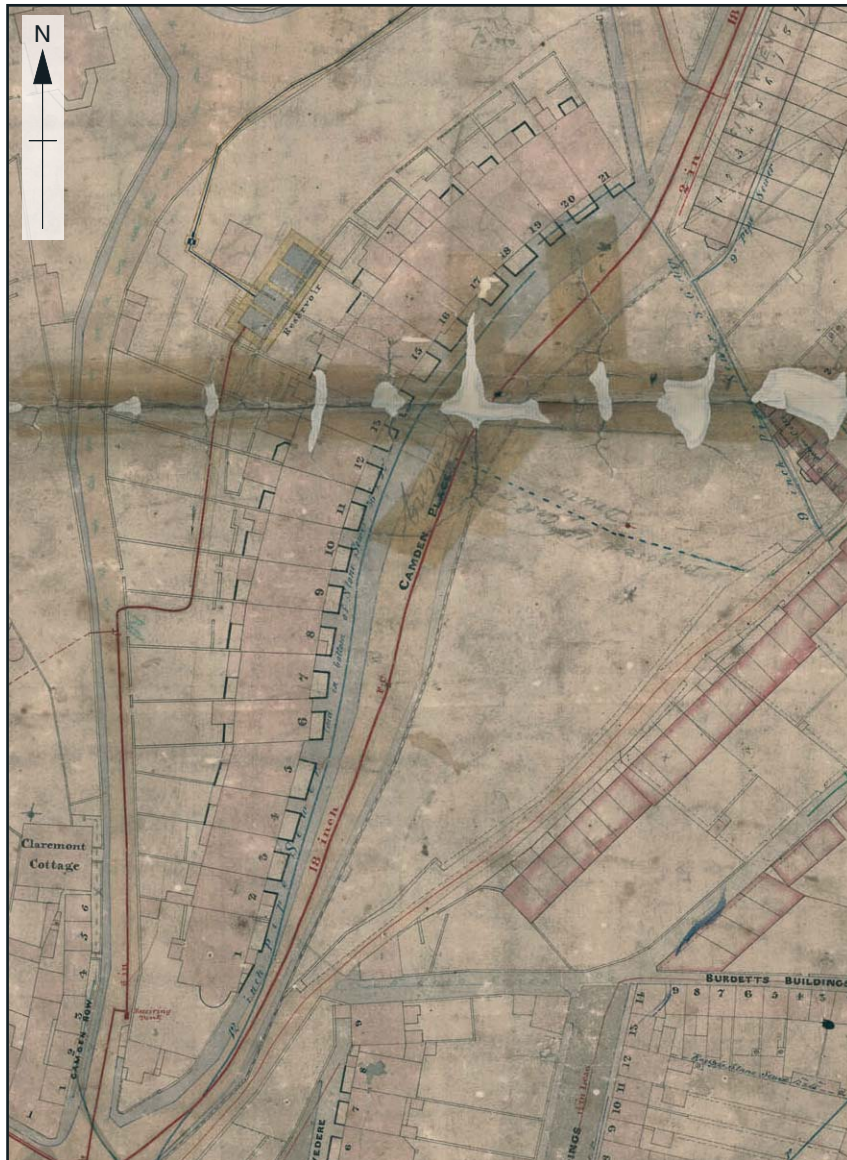
Figure 4: 1852-54 Plan

- 2.4.5 Although there are two further maps which show Camden Crescent dated 1816 and 1845 these are clearly amended versions of the 1810 map and neither show any differences to Camden Place. The next significant new map dates to 1852-4 and this is much more detailed showing individual numbered houses, gardens, small extensions to houses, sewer pipes, retaining walls and what is assumed to be an accurate representation of the road layout in the area at this time (Fig. 4).

- 2.4.8 However the irregular layout shown on the 1850s plan is quite different to the gracefully curved road shown on several views from the first half of the 19th century and it may be that the map is a simplified or schematic representation merely intended to show the rough layout of the road for the purposes of identifying the sewer set within it. The plan clearly shows the southern end of the road as

considerably narrower than the northern half so it probably did narrow but not with the long taper shown. The whole junction between the southern end of Camden Crescent and the lower, adjoining road (*Hedgemoad*) which originally led to Lower Camden Place was realigned between these maps. On the 1886 map (as now) there is a clear retaining wall which stretches partly down the hill towards the north-east and which continues south-west well beyond the end of Camden Crescent.

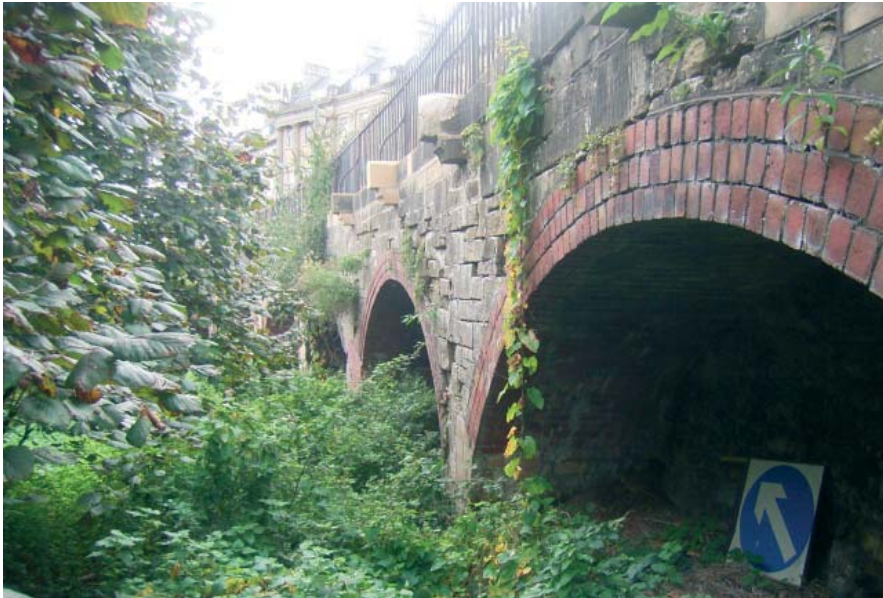
3.2.1 **Vault 1** is at the north-eastern end of the viaduct and it comprises a 35 cm deep brick arch (3 headers deep) which rests on low stone sleeper walls. The vault is much narrower (c.1.4 m deep) than most of the other vaults and it is truncated by a roughly coursed stone wall without a doorway (as in some vaults) or other significant features. The bricks appear to be of probable later 19th or possibly early 20th century date. Immediately to the north-east of Vault 1 is a relatively modern (mid to later 20th century) stone buttress c.2 m wide which appears contemporary with a large amount of stone patching throughout the outer face of the viaduct.

Plate 1: Face of Vault 1 in foreground

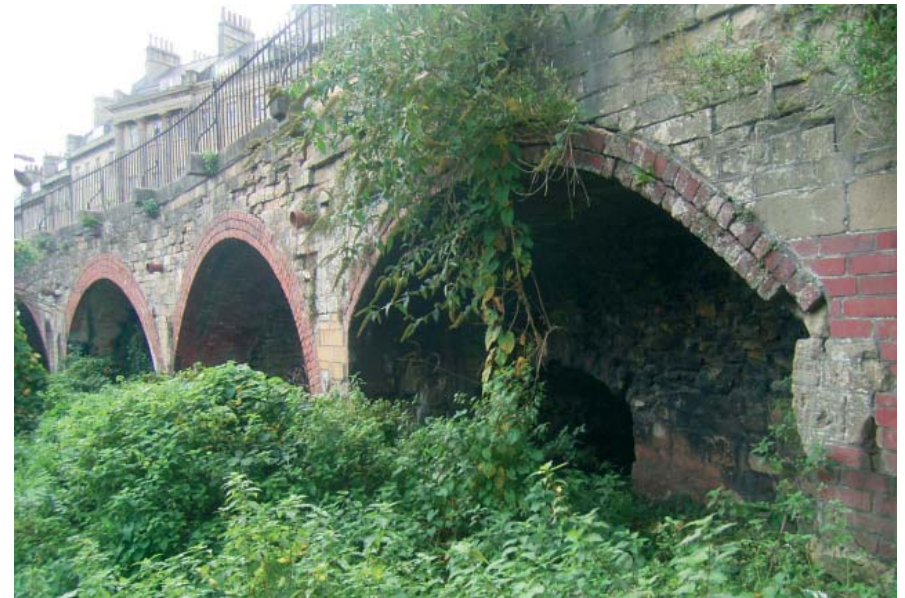
- 3.2.3 **Vault 3** again comprises a brick arched vault but this has a shallower segmental profile to all the other arches and it is only two headers deep (24 cm). The bricks are older than those in the other arches but as detailed above the original viaduct is believed to have had stone voussoirs so the bricks are probably not primary and probably date from an earlier 19th-century reconstruction. The junction between Vaults 2 and 3 present a good example of the development of the viaduct and of its different phases of construction as at this point the (probably) earlier 19th-century arch of Vault 3 meets the (probably) later 19th-century arch of Vault 2 and they are both supported by the 20th-century, rebuilt pier. The rear wall of Vault 3 is of uncoursed stone and has a slightly different character to Vaults 1 and 2 but it is also of interest as it incorporates an opening towards its southern edge which leads to a small chamber and a low tunnel which extends north and then returns westwards. There is a very small opening in the rear (west) wall of the chamber and it is possible to see a small room with a later vaulted ceiling. This is marked on the 1st ed OS map, as well as the modern survey provided by B&NES council, as *site of St Swithen's well*. This awkward arrangement of tunnels and chambers presumably relates to the site of the well and is either designed to allow its preservation in-situ or to avoid it constructionally.

Plate 2: Vault 3 in foreground

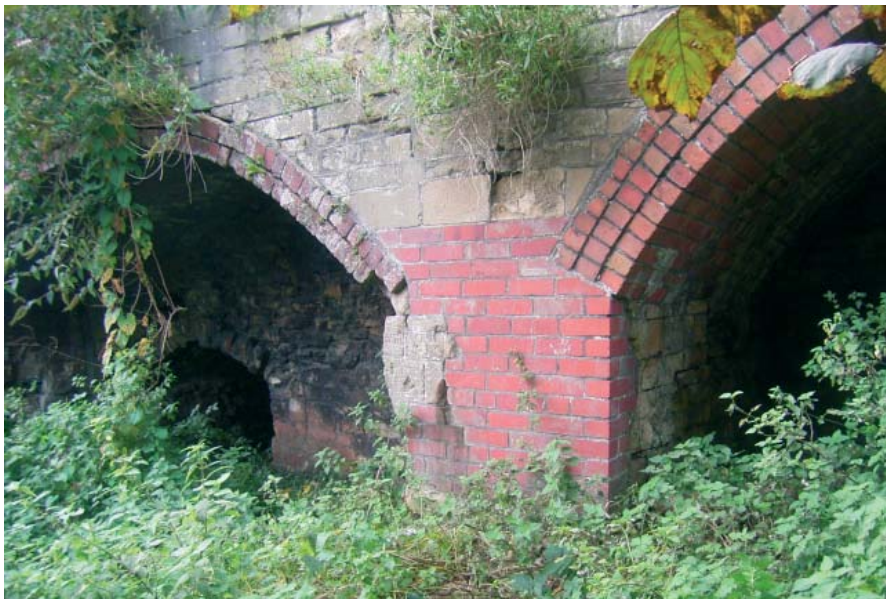
3.2.2 **Vault 2** is deeper (c.2 m) than Vault 1 but again has a 3-brick arch (all vertical headers) of probable later 19th or early 20th-century date. The rear wall and the sleeper walls are both again of roughly coursed stone but the vault is narrower (4.3 m wide) than Vault 1 (5.3 m) which results in the sleeper walls being significantly taller to maintain a similar highest point to the arch. The west pier of Vault 2 has been reconstructed with mid to later 20th-century engineering bricks of a distinctly different character to the bricks in the vault.

Plate 3: Pier between Vaults 2 (to right) and 3

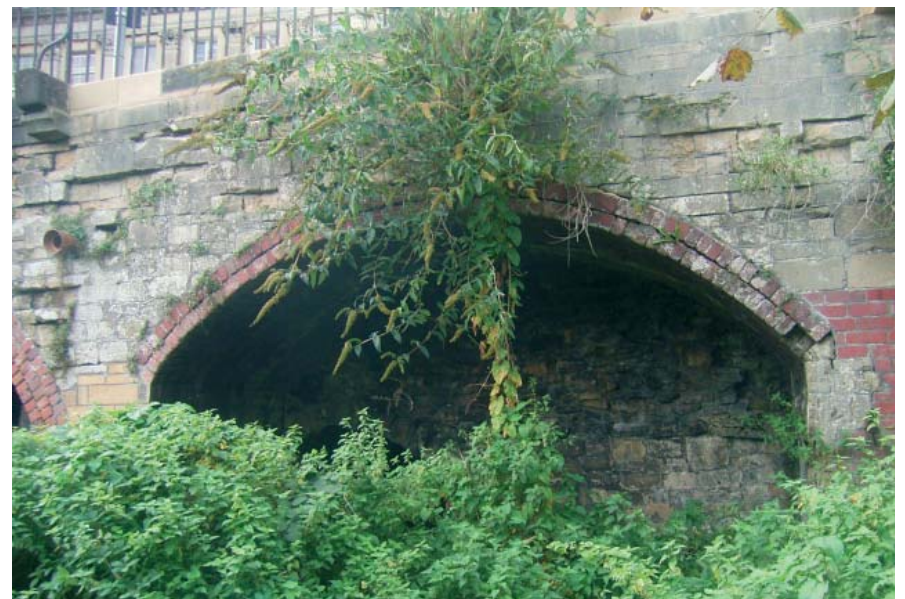
Plate 4: Face of Vault 3

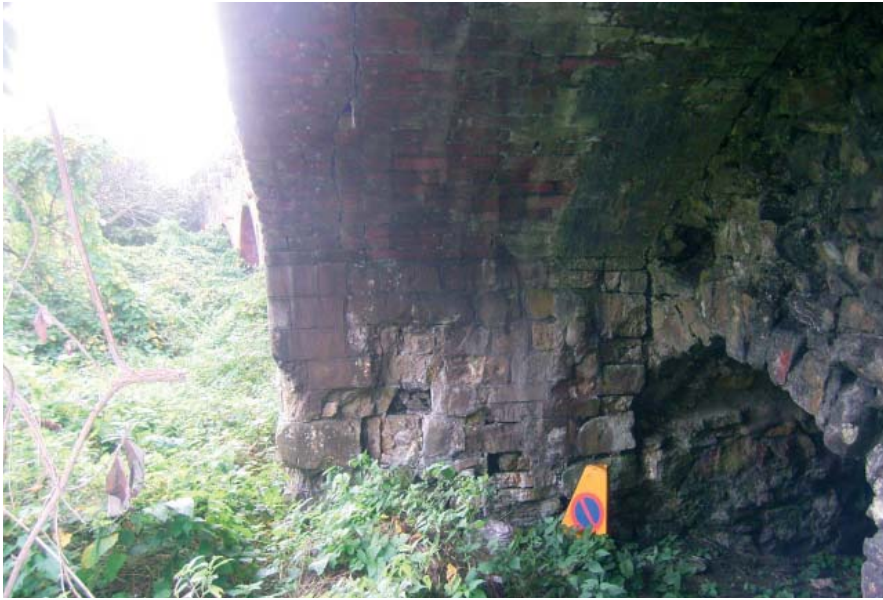
Plate 5: Inside of Vault 3

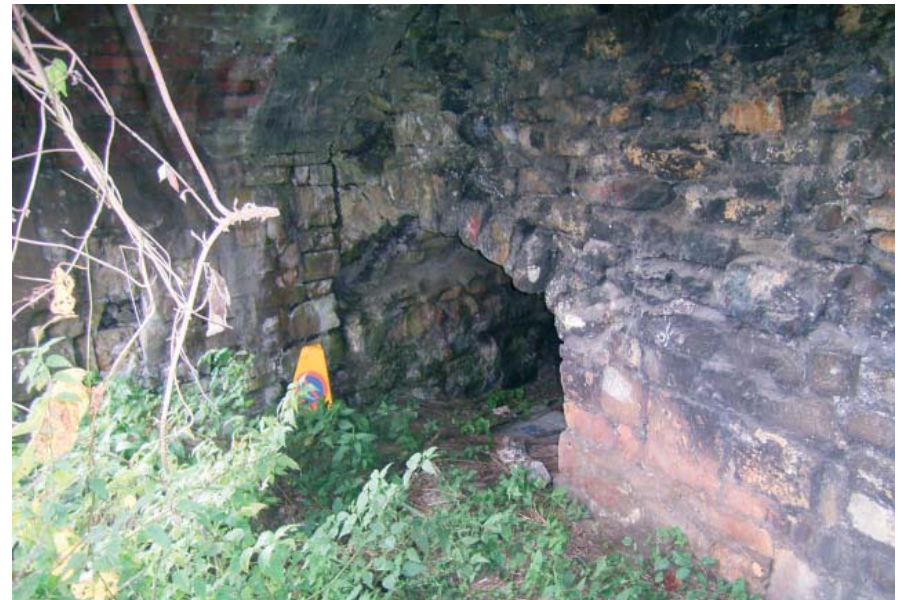
Plate 6: Passage in Vault 3

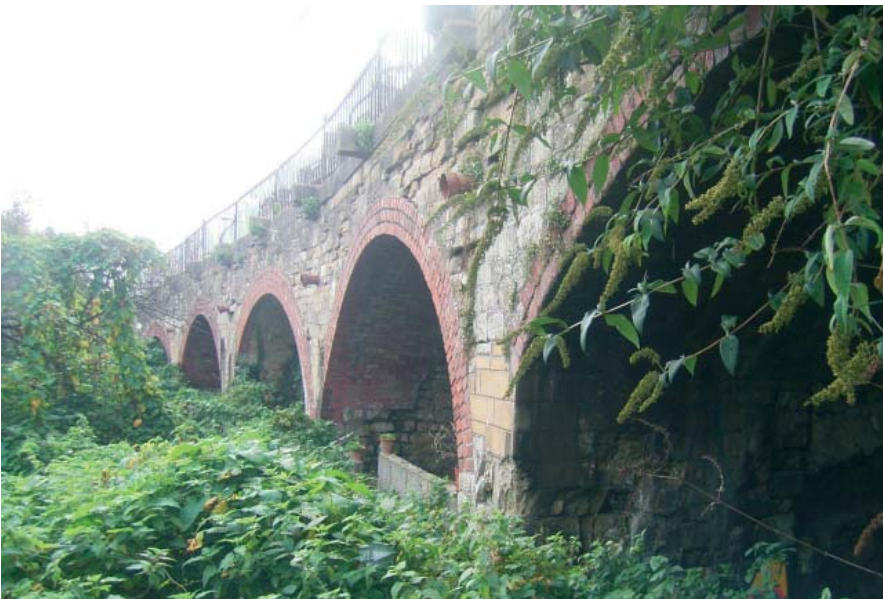
Plate 7: Arch face of Vaults 3, 4, 5 and 6

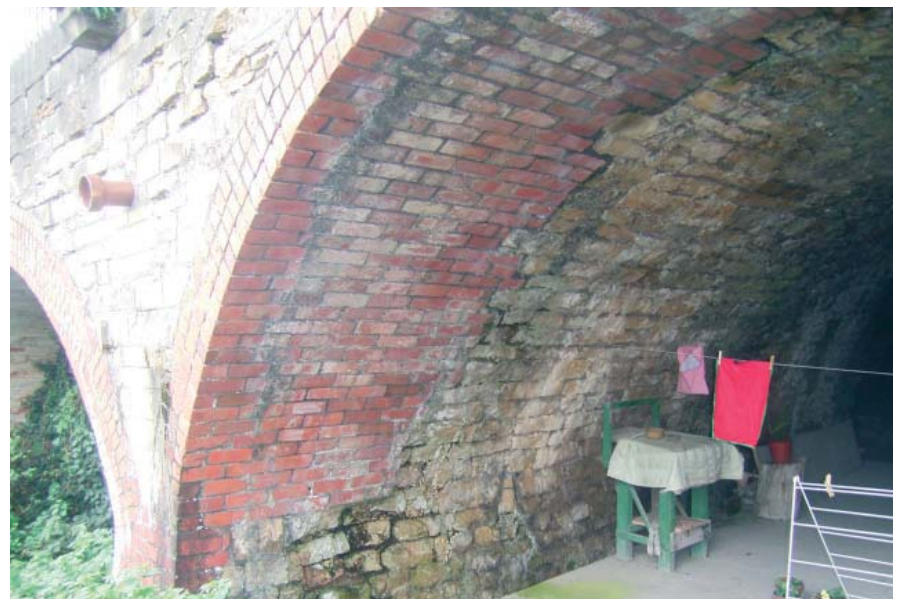
- 3.2.4 **Vault 4** is c.10.5 m long and is the northernmost vault to be open for the full width of the road. At the rear of the vault is a door opening which leads up to the cellar of one of the houses in Camden Crescent and the entire vault is clearly used as the private cellar of that house. A modern concrete slab has been laid within the vault and on this a garden shed has been constructed as well as a low concrete block wall at the eastern edge of the vault. It is unclear whether the space within this vault (along with all the other vaults) is publicly owned or whether it belongs to the house in Camden Crescent to which direct access is possible.

- 3.2.5 The main interest of Vault 4 is the fact that much of the arch is constructed of stone (roughly squared blocks) rather than brick in most of the other arches. The outer face of the arch, extending c.1.5 m into the vault, is of the same bricks (probably later 19th-century) as found widely throughout the viaduct but the stone vault almost certainly survives from the original viaduct (late 18th century). This supports documentary evidence which suggests that the whole of the original viaduct was probably of stone.

Plate 8: Interior of Vault 4

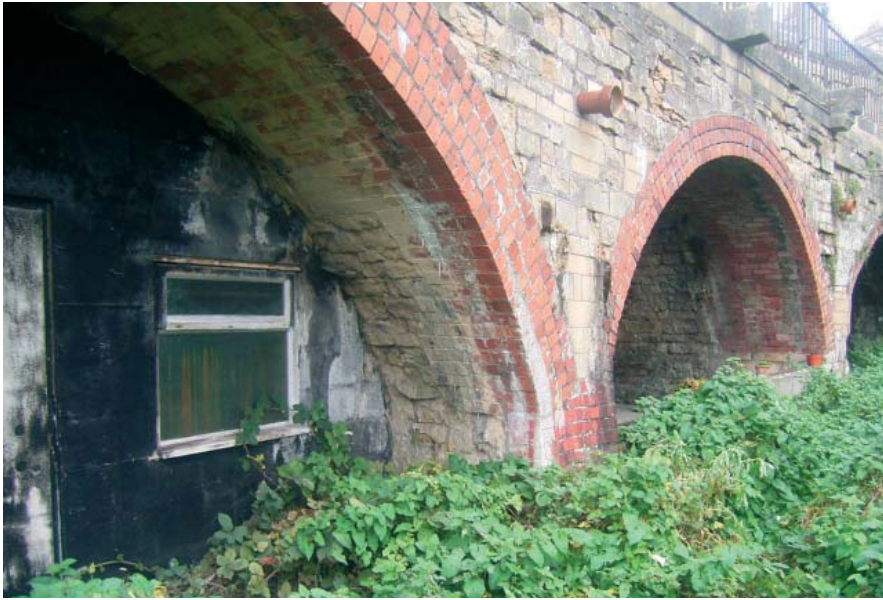
- 3.2.6 Very little of **Vault 5** is now visible due to a breeze block wall (painted black) having been constructed c.1m within the vault to form an enclosed cellar for the adjacent house within Camden Crescent. The wall, which has clearly been constructed in recent decades (1980s?) comprises two windows and a central door. Little of the arch is visible but from what can be seen it is at least partly stone built similarly to Vault 4. The face of the vault portal is of later 19th-century bricks (4 bricks, 47 cm deep) and towards the top of the vault this construction extends beyond the breeze block wall but towards the sleeper walls and arch springs there are surviving areas of older stonework.

Plate 9: Face of Vaults 5 (to left) and 4

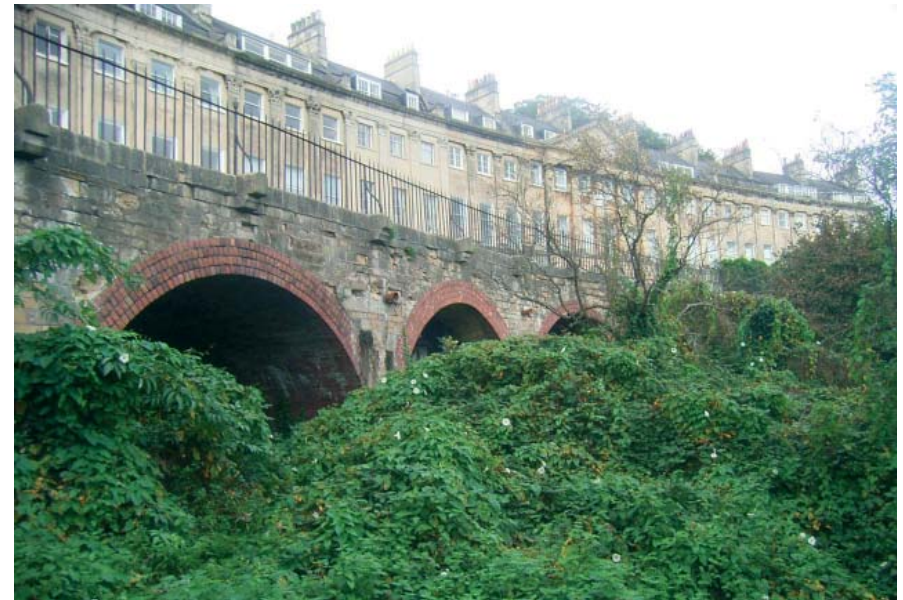
Plate 10: Face of Vault 6 (to left)

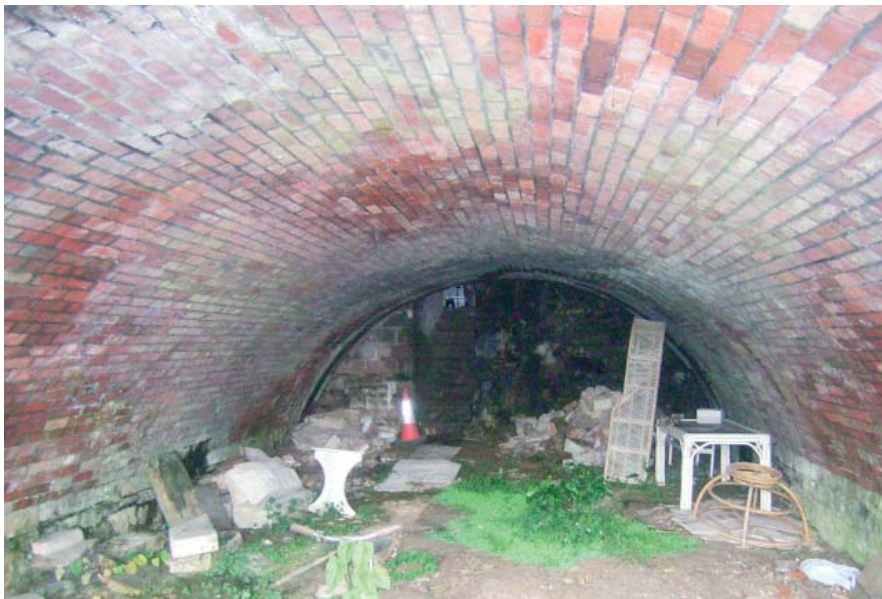
- 3.2.7 **Vault 6** is at the northern end of a row of seven arched vaults, each of which extend for the full width of the road and each of which are publicly accessible. Vault 6 is entirely built with probable later 19th-century bricks (4 bricks deep c.46 cm) and which rest on an older stone sleeper walls. The west end of the vault is terminated by a stone wall (roughly coursed to uncoursed) and within this is are two openings. In the southern half is a door opening with a set of steps (c.10) directly behind which lead up to two basement rooms of the adjacent house in Camden Crescent. The steps and the flanking wall have been partly rebuilt in recent decades with concrete blocks and the basement rooms are in use. Immediately to the north of this doorway is a low stone segmental arch within the wall with splayed jambs immediately beneath. The arch is c.1.75 m long and c.50 cm high (at the arch springs) and although it was once infilled the face of this fill has now largely collapsed. This arch is directly beneath a cellar room and it is assumed that it was merely a relieving arch to add support beneath this room. The jambs presumably rest on deeper foundations and the slight inward splays would add strength by countering the spread of the arch. As detailed elsewhere subsidence was a significant problem on this site

Plate 11: Interior of Vault 6

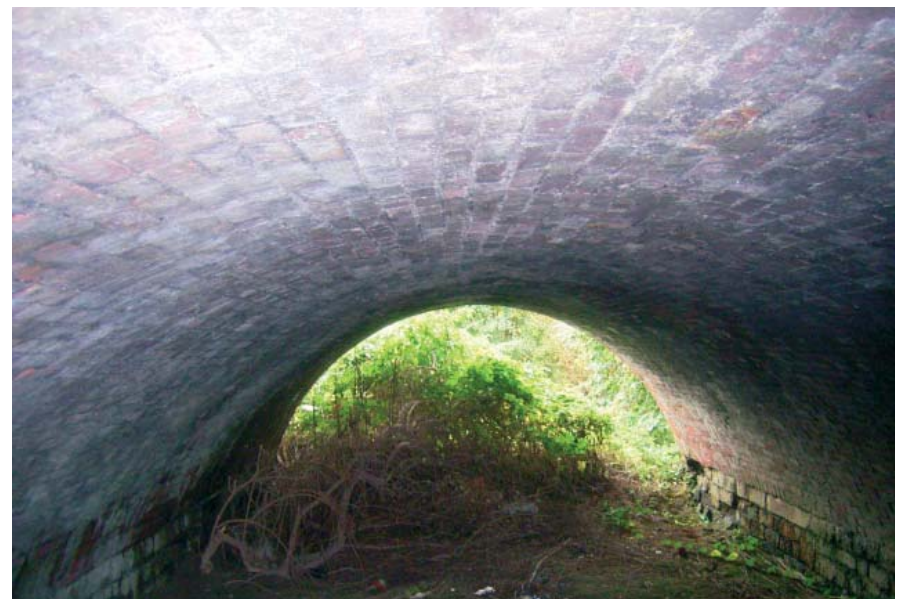
- 3.2.8 **Vault 7** is similar to Arch 6 comprising a fully brick vault (probable later 19th century bricks, 4 deep) resting on a stone plinth and with an unmade dirt floor. The rear (west) wall is of rough stonework with a door opening around a set of steps which lead up to two cellar rooms which are in use. The western of the two raised rooms has a stone flag floor and a limewashed stone vault. Again similarly to Vault 6 there is a low segmental stone arch in the rear wall of the main vault which is believed to have been a relieving arch to support the floor of a cellared room above. Unlike in Vault 6 the infill directly beneath the arch remains in-situ.

Plate 12: Interior of Vault 7

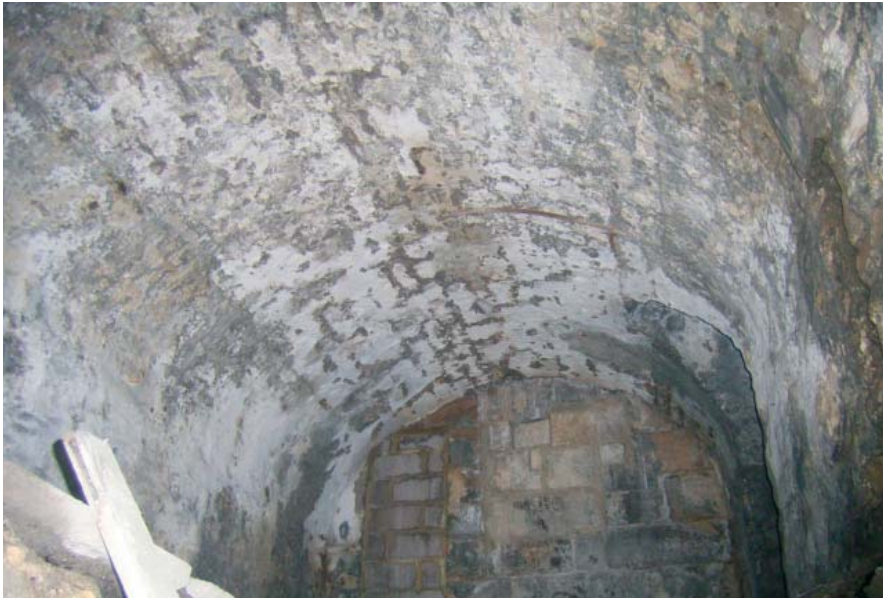
Plate 13: Basement room of house beyond Vault 7

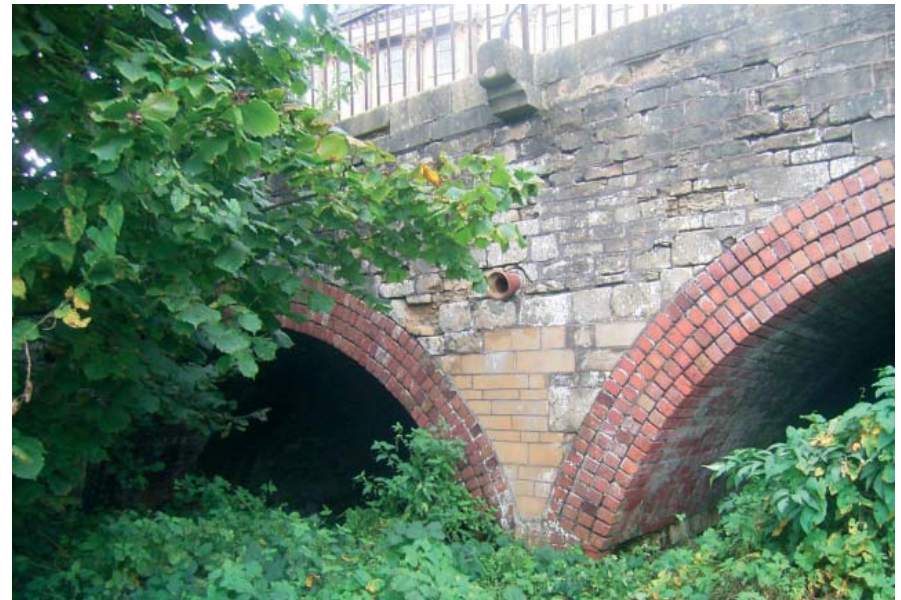
- 3.2.9 **Vault 8** is again similar to Vaults 6 and 7 with a probable later 19th-century brick vault (4 deep) resting on stone sleeper walls. A large quantity of builders waste has been dumped within the vault together with blue plastic sheeting and this obscures some parts of the vault and limits access but it is possible to see that the rear stone wall again has a door opening with steps leading up to a cellar. However a modern floor has been constructed over this opening preventing access between the vault and raised basement area.

Plate 14: Face of pier between Vaults 7 (to right) and 8

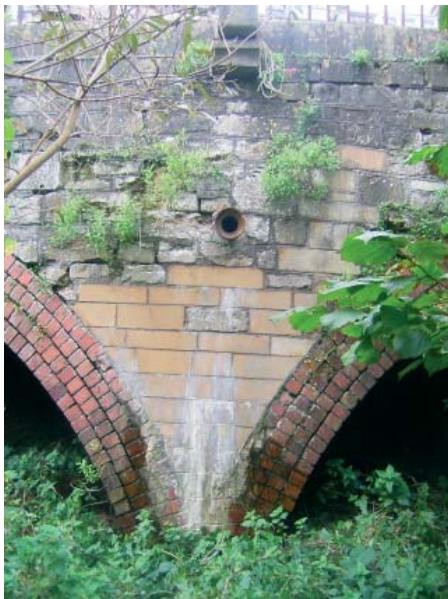
Plate 15: Vault 9 (to right) and 10

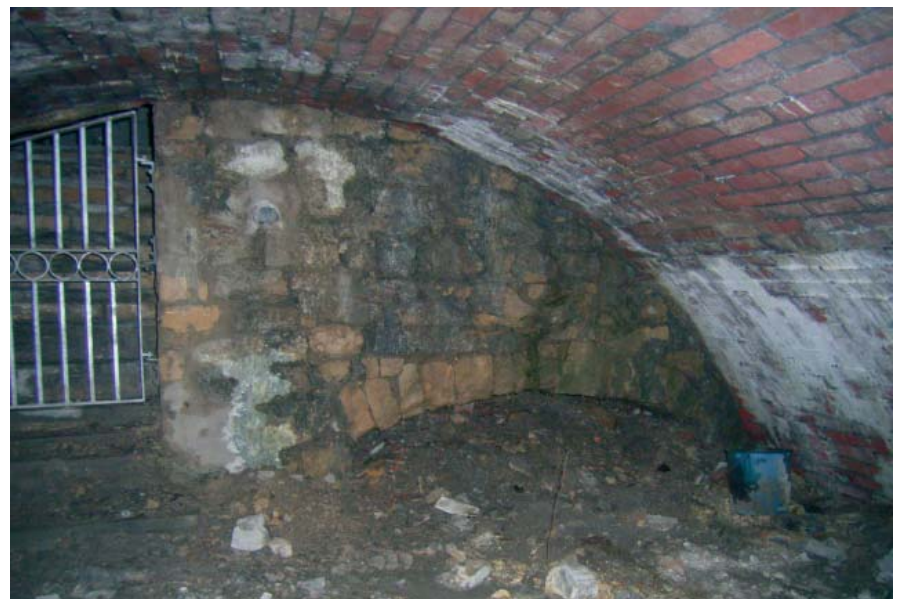
- 3.2.10 **Vault 9** again comprises a 4-brick vault which is believed to date to a substantial reconstruction of the viaduct probably in the later 19th century. It again rests on low stone side walls and the rear (west) wall is also of roughly coursed stone blocks. There is a door opening which leads to steps up to the basement immediately adjacent to the house but a locked later 20th-century galvanised metal gate prevents access to the steps. It is possible to see that the steps lead up to a main room immediately above and then a further room to the north. The rear wall again comprises a low segmental stone arch which supports the room above.

Plate 16: Rear wall of Vault 9 showing relieving arch

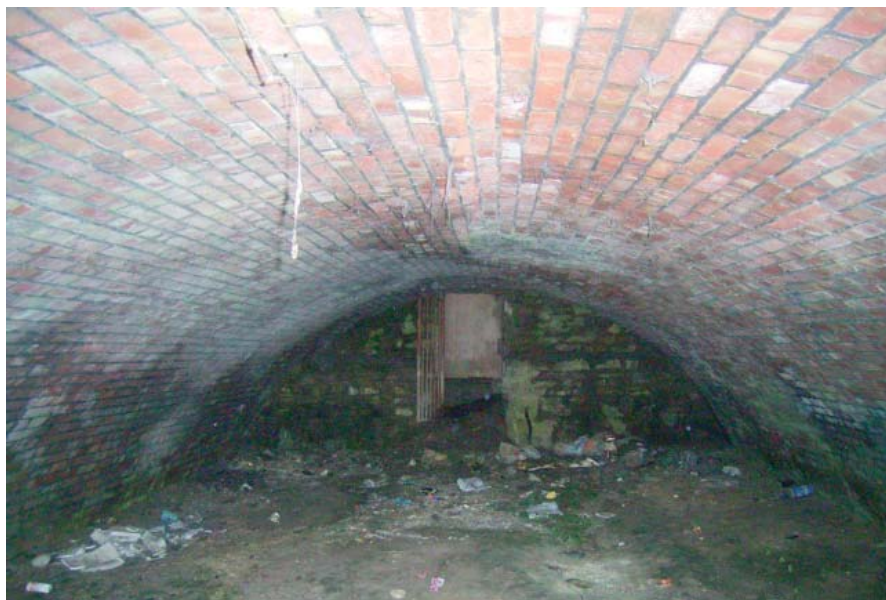
- 3.2.11 **Vault 10** also has a brick arch (probably later 19th century) on stone sleeper walls. The rear wall is again of roughly coursed stone with a doorway which formerly led to the basement of one of the houses in Camden Crescent but this has now been

blocked by a fixed wooden board. A secondary iron gate remains in-situ but there appears to be no evidence of an adjacent relieving arch.

Plate 17: Vault 10

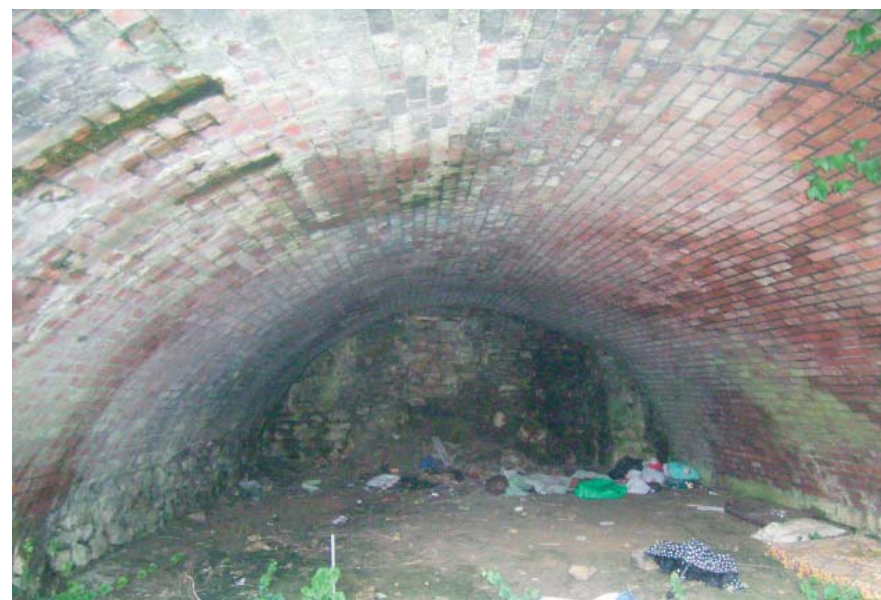
- 3.2.12 **Vault 11** also comprises a brick segmental arch (4 brick) which rests on earlier stone sleeper walls. The end wall is of stone and has a former door which is now infilled with stone. A timber lintel remains in-situ.

Plate 18: Vault 11

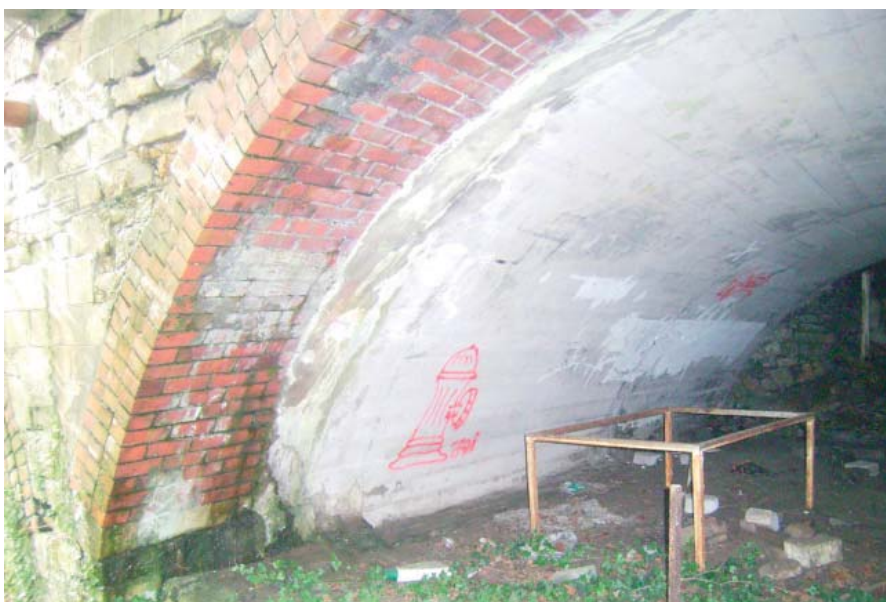
- 3.2.13 **Vault 12** appear to have been substantially rebuilt in the mid to later 20th century as it comprises an in-situ poured concrete arch (shuttering marks visible) which rests on concrete raft foundations. The outermost 75 cm of the arch (including the portal) is of brick but unlike most of the arches to the north it is only three bricks deep (35 cm). The rear wall is of rough, uncoursed stone in which is a former doorway which is now infilled with concrete block. The rough, secondary timber frame from a former doorway is in-situ. Below the height of this door way are two relieving arches, which are formed with relatively high quality Bath stone although they are now blocked and in poor condition.

Plate 19: Vault 12 showing concrete arch and brick face

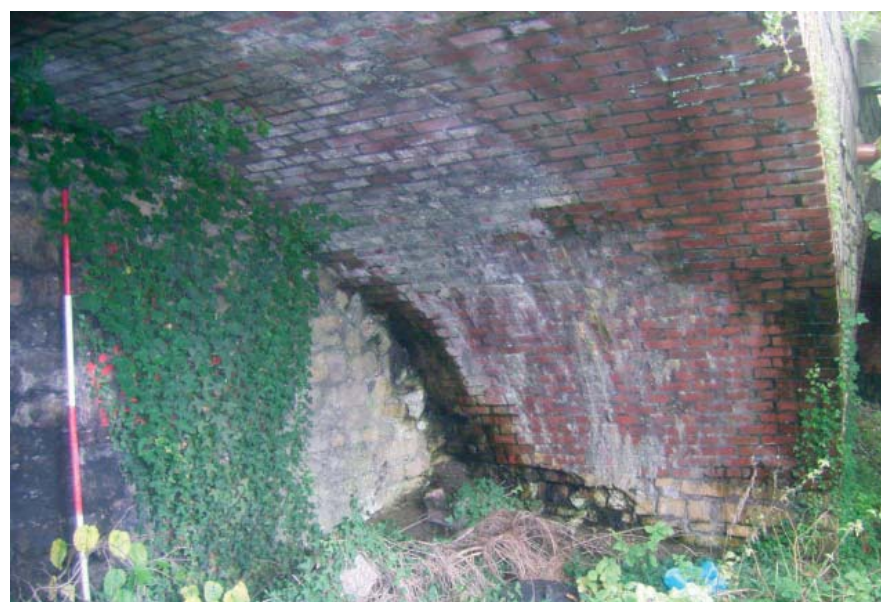
- 3.2.14 At its highest point **Vault 13** is 2.83 m above the external ground surface, 2.5 m above the floor within the vault and c.2.2 m above the arch springs. The arch comprises three courses of brick with headers facing the portal and stretchers to the underside of the vault. The brick vaults are a secondary addition and they rest on earlier stone sleeper walls. However, the stone walls had clearly sunk in areas prior to the addition of the brick vault in order to ensure that the vault was at the necessary height the lowest course of bricks (directly on the stone) has been cut in areas to achieve the right height and abuts the stone at a skewed angle. The bricks are 22 cm x 8 cm x 11 cm and probably date to the second half of the 19th century although they could be early 20th.

- 3.2.15 Vault 13 is significantly shallower than most of the other vaults (c.3 m deep) and is terminated by a roughly coursed stone wall with a former doorway at its centre blocked with stone. Together with the sleeper walls this wall has subsided so that the outline of the former arch is visible, particularly towards the northern side, slightly below the later brick arch. The rear wall and the brick arch were clearly never keyed in and there is a rough edge between them.

Plate 20: Interior of Vault 13

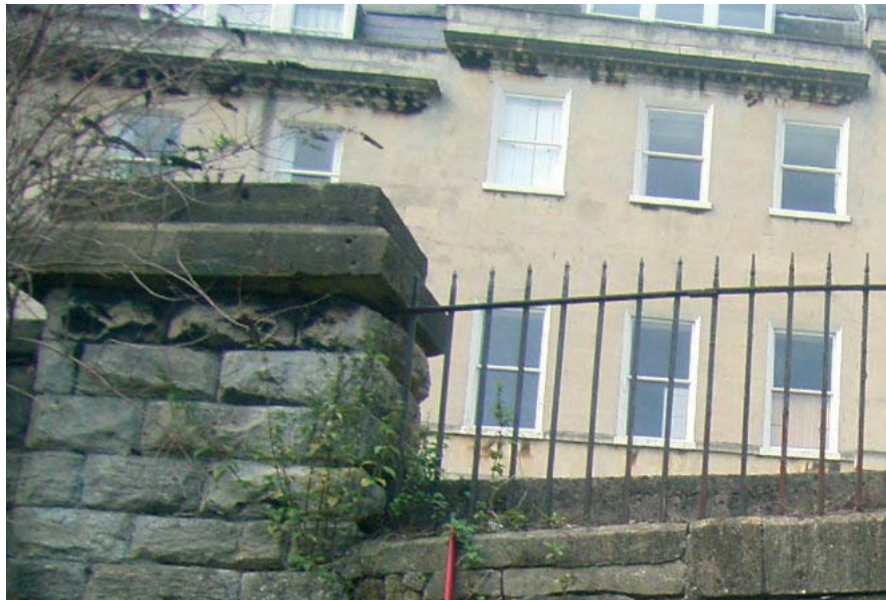
- 3.2.16 The section of wall immediately to the south-west of Vault 13 is constructed of non-coursed (roughly coursed in some areas) squared blocks which vary considerably in size from c.15 x 10 cm to c.50 x 30 cm. The face of many of the stones has crumbled away in patches and there is much evidence of patching with cement mortar. This section was not included in the metric survey provided by Bath & NE Somerset Council.

Plate 21: Wall to south of Vault 13 and later pier

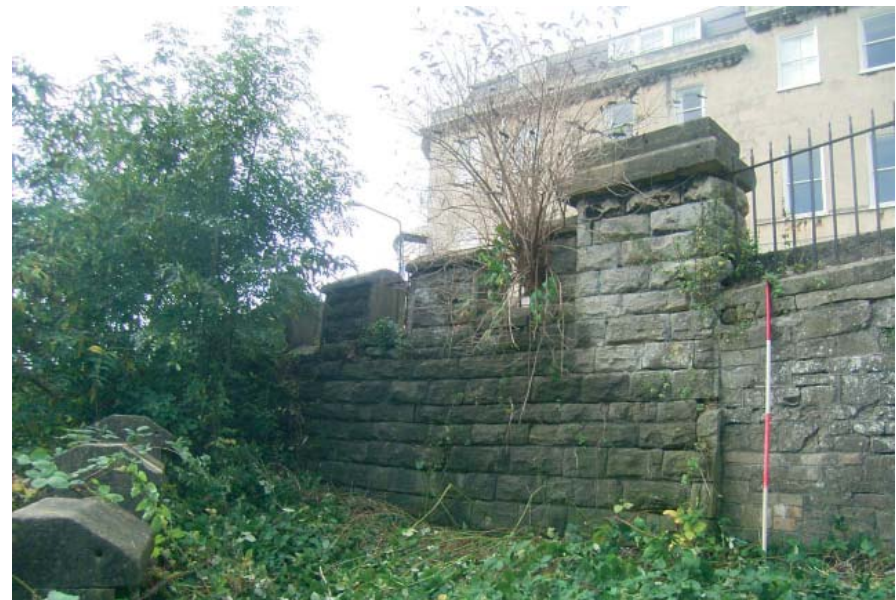
- 3.2.17 The *south-westernmost section* of the retaining wall has a distinctly different character to the section described immediately above, between it and Vault 13, and almost certainly dates to the realignment of the southern part of the road believed to have been undertaken between 1854 and 1886 (detailed above in historical background). This section of the wall is c.5 m long and it is constructed with

regular, coursed stone blocks which are squared but with the outer face non-dressed to give a rusticated appearance to the wall. The size of the stones range from c.30 x 50 cm to c.20 x 30 cm. The character of this section is the same as the very tall retaining wall which flanks the adjacent section of Upper Hedgemoor Road from its junction with Camden Crescent. Each wall has ornamental battlements to its top with dressed stone coping and jambs. The section flanking Camden Crescent also has iron railings between the battlements and at its north-eastern end this section has a taller pier which abuts the section immediately to the north-east.

Plate 22: Later pier and wall at south end of viaduct

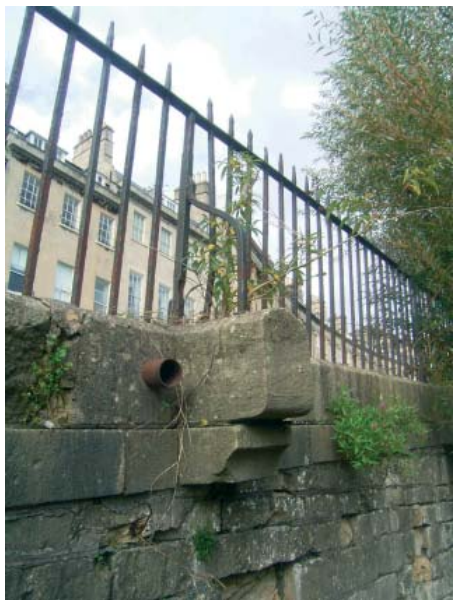
3.1.2 The railings are set on a stone plinth and both of these are believed to survive (albeit with some replacements) from the original viaduct. Every 22nd railing is supported by an iron prop or buttress which rests on a stone corbel.

Plate 23:
Corbel supporting iron railing

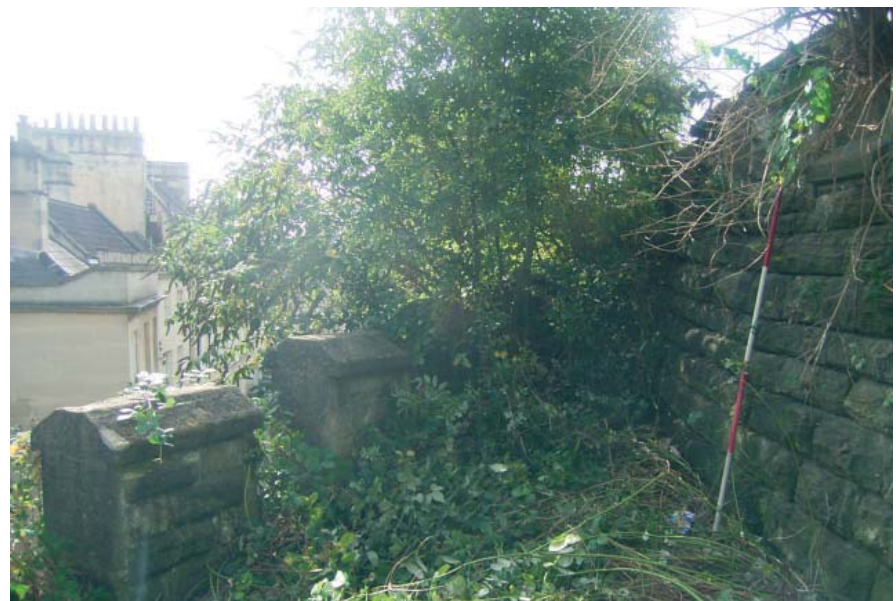
Plate 24: Junction between viaduct and Hedgemoad retaining wall
