January 2019

Client: Wigley Building and Development Limited

## Kings House, Stockton, Warwickshire

# Archaeological Watching Brief Report

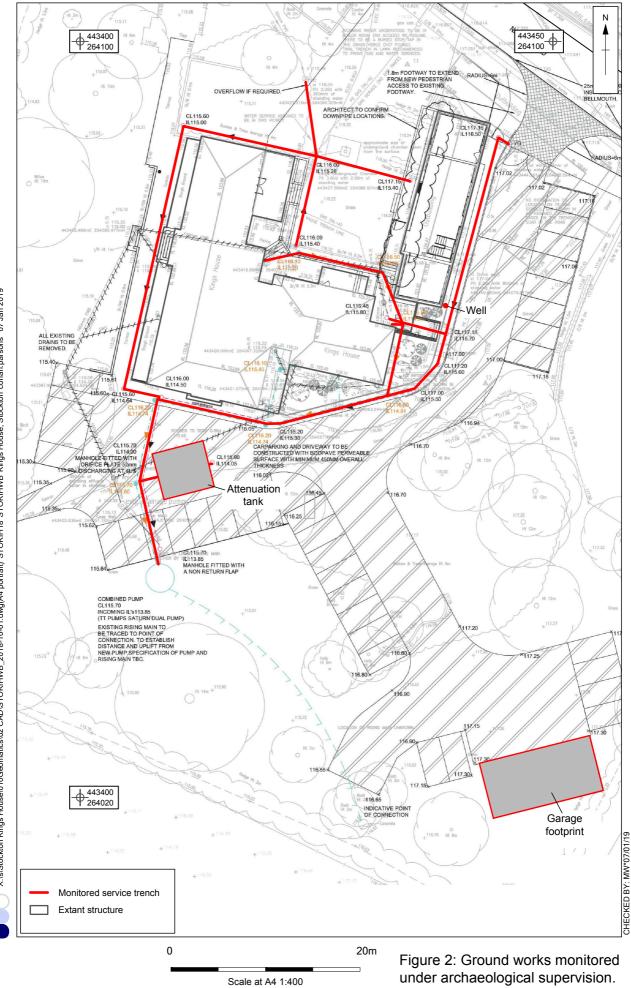
under archaeological supervision.

- 3.2.1 No significant archaeological features or deposits were recorded during the course of the watching brief.
- 3.2.2 A layer of mid brown silt was recorded within the footprint for the garage (Plate. 1, Fig. 2), to the south-east of the house. This deposit almost certainly represents a medieval or post-medieval agricultural soil, and relates to extant ridge and furrow noted in adjacent fields to the south-east and south-west.

- 3.2.3 A well, measuring 1.24m in diameter, was partially revealed to the east of the house (Fig. 2). It was constructed from bricks laid vertically (Plate 2). Each brick measured 0.24m x 0.114m x 0.075m. It is likely to be contemporary with the construction of the house in the early 19<sup>th</sup> century.

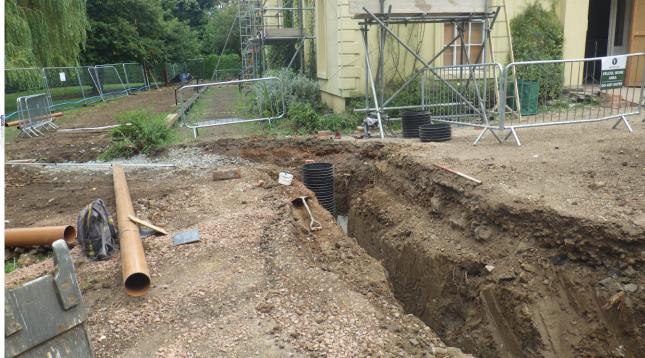
Plate 3: Service trench

- 3.1.1 The stratigraphic sequences revealed were well defined. The geology of Charmouth Mudstone was recorded along the length of the service trenches, and this was overlain by modern gravel surfaces to the south of Kings House. To the east and north of the house made ground was recorded, generally consisting of reworked natural geology with no archaeological potential.
- 3.1.2 Ground conditions throughout the watching brief were generally good, and the site remained dry throughout.
