Ashgrove Farm Ardley Oxfordshire

**Historic Building Recording
and Investigation**

Ashgrove Farm, Ardley, Oxfordshire

Historic Building Recording and Investigation

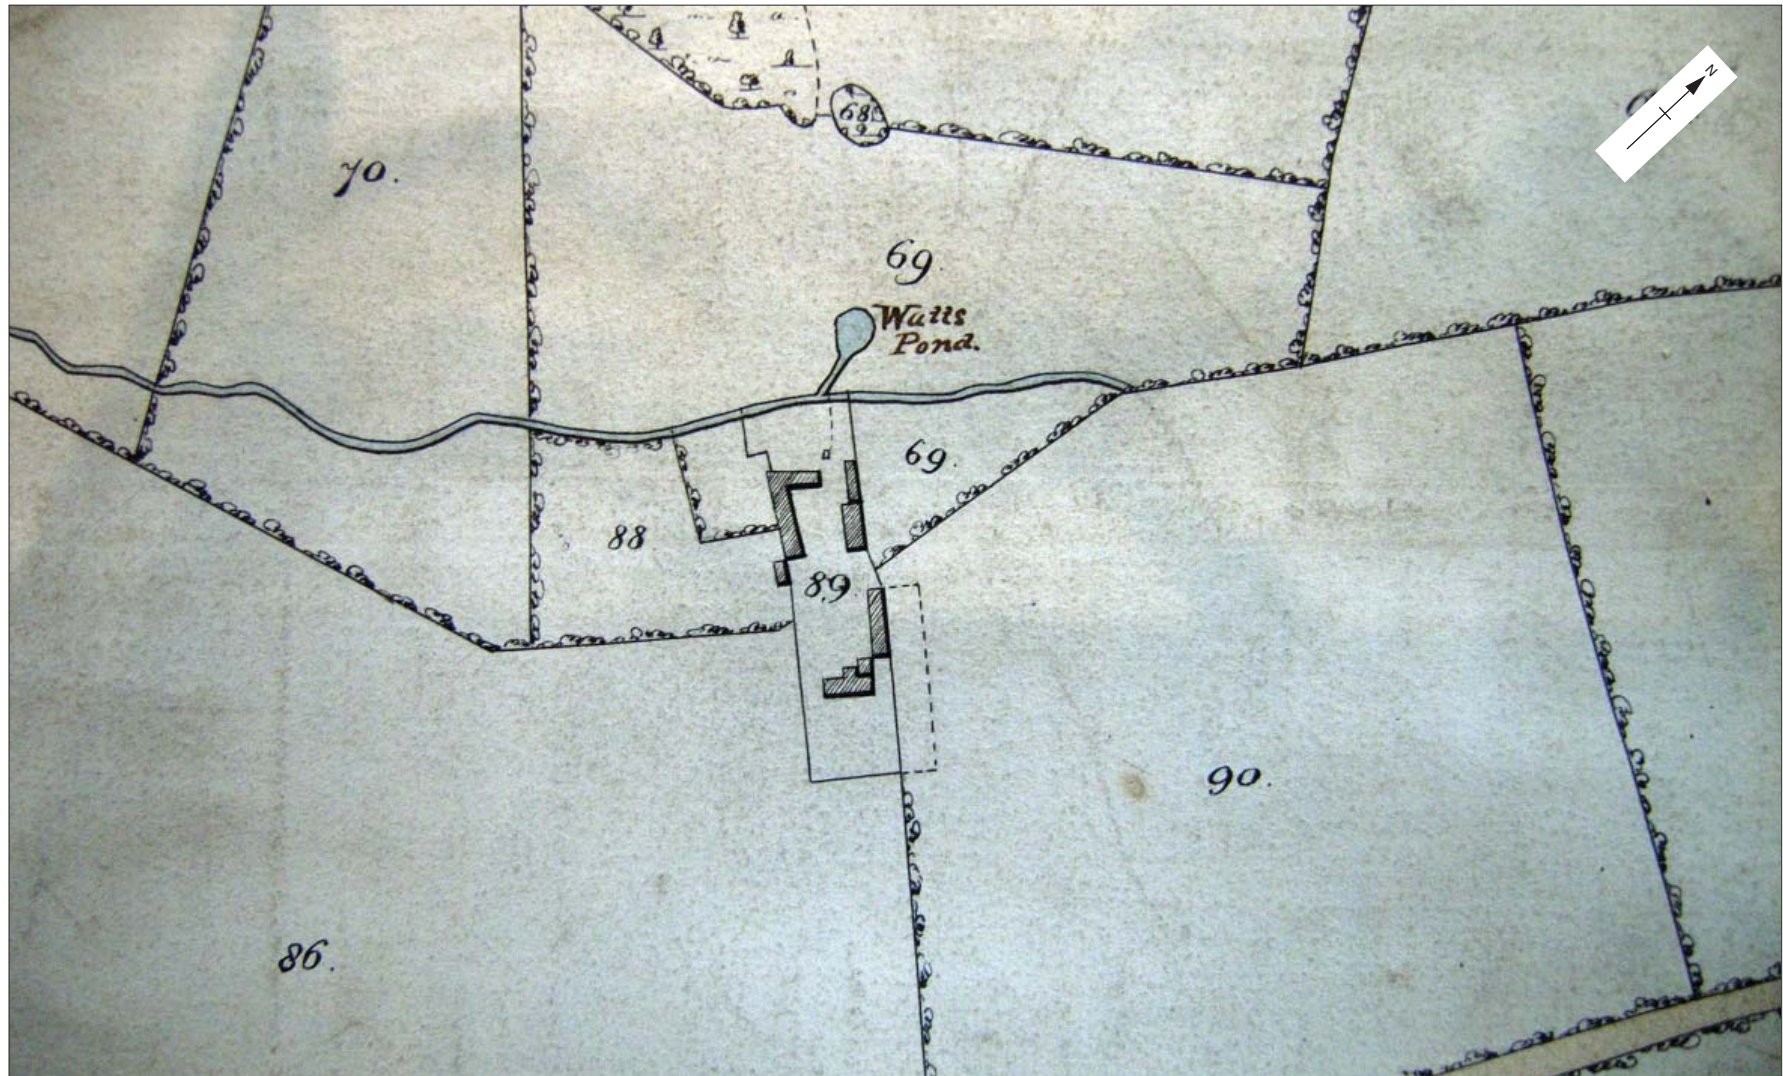
Figure 3: Tithe Map, 1839

2.2.3 The Tithe Map of 1839 (Fig 3) is the earliest map available which shows the farm in detail; the threshing barn is clearly shown with the adjoining later stable or loosebox building to its western end. It can also be noted that the pigsties at the south of the threshing barn are not yet built. 'Barn 2', that which now contains the workshops, is also notable by its absence.

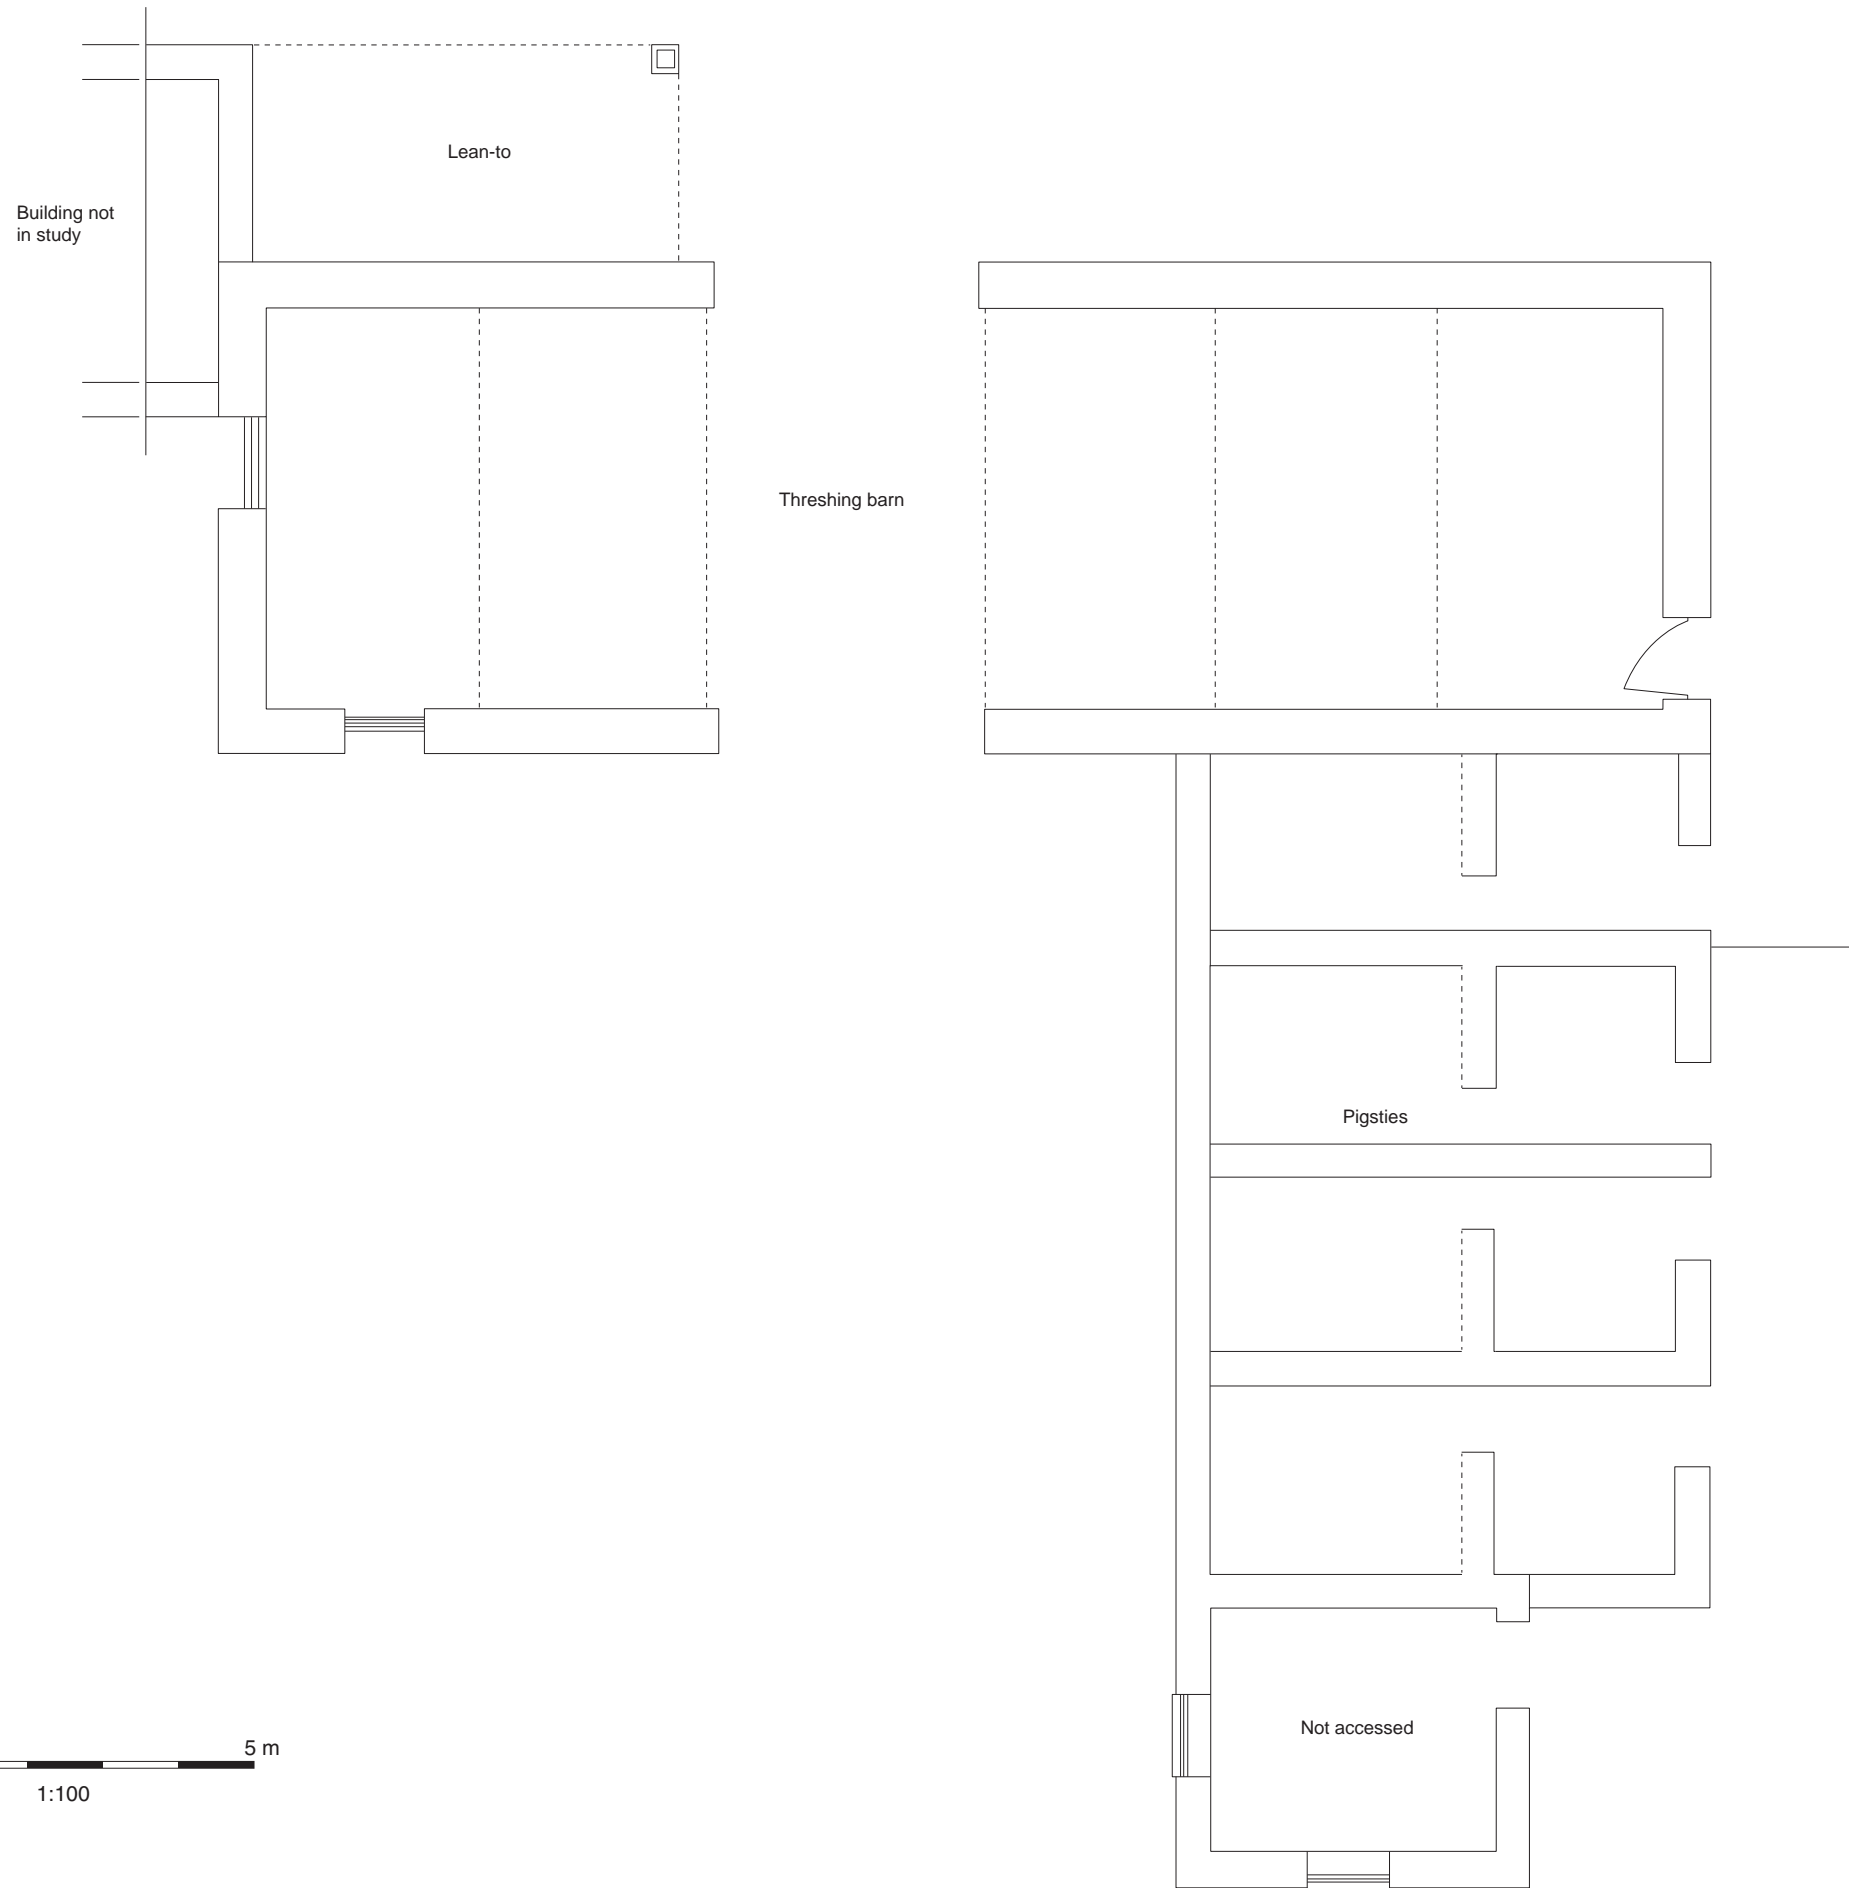
Figure 8: Barn 3

- 6.1.1 The only listed building on the site, and the earliest surviving building on the farm, the threshing barn (Fig 8) had its original slate roof covering removed and replaced with corrugated sheeting, now much degraded, at some point before its Listing in 1988 (Appendix B) (Pl. 30).

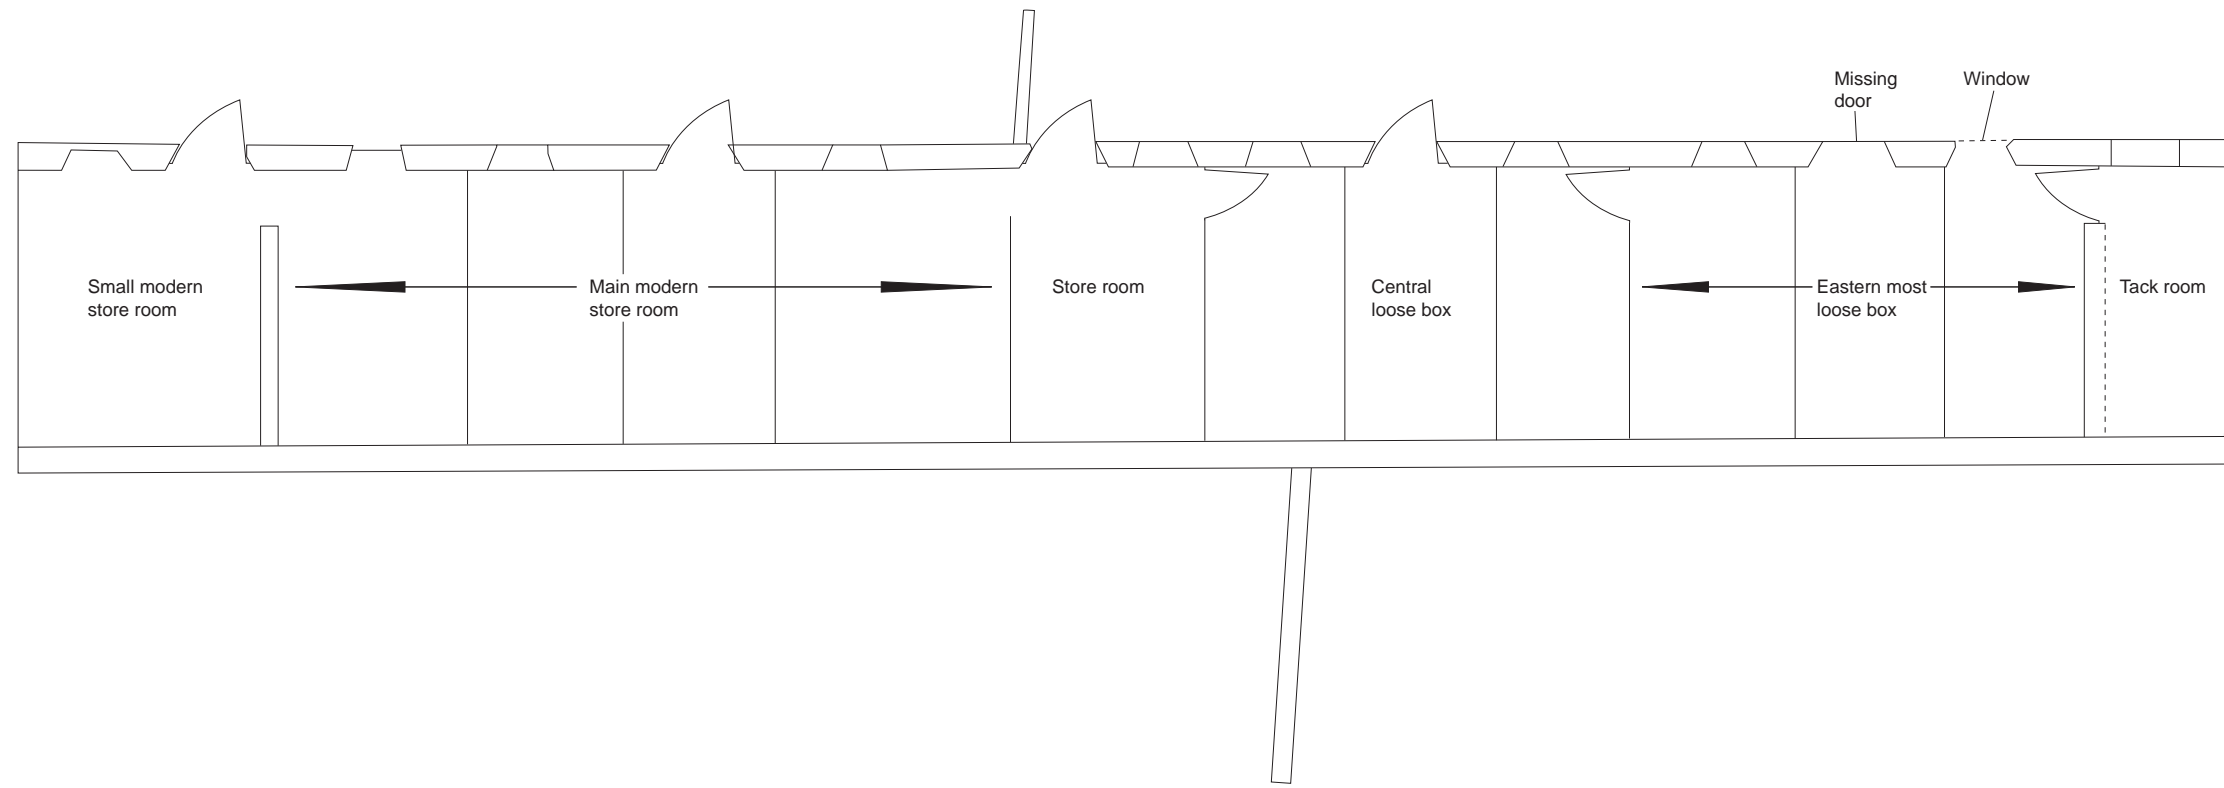
Figure 9: Barn 4 and Barn 5

- 7.1.1 The stable block to the south of the site (Fig 9) is not present on the 1839 Tithe Map, but by the sale of 1894 it is shown, butting up to the earlier brick range attached to the farmhouse. Externally, the block has undergone little structural alteration, however, the north pitch of the roof has lost its original slates which have been replaced with corrugated sheeting, and most of the original windows and doors have been lost or replaced.

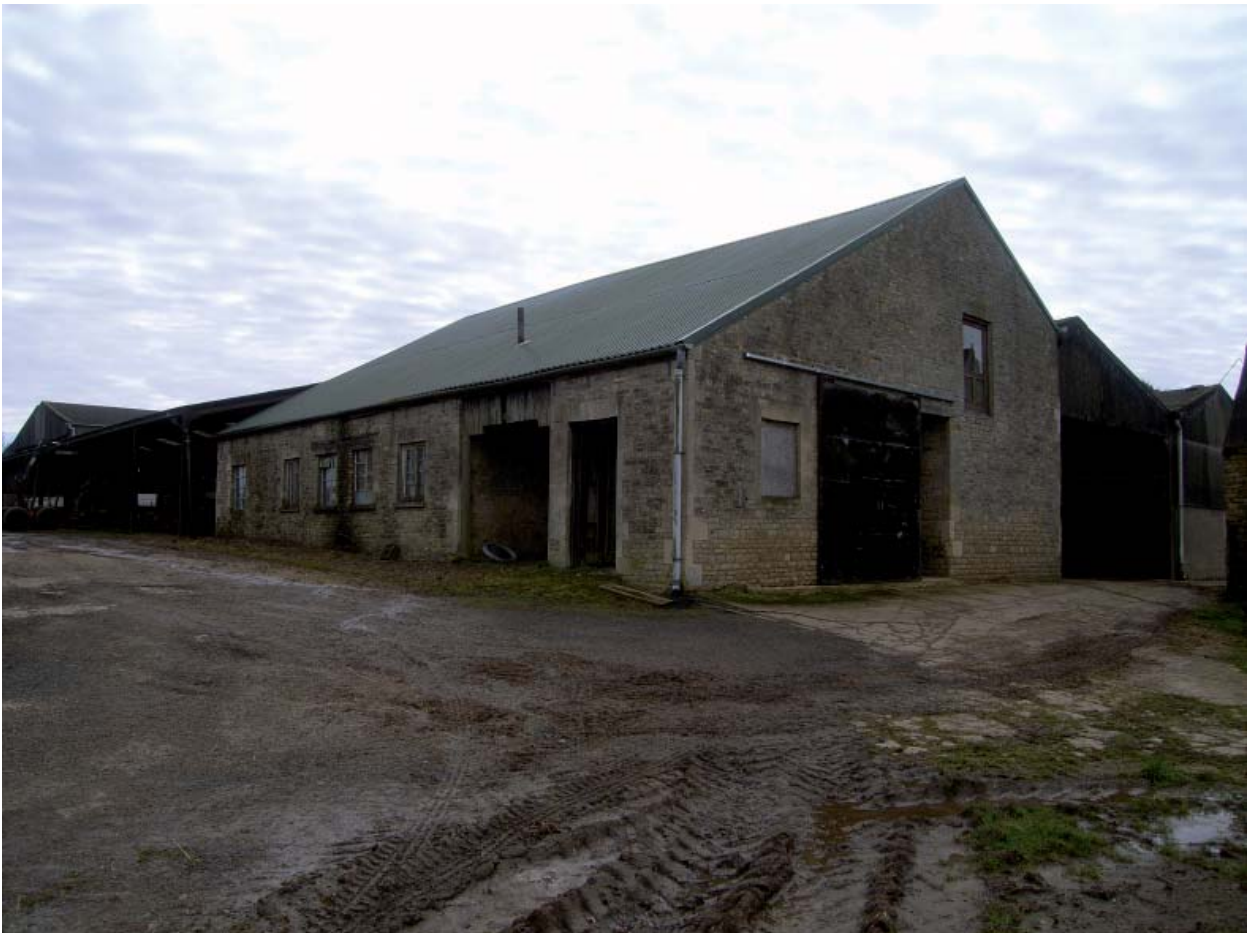
- 5.1.1 Barn 2 (Figs 6&7) is the most grand of the agricultural buildings (Pl. 10). Appearing at a point between the Tithe Map of 1839 and the Sale Catalogue plan of 1894, the walls are of irregular coursed limestone with rusticated limestone quoins with matching dressings to the original external doors, windows and openings.

Plate 10: Barn 2; north and west elevations

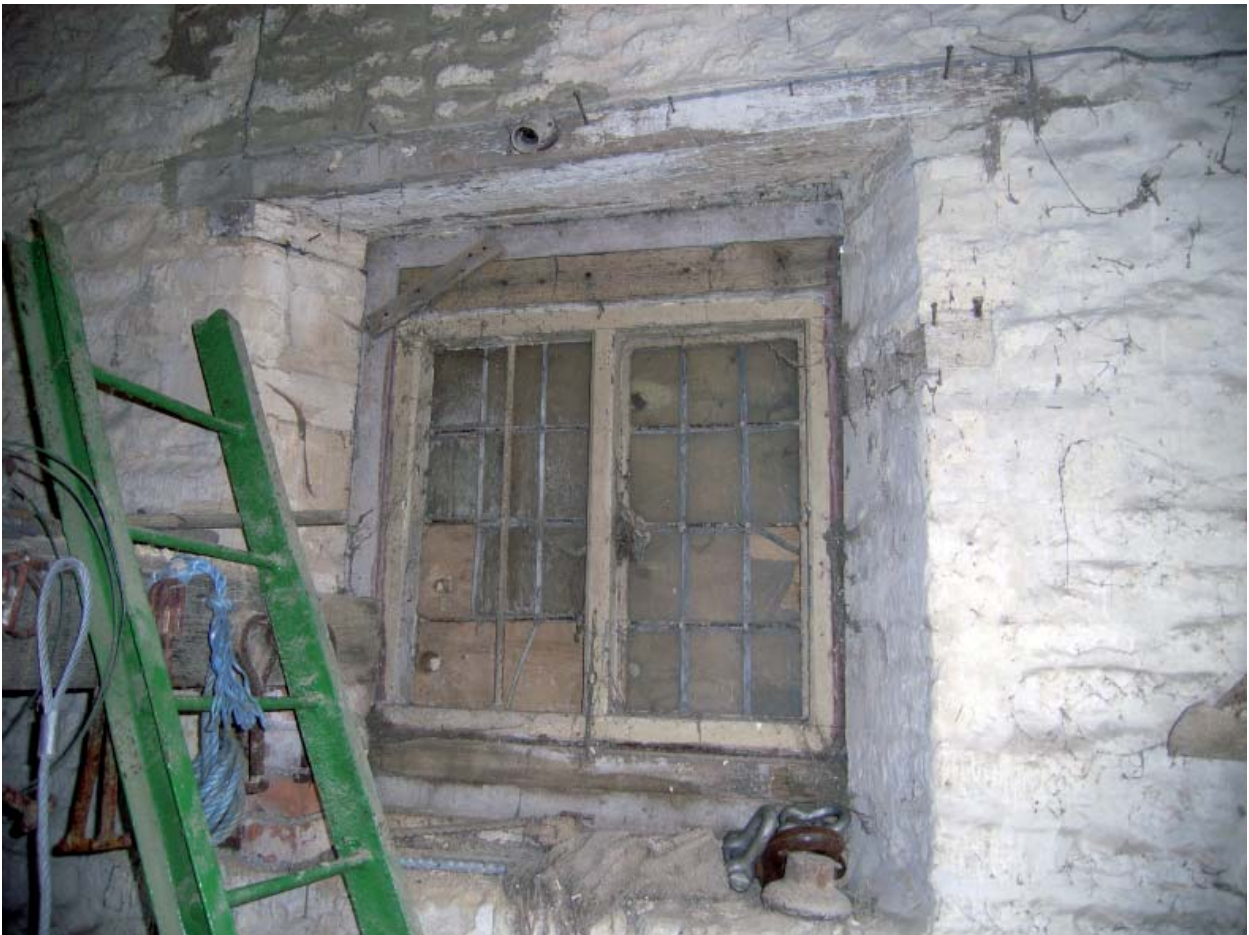
- 5.2.10 The one-bay warming room retains a very small timber mezzanine and shelves which are still used for tool storage. The room is accessed by a later ledged door, but retains a window, boarded externally (Pl. 20). Probably an early replacement due to the extra timber packing around it, the window currently consists of one fixed light and one opening casement, with 12 rectangular leaded panes in each, although a central glazing bar in the fixed light may indicate an earlier glazing scheme. Internally, the window is splayed and below a timber lintel.

Plate 20: Barn 2; Warming Room window

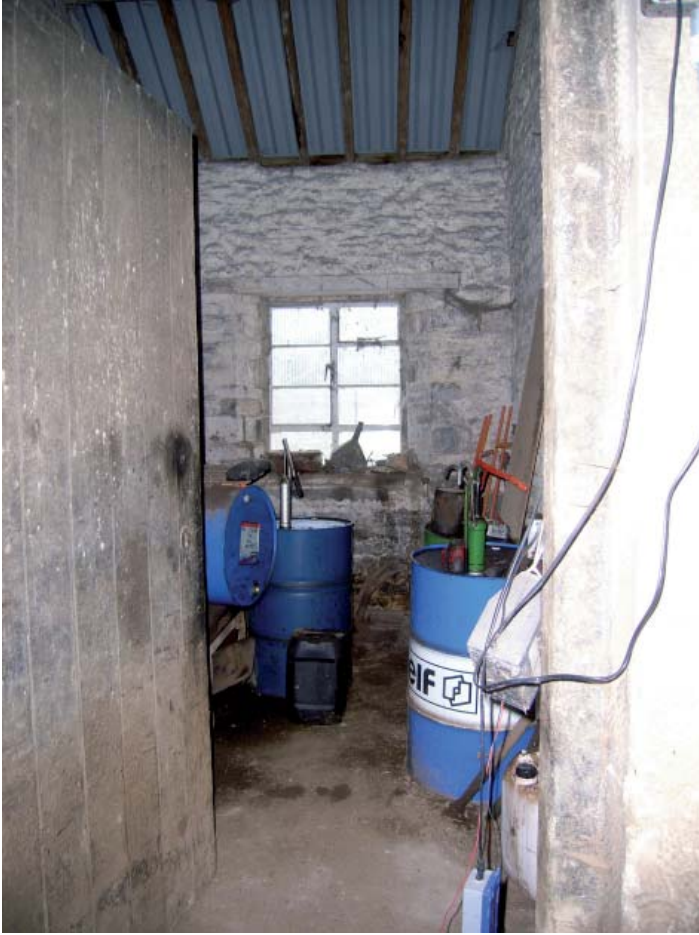
- window is a later replacement which matches the reclaimed windows used in the General Workshop, as described previously (Pl. 23).
- 5.2.15 To the south of the passageway, the building is split into two two-storey compartments: the westernmost of six bays and the easternmost of two bays with a brick wall dividing the compartments.

Plate 23: Barn 2; Oil Drum Store

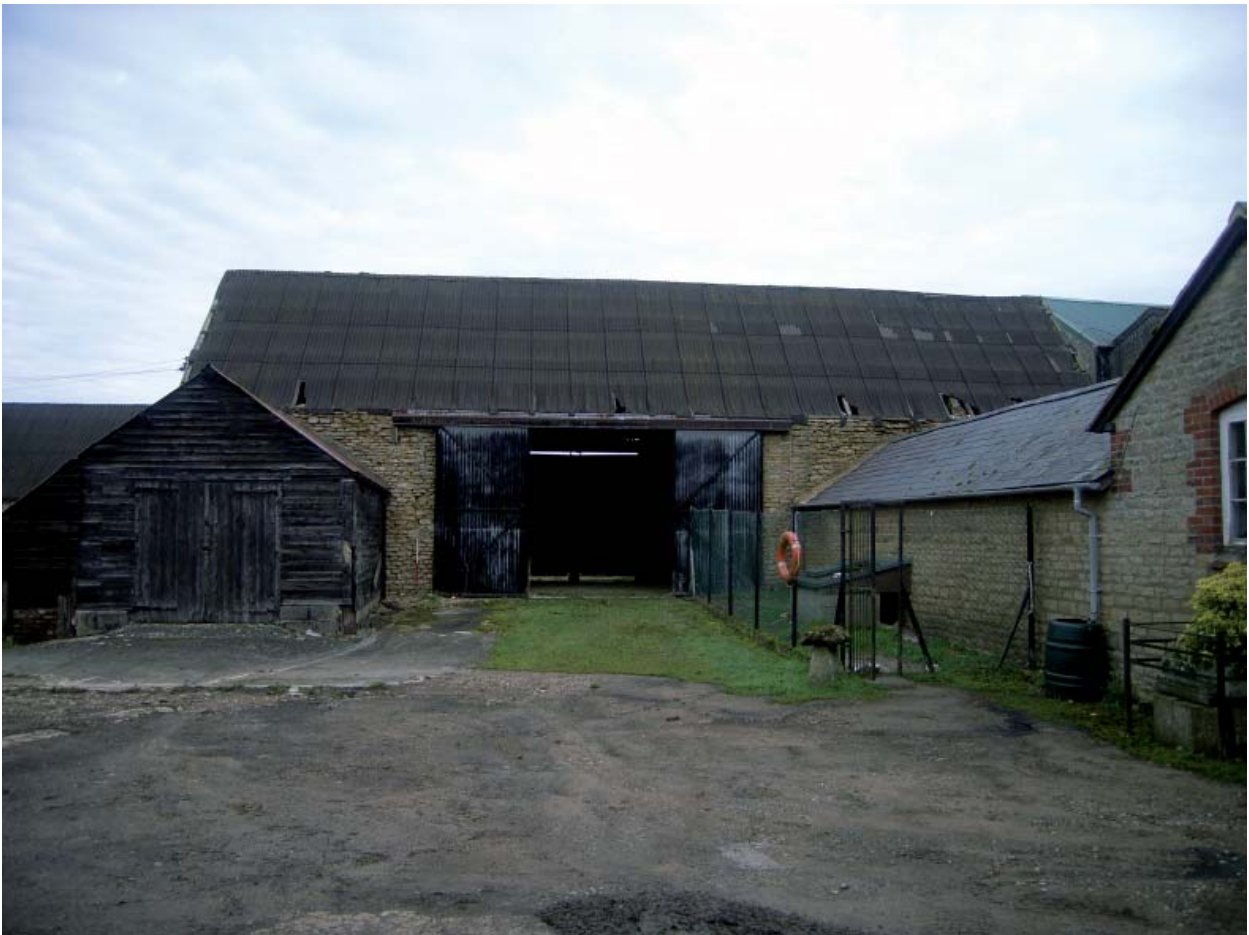
Plate 30: Barn 3; south elevation
