# North Side Cable Trench, Basildon Park

## Archaeological Watching Brief Report

October 2017

**Client: National Trust**

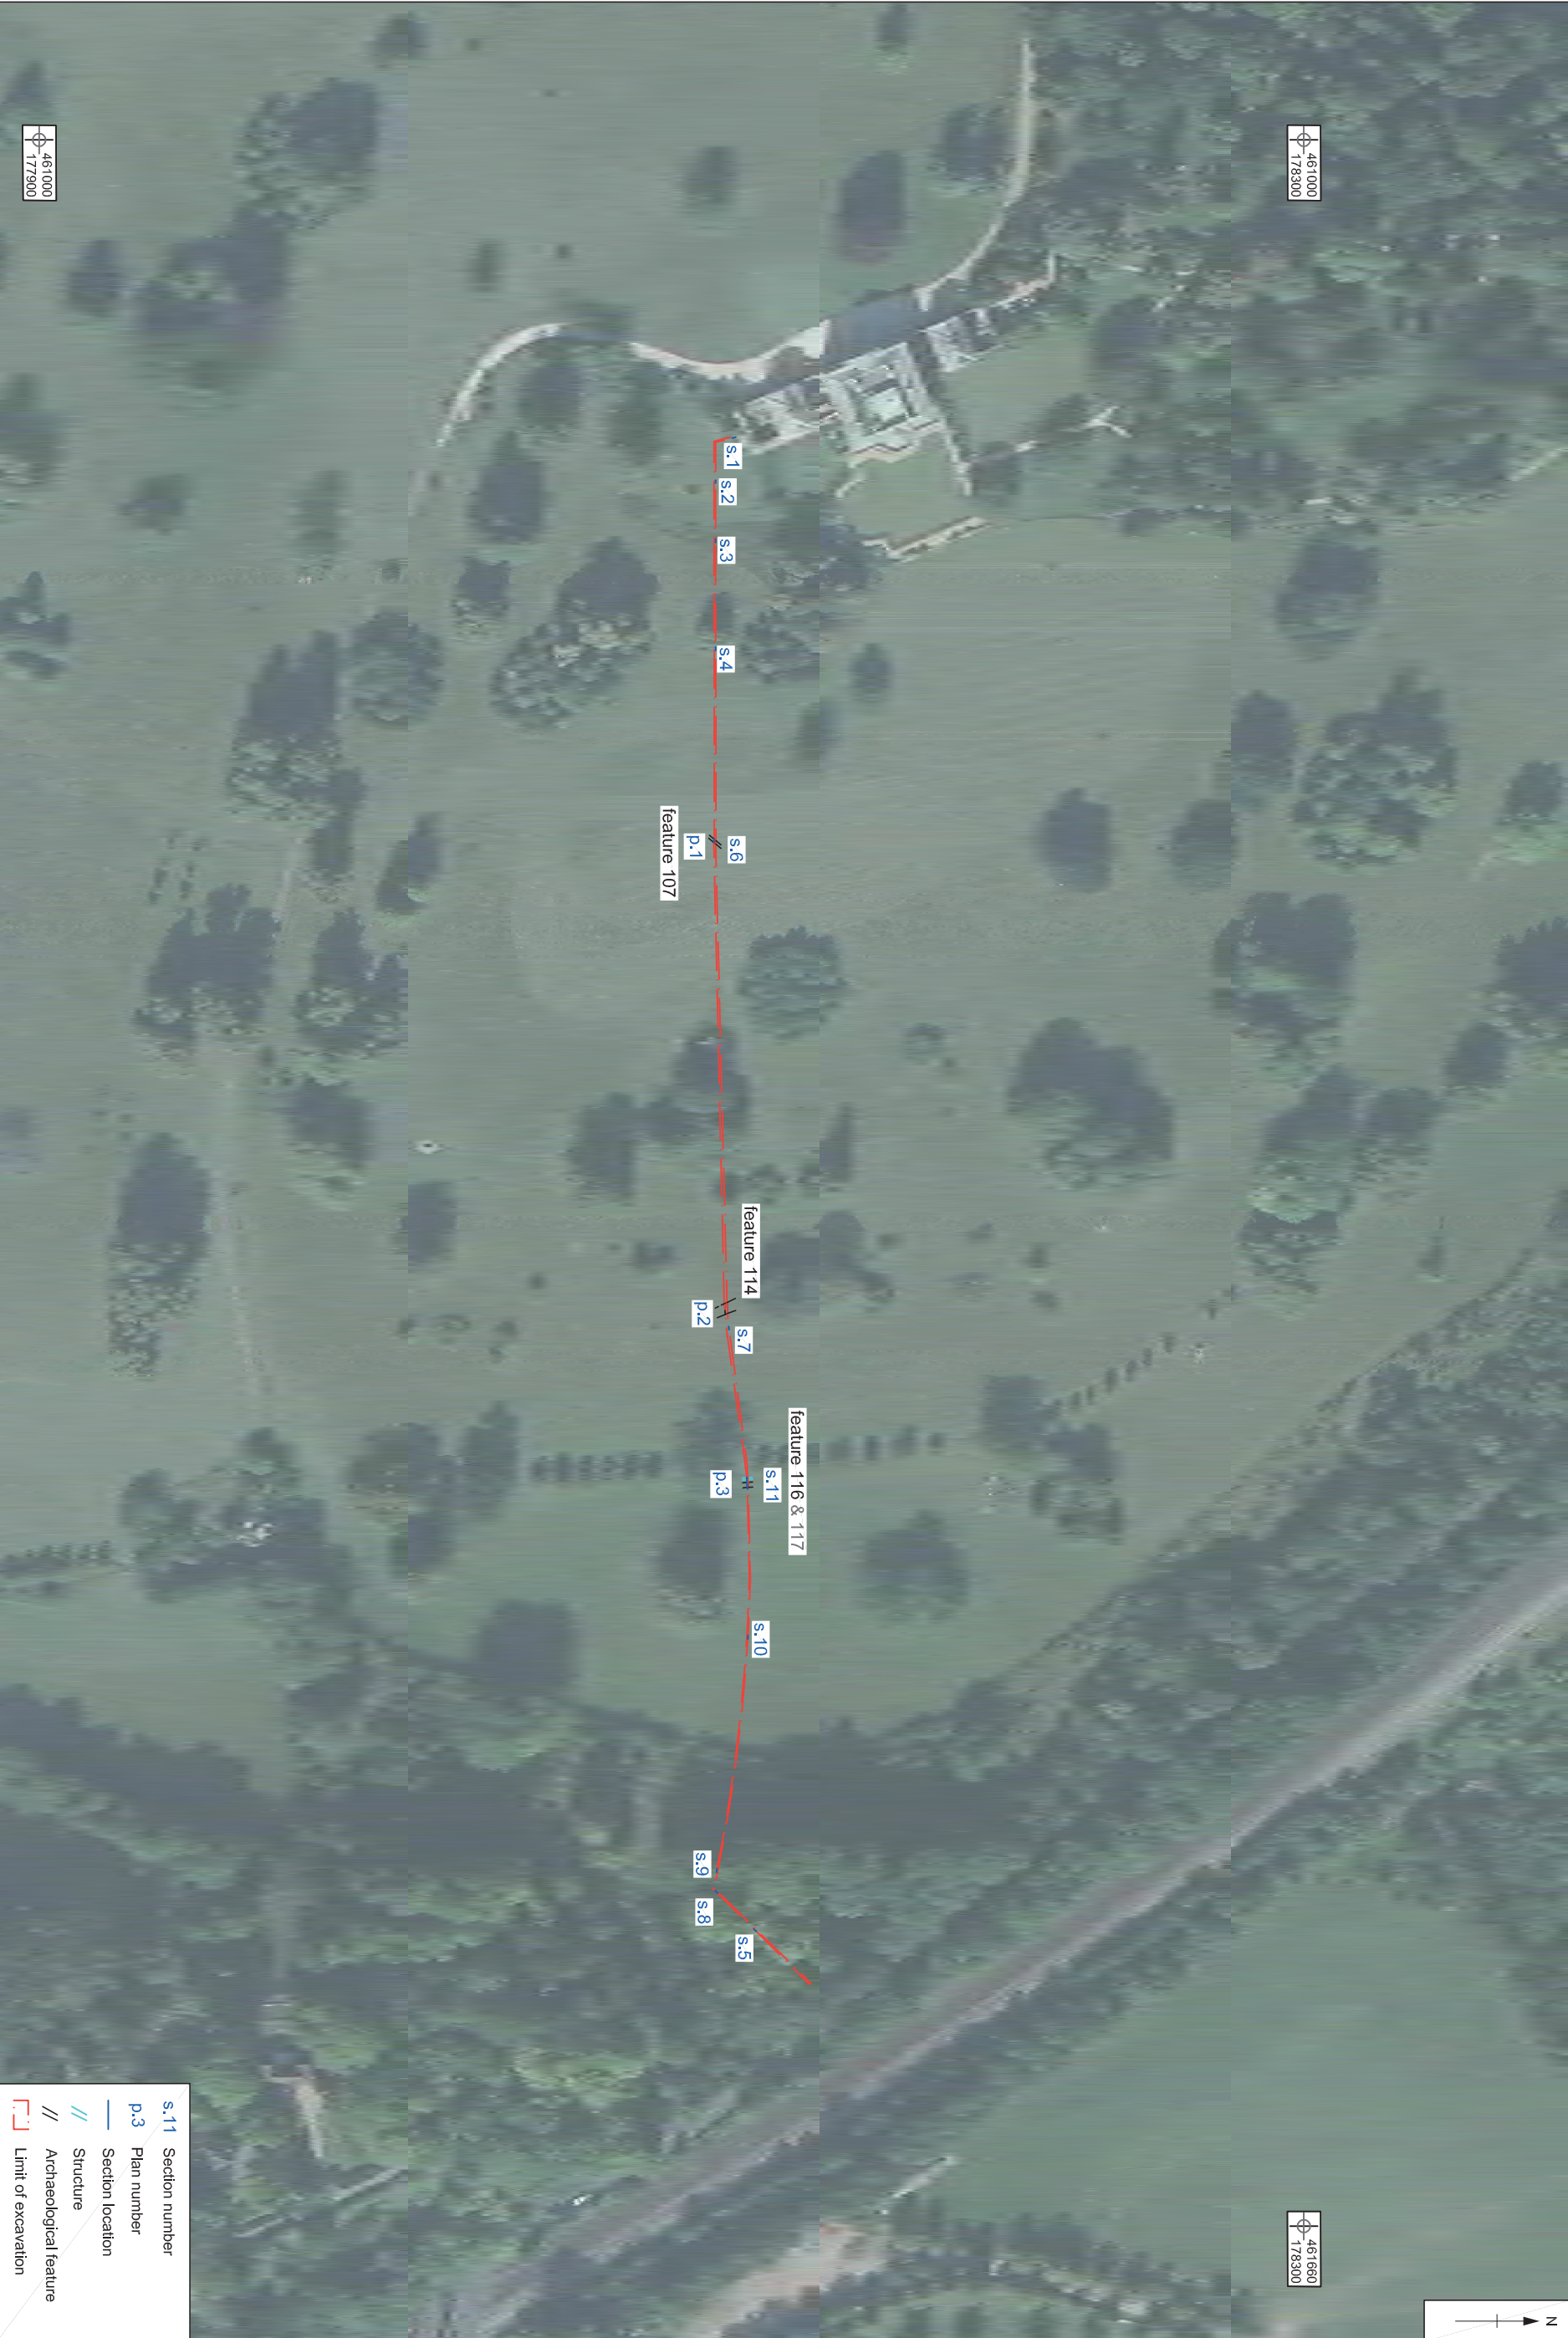
Figure 2: Ducting route with section locations and plan locations.

- 1.2.1 Basildon Park is a country house situated 3 kilometres south of Goring-on-Thames and Streatley in Berkshire, between the villages of Upper and Lower Basildon. Its location and the location of the works within the Park are shown on **Figure 1**.
- 1.2.2 The cable trench runs through the lawn to the south of the house for a short distance and then runs east down the slope into the valley bottom. It then continues a short way up the opposing slope and turns north-east upon reaching a track, which it then follows to the edge of the A329. The line of the trench can be seen on **Figure 2**.
- 1.2.3 The geology of the area is in the Lewes Nodular Chalk Formation (BGS website).

- 3.1.11 The locations of the drawn sections and an illustration of the layers within this area can be seen on Figures 2 and 3.

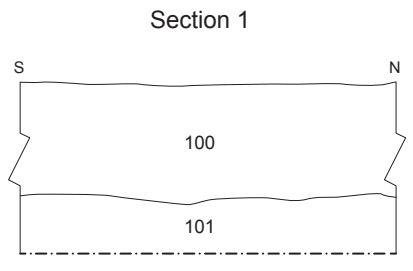
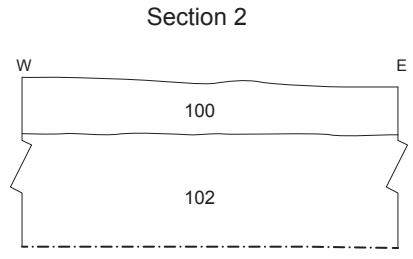
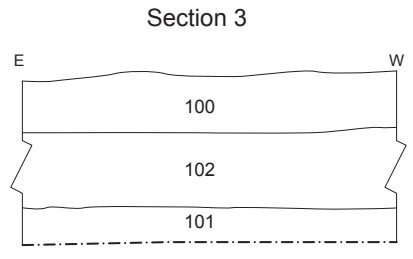
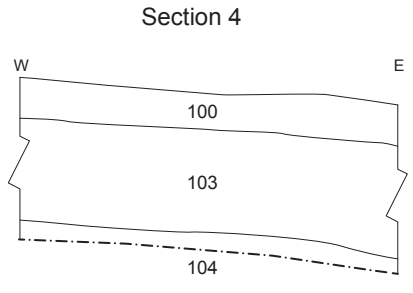
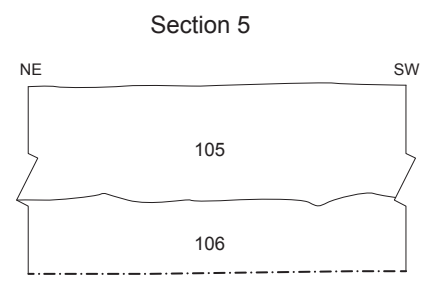
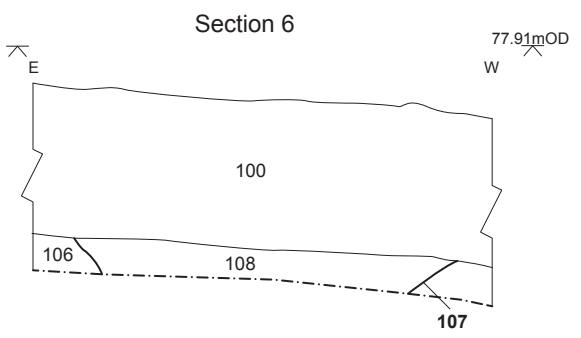
Figure 3: Sections 1 - 10

- 3.1.2 The topsoil sealed two subsoil layers (Layers 101 and 102) which both probably represent layers created during the landscaping of the garden. Deposit 101 was a friable, yellowish brown silty sand with a high gravel content, and occasional flecks of ceramic building material (CBM) visible, it exceeded 0.15m in depth but its full height was not seen. Deposit 102 was a friable, grey sandy silt with charcoal and CBM flecks. It was 0.3m in depth. Layer 101 was present beneath layer 102 in the eastern edges of the garden however closer to the house layer 102 was entirely absent.
- 3.1.3 Illustration of the layers within this area can be seen on Sections 1 & 2 (Figure 3).

- 3.1.7 Where the natural (106) was observed it was a compact white chalk.
- 3.1.8 Ditch 107 cut the natural (106). It was orientated north-east south-west and was 1m in width. Only the top 0.1m of it was excavated, showing that the sides were quite steep (Fig. 3, section 6). It was filled by (108) a compact, medium to light yellowish brown clay, with moderate amounts of stone inclusions. It was located half way between the garden area fence and the false crest.

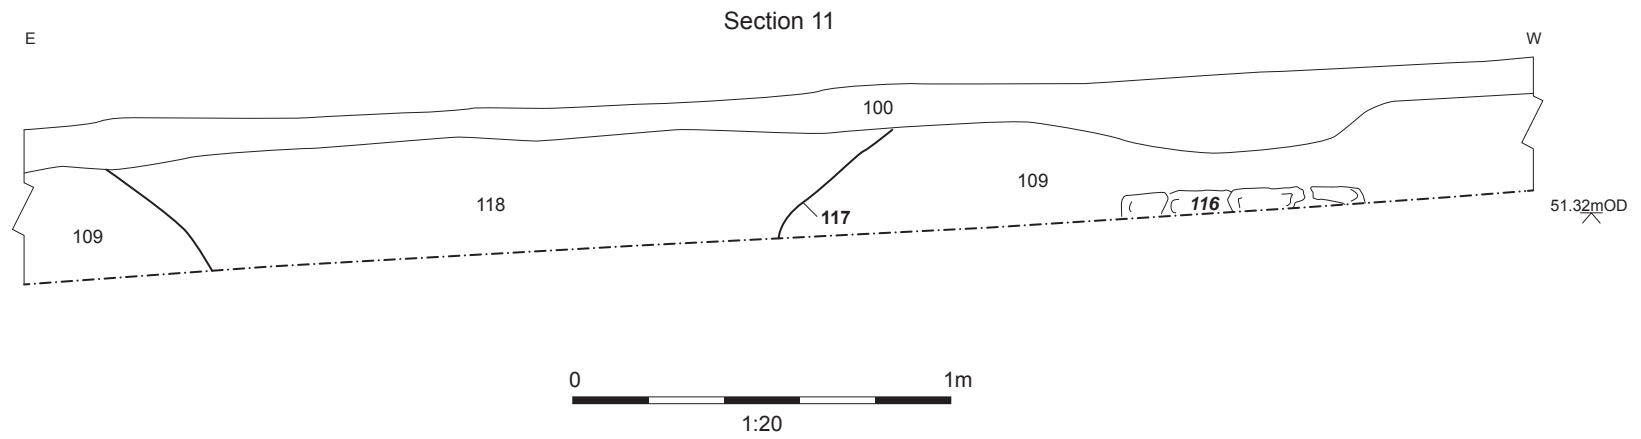
Figure 4: Section 11

3.1.13 Bordering the lynchet to the eastern side and cutting through the subsoil (109) was a ditch (117) and the base of a wall (116) running parallel to the lynchet (Figure 4, section 11). Wall 116 was constructed of chalk blocks roughly 0.15m sub-square and without any mortar. It was 0.65m in width, and of unknown height. Ditch 117 was located 0.9m to the east of wall 116. It was 2.1m in width, had steep sloping sides and its base was unseen. It was excavated to a depth of 0.3m and was filled by a loose, brownish grey clayey silt (118) with very frequent broken chalk blocks and occasional ceramic building material (CBM) pieces. The feature lies just to the north of the area which was subject to geophysical survey in 1995. The 1995 survey did pick up a substantial north-south feature to the south of the 116 and 117 (see Figure 7) and it would appear likely that this feature represents the line of the wall and ditch within the parkland to the south of the area crossed by the scheme.

- 4.1.3 The lynchet and valley bottom area excavation did not reach the natural geology at any point. However, the remains of a wall (116) and ditch (117) running along side of the lynchet were revealed. As the ditch was cut through the subsoil it is unlikely to be ancient in origin and this assertion is supported by the fact that it contained pieces of 18<sup>th</sup> and 19<sup>th</sup> century ceramic building material. The fill of the ditch (118) indicated that it had been intentionally backfilled with the demolished remains of the wall, although the bricks which showed traces of both lime mortar and whitewash and interestingly contained a piece of possible window or door surround, may have come from a (nearby?) demolished building rather than from the adjacent wall.

- 4.1.4 The feature is of uncertain function but its location at the bottom of the slope, just to the east of the prominent lynchet feature would suggest that it represents the remains of a previous boundary wall either an internal parkland wall or a previous outer boundary wall. Evidence for the feature is provided by a sketch plan of a possible new road<sup>2</sup> within the park, drawn by JB Papworth<sup>3</sup> and dated to 1844 (Figure 9). This plan appears to mark the lynchet in this area as 'Old Wall' (although whether this means an internal or an external wall is unclear). It may however be worth noting that the slightly earlier (1838) Park Sale Plan (Figure 8), which shows the lynchet as a large wooded feature, does not appear to show the line of a wall on its eastern side, although clearly the scale of this plan means that its absence is inconclusive.

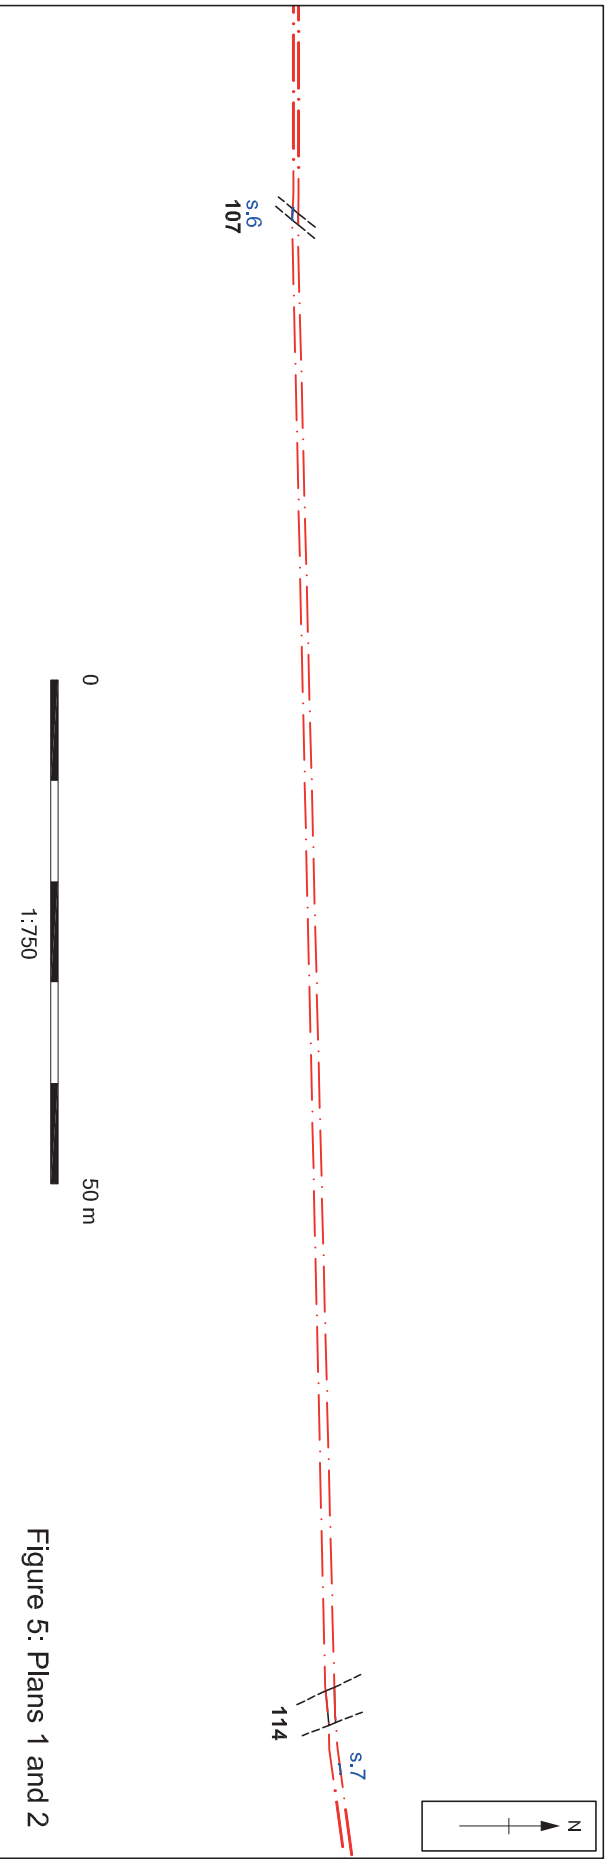
Figure 5: Plans 1 and 2

- 3.1.4 The slope ran gently downwards, in an easterly direction, from the fence of the garden until it reached a false crest from which point it ran steeply down as far as a large lynchet. The natural (Layer 106) was only revealed intermittently in this area and predominantly the trench only revealed subsoil (Layer 103). Two ditches were observed in this area (107 and 114) both in the gently sloped portion.

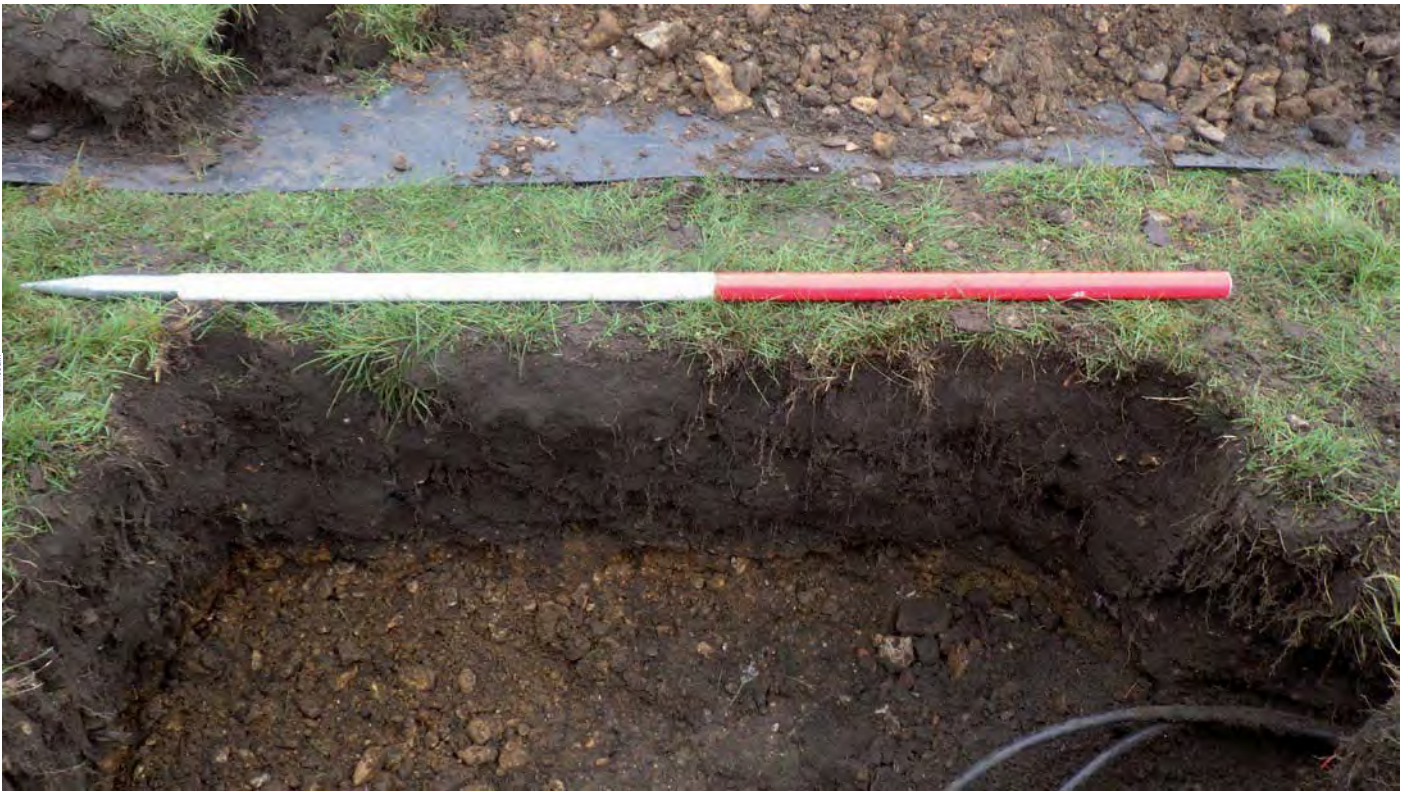
Plate 1 Layers 100 and 101 through garden area, looking east

3.1.1 The garden area was a small area fenced off around the southern part of the manor house. It was predominantly covered in a croquet lawn. The excavation in this area never reached the natural. The topsoil (100) for all of the grassed area was 0.3m in depth closest to the house and reduced in thickness towards the edge of the garden to

a minimum of 0.1m. Outside of the garden area layer 100 was a fairly consistent 0.3m to 0.4m in depth. It was a loose, dark brown silty sand with occasional pebble inclusions.

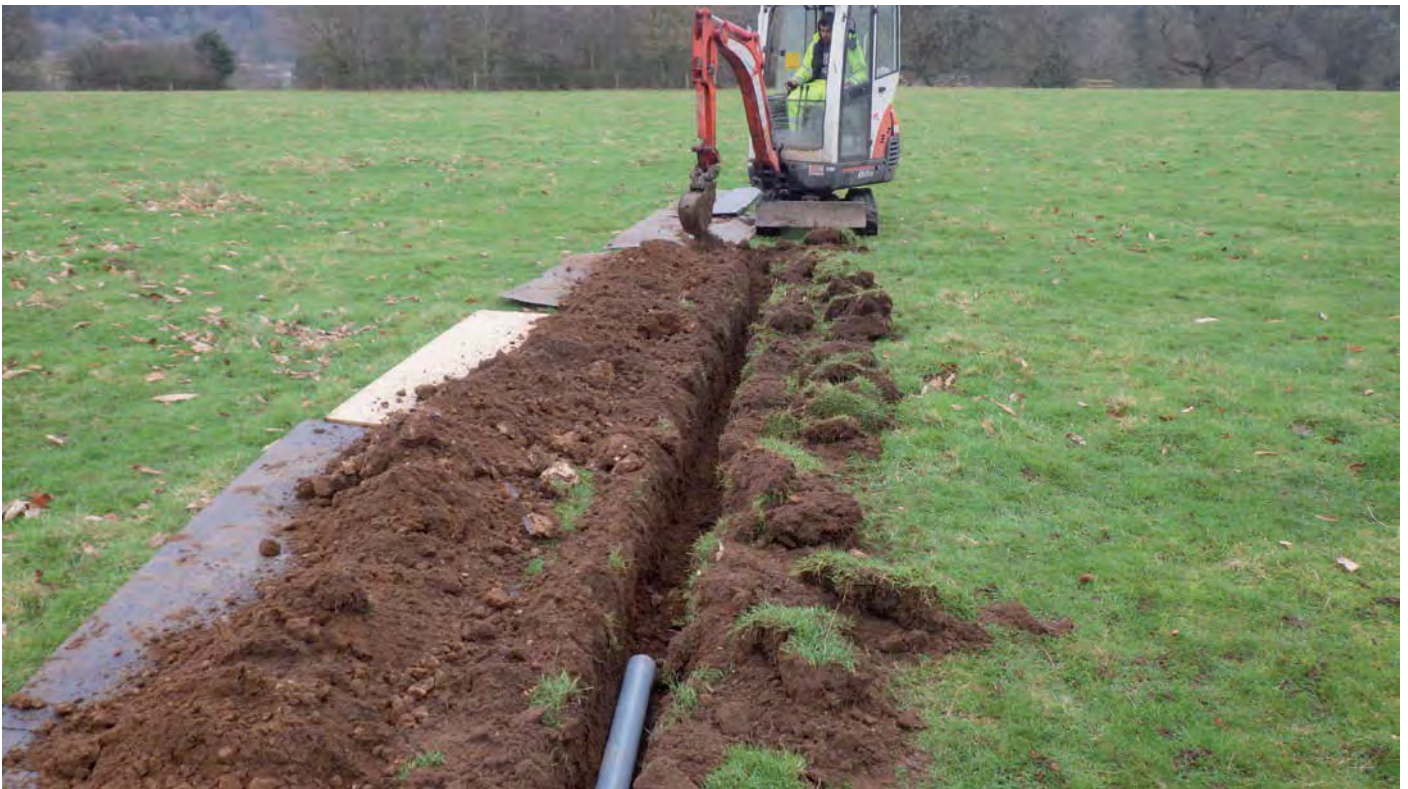
Plate 2 Excavation trench through sub-soil, looking east

- 3.1.5 Deposit 103 was a subsoil layer present before the false crest of the hill. It was a friable, light greyish brown sandy silt with occasional small and medium stones, it was 0.3m in depth.
