Corpus Christi College, Oxford: New Sub Main West Archaeological Watching Brief Report

October 2019

Archaeological Watching Brief Report

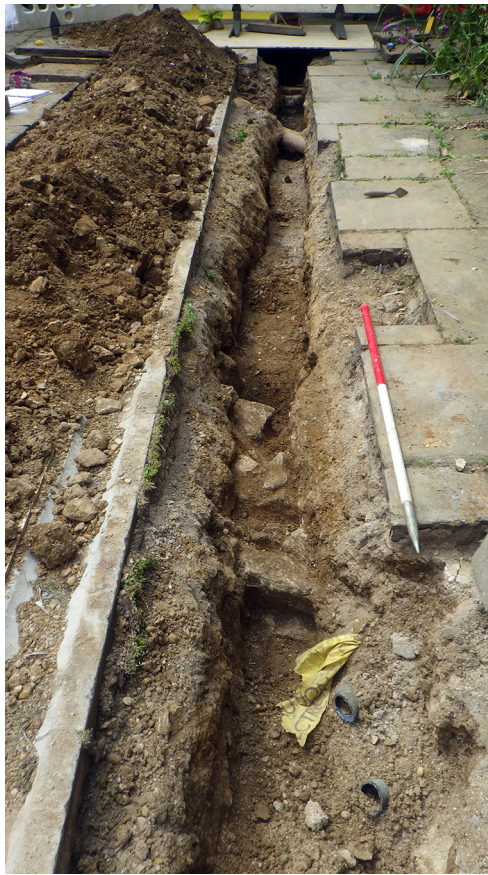
Plate 1: Trench 1, wall 8 in foreground,
view to west

8	Structure	1.1	0.3	Stone wall, trench 1. NNE-SSW aligned. Roughly hewn limestone and mid greyish yellow limestone mortar construction, faced on both sides with a rubble core.		
9	Layer	1.3	0.10	Compact layer over wall, trench 1. Mid yellowish brown sandy clay.	Pot; vessel glass; CBM ridge tile	C 1350-1450 (pot); Late 18th- or early 19th-century (glass); c 1175-1350 (tile);
10				VOID

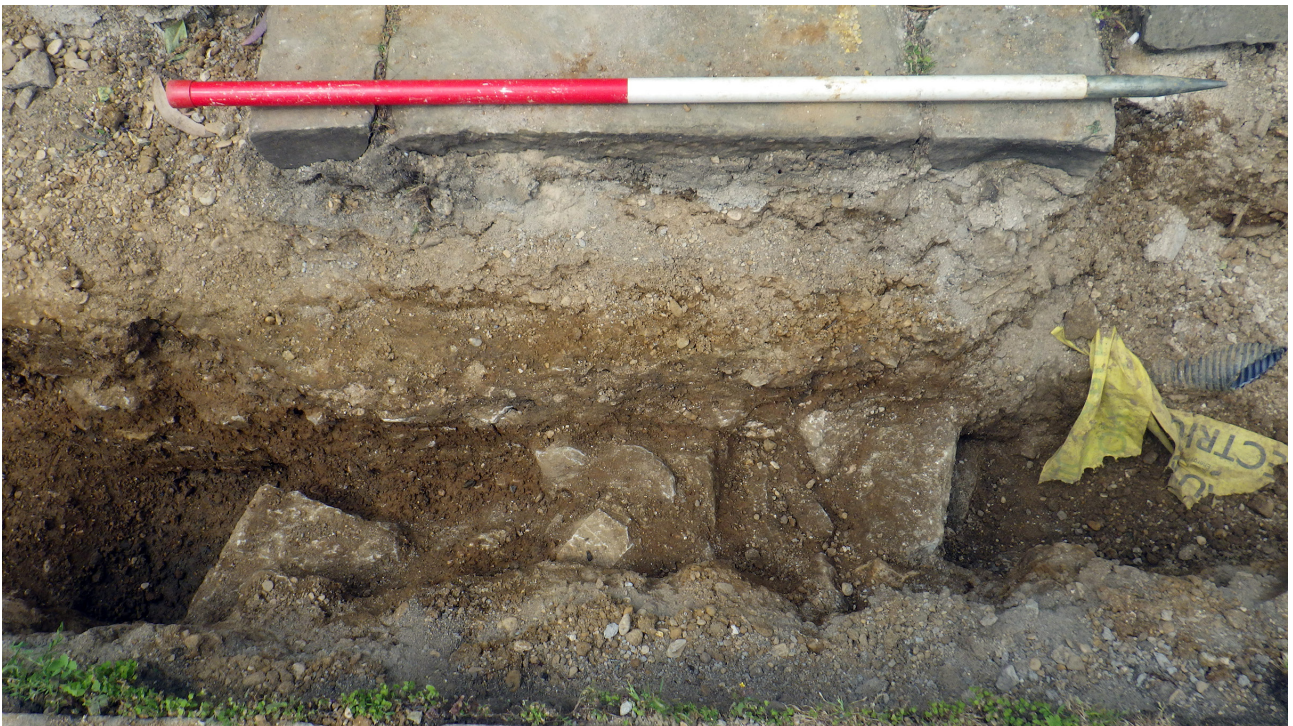
Plate 2: Detail of Wall 8 in Trench 1, view to north

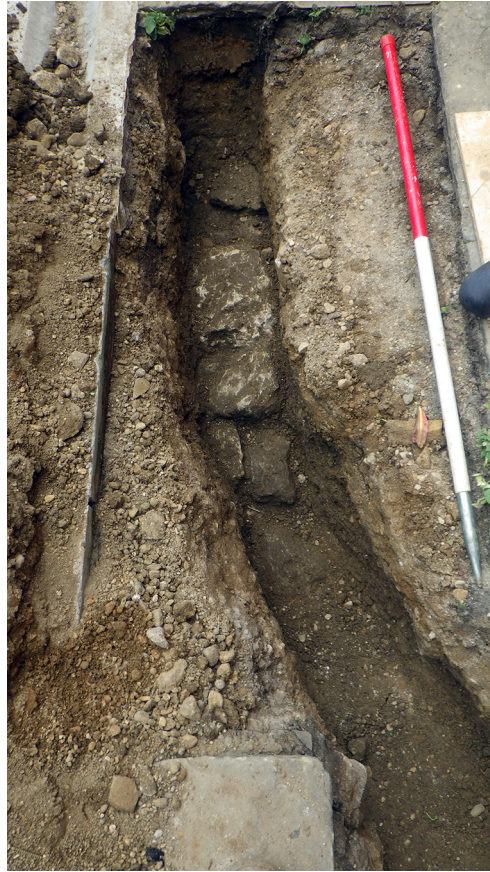
Plate 3: Detail of wall 13_view to west

3.4.3 In the northern end of the north-south part of Trench 1, the upper two courses of a wall, 13, were constructed from both roughly hewn limestone blocks (Figs 3 and 7, Section 3; Plate 3). The blocks were laid at random with occasional patches of yellow-grey mortar present. The wall was sealed by layer 4, in turn sealed by 3 which was overlain by the quad surface (1).

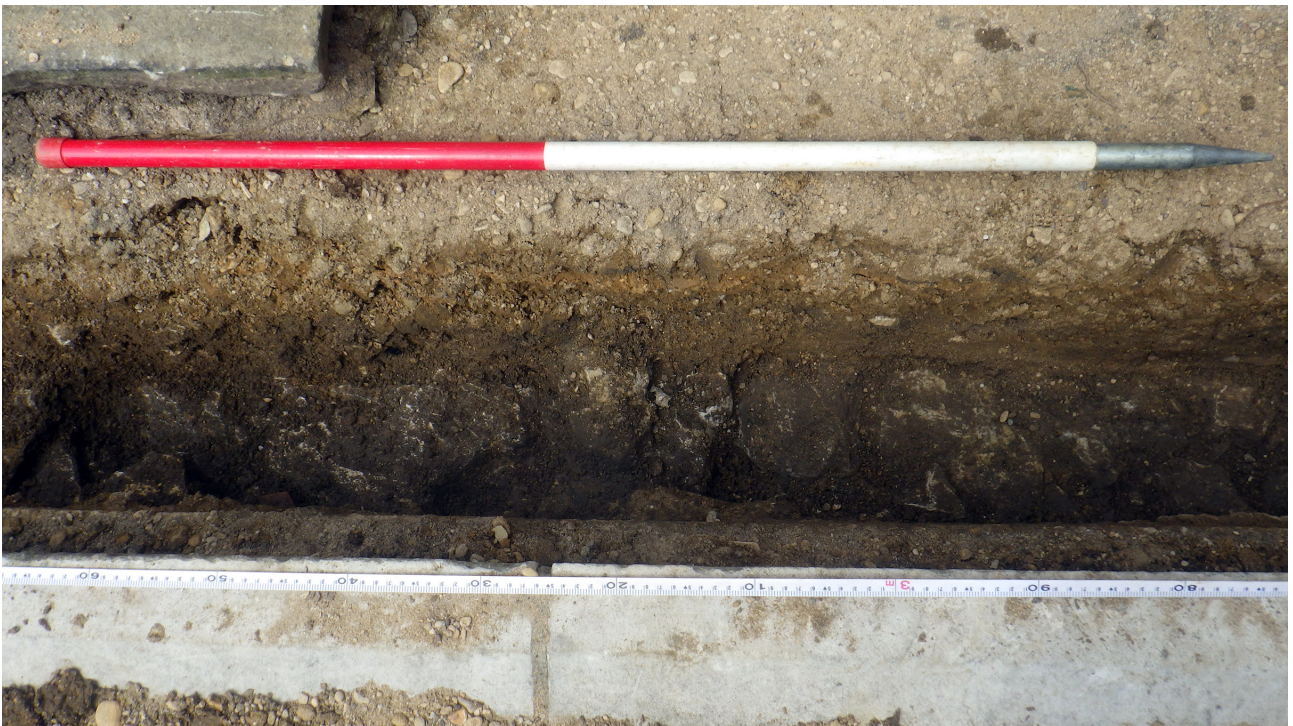
Plate 4: Detail of wall 26 in Trench 1, view to west

3.4.4 A few metres to the south a further wall, 26, is likely to be a continuation of wall 13, and was of similar construction (Figs 3 and 7, Section 4; Plate 4). The wall was cut by a later feature, a pit or the base of a robber trench, 32, which was only visible in plan (Fig. 3). The fill (33) comprised mainly flat stones and roof tiles, and also contained CBM dating from the 13th or 14th century. The wall was partially overlain by layer 27 (only seen in plan), which may also represent the remnant of a robbing event, and comprised a grey-brown sandy clay containing tile dating from the 13th-14th century. Above layer 27 were layers 4, 3 and the quad surface (1).

4.3.1 Walls 28 and 26 are likely to belong to the halls that occupied the site prior to the foundation of the college in the 16th century, potentially Neville's Inn and Leden Porch. Wall 26 was cut by feature 32 which contained 13th-14th century material, and wall 28 was sealed by layer 29 containing material of 13th to 15th century date, potentially the fill of a robber trench associated with clearance prior to the foundation of the current college. The orientation of the walls could not be established, as they ran parallel with the narrow trenches that were subject to this investigation, but it is possible that as with wall 8 (the only wall that ran across a trench), they shared an orientation slightly different to the current college layout. The restricted nature of the trenches subject to the watching brief and high degree of modern truncation did not allow the opportunity to see how all the walls related to one another.

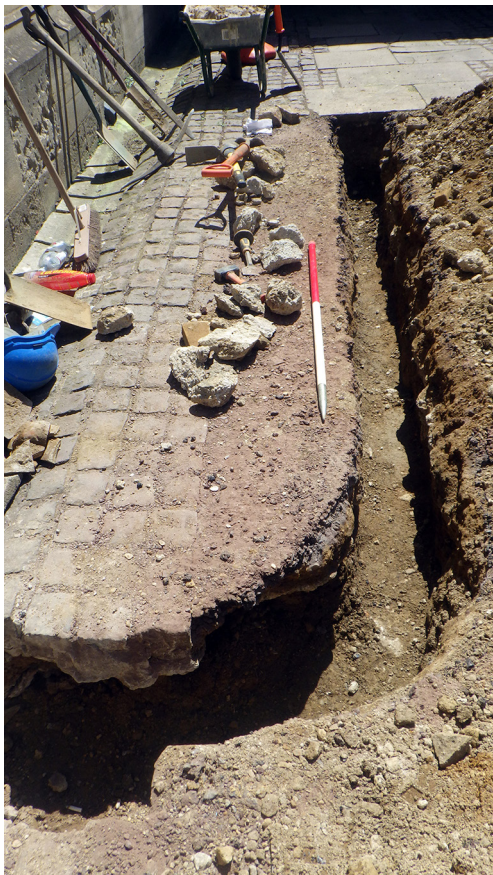
Plate 6: Trench 2, view to south

3.5.2 Trench 2 revealed the top course of the foundations, 24, for the current college quad building walls which were observed at the north end of the trench. The wall foundation was abutted by layer 25, a yellow-brown sandy clay with small limestone fragments and gravel inclusions. This was sealed by the formation layer (20) for the current tarmac surface of the carpark to the west.

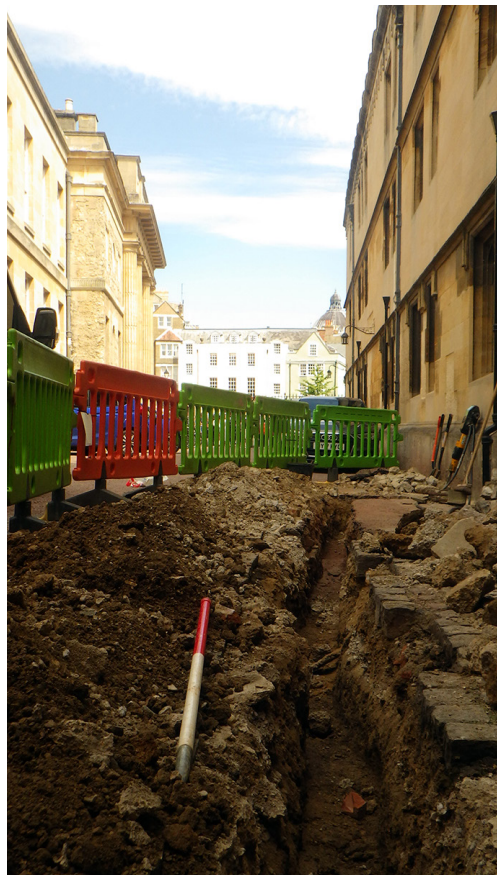
Plate 7: Trench 2, view to north

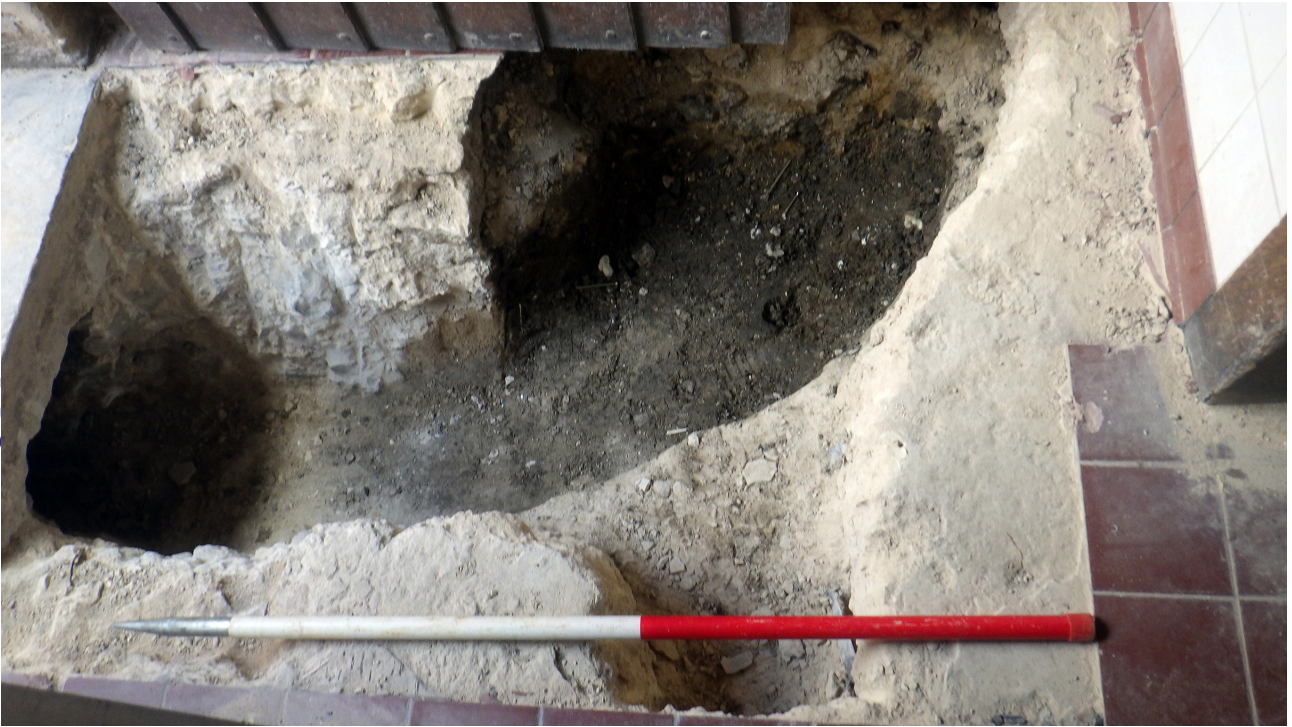
Plate 8: Trench 3, view to east

3.6.1 Trench 3 (Figs. 2 and 4; Plate 8) revealed the foundations for the current kitchen wall (23). This was abutted by a yellow-brown sandy-clay layer (22), into which a small trench was excavated to a depth of 0.26m. The layer was sealed by the concrete foundations (21) for the modern kitchen floor tiles.

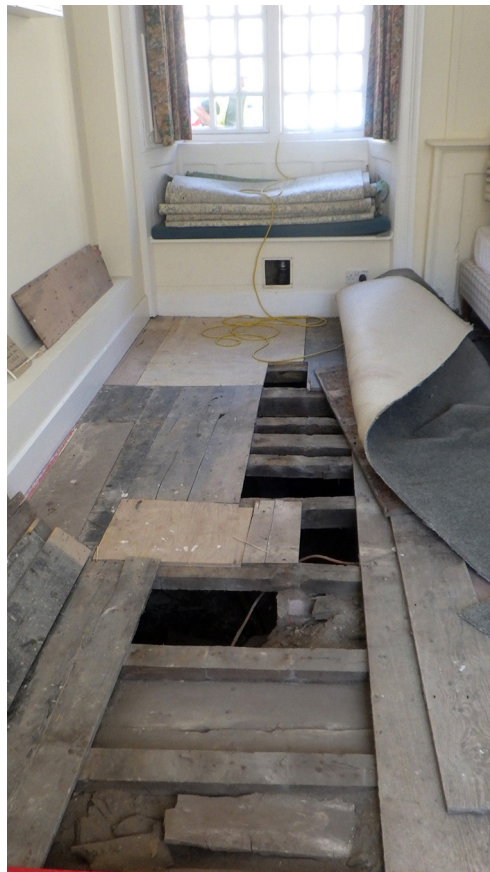
Plate 9: Floor 16 and basement structure 19, internal, view to east

3.5.1 Between Trenches 1 and 2, within the western range of the quad, an area of the current floor was lifted, revealing an earlier phase of floor joists and floorboards (16) above the void of the basement, 19 (Figs 2 and 6), and an earlier mortar-rich deposit (18). The boards were overlain by a thin brownish-grey dusty rubble layer (17) containing pottery dating from 1750-1900.
