# Beech Court, Abingdon School, Abingdon, Oxfordshire

## Watching Brief Report

OA Reference No: 6429

### *Archaeological Watching Brief Report*

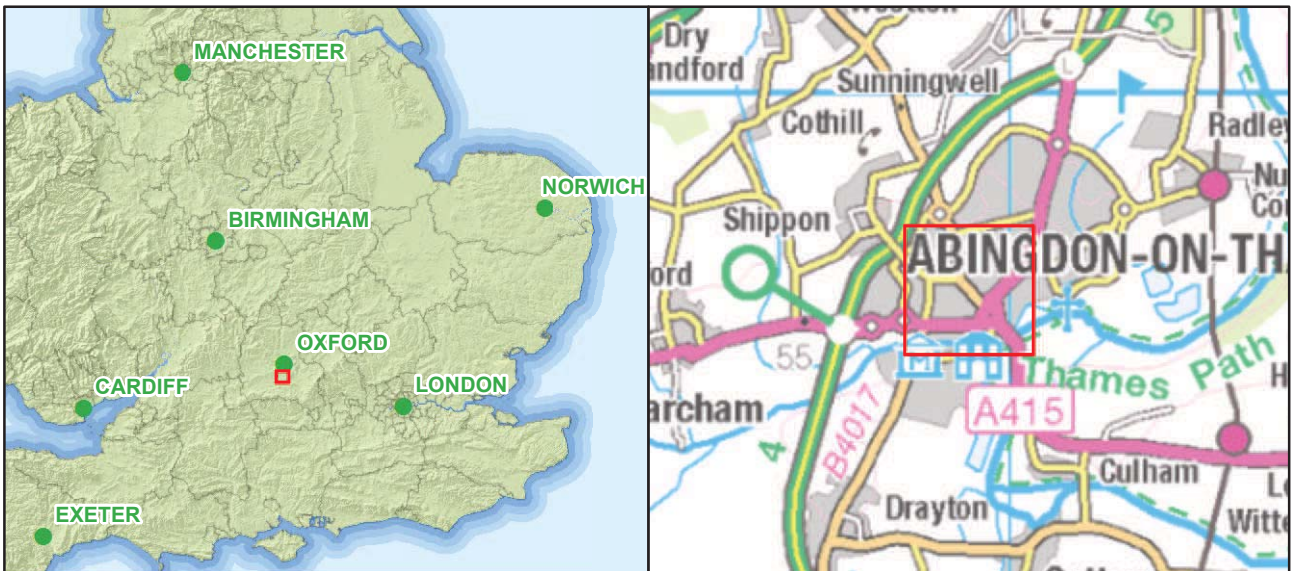
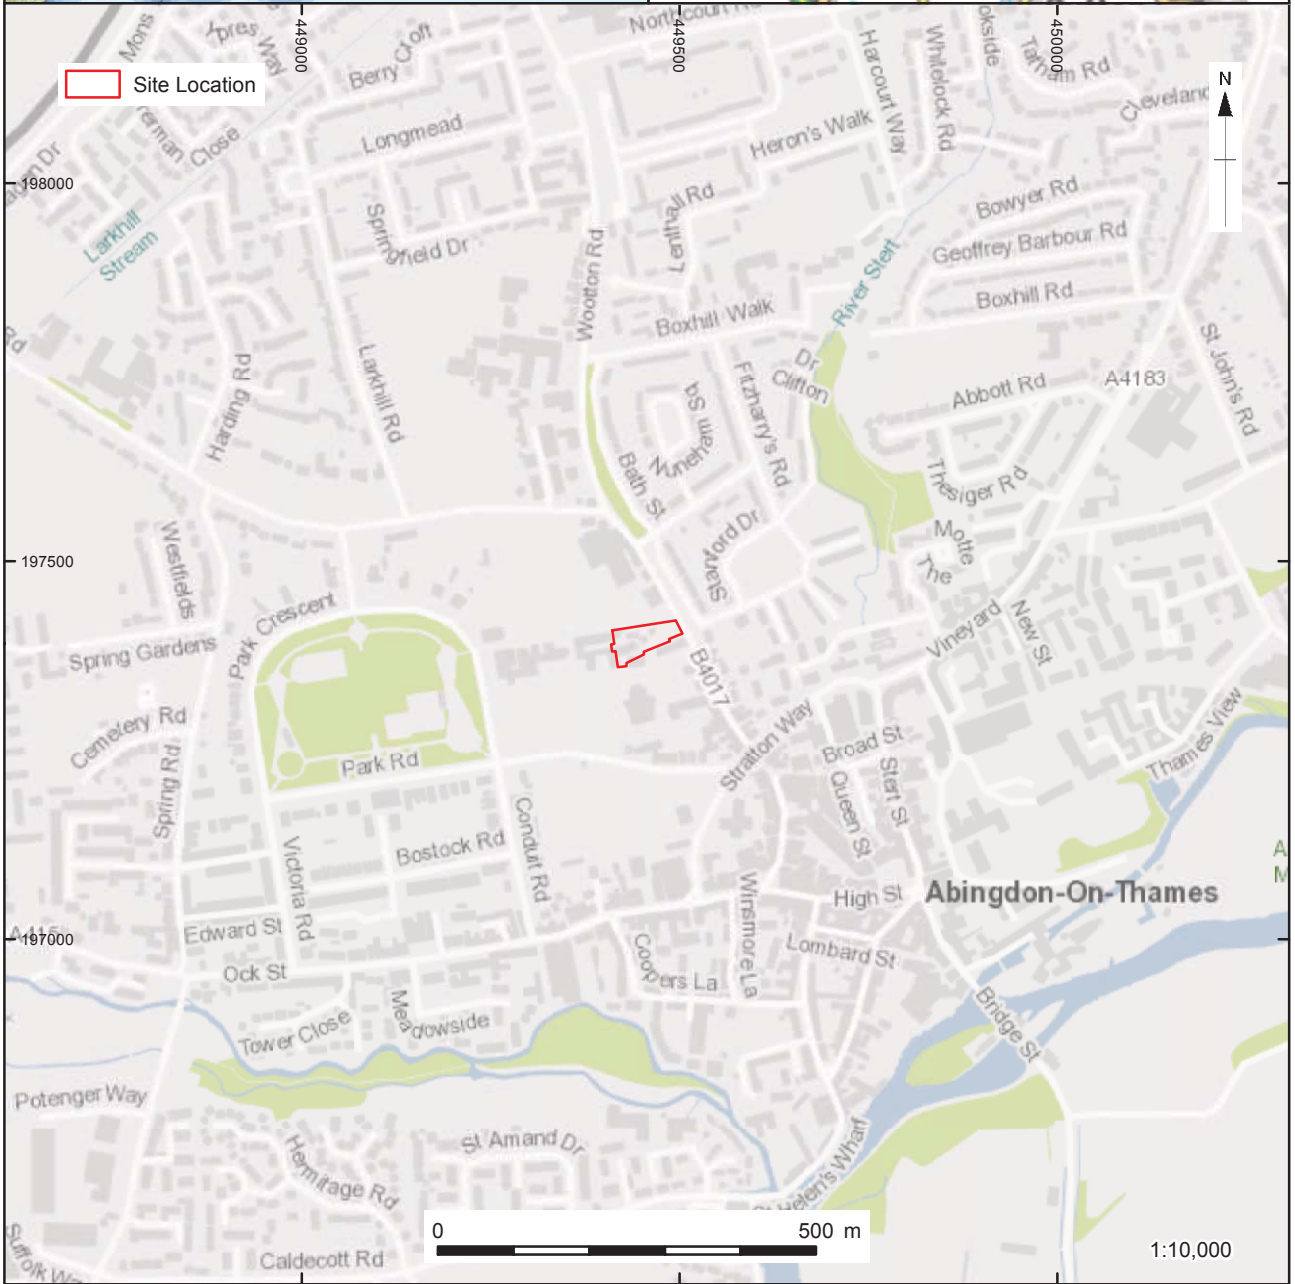
Figure 1: Site location

- 1.2.1 The development site is located on the north side of Abingdon, within the grounds of Abingdon School, west of Bath Street and east of the main school buildings (Fig. 1). It is immediately south of Roysse's Alley between Waste Court to the north and Lacies Court to the south (NGR SU4935 9739). The site is located within a Conservation Area.
- 1.2.2 The geology consists of superficial sand and gravel overlying Kimmeridge Clay.
- 1.2.3 The site lies at approximately 60m aOD, sloping slightly downwards to the south. It comprised a parking area surfaced with tarmac, a garden with composting plots surrounded by gravel paths to the east, small grassed areas and scattered trees. The Larkhill Stream lies about 750m west of the site.

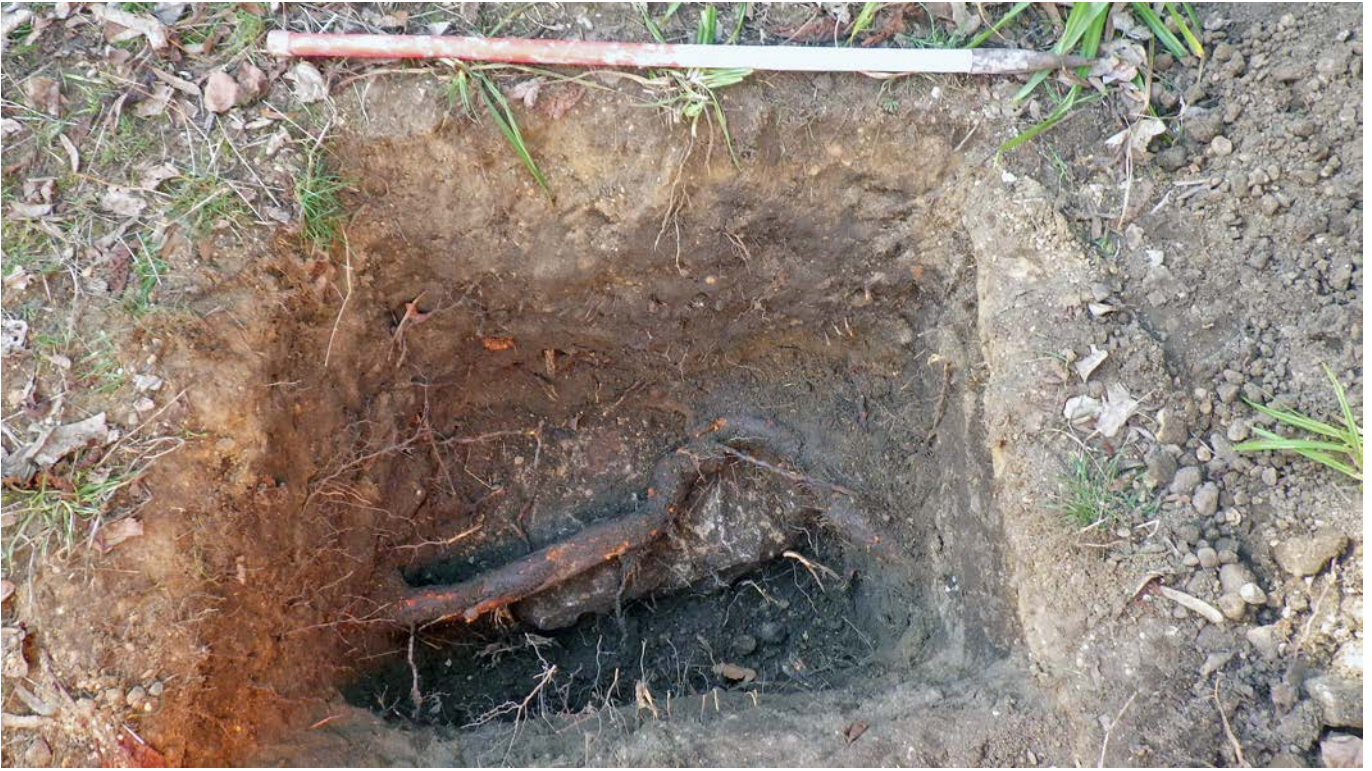
Plate 1: Test Pit 12, showing wall 132, looking west

- 5.1.10 The stone structure found in TP 12 and in Areas 6 and 7 proved to consist of two stone piers in Areas 6 and 7, and either a wall or another pier in TP 12, spaced at intervals of 3.5m (or 11' 8") centre to centre. Excavation of Area 5 to the south did not find a continuation of these piers, and subsequent monitoring of the excavation of the footprint of the new building confirmed this. This structure therefore appears to have ended, or changed direction, in Area 7.

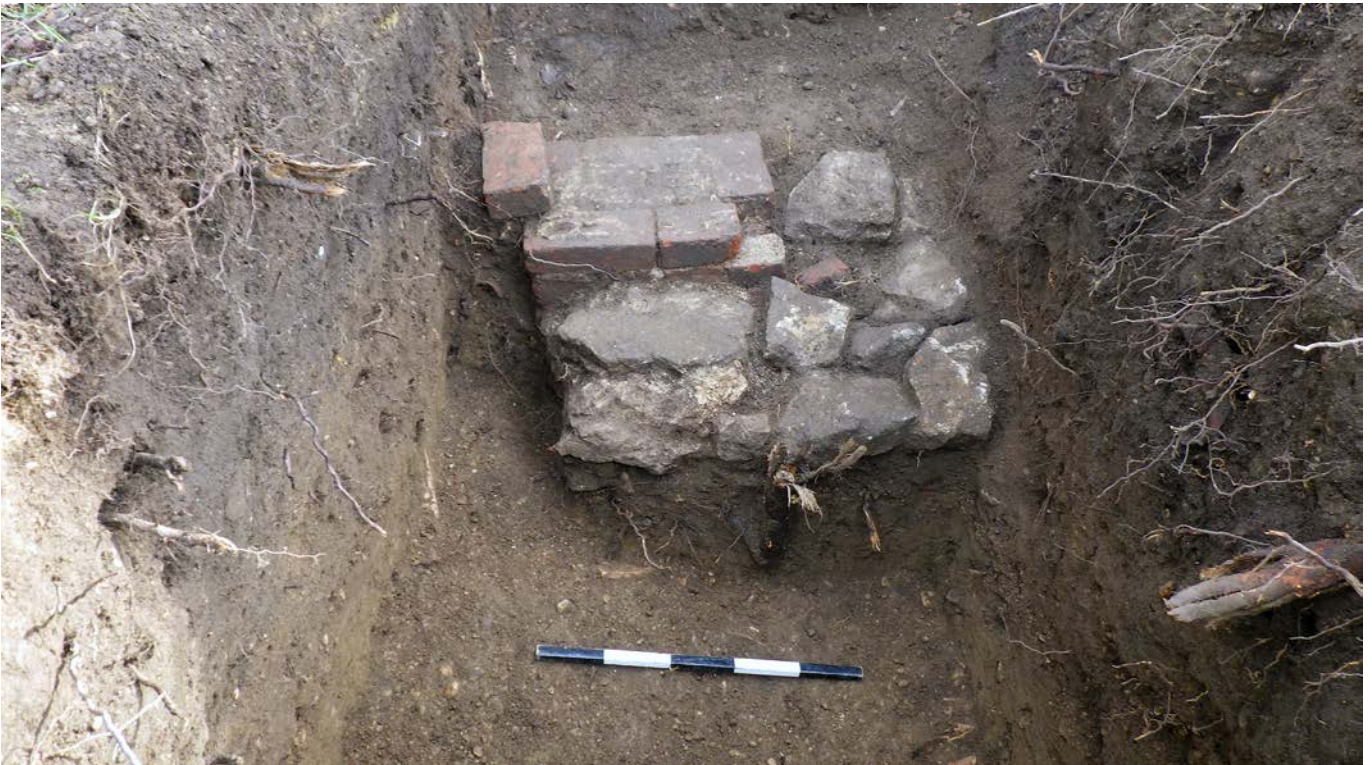
Plate 2: Area 6, stone pier 1025 and brick pier 1024, looking east

- 5.1.12 The stone structure in Area 6 was itself overlain by a brick pier. This was offset from the stone pier beneath it, so it is unlikely that the stone piers were simply foundations for a brick superstructure. Two separate phases of structure therefore seem probable. The bricks of the brick pier were unfrogged and only 60mm thick, but were probably machine-made, and so must date to the mid-19th century or later. No structure was evident on the 1st Edition Ordnance Survey map of 1872, however, so the brick pier must have been constructed before this, in the mid-19th century. The date of the stone structure is therefore probably later 18th or early 19th century. Only traces of one brick pier were found, so this may have been a repair rather than a complete rebuilding.

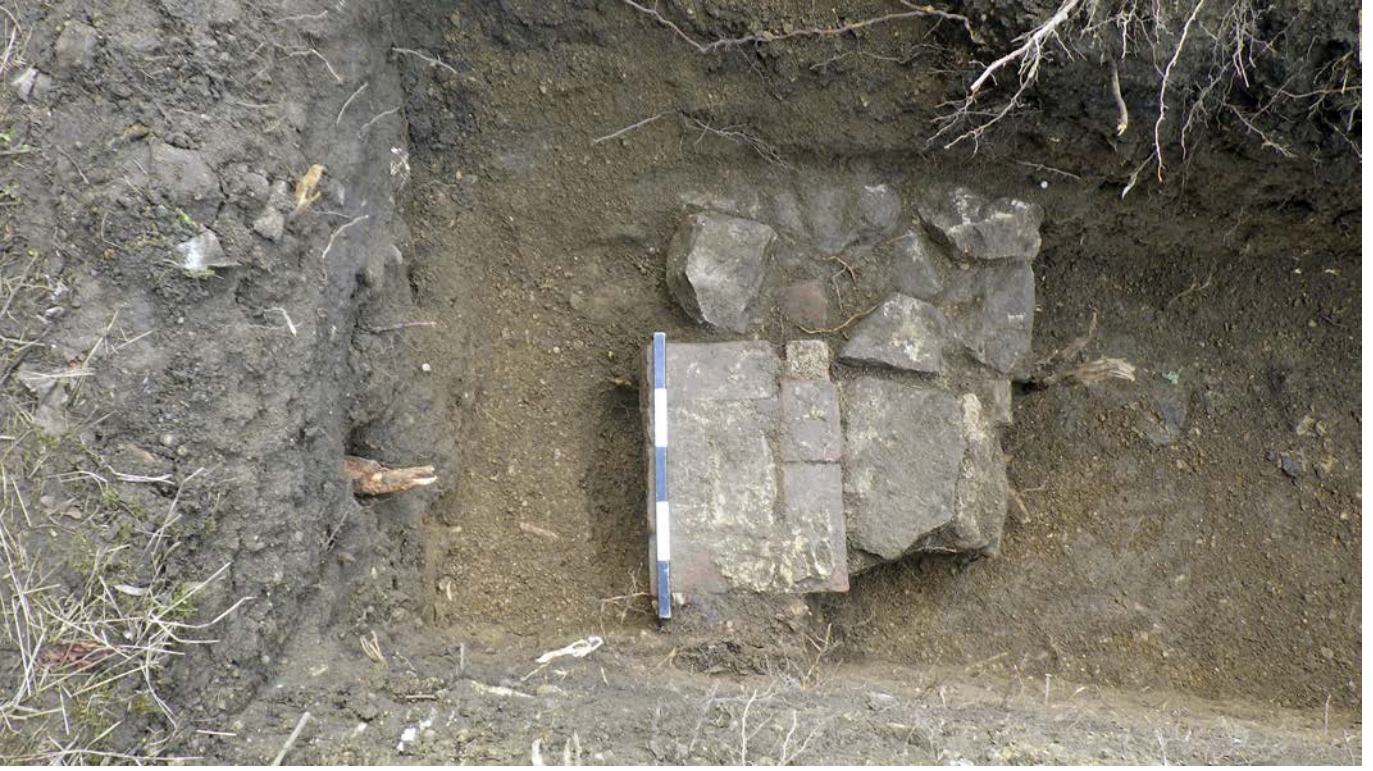
Plate 3: Area 6, stone and brick piers, from above looking south

- 3.3.7 The pier was constructed as a hollow 'box' consisting of 19th century, unfrosted red bricks bound by a light buff sandy mortar (Fig. 3; Plates 3 and 4). The 'box' was then infilled with mortar and possibly rubble. The remainder of construction cut 1041 was filled with deliberate backfill, 1042.

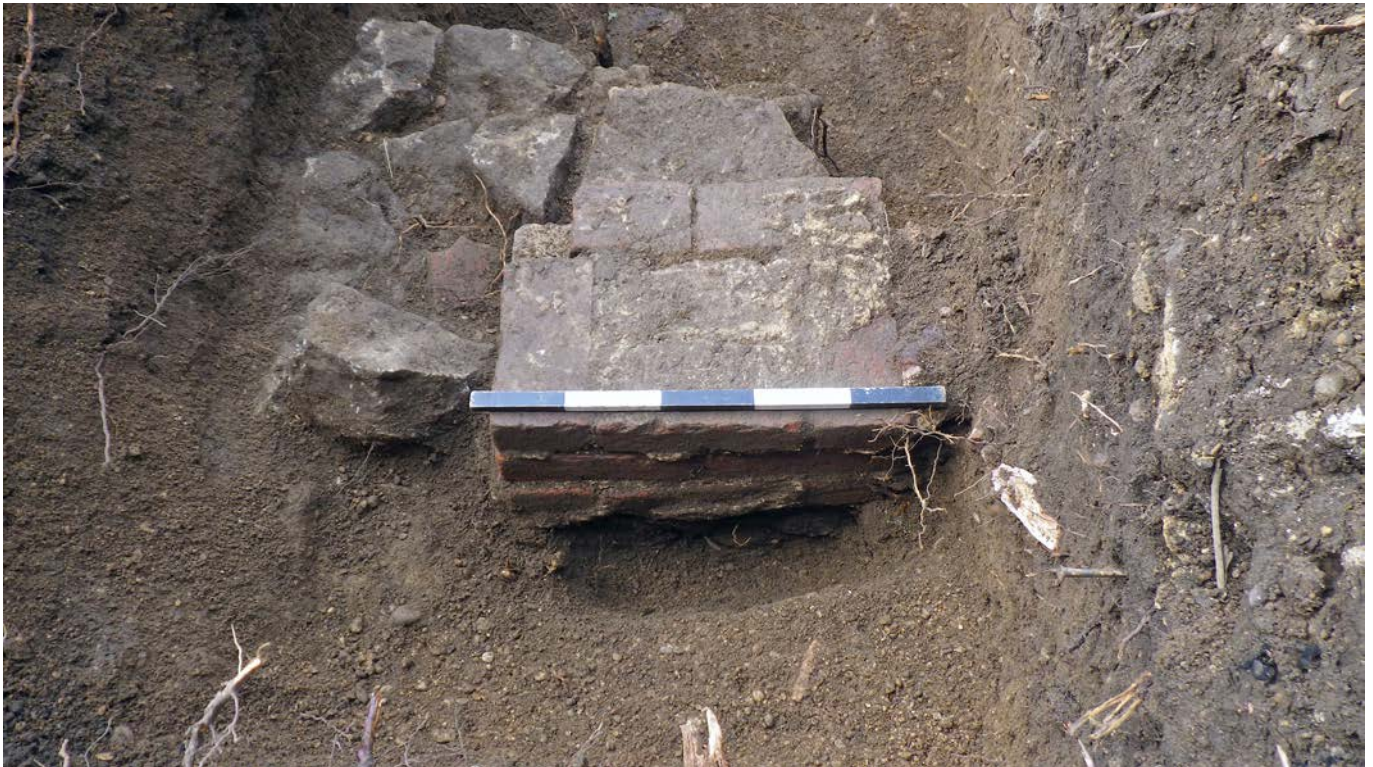
Plate 4: Area 6, brick pier 1024 detail, looking west

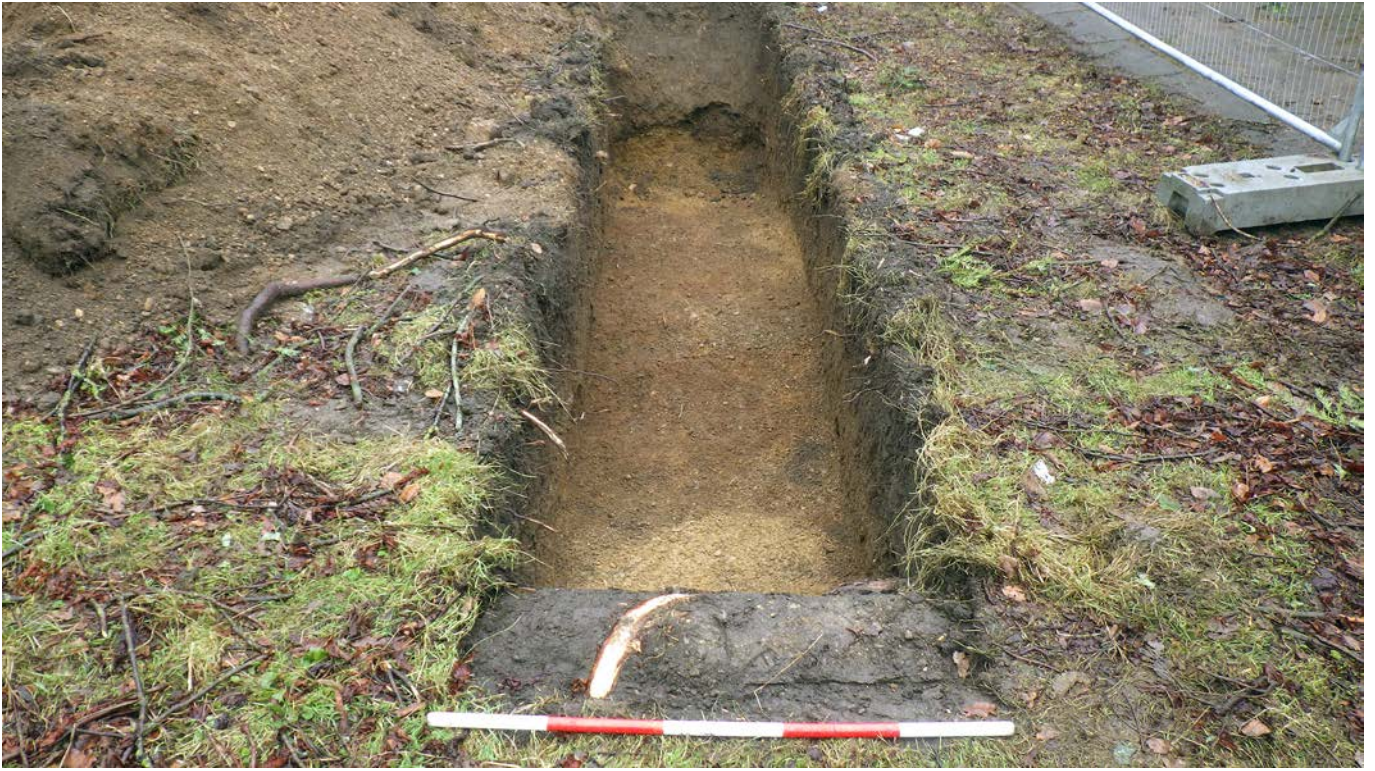
Plate 5: Area 5 with pit 1036, looking east

- 3.3.10 Natural gravel 1035 was observed at the base of the area, into which a large feature, 1036, and a small pit, 1038, were cut (Fig. 3; Plate 5). Only the southern part of feature 1036 lay within Area 5, and despite some irregularities on the south-east side, this appeared to be a sub-rectangular feature with rounded corners, whose long axis was on a south-west to north-east alignment. Feature 1036 was not excavated, and its visible upper fill, 1037, did not have any finds in its surface.

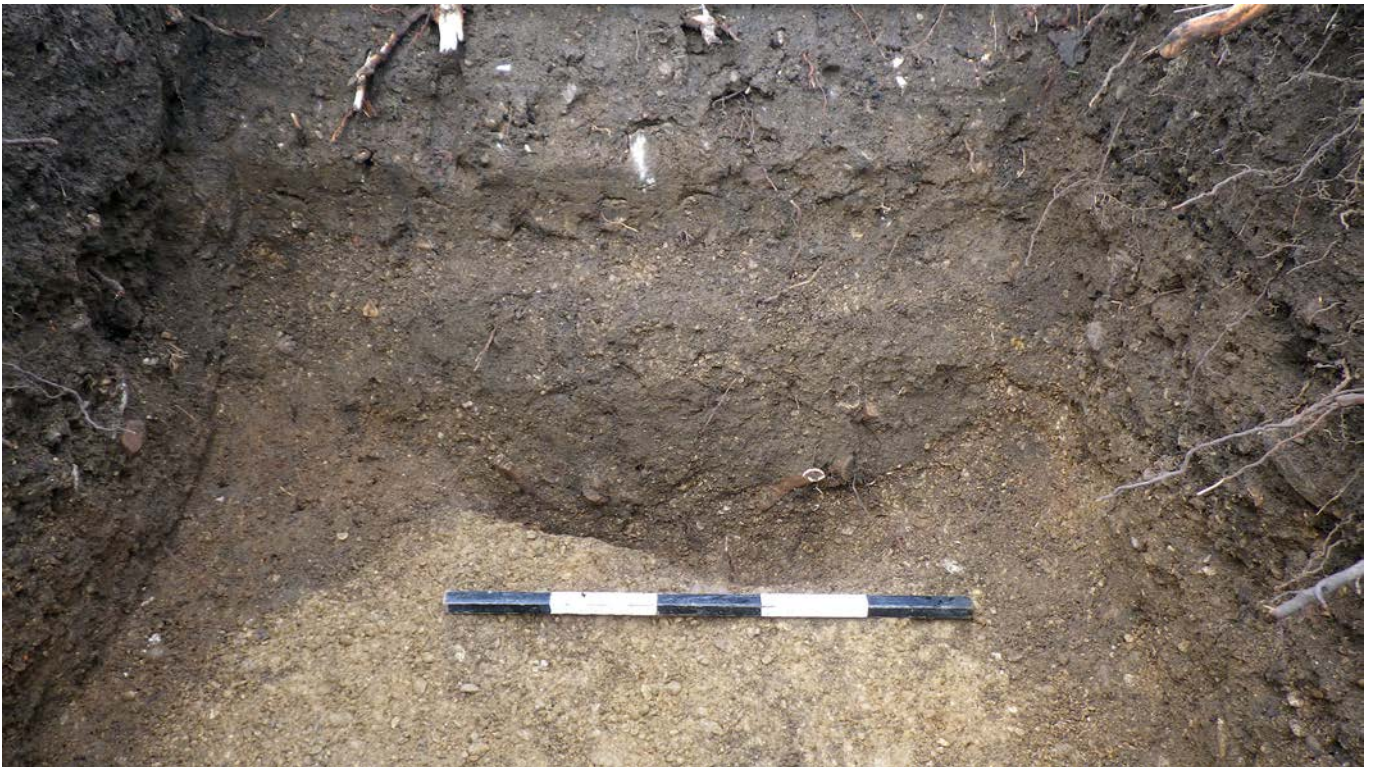
Plate 6: Area 5, pit 1038 in section, looking west

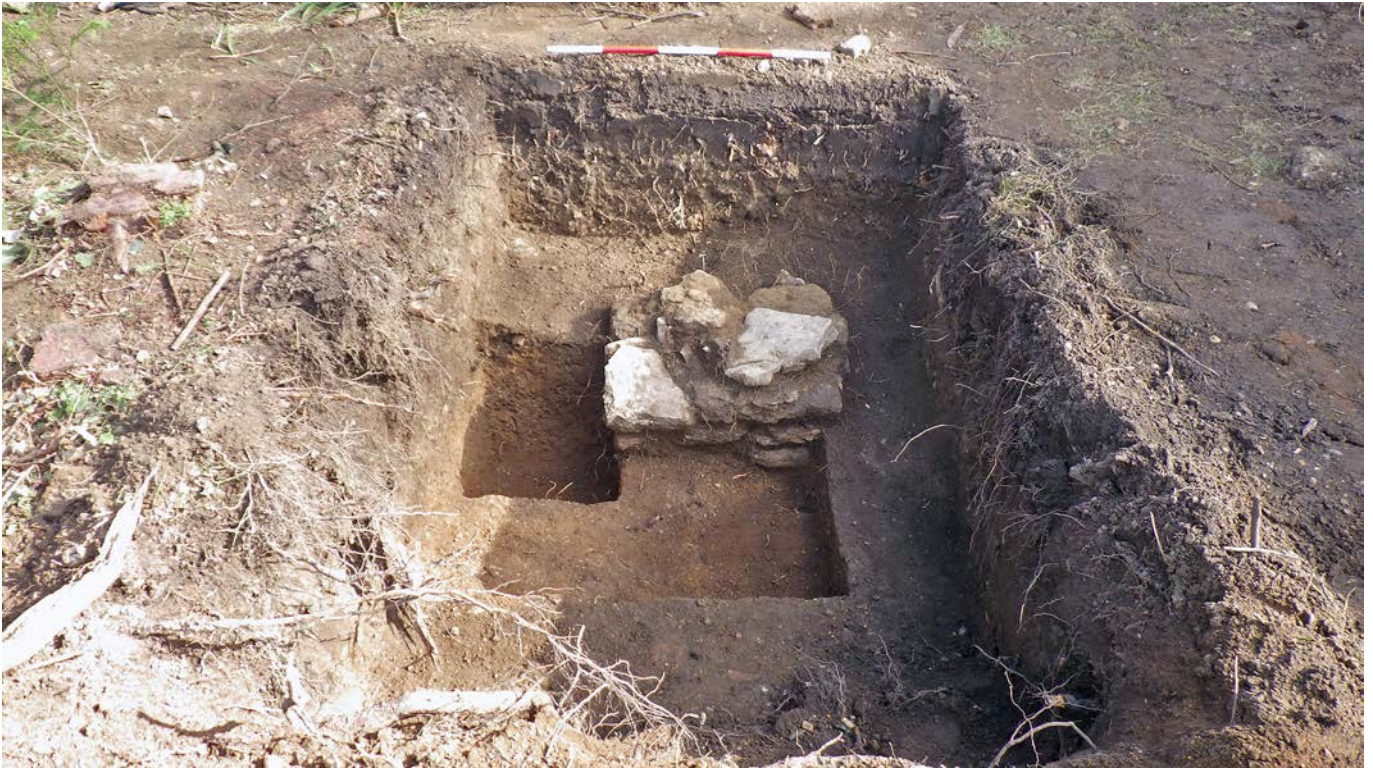
Plate 7: Area 7 excavated looking east

3.3.16 Natural gravel 1035 was observed at the base of Area 7, into which the northern corner of a curving feature was cut. The fill of this was very similar to fill 1037 of feature 1036 in Area 5, and is believed to be the north end of the same feature. As in Area 5, no finds were visible on the surface of this feature, which was not excavated.

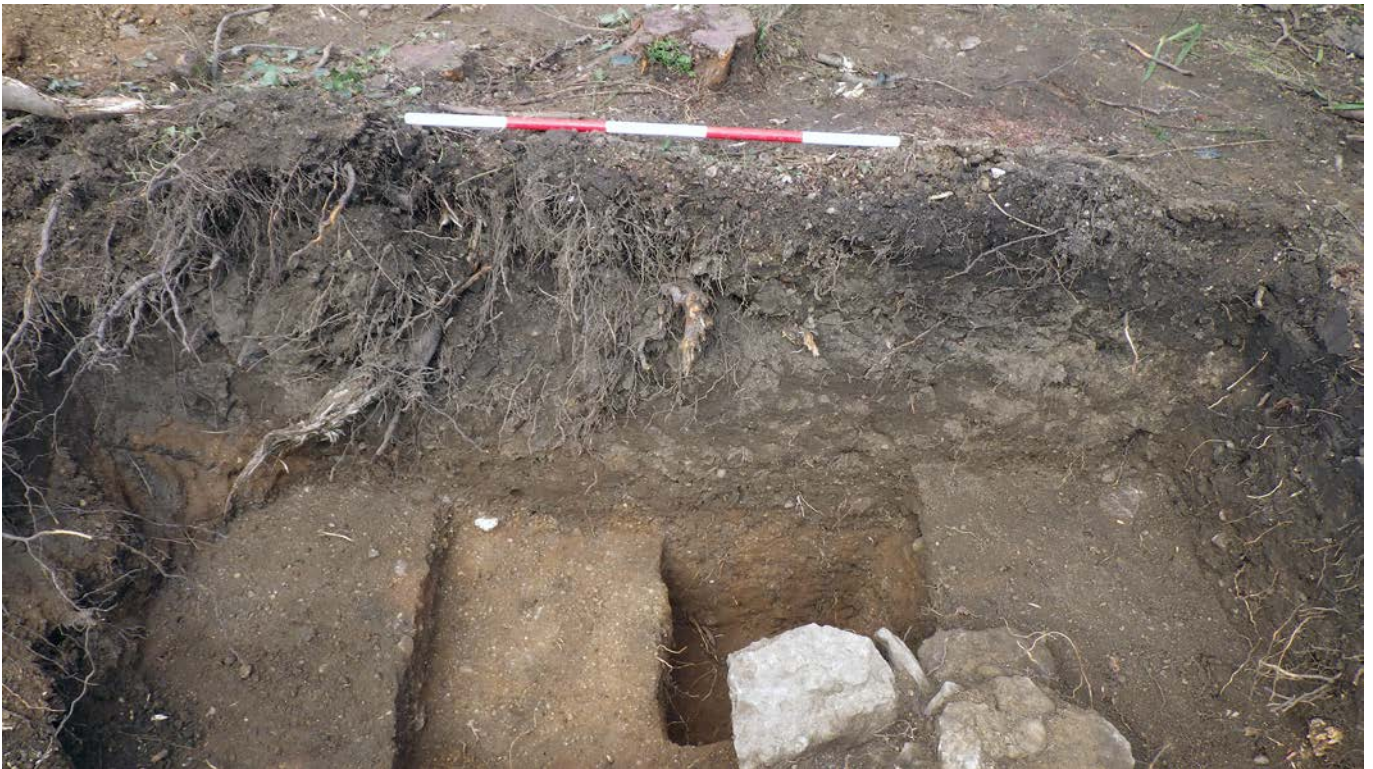
Plate 8: Area 7, cut 1042, looking north

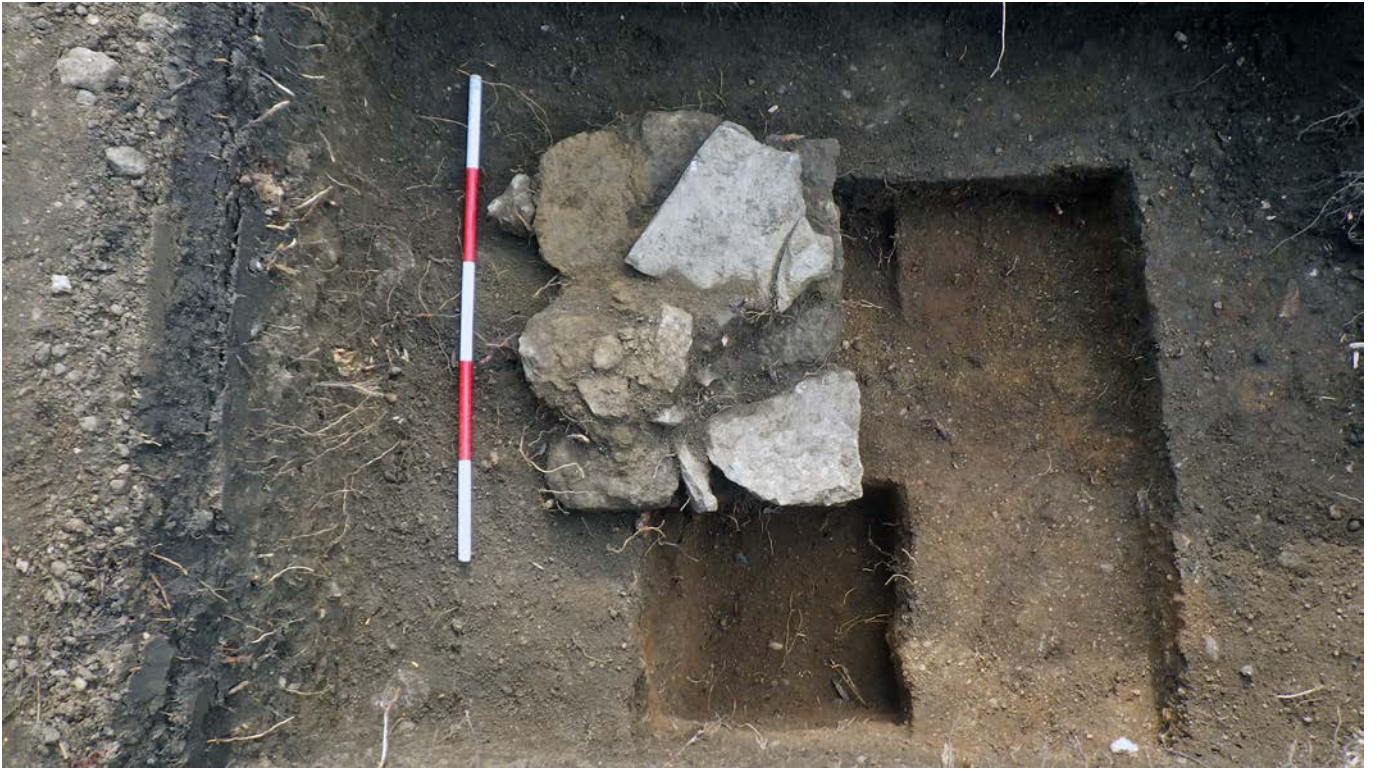
Plate 9: Area 7, stone pier 1043 from above, looking south

3.3.19 Stone pier 1043 was built on top of fill 1045 with the bottom course of stone set into both this fill and layer 1034. No construction cut was observed, and it may be that the pier was originally built on the surface of these layers, but subsequently sank into them due to its weight. Pier 1043 was rectangular, 0.8m north–south and 0.63m east–west, and consisted of three courses of roughly-hewn limestones bound by a mid-orange brown, sandy mortar (Fig. 4, section 26; Plates 9 and 10). The top of stone pier was found at a height of 57.54m aOD.

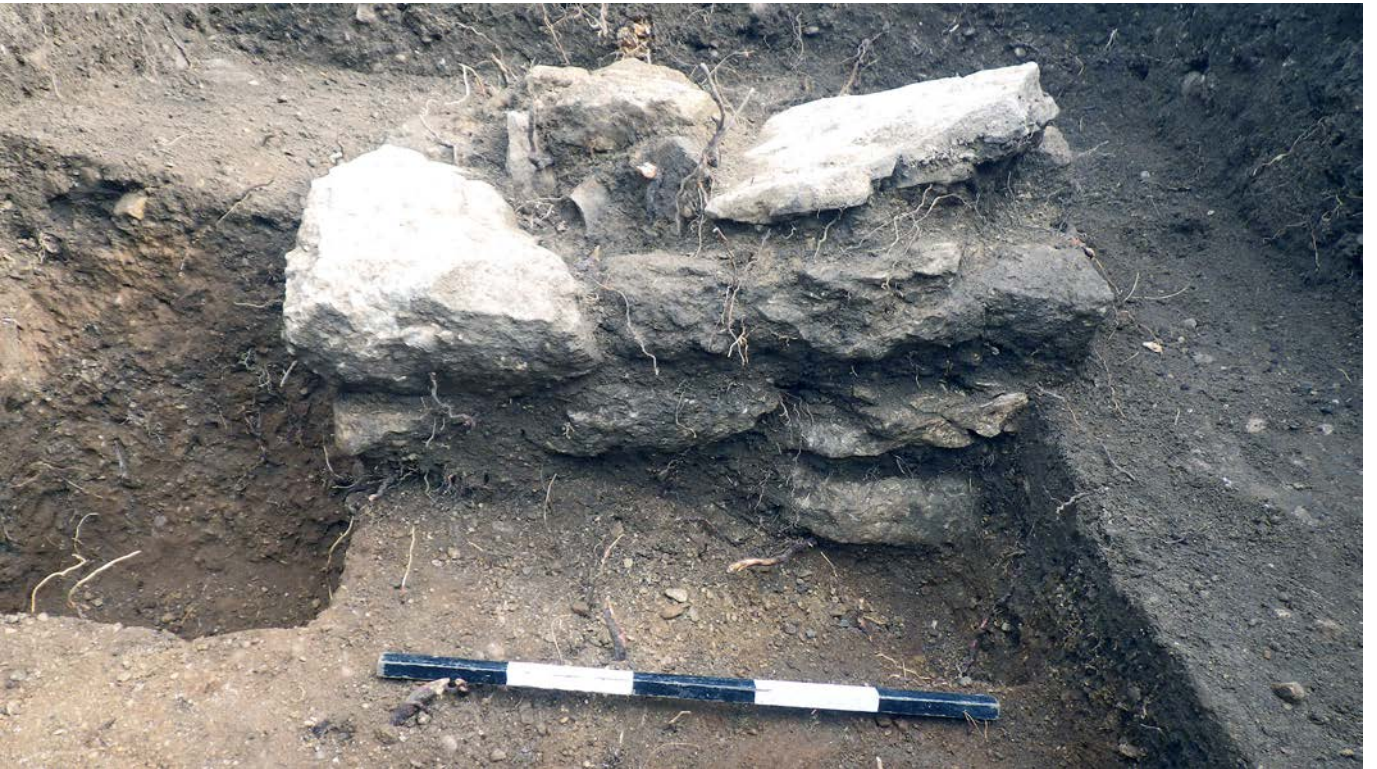
Plate 10: Area 7, stone pier 1043 detail, looking east

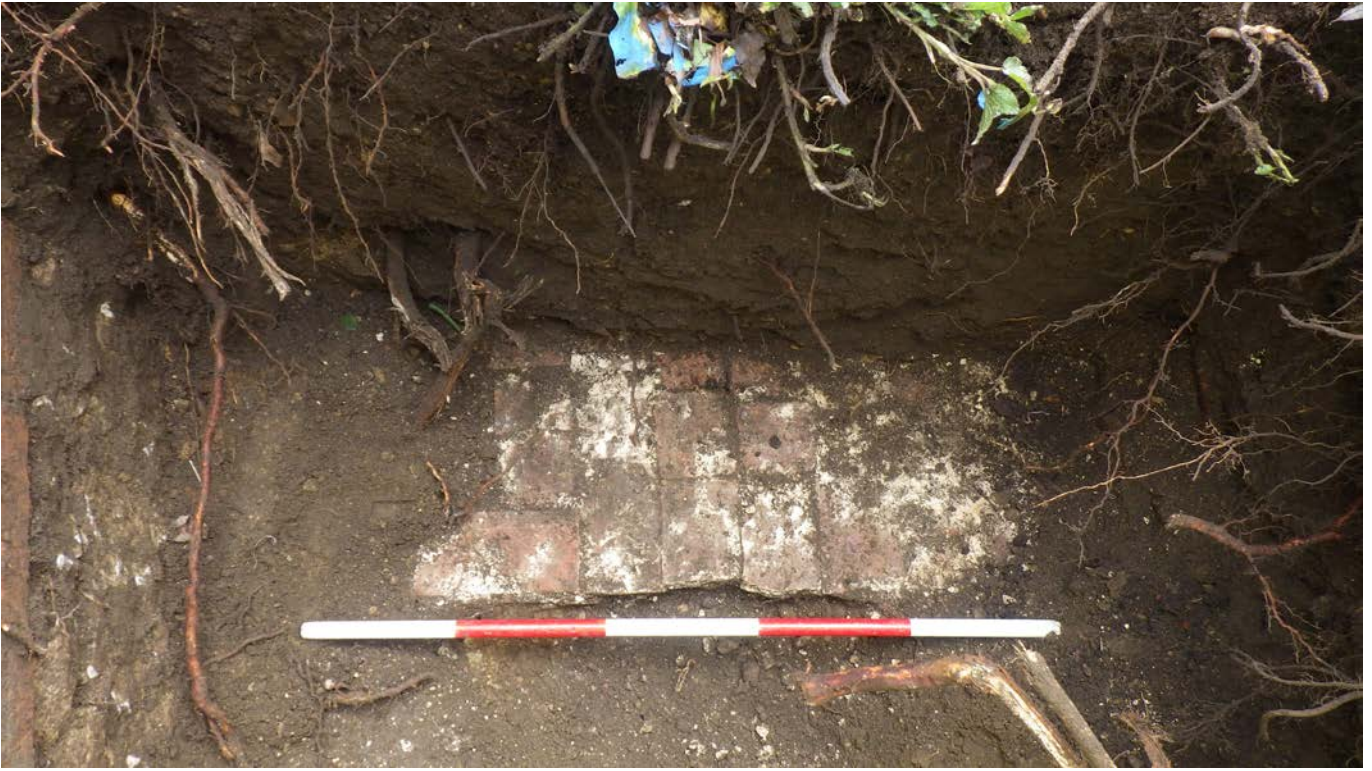
Plate 11: Area 1: brick surface 1002, looking south

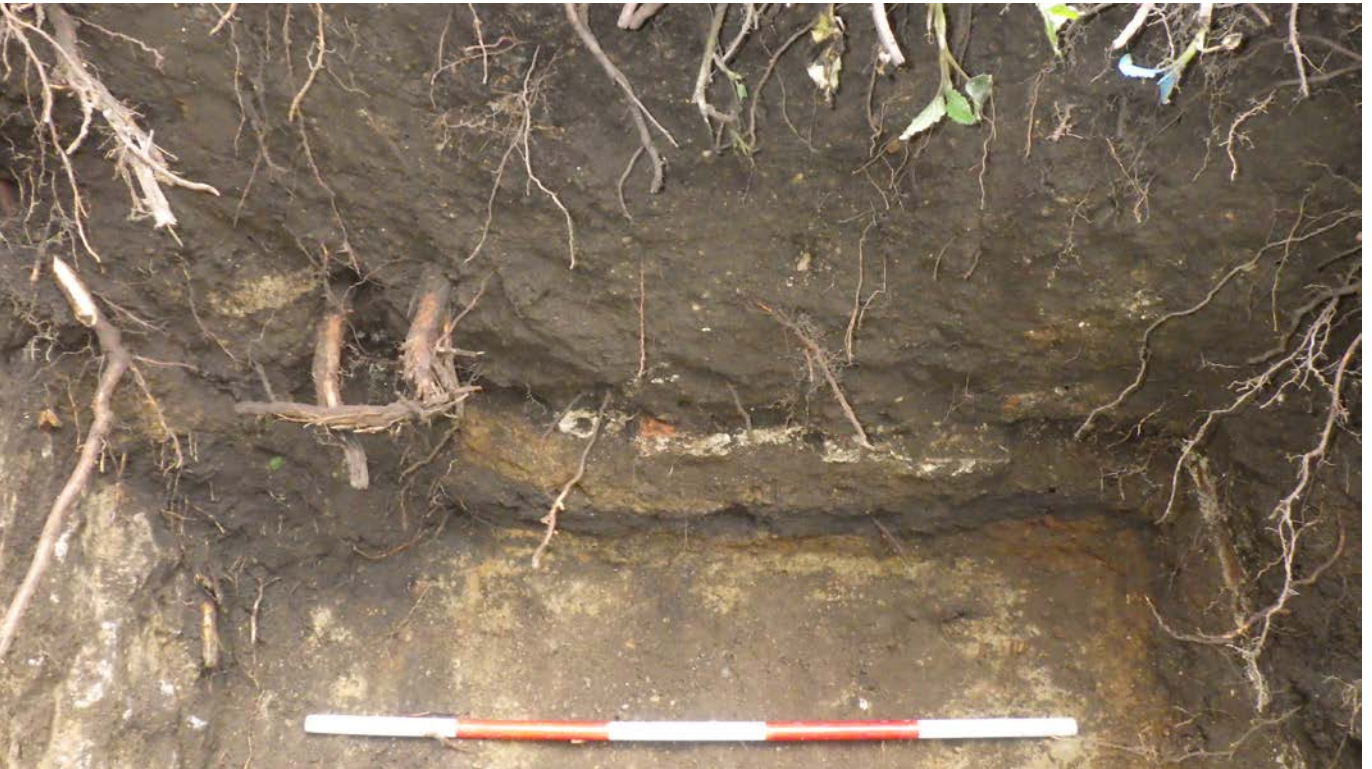
Plate 12: Area 1 fully excavated: south section, looking south

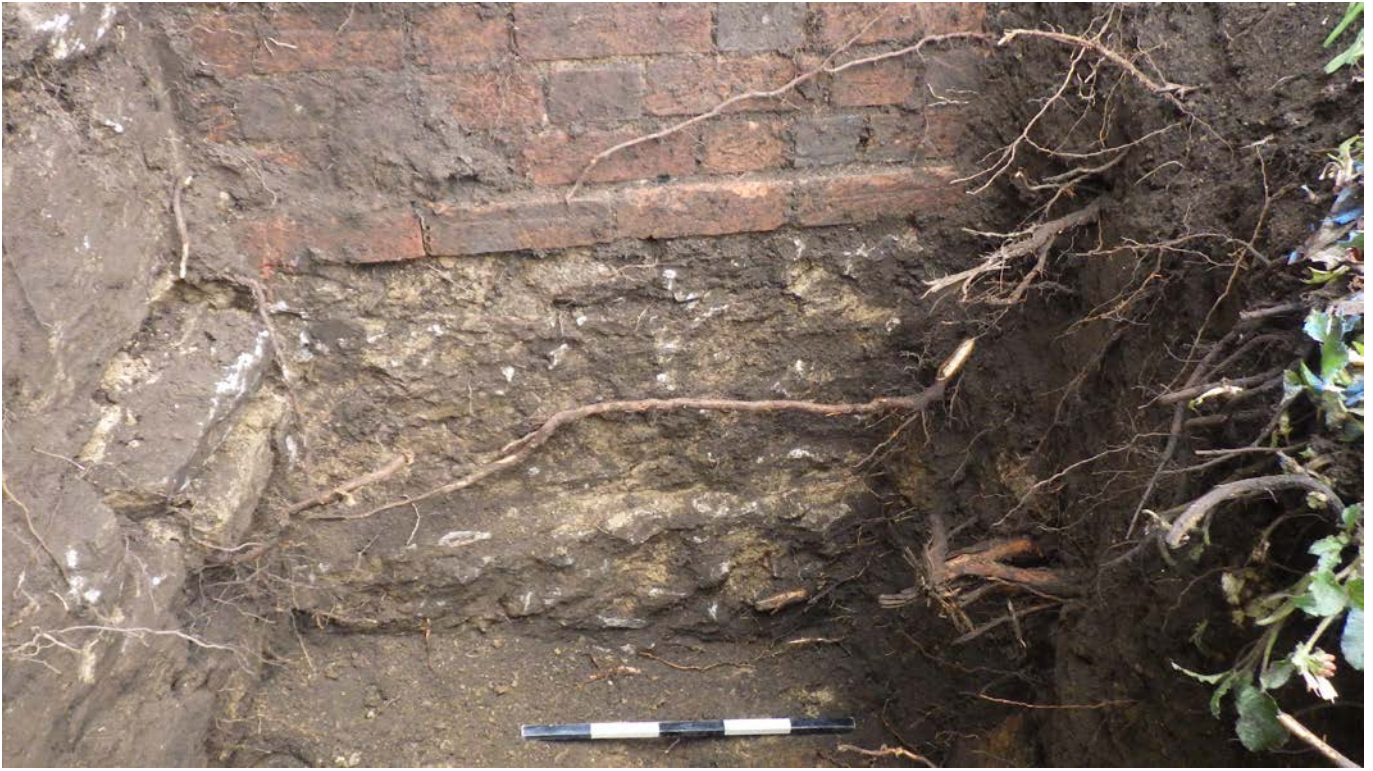
Plate 13: Area 1: east stone and brick wall, looking east

- 3.4.5 The brick surface was cut by foundation cut 1009 on the east, which had a flat base and vertical west side, and was 0.4m wide and 0.3m deep (Fig. 5). It bottomed on layer 1007, and severed any relationship between layers 1002-1006 with the walls on the east and the north (Plate 12). It was filled with 1008, a loose dark brownish-grey clay sandy silt with occasional well-sorted gravel. Removal of the fill revealed that the wall had been built in at least three stages. The earliest phase exposed was a wall of undressed limestones (up to 150mm across) in rough courses, bonded with a coarse cream mortar. The section indicated that the wall was not bottomed, continuing down below the base of foundation trench 109 and the base of the excavation, though this is not clear from the photographs (Plate 13).

- 5.1.13 In the eastern part of the site, the eastern boundary wall is likely to have been of at least two periods. The lower, stone, wall, while coarsely made, was exposed to a depth of 0.9m, and apparently continued down below the bottom of Areas 1 and 2. If so, then this is a very deep foundation for a boundary wall, and the fact that it was mortared throughout its depth makes it less likely that this was simply the stone foundation for the overlying brick wall. An earlier boundary than the late 19th century must have existed, but its date and dimensions were not able to be established within the scope of the watching brief work.

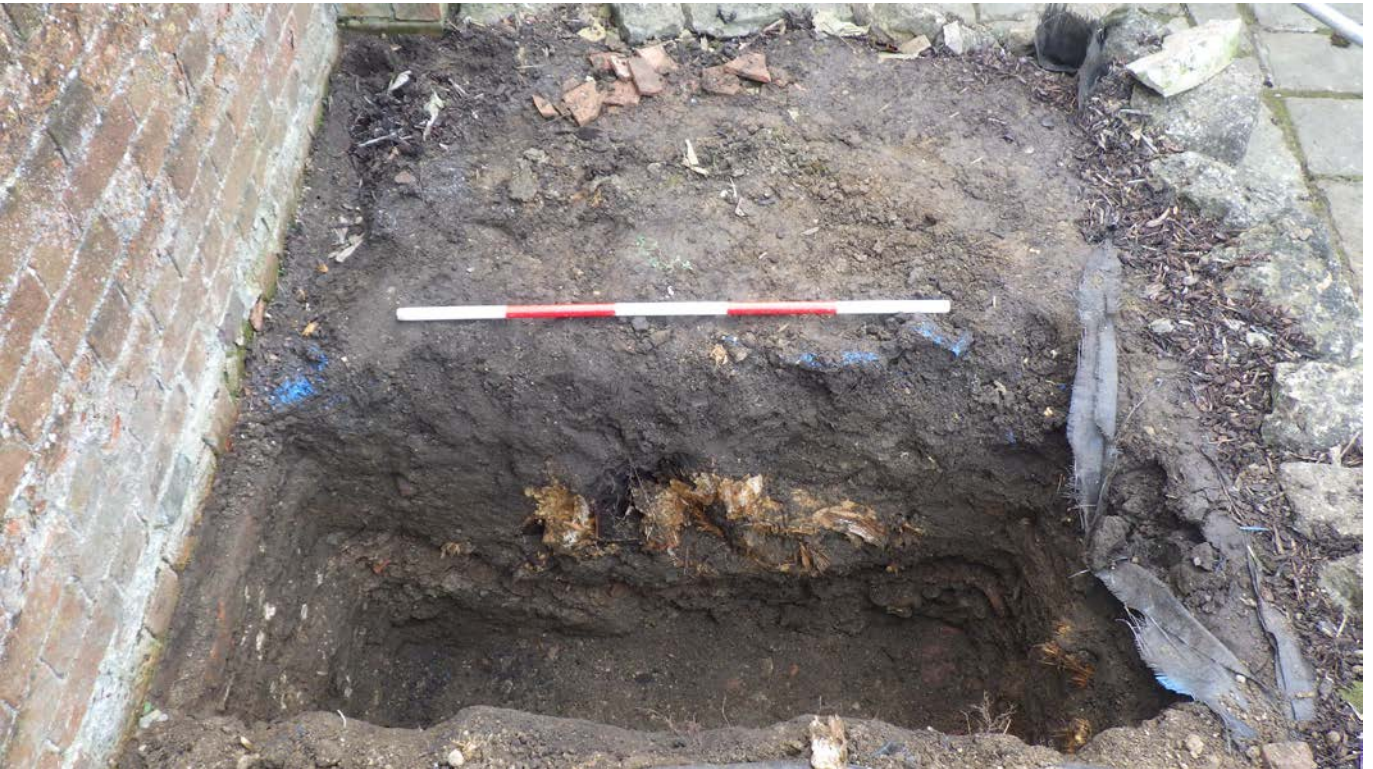
Plate 14: Area 2, looking south

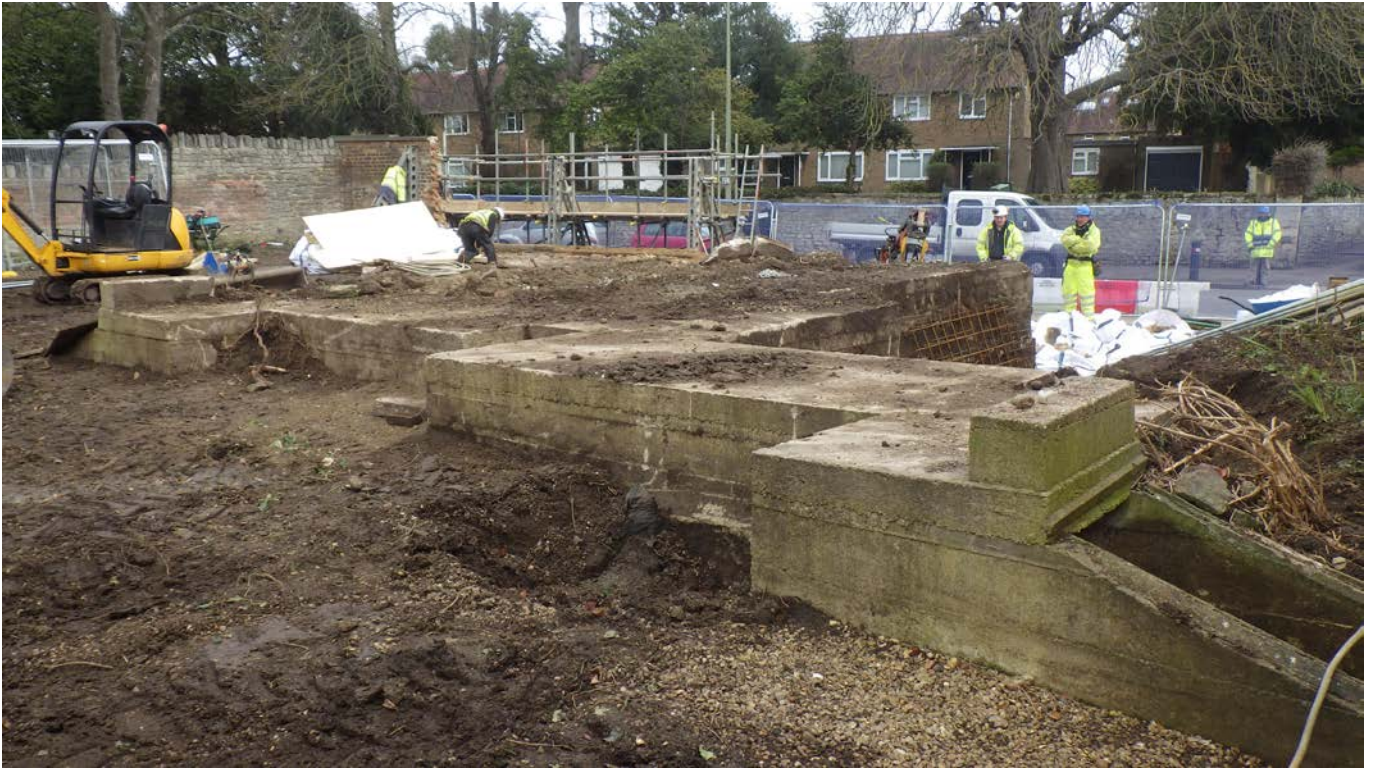
Plate 15: Air-raid shelter exposed before demolition, looking north-east

- 3.4.22 Over this was layer 1015, a modern deposit surrounding the air-raid shelter adjacent to Bath street. This layer, which was a loose brownish-grey sandy silt with occasional small stones, contained iron, wood, plastic, and other detritus, and covered an area of 2.6m by 2m and was 0.88m in depth. This was clearly the fill of a construction cut for the air-raid shelter.

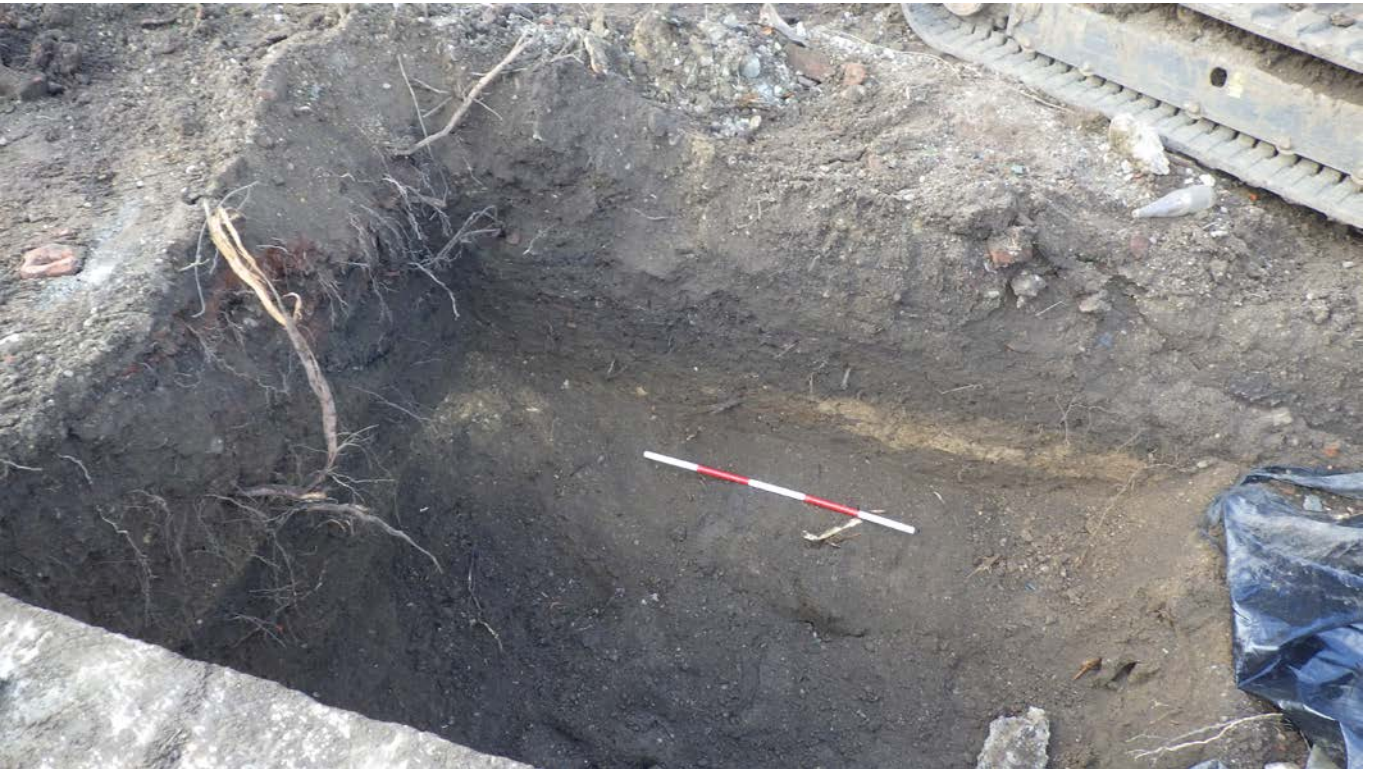
Plate 16: Area 3, section 20, looking north-west

- 3.4.18 East of the air-raid shelter a small area of surviving deposits was seen (Fig. 2 section 20; Fig. 6). Layer 1020 was the lowest deposit observed within Area 3, and within the excavated area measured 2.60m by 2m wide, but was not bottomed. This was a mix of friable, greyish-brown clay sandy silt containing 10 -15% sub-rounded to sub-angular well-sorted stones up to 40mm across, occasional pea gravel and infrequent charcoal. There were no finds.

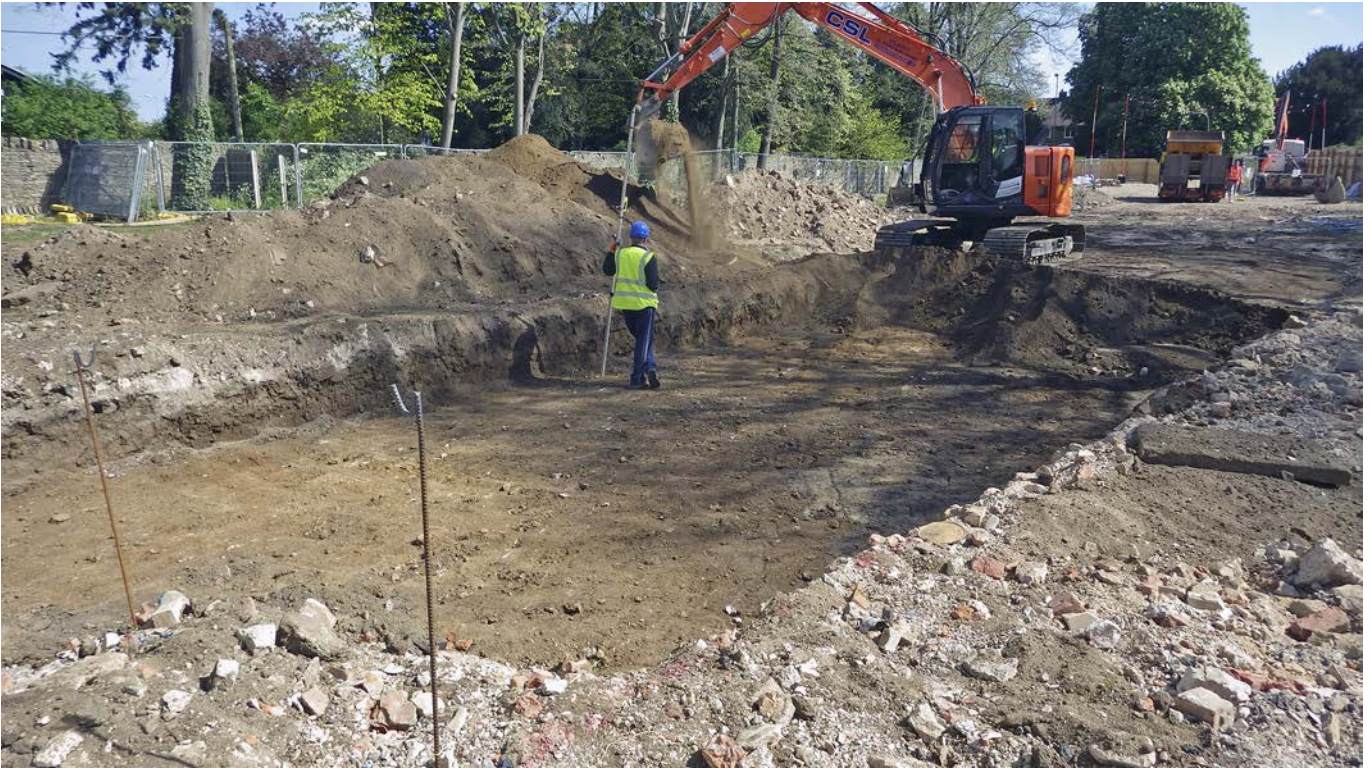
Plate 17: Stripping of the footprint of the new building, looking north-east
