# Beech Court, Abingdon School, Abingdon, Oxfordshire

## Watching Brief Report

OA Reference No: 6429

### *Archaeological Watching Brief Report*

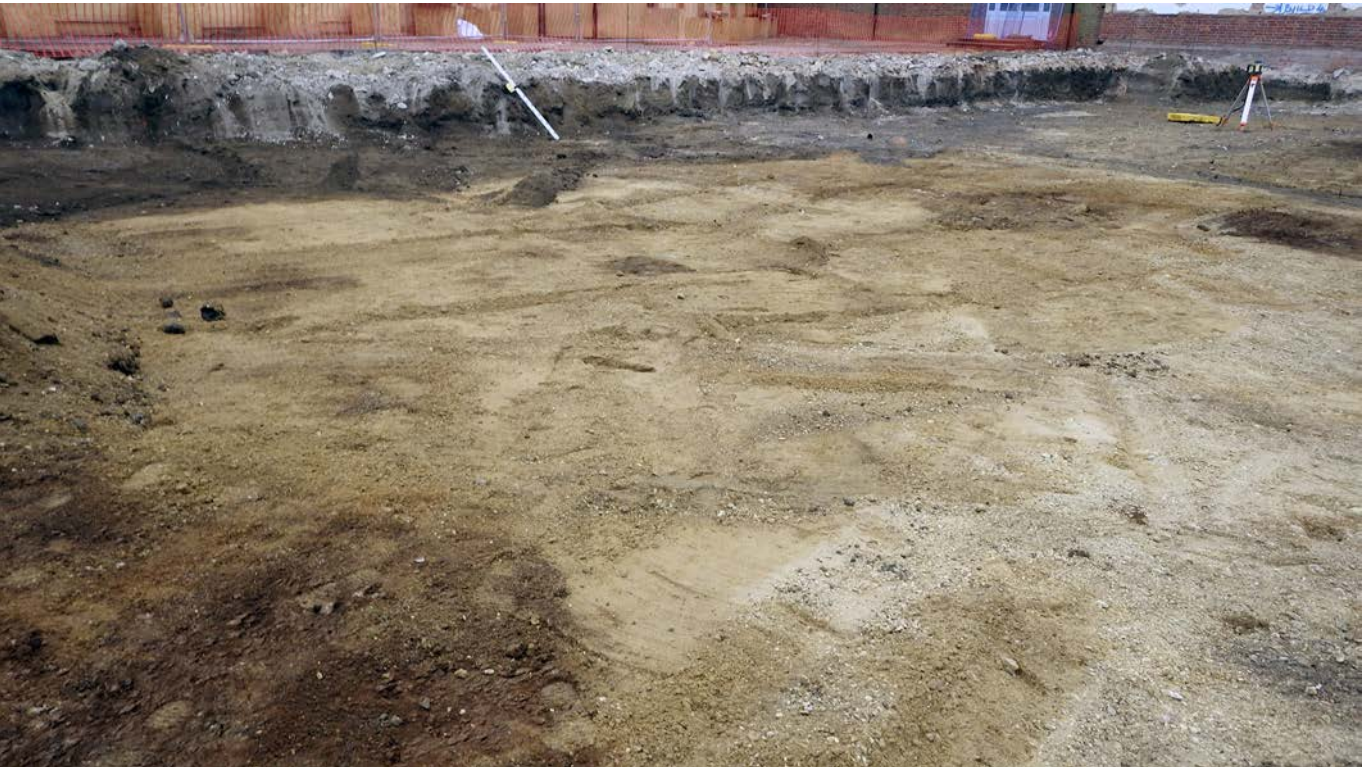
Plate 18: Footprint of new building showing quarry deposits on south side, looking south

3.3.22 Down the west, south and much of the east sides of the site, natural gravel was not reached, but gravel was found at similar depth in the centre and most of the north edge of the site (Fig. 2). The soils that were exposed in the base of the excavation on the west, south and east were of mixed character (Plate 18), suggesting that they belonged

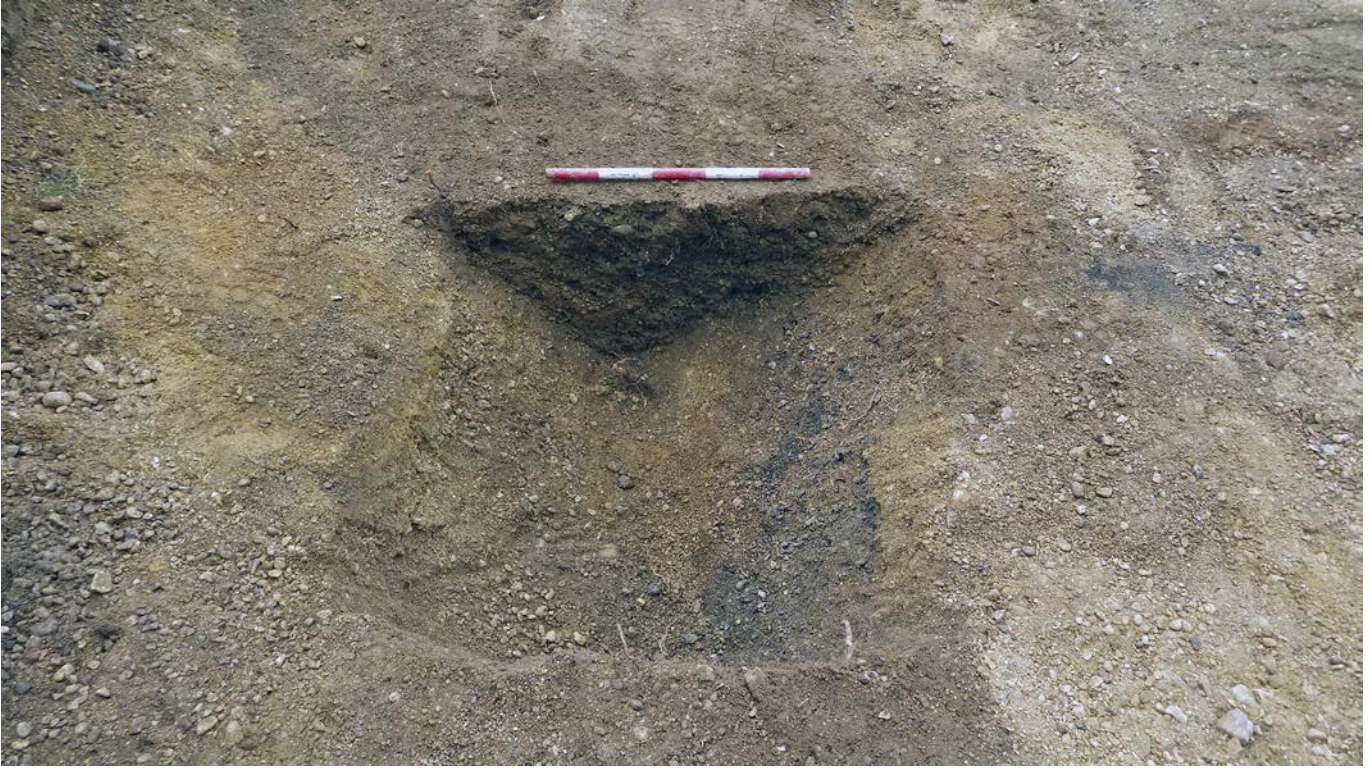
Plate 19: Ditch 1053 excavated, looking south

- 3.3.23 A north-south ditch numbered 1053 was found in the north-east corner of the area, and was excavated. This was exposed over a length of over 6m, being truncated by a quarry on the south, and continuing beyond the stripped area to the north. It was 0.9m wide and 0.4m deep, and its single fill (1054) was a yellowish-grey sandy silt with frequent gravel (Plate 19). Following hand-excavation of a length of the ditch, the remainder was emptied by machine under close archaeological supervision to look for finds, but none were found. .
- 3.3.24 One very modern square pit filled with bricks, glass and sand was found. This was not recorded.
