Tumbling Bay, Oxford

Archaeological Watching Brief Report

December 2019

Client: Environment Agency

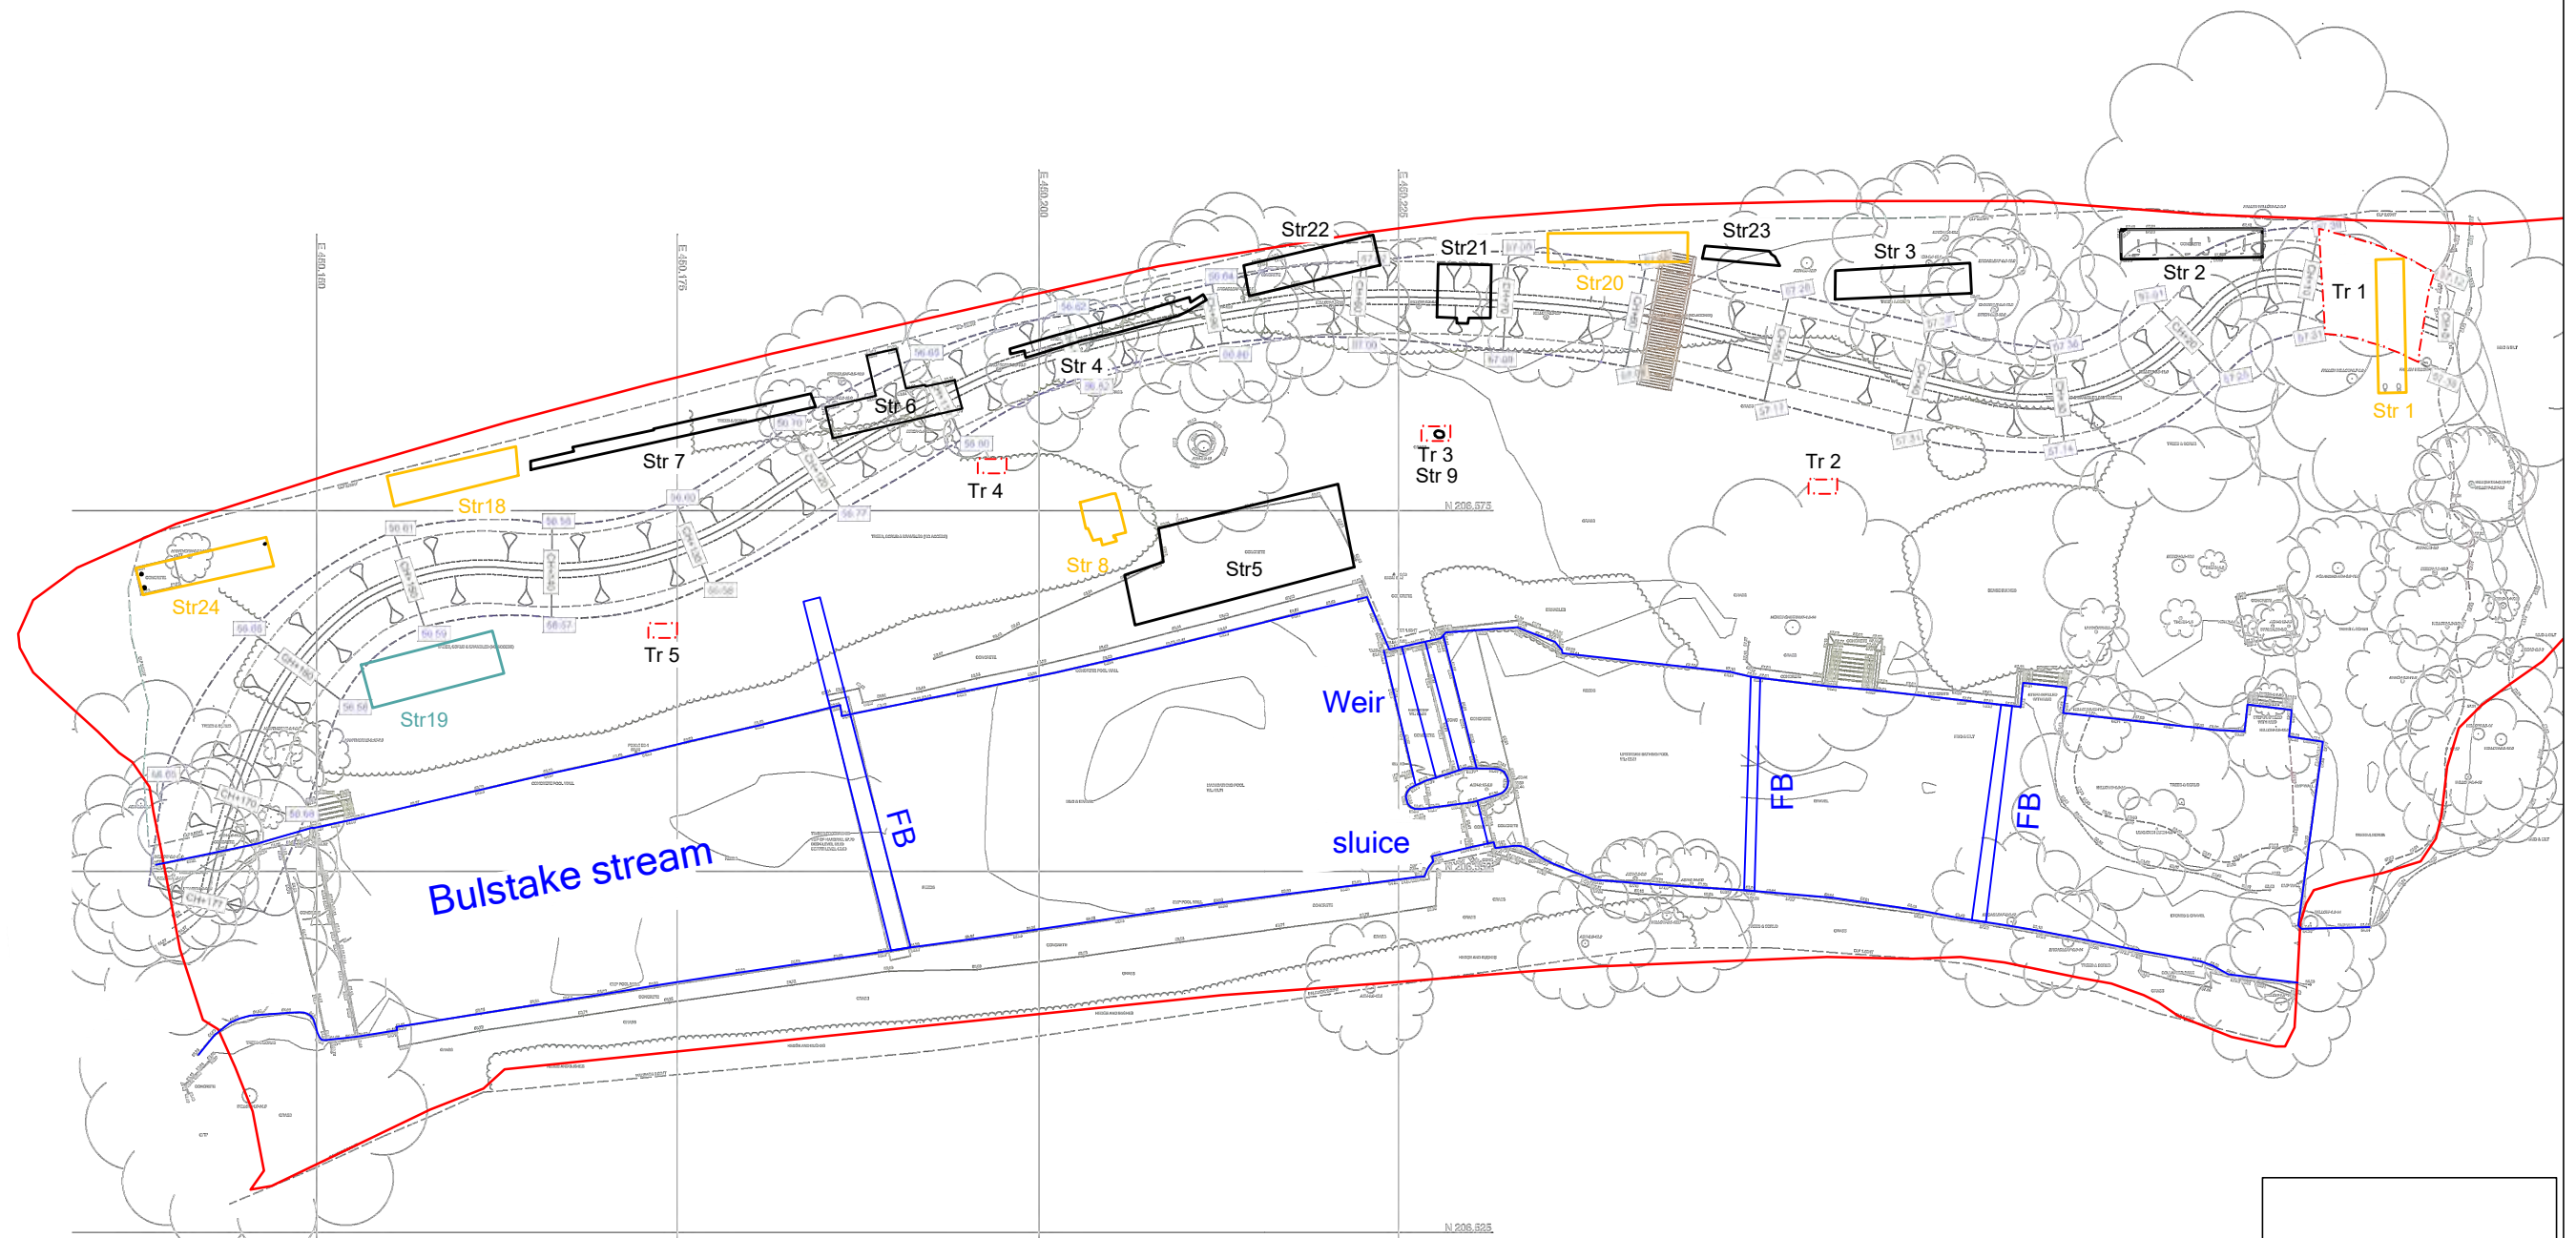
- 3.1.1 A total of 16 structures related to the Tumbling Bay bathing place were recorded at locations scattered over the site (Fig. 2).
- 3.1.2 The five trial trenches, which were excavated to a depth of 1m to 0.8m below ground level, uncovered foundation layers for the bathing facilities and buried ground levels (Fig. 2).
- 3.1.3 No other archaeological deposits or finds were found during the watching brief.
- 3.1.4 The full measurements and descriptions of structures and trenches are tabulated in Appendix A.

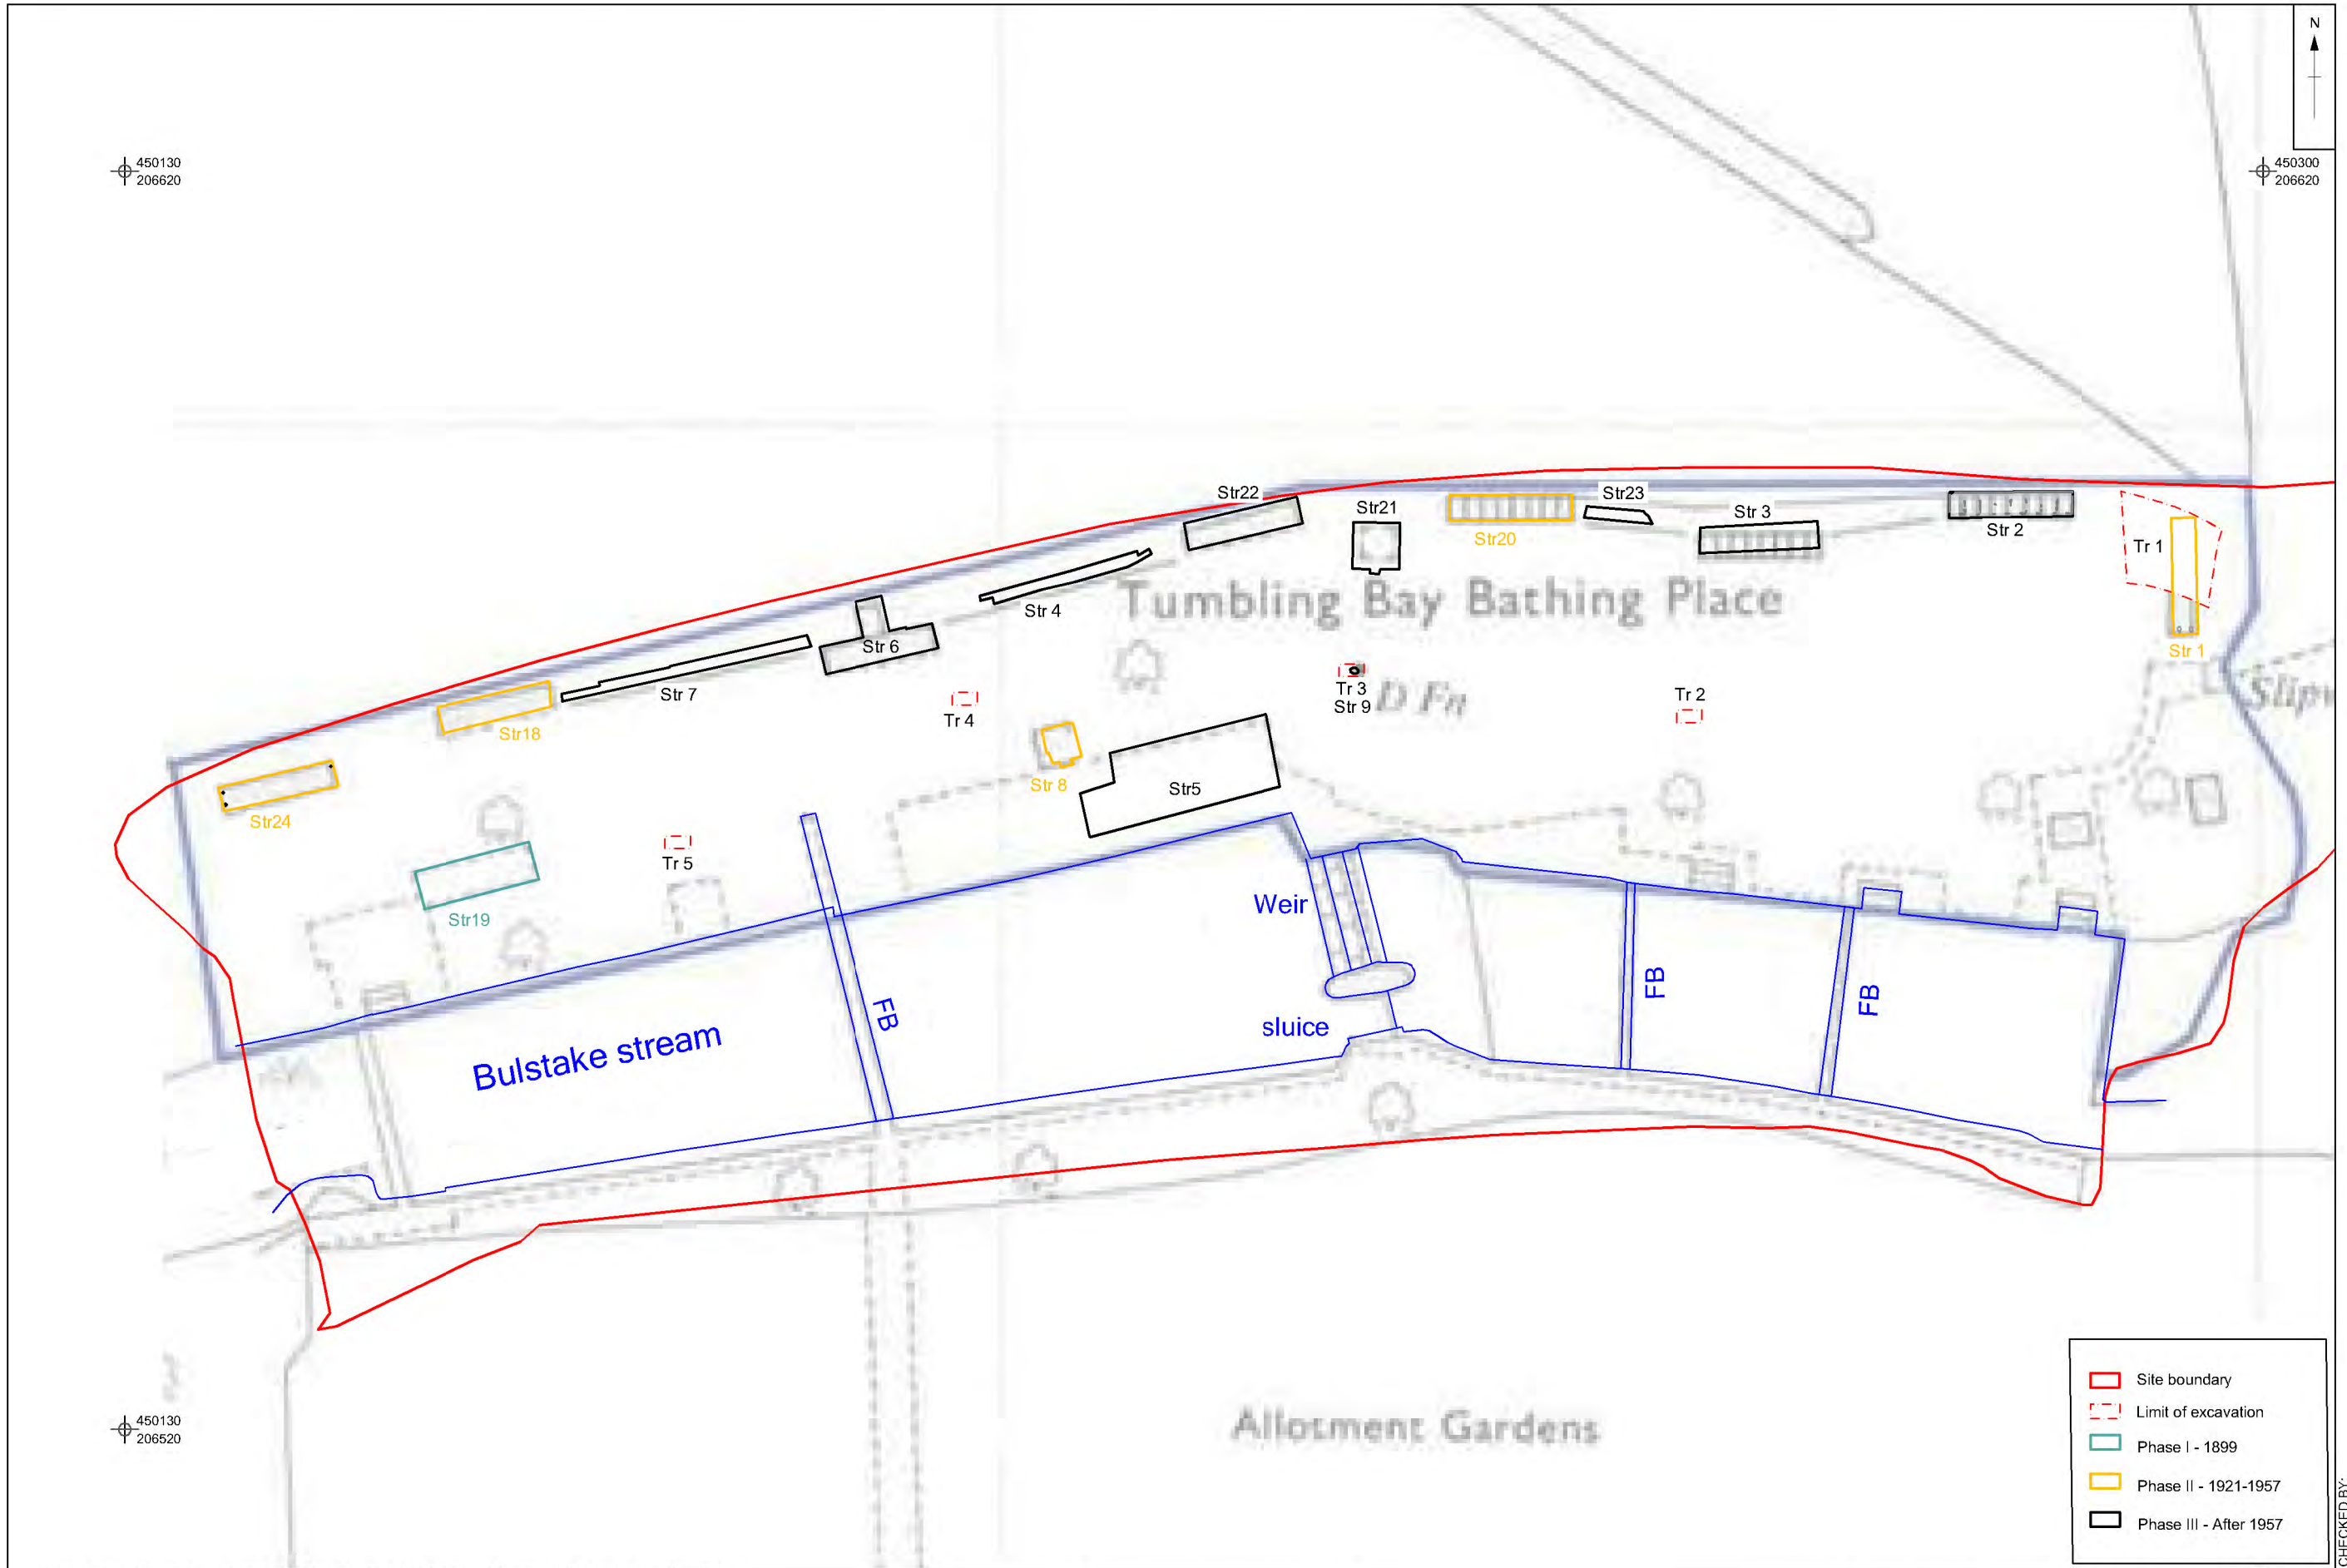
4.2.2 The Tumbling Bay bathing place was established in the mid-19th century. According to the 1876 Ordnance Survey map it originally consisted of two areas (Fig. 3). A toll house associated with a ferry-crossing point were at this time surrounded by parkland that stretched from the River Thames and further westwards to the sluice. The bathing facilities were located within an 80m wide area along the Bulstake Stream east of the sluice gate. It comprised a north-south L-shaped building by the sluice and two smaller east-west rectangular buildings positioned along the northern boundary. Four structures were recorded in the bathing area, but none in the parkland surrounding the toll house.

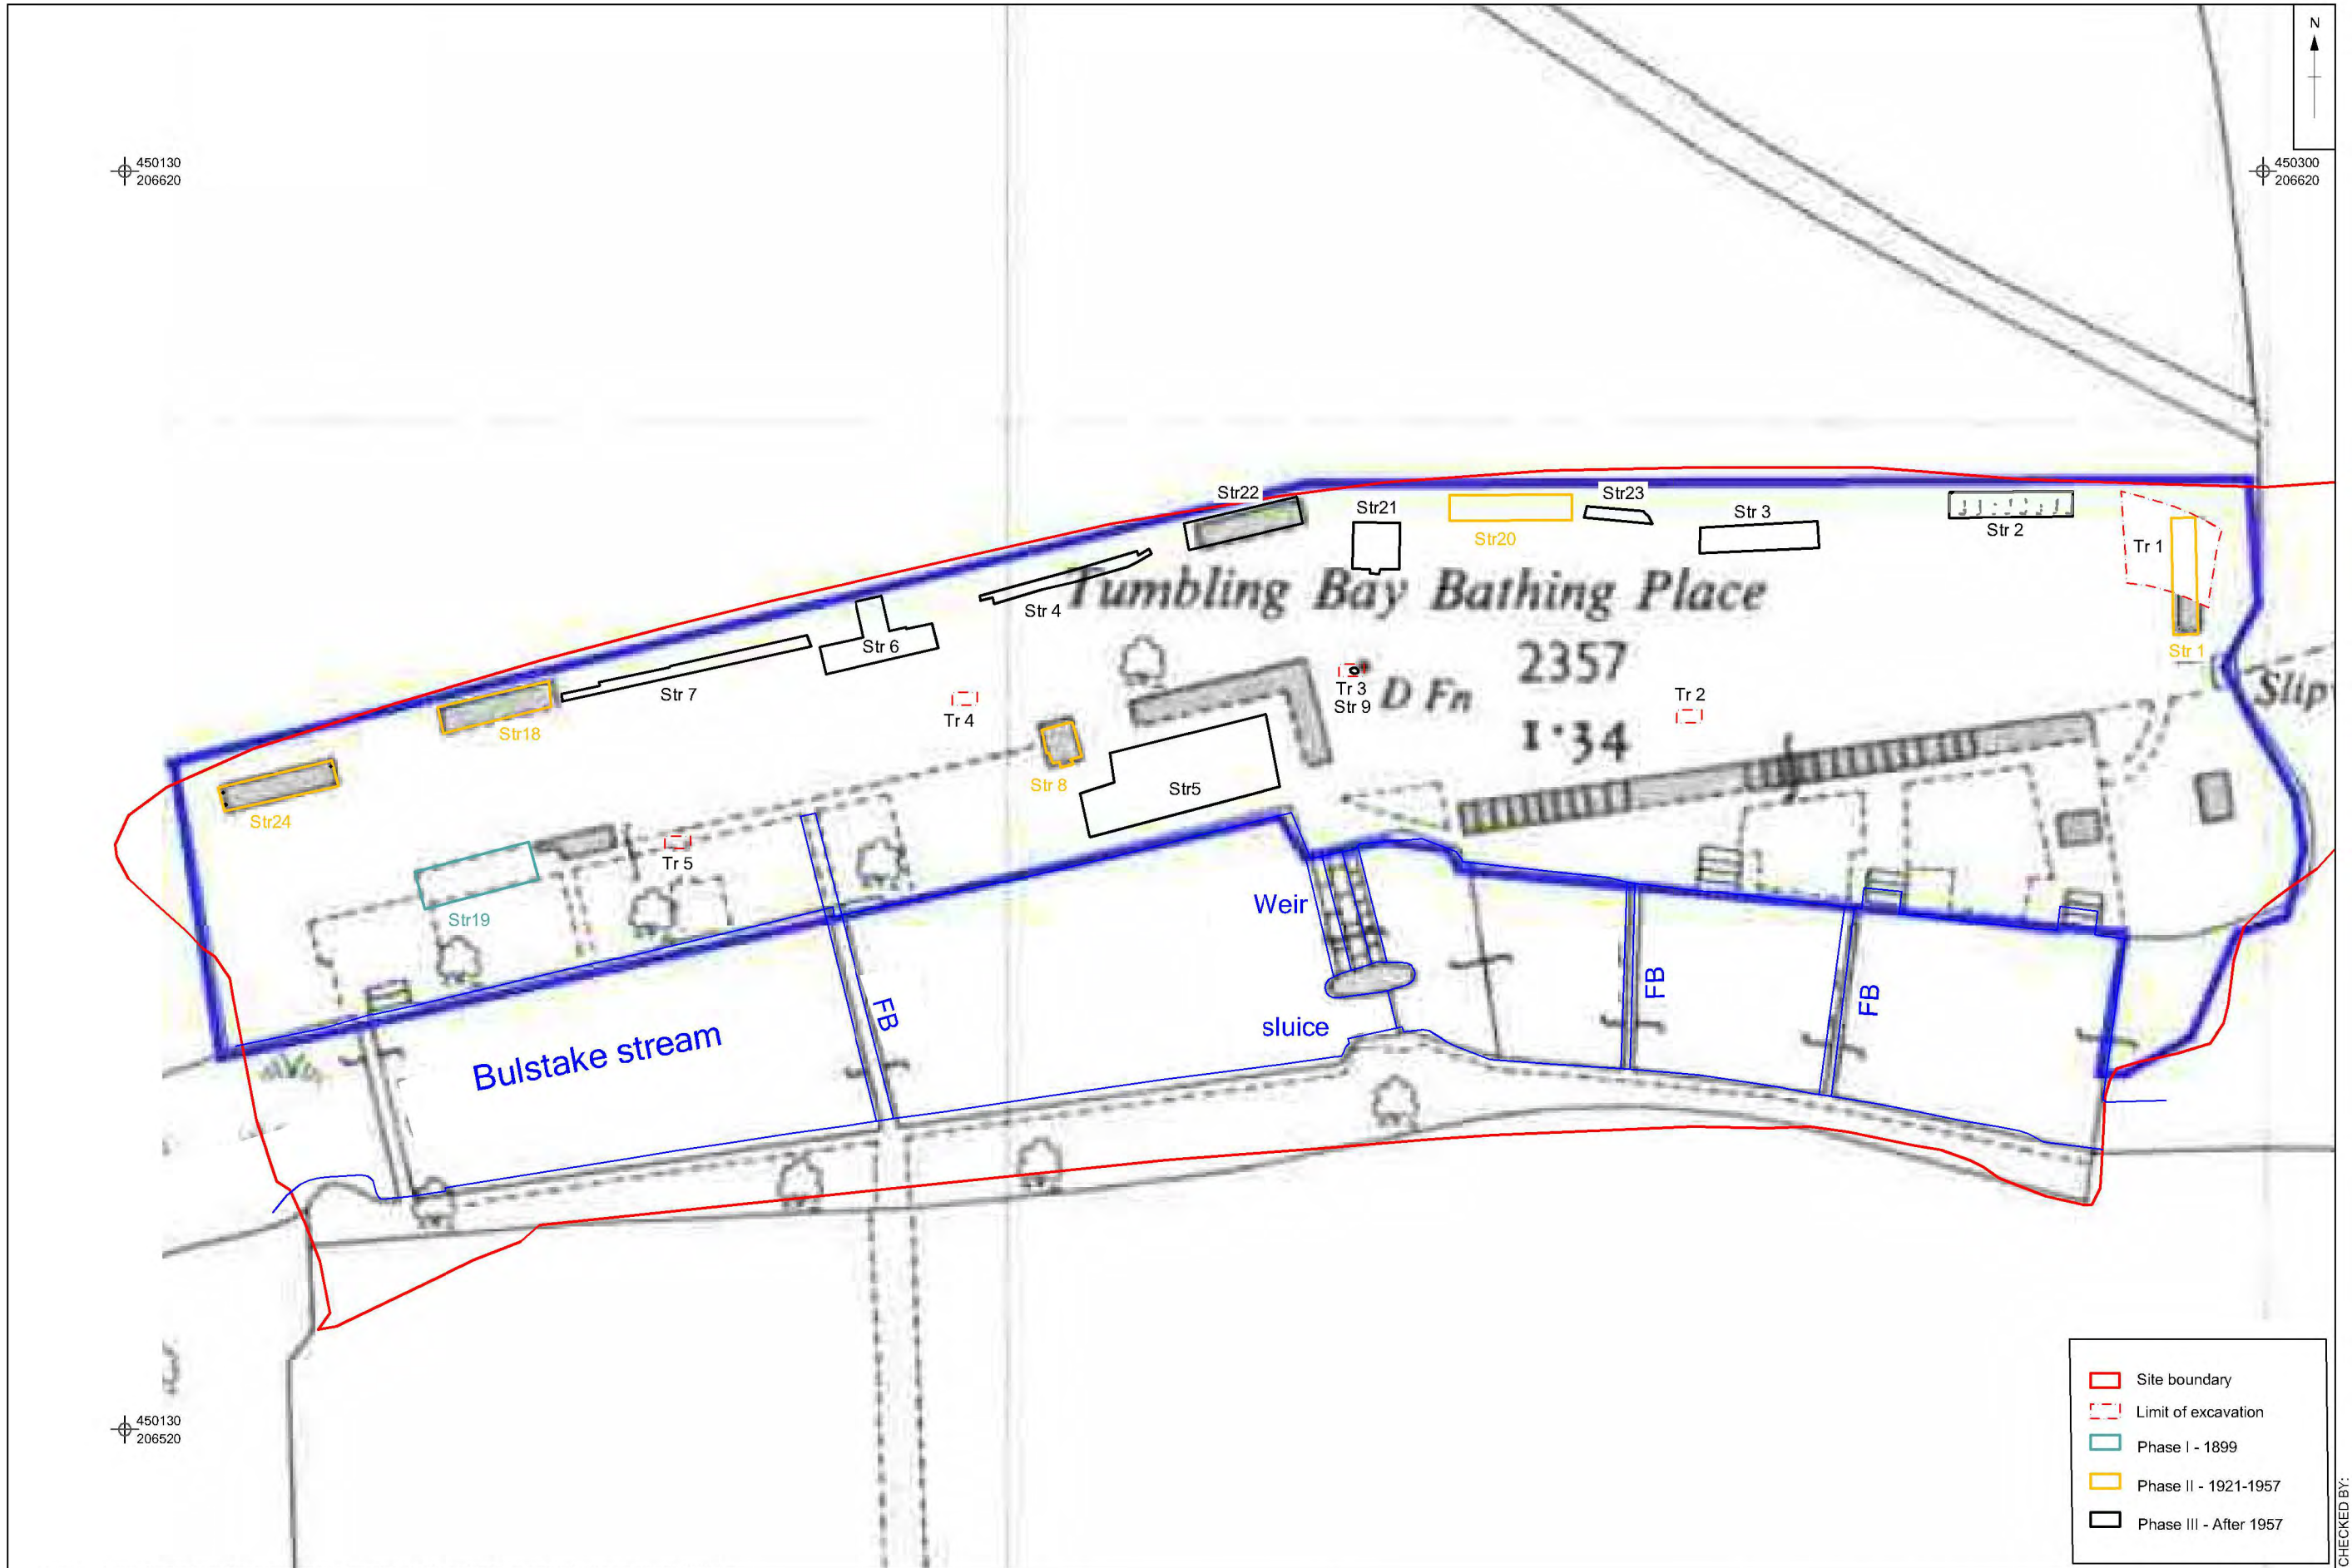
4.2.4 Map progression shows the development of Tumbling Bay bathing place into the 20th century (Fig. 4). By 1921 the bathing area had been expanded to the north and east. The natural bank of the Bulstake Stream had been consolidated along its northern side. Buildings had been built in the eastern part of the site. Between 1937 and 1957, further outbuildings were constructed along the northern and eastern boundaries of the site and four footbridges had been built over the stream. The stream had now taken the form of rectangular pools with concrete sides and steps, which are evident at the site today.

- 4.2.6 Six of the recorded structures can be identified on the 1957 National Grid map (Fig. 4). The buildings in the very north-eastern and north-western (S1, S24) edges of the site functioned as toilets (Plates 2–3). Between these and aligned with the northern boundary, there were two rectangular buildings, possibly locker rooms. A square-shaped and high building foundation (S8) was located midway north of the pool located east of the sluice. Remains of brick walls suggest that it had a sturdier construction than the toilet buildings and probably functioned as a lifeguard house. Finally, a 0.5m-diameter stone foundation was located in the north-eastern corner of the bathing place area (S9). It appears on the 1957 and 1969 National Grid maps and is labelled “D Fn”, probably denoting a datum point and/or the location of a flagpole.

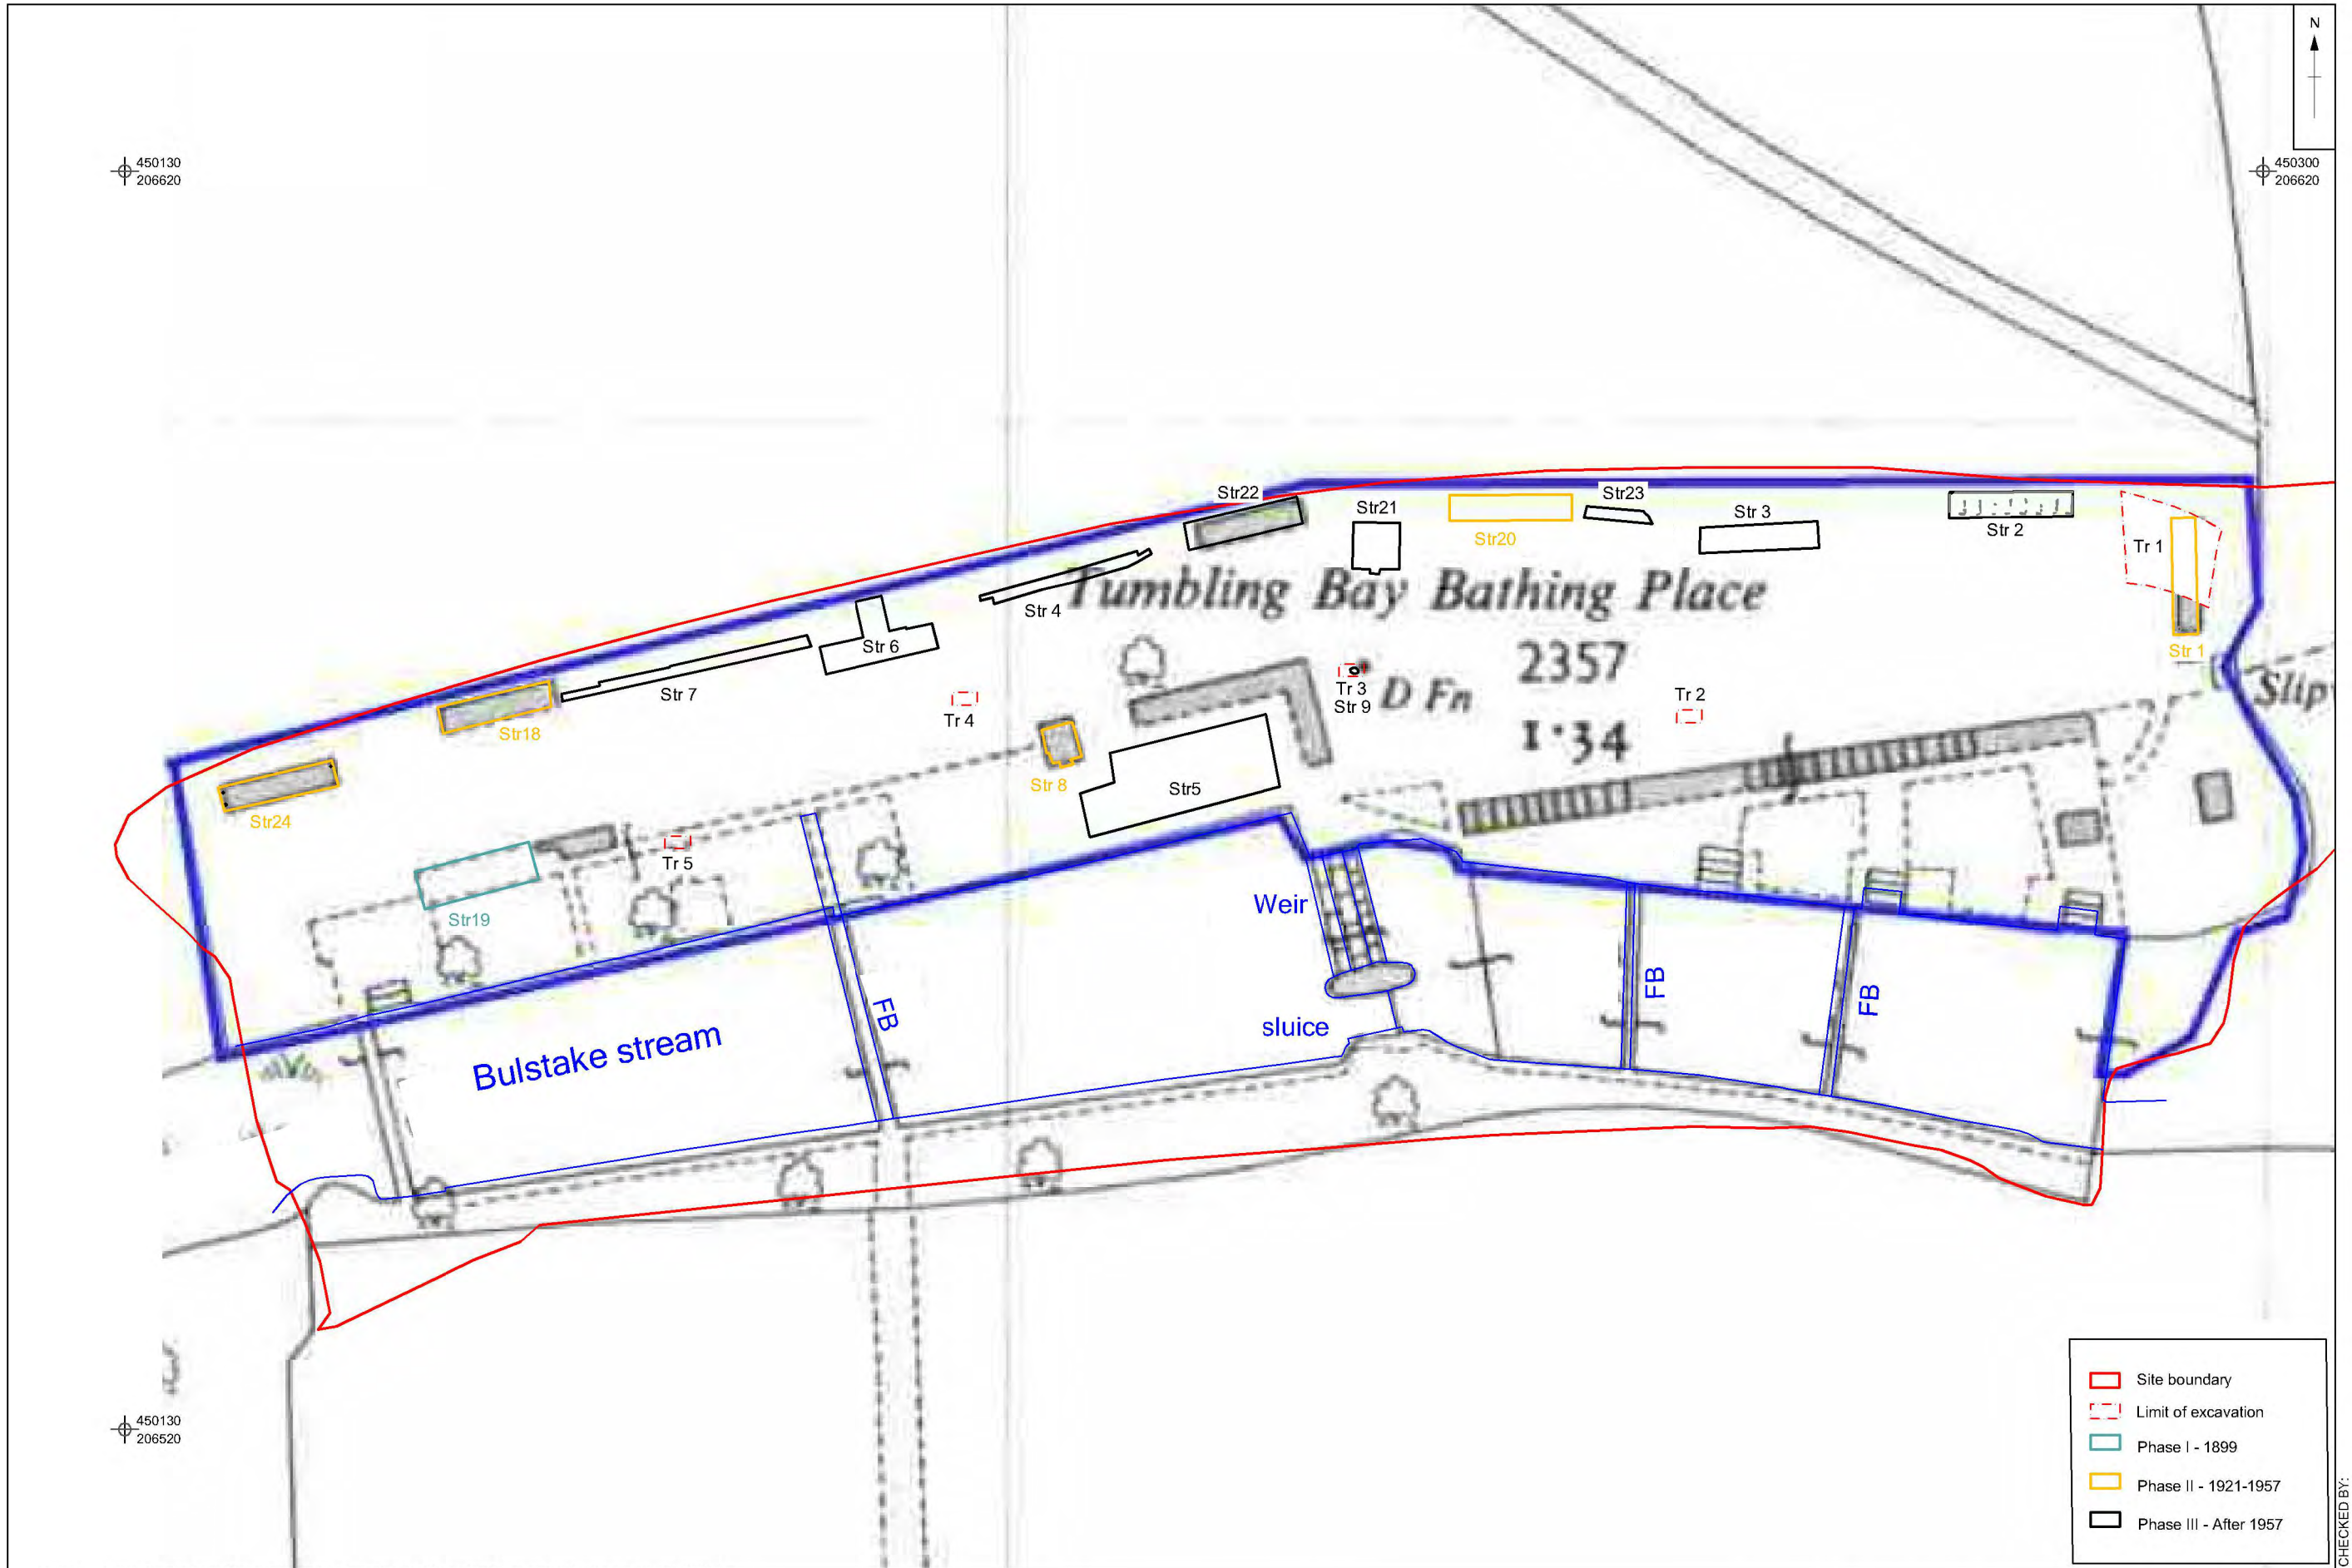
Figure 5: Structures overlaid on the 1969-72 OS National Grid Series Ordnance Survey Map

- 4.2.8 All five buildings first appearing on the 1969 National Grid map were recorded during the watching brief (Fig. 5). Three of these, S2, S3 and S20 (Plates 4–5) had interior brick-built divisions, likely functioned as locker rooms. Another square-shaped and high concrete foundation (S21), situated in the central northern part of the site overlooking the bathing facilities, was probably used as a guard house. Several concrete pavements, one with remains of a brick wall and floor tiling (S7), connected several of the east-west aligned buildings along the northern boundary.

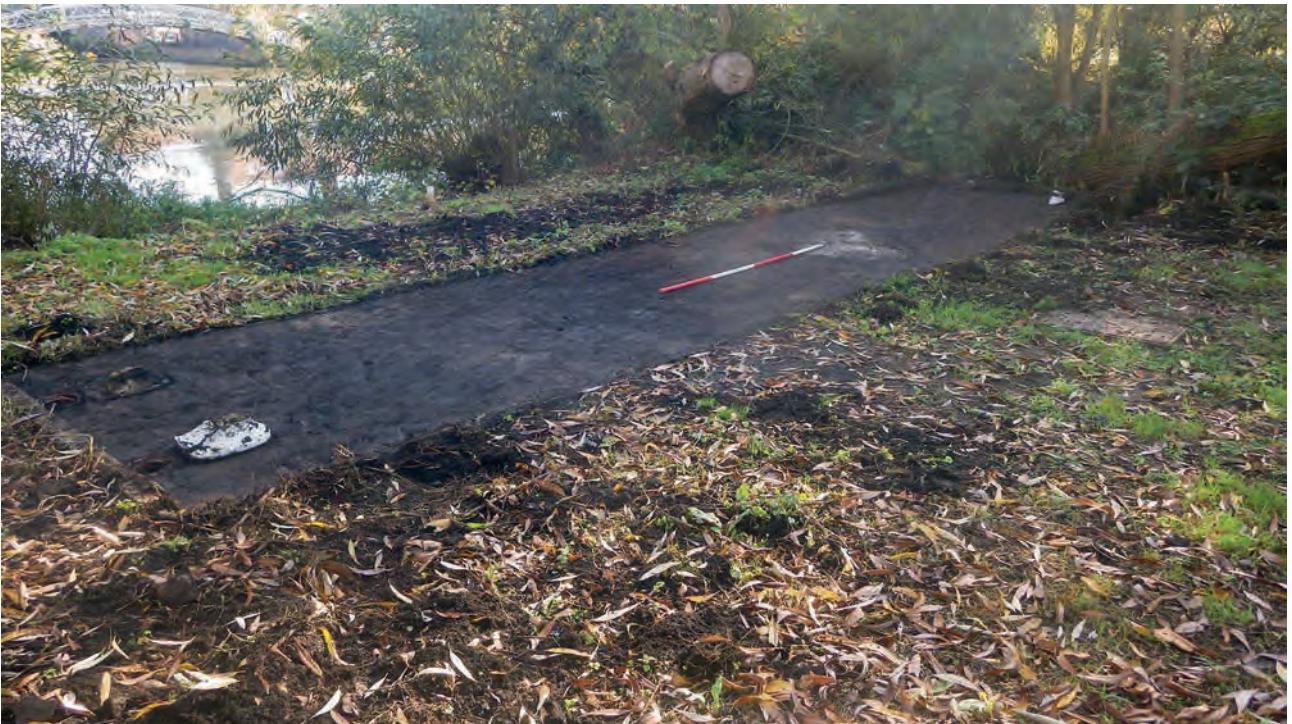
- 3.3.2 The building foundations mostly comprised rectangular concrete slabs. With the exception of S1 (Plates 2–3), all the structures had an east-west alignment with their southern long sides facing Bulstake Stream. Remains of brick walls were observed in relation to S2, S3, S8 and S20 (Plates 4, 5 and 8). Preserved concrete paving was observed in relation to S8 (Plate 8). Sewage pipes and lavatory porcelain were found in association with S1 and S24 at the very eastern and western ends of the site.

Plate 2: Structure 1, facing north

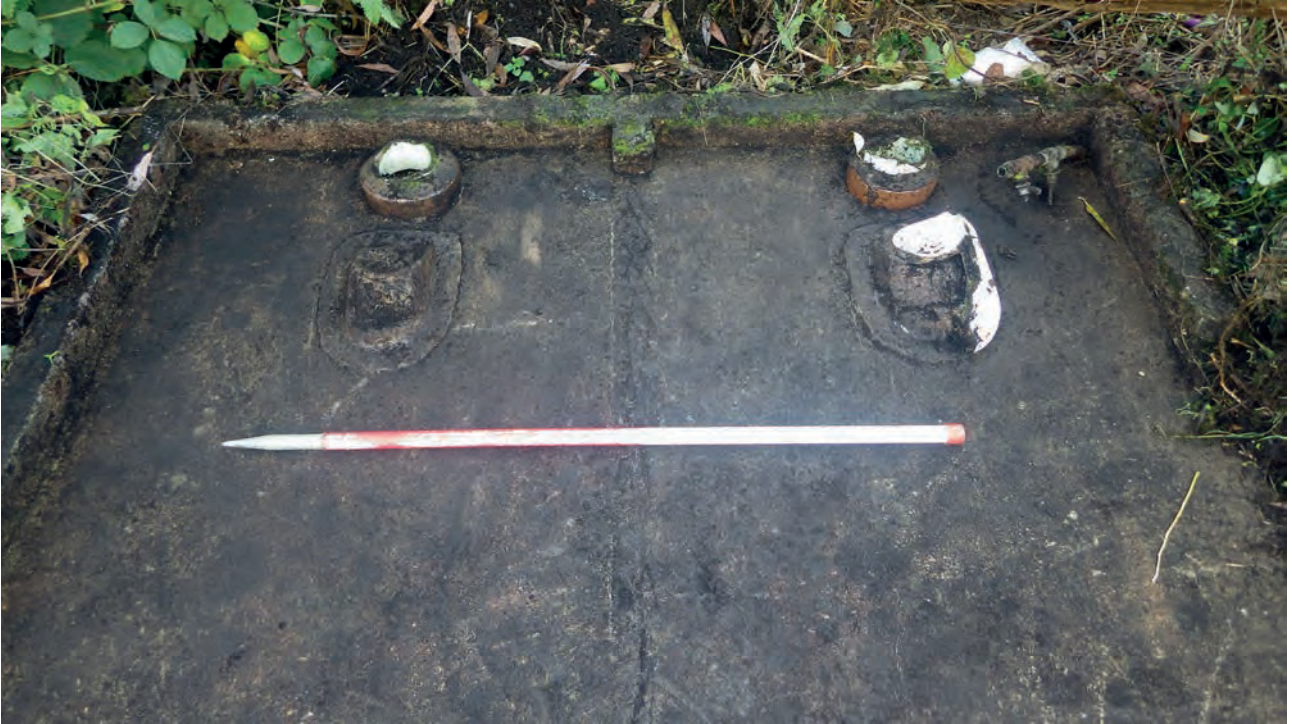
Plate 3: Structure 1, detail of toilet cubicles facing south

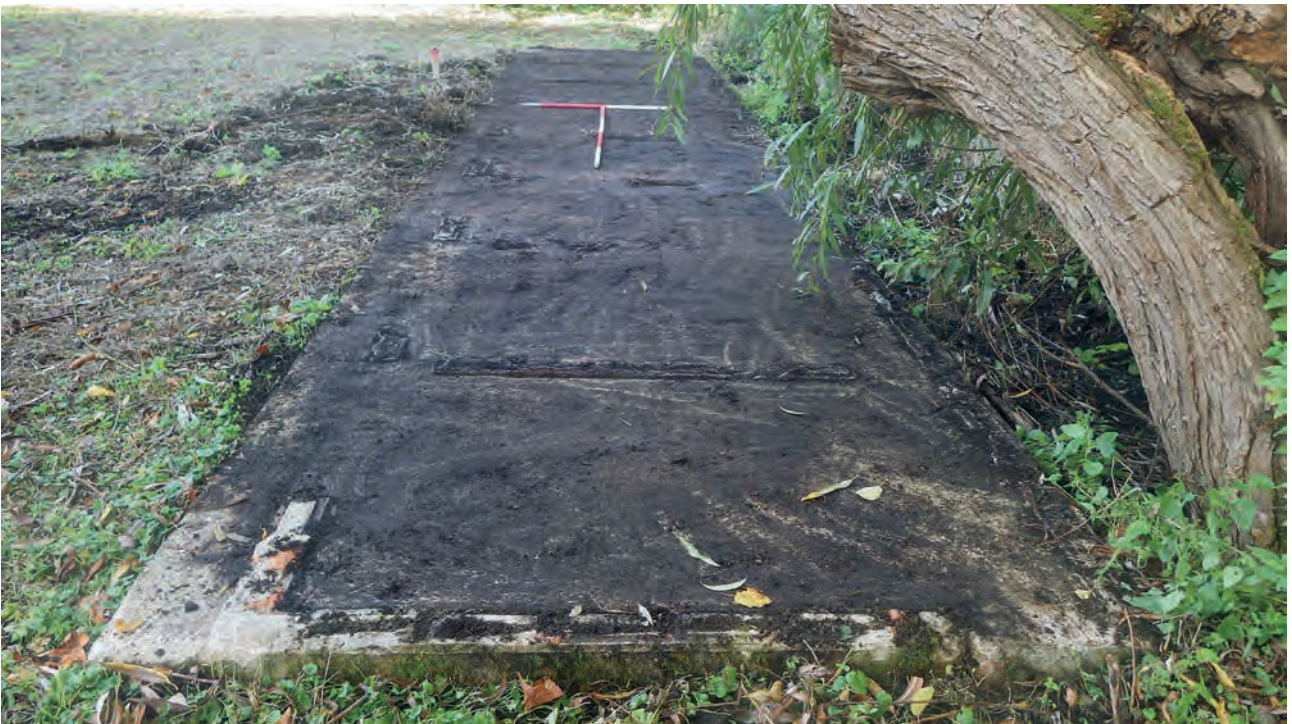
Plate 4: Structure 2, brick foundations of locker rooms visible, facing west

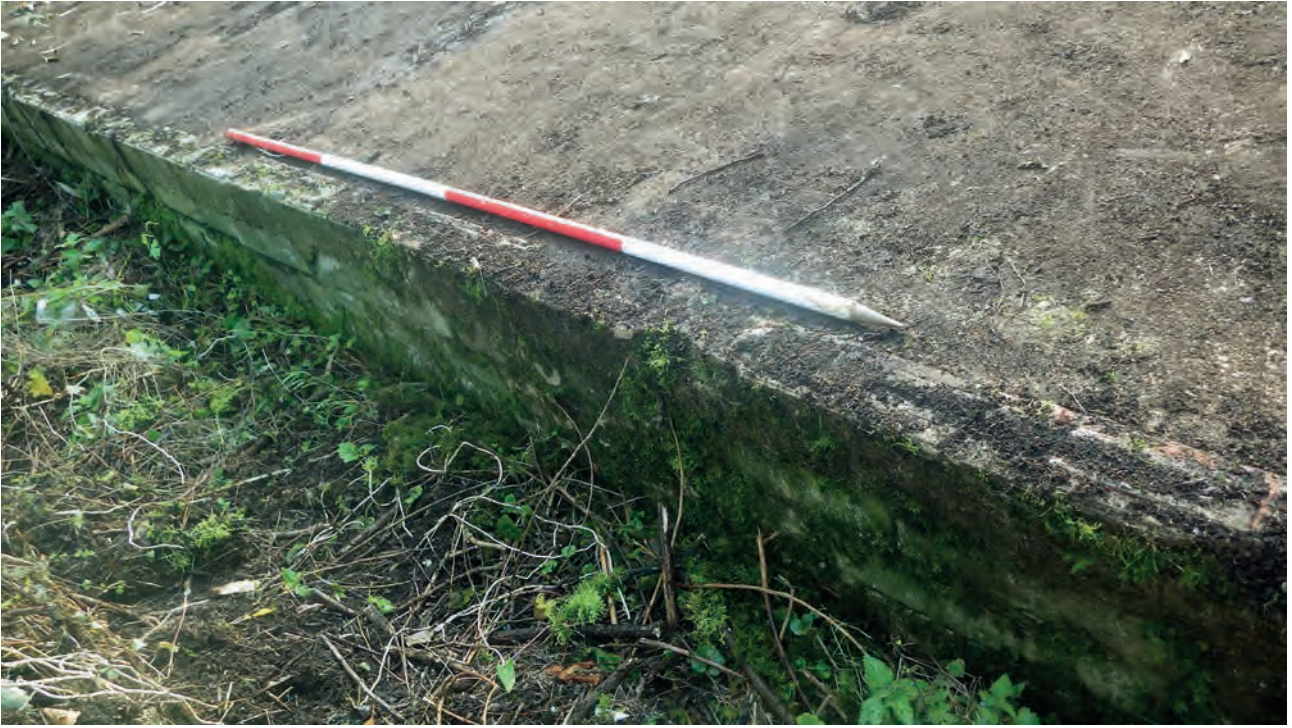
Plate 5: Structure 2, foundation of outer wall

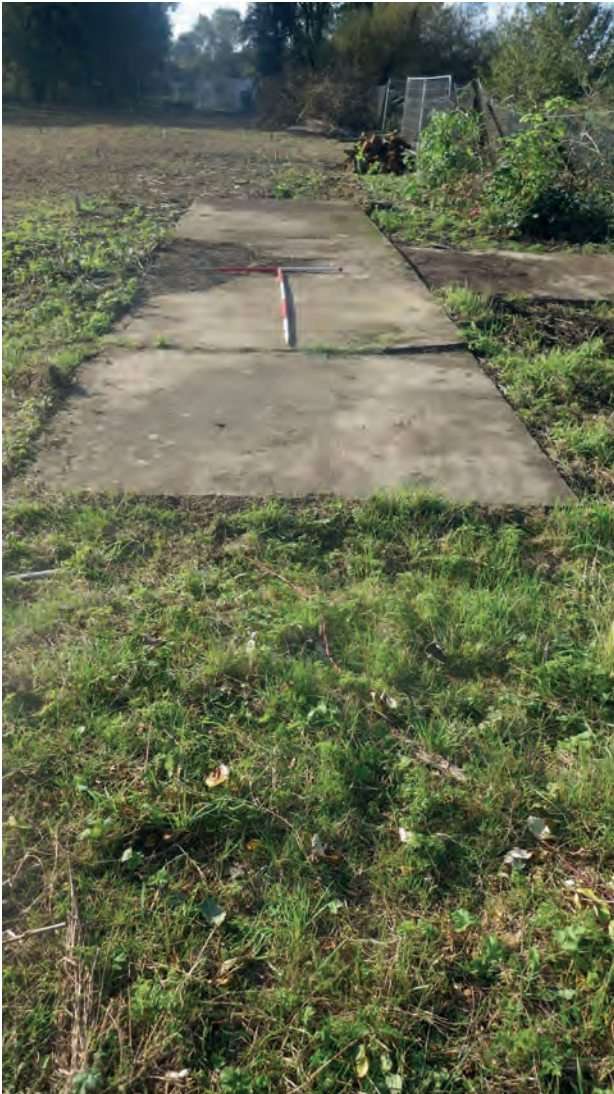
Structure 6						
General description					Orientation	E-W
T-shaped concrete foundation pad. Depth not visible from surface. Had an extension, comprising a square pad, to the north of the main rectangular pad measuring 3m long x 2.13m wide.					Length (m)	9.16
					Width (m)	2.05
					Avg. depth (m)	/
Context No.	Type	Width (m)	Depth (m)	Description	Finds	Date
6	Structure	2.05	/	Concrete foundation pad	-	-

Plate 6: Structure 6, facing west

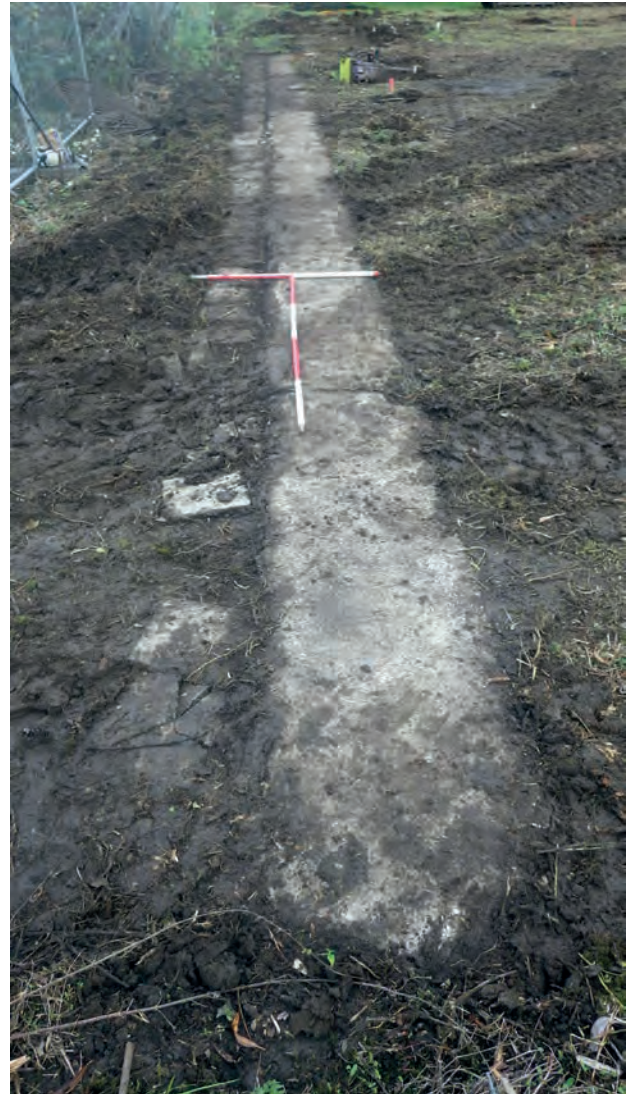
- 3.3.4 The pavements were of two types. Three long and narrow platforms found in S4, S7 and 23 (Plates 7 and 10) were aligned with the northern boundary of the site. Remains

Structure 7						
General description					Orientation	E-W
Concrete foundation walkway or wall. Depth not visible from surface. Comprised long concrete walkway, floor tiling, and brickwork.					Length (m)	20.30
					Width (m)	1.06
					Avg. depth (m)	/
Context No.	Type	Width (m)	Length (m)	Description	Finds	Date
7:1	Structure	0.62	20.3	Concrete walkway	-	-
7:2	Structure	0.33	19.5	Tiling		
7:3	Structure	0.11	10.8	Brickwork

Plate 7: Structure 7, facing east

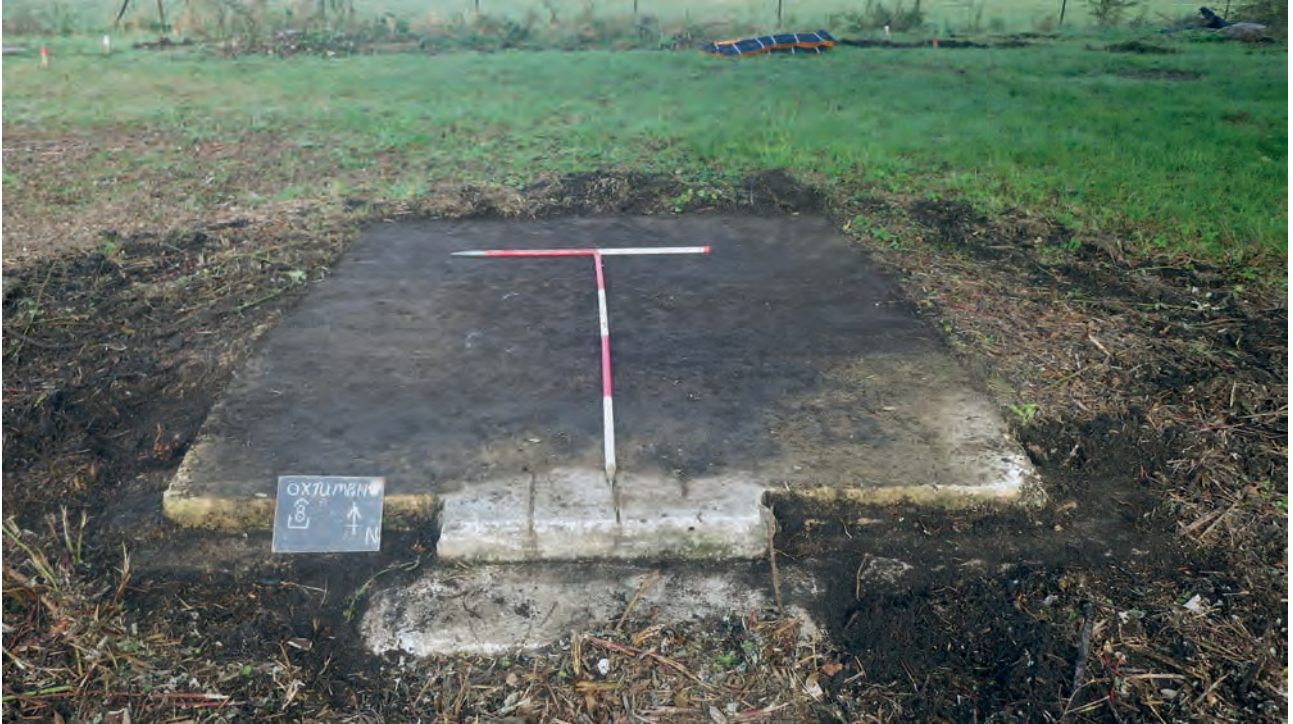
- 3.3.3 Two of the building foundations were square shaped. Remains of brick walls were observed on the southern platform of S8 (Plate 8). Parts of a concrete paved floor were preserved on the northern foundation of S21 (Plate 9).

Structure 8						
General description					Orientation	N-S
Concrete foundation pad. Some brickwork at eastern and western edge. Concrete step and tiling at the southern end. Depth not visible from surface.					Length (m)	2.84
					Width (m)	2.58
					Avg. depth (m)	/
Context No.	Type	Width (m)	Length (m)	Description	Finds	Date
8:1	Structure	2.24	2.84	Concrete foundation pad	-	-
8:2	Structure	0.09	2.43	Eastern brickwork		
8:3	Structure	0.09	1.87	Western brickwork (partially broken)		
8:4	Structure	0.41	2.58	Concrete step		
8:5	Structure	0.25	0.77	Tiling

Plate 8: Structure 8, facing north

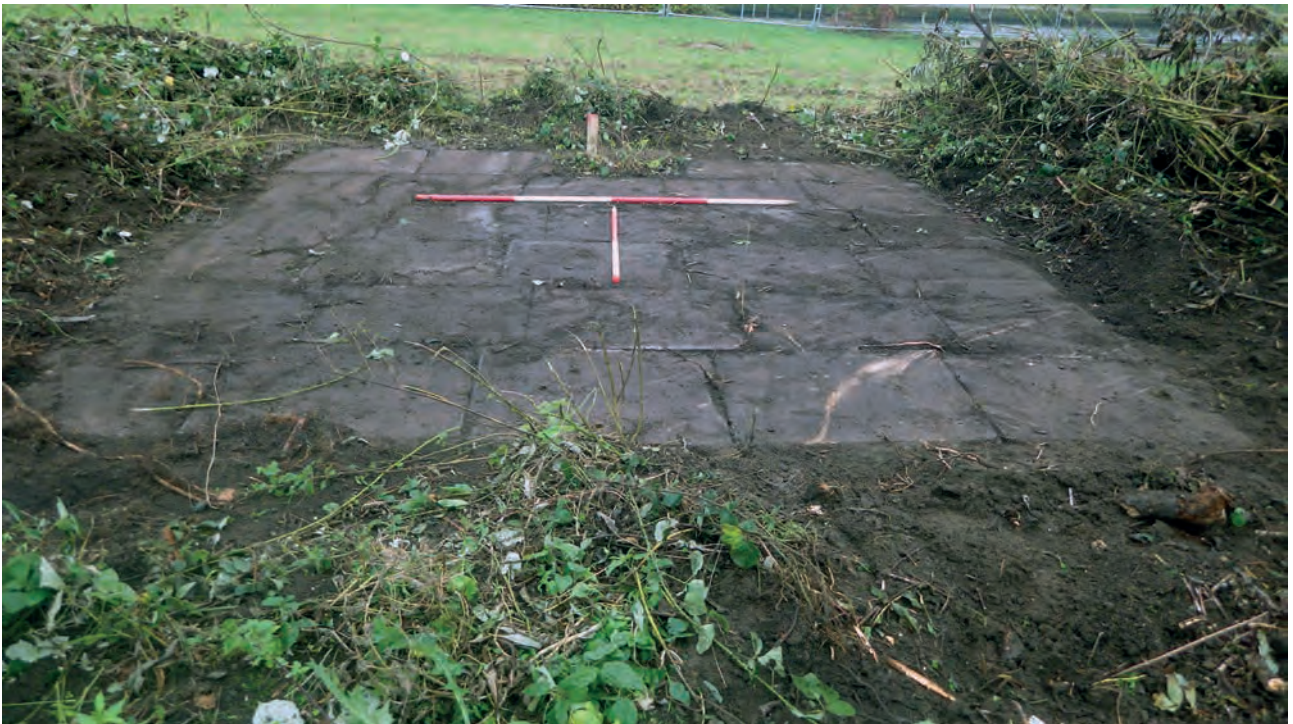
Plate 9: Structure 21, facing south
