Tumbling Bay, Oxford

Archaeological Watching Brief Report

December 2019

Client: Environment Agency

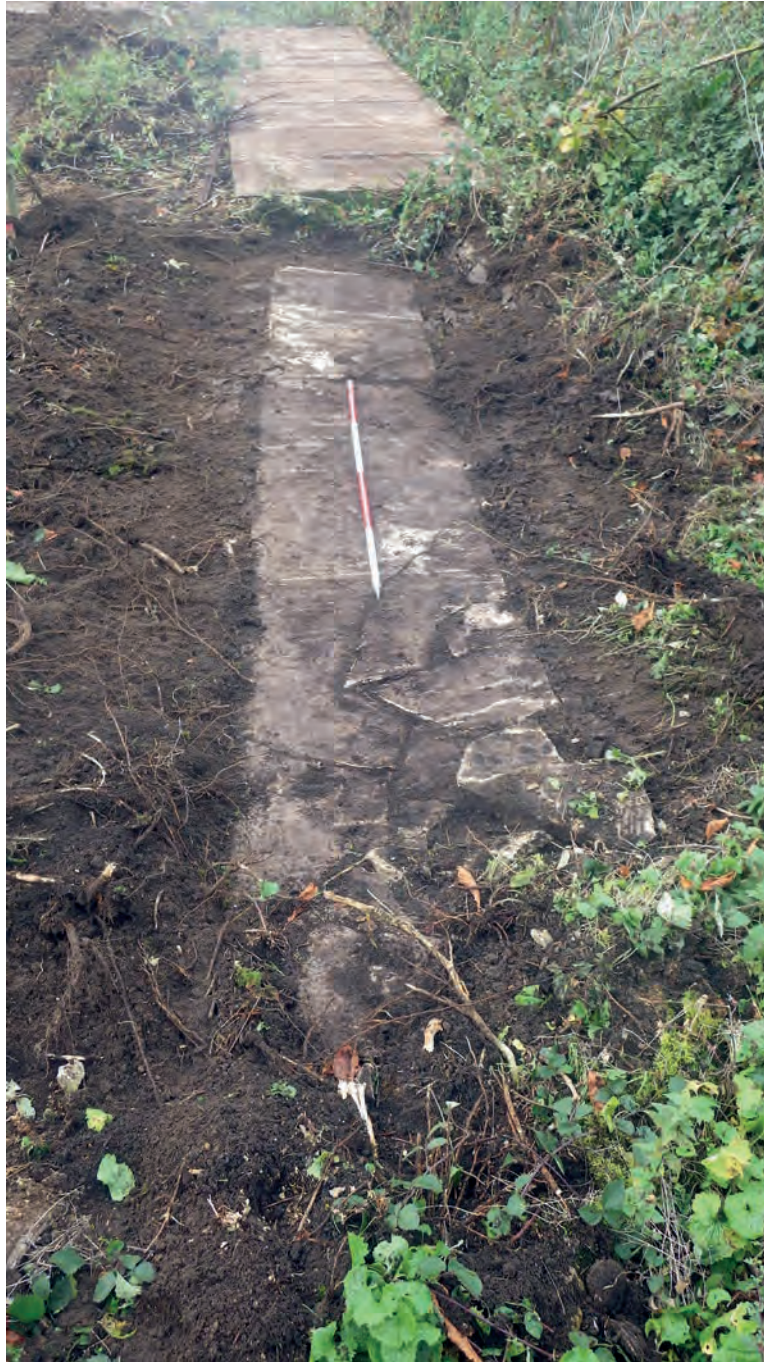
- 3.3.4 The pavements were of two types. Three long and narrow platforms found in S4, S7 and 23 (Plates 7 and 10) were aligned with the northern boundary of the site. Remains

Plate 10: Structure 23, facing west
